PERFORMANCE MONITORING OF PRESERVATION TREATMENTS IN HONOLULU

FINAL PROJECT REPORT

Adrián Ricardo Archilla University of Hawaii at Manoa

May 2019

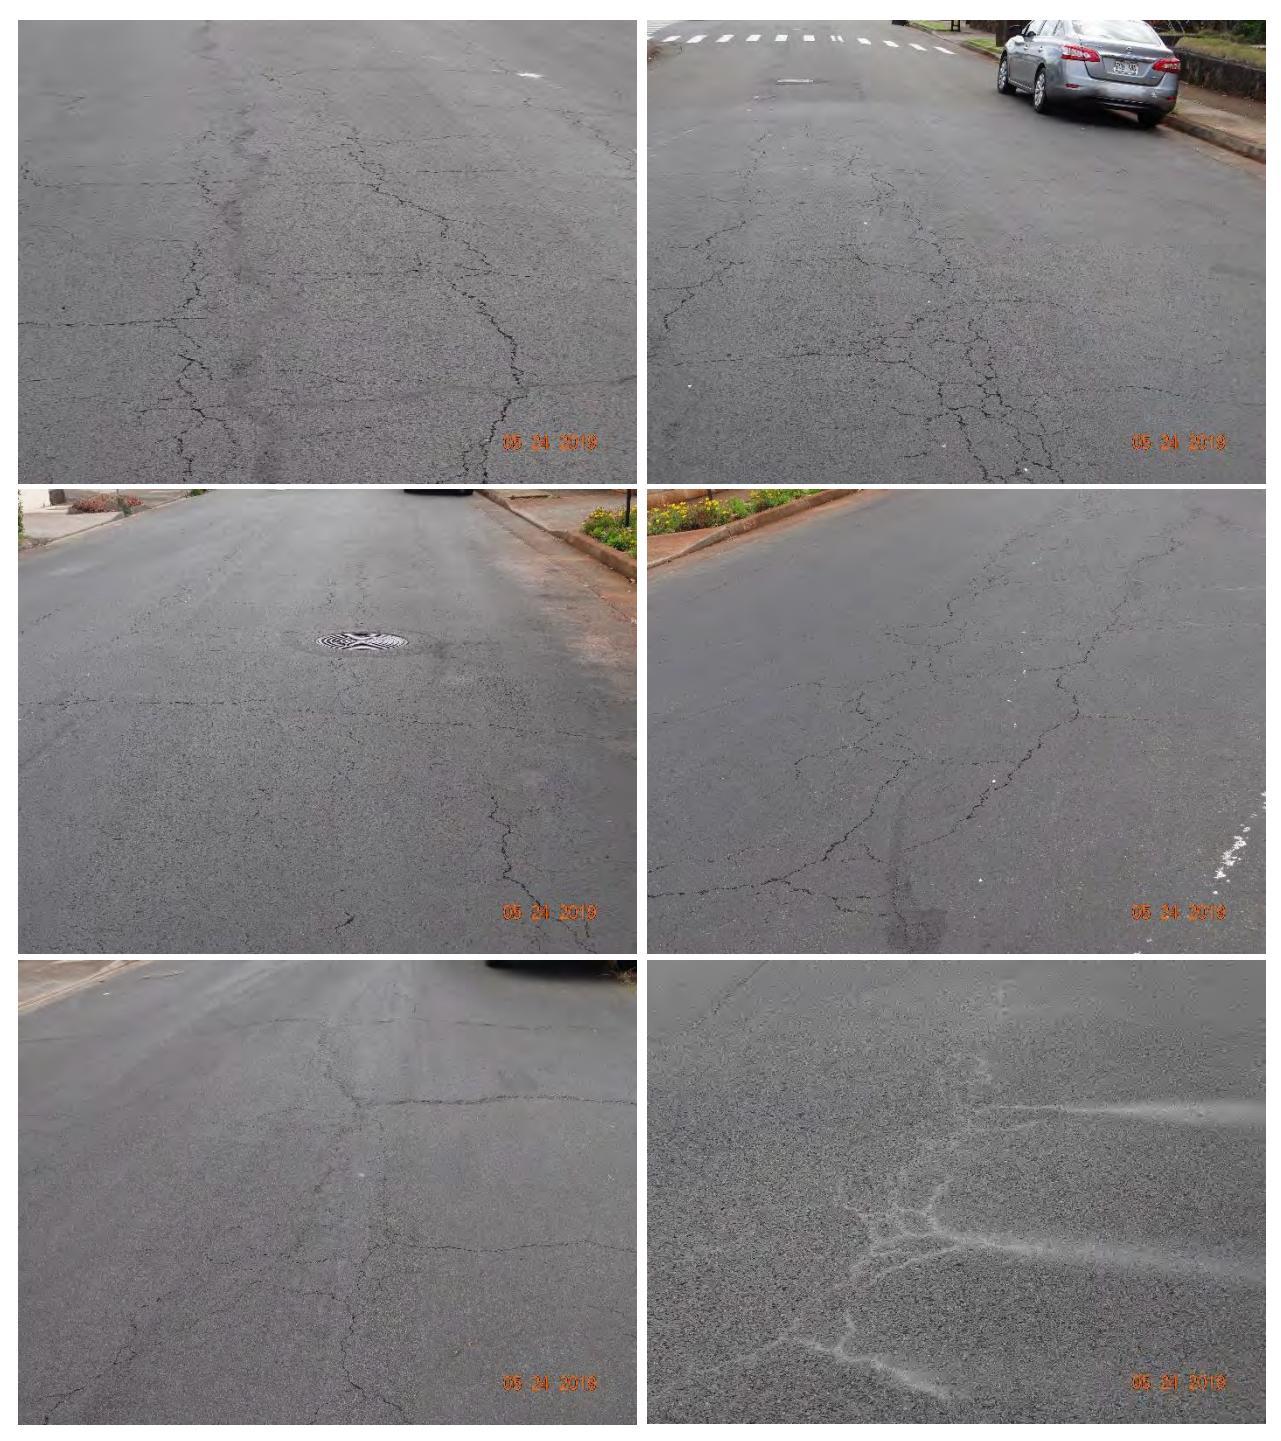
Figure 4-33 Fatigue cracking progression in the sections with bus traffic.

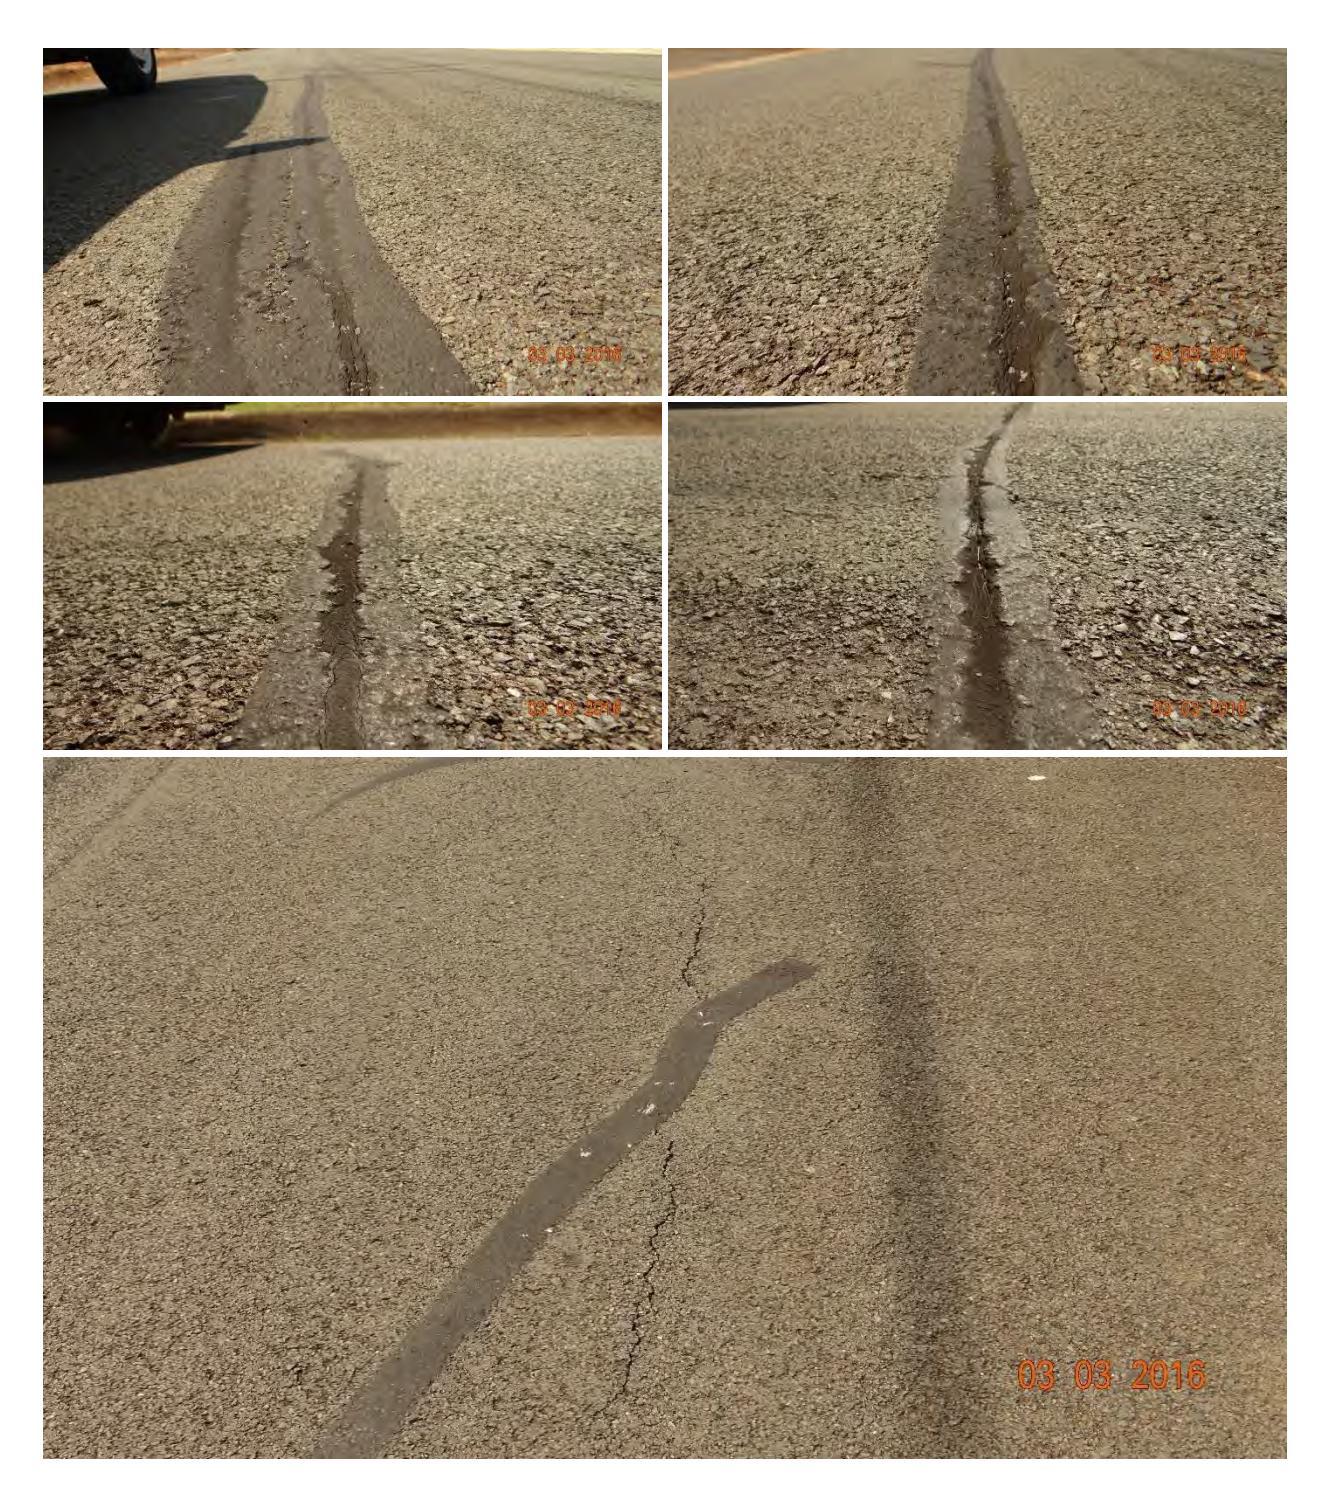
Figure C-6 Condition of crack sealing observed on Hoowali Street on 03/03/2016 (sealed with CrackMasterTM PL-HT).

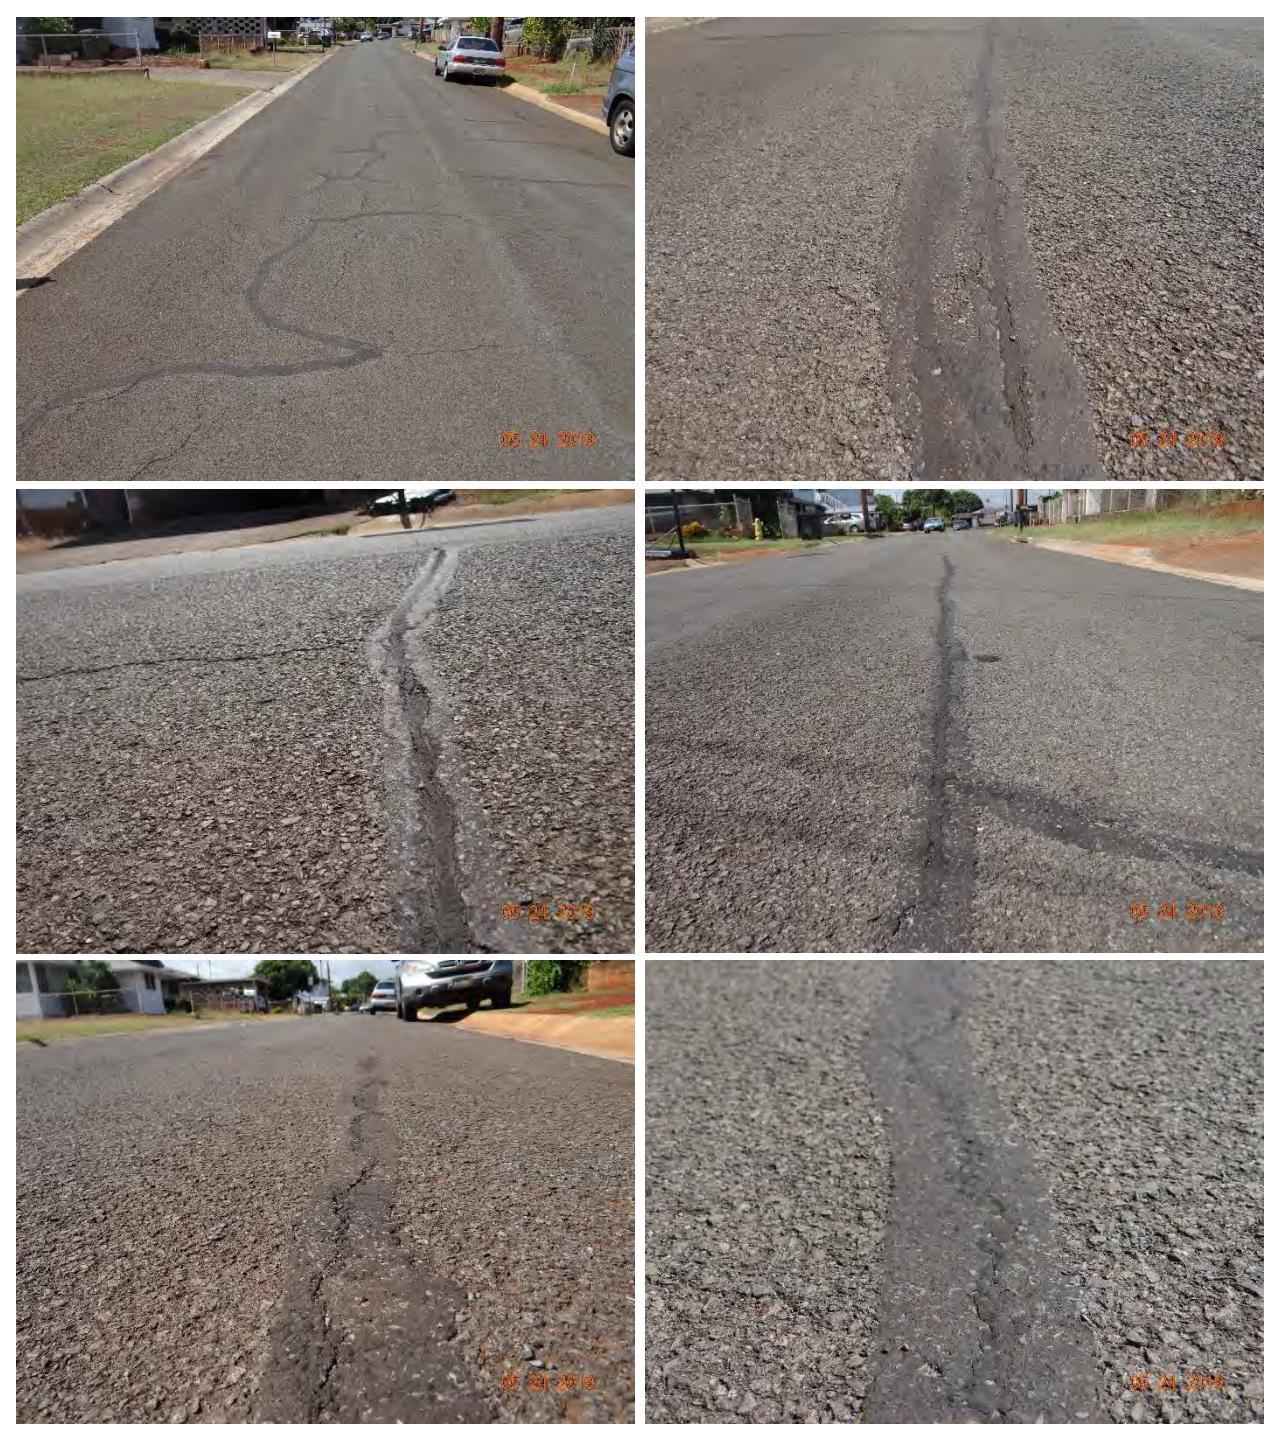
The condition of the sealer on 5/24/2019 is shown in Figure C-10. In routed cracks or in wide cracks, the crack sealer is still performing well after 4.5 years. Although no photo was taken, it can still be indented.

Figure C-10 Condition of crack sealing observed on Hoowali Street on 5/24/2019 (sealed with CrackMasterTM PL-HT).

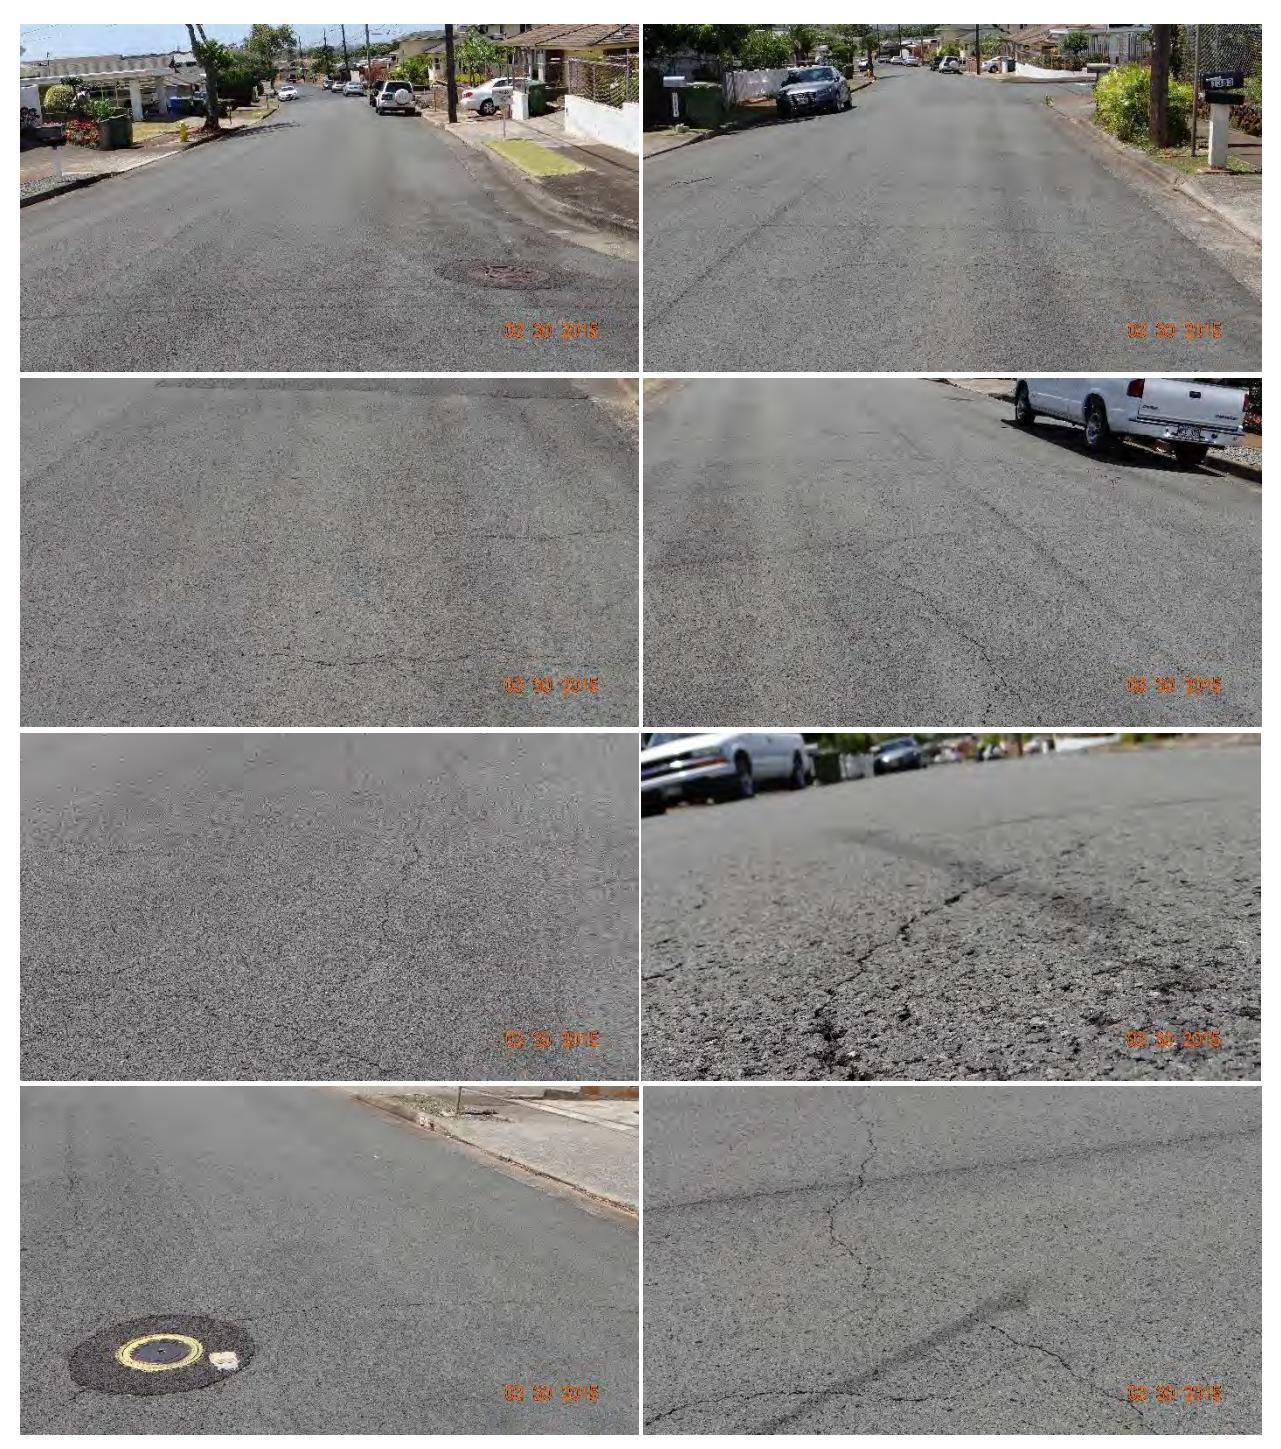
the joint, transverse cracking, and some block cracking. The cracking appeared to be for the most part environmentally related.

Figure C-50 Condition of Kaweloka Streets control section 3'on 03/30/2015.

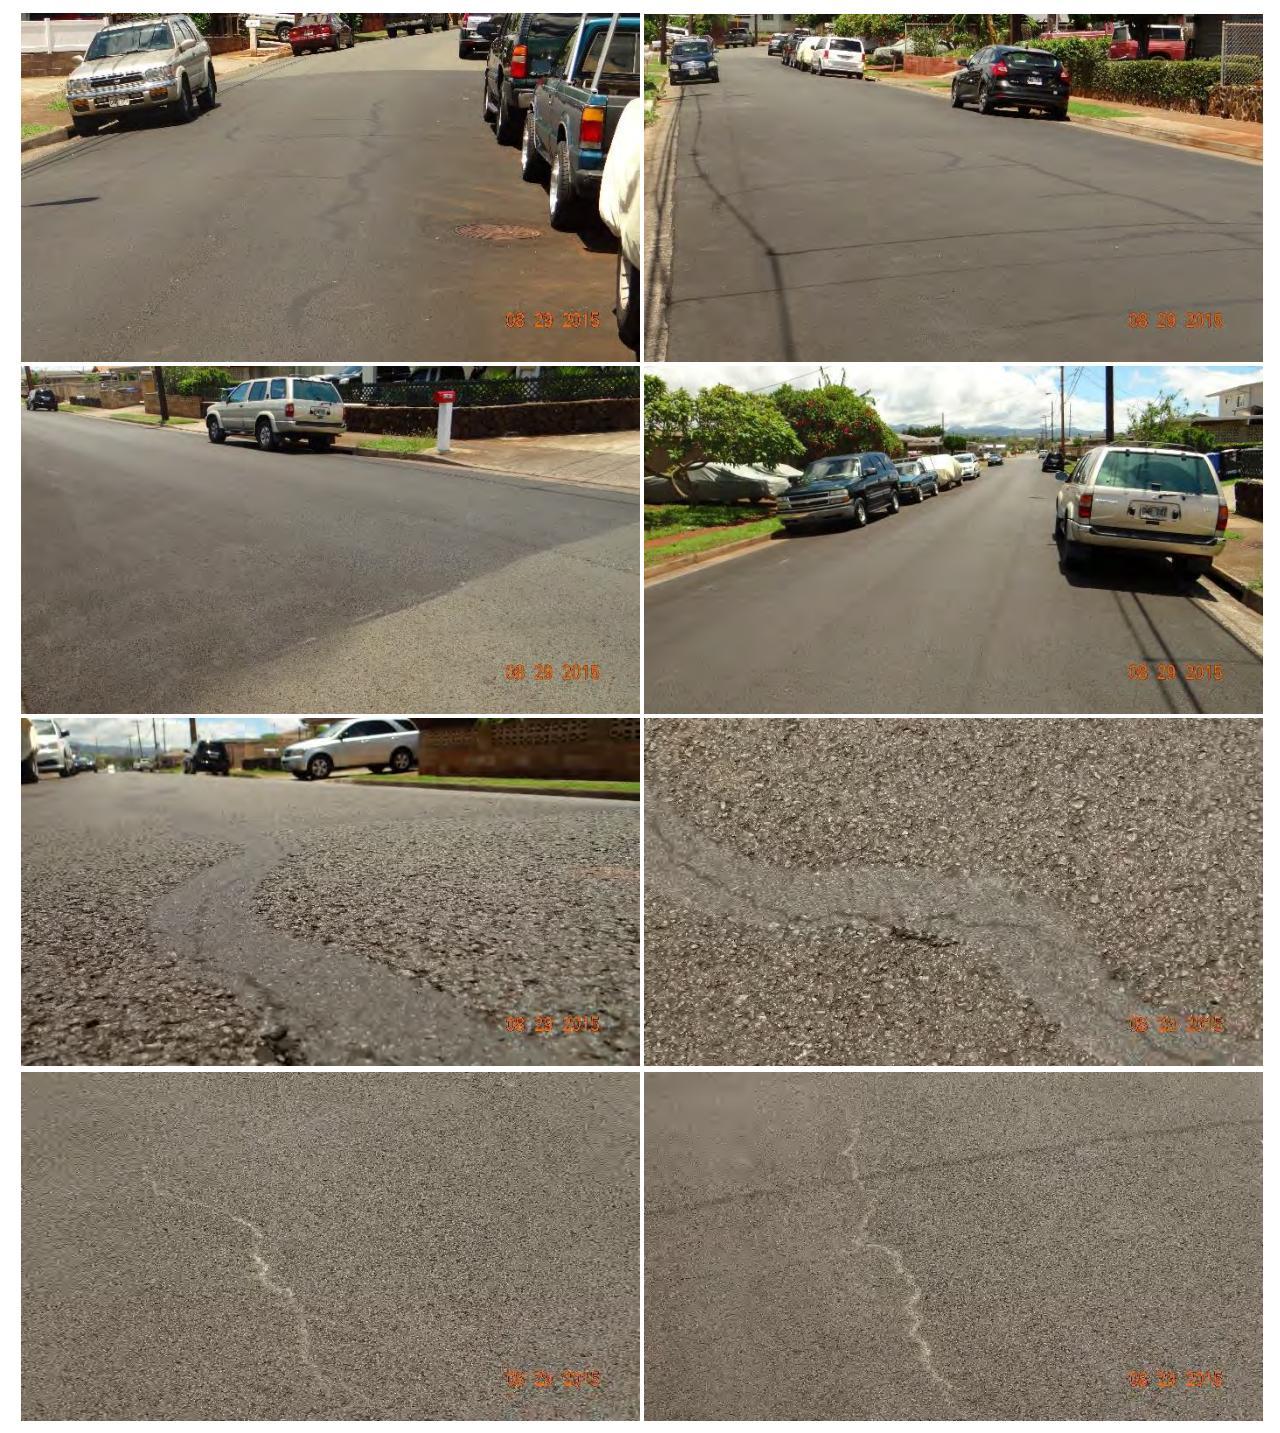
contrast between the treated section and the adjacent pavement still provided on 08/29/2015, more than nine months after the treatment application. The two photos on the third row show the sealed cracks were still sealed (even though most were relatively thin). The last two photos show that pumping of fines was still occurring.

Figure C-52 Condition of Kaweloka Street section 1, treated with Plasti-Pave, on 08/29/2015.

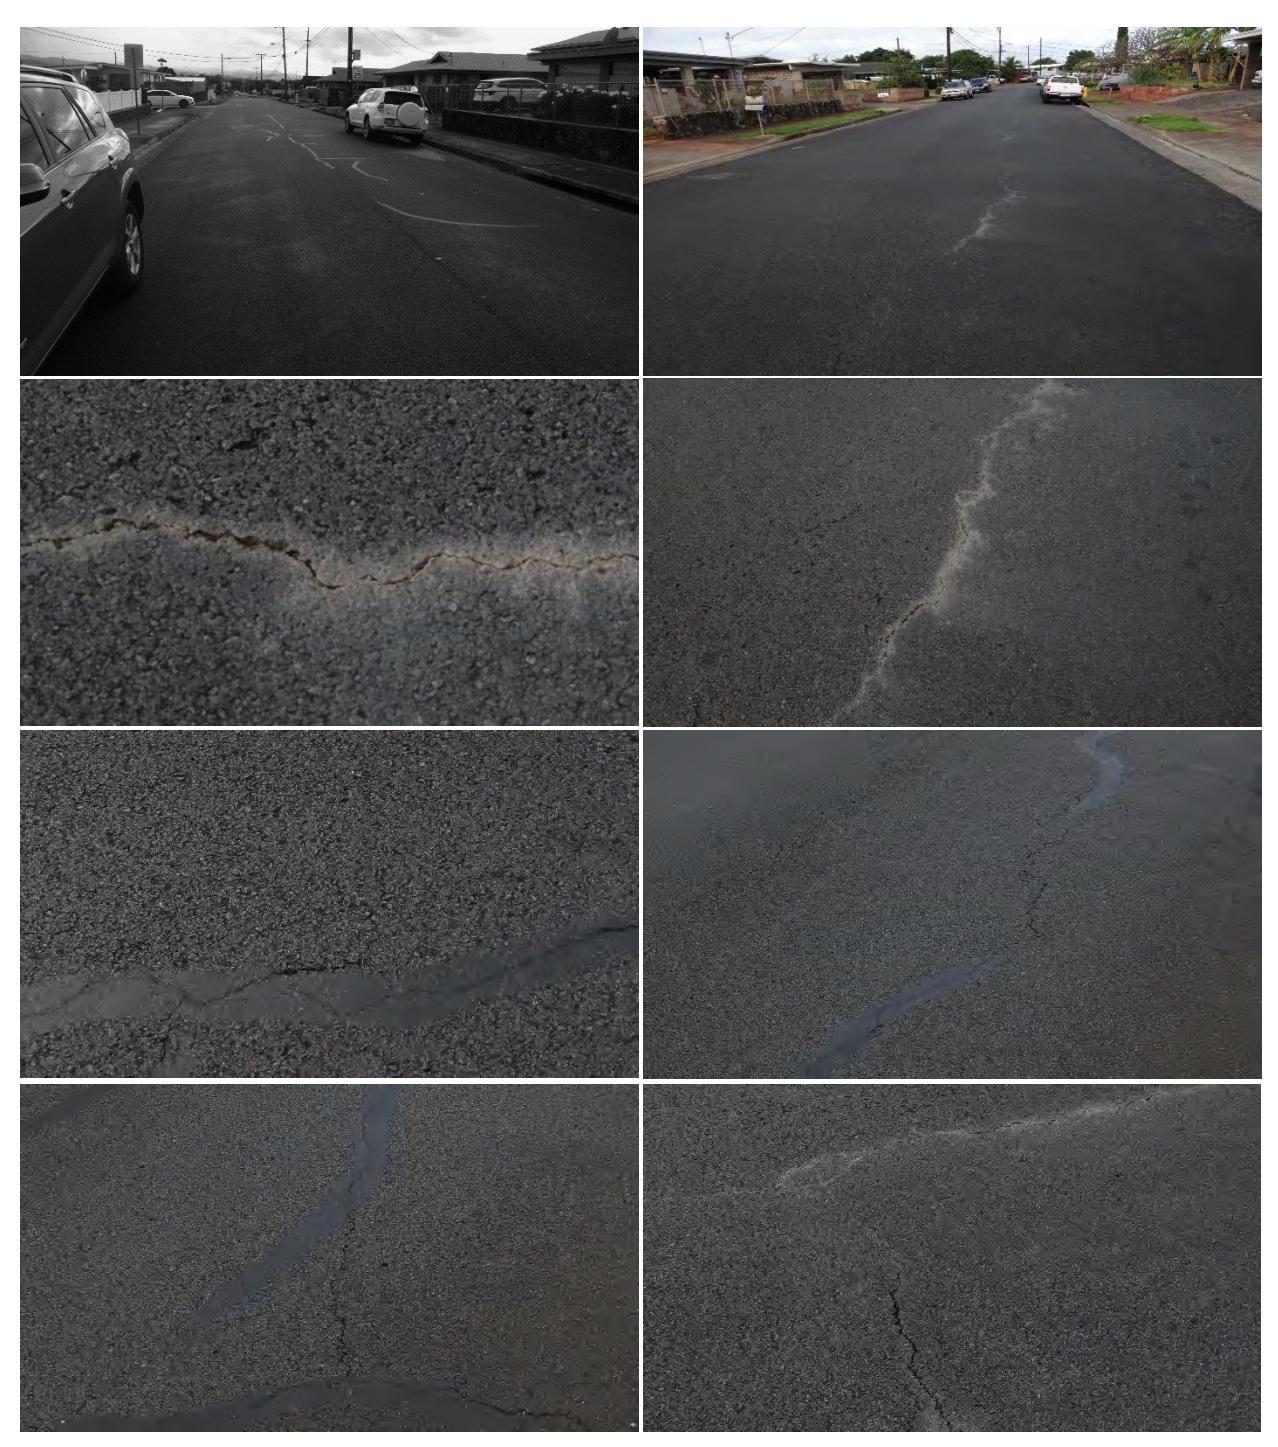
The photos in second row of Figure C-55 provide a closeup of the cracks with pumping issues. In addition to the fines, moisture in the cracks was evident. The other photos in the figure show how the sealed cracks continue propagating and the coexistence in the bottom right photo of load related cracks (longitudinal with pumping) and transverse cracks.

Figure C-55 Condition of Kaweloka Street section 1, treated with Plasti-Pave, on 12/13/2016.

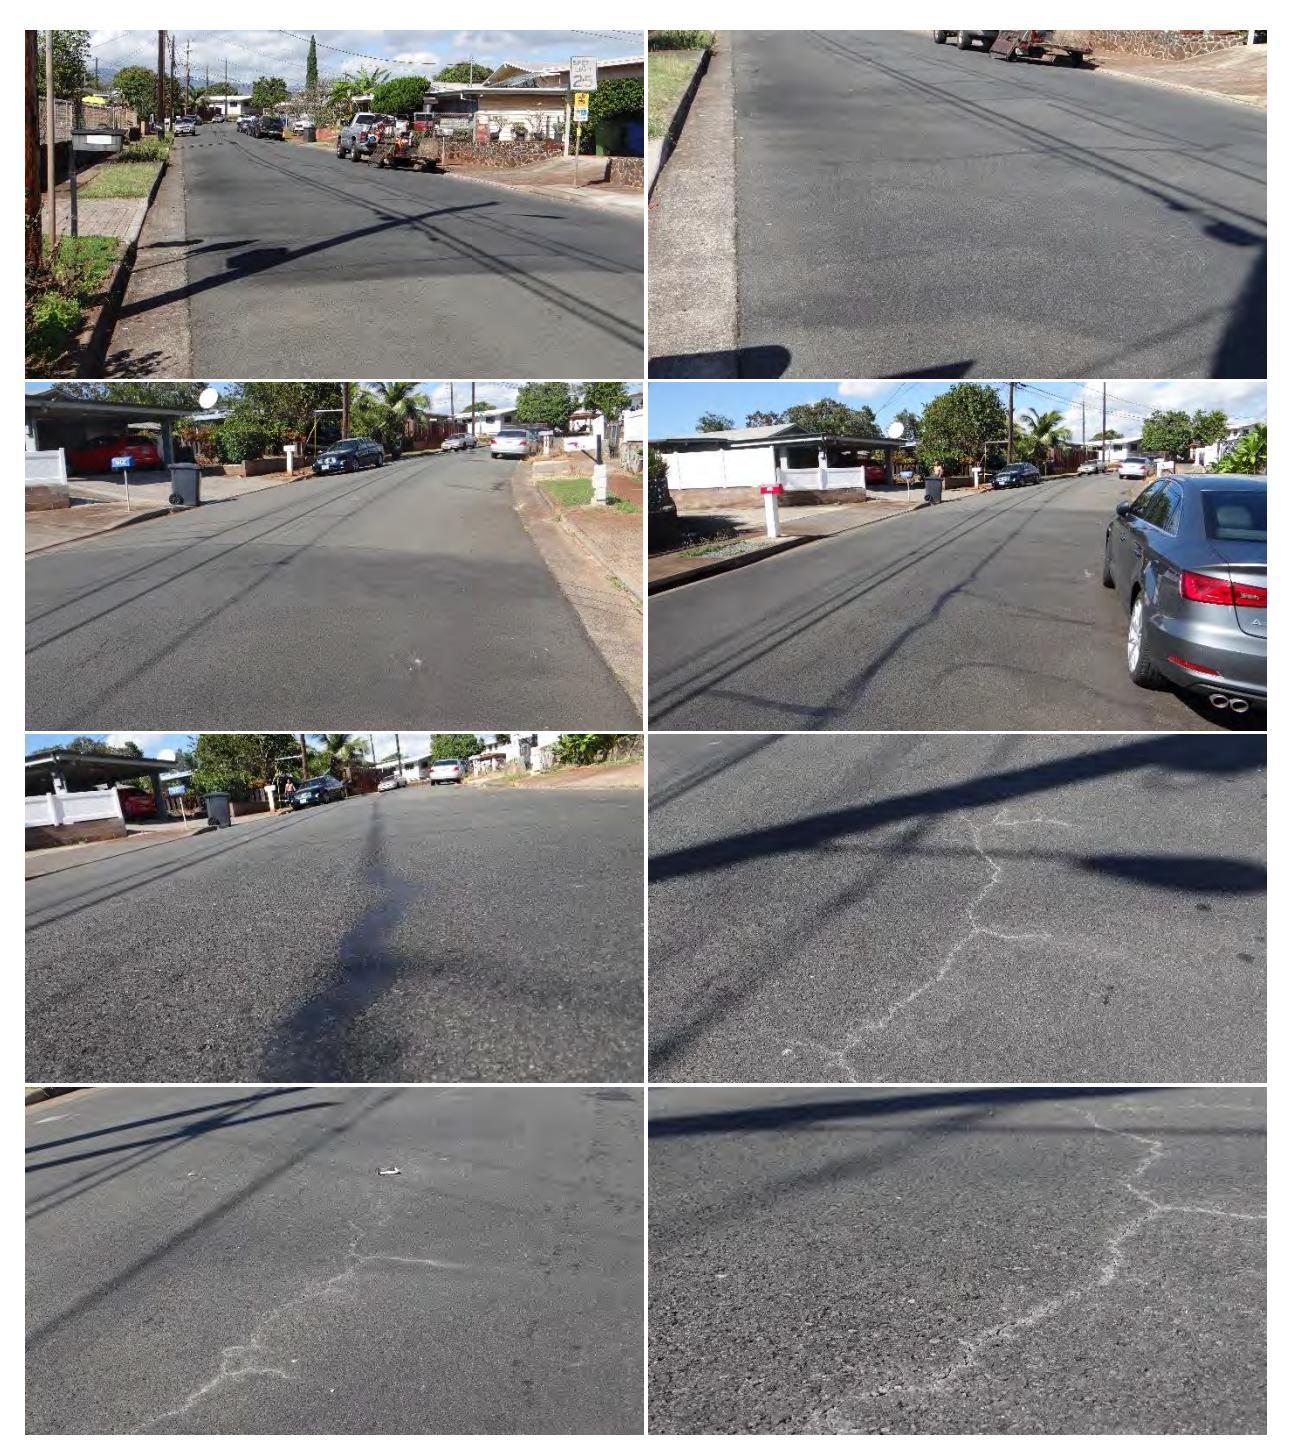
The photos in Figure C-56 show that on 1/26/2018, 38 months after the treatment application, there was significant and uneven fading of the fog seal. Although there is less contrast with the untreated pavement, this was still quite visible. This indicates that the seal is still covering the depressions between aggregates. The figure also shows that some of the cracks with pumping were starting to develop the typical fatigue cracking pattern. It is important to note that during the more than three years with the seal coat very limited loss of aggregate was noted.

Figure C-56 Condition of Kaweloka Street section 1, treated with Plasti-Pave, on 1/26/2018.

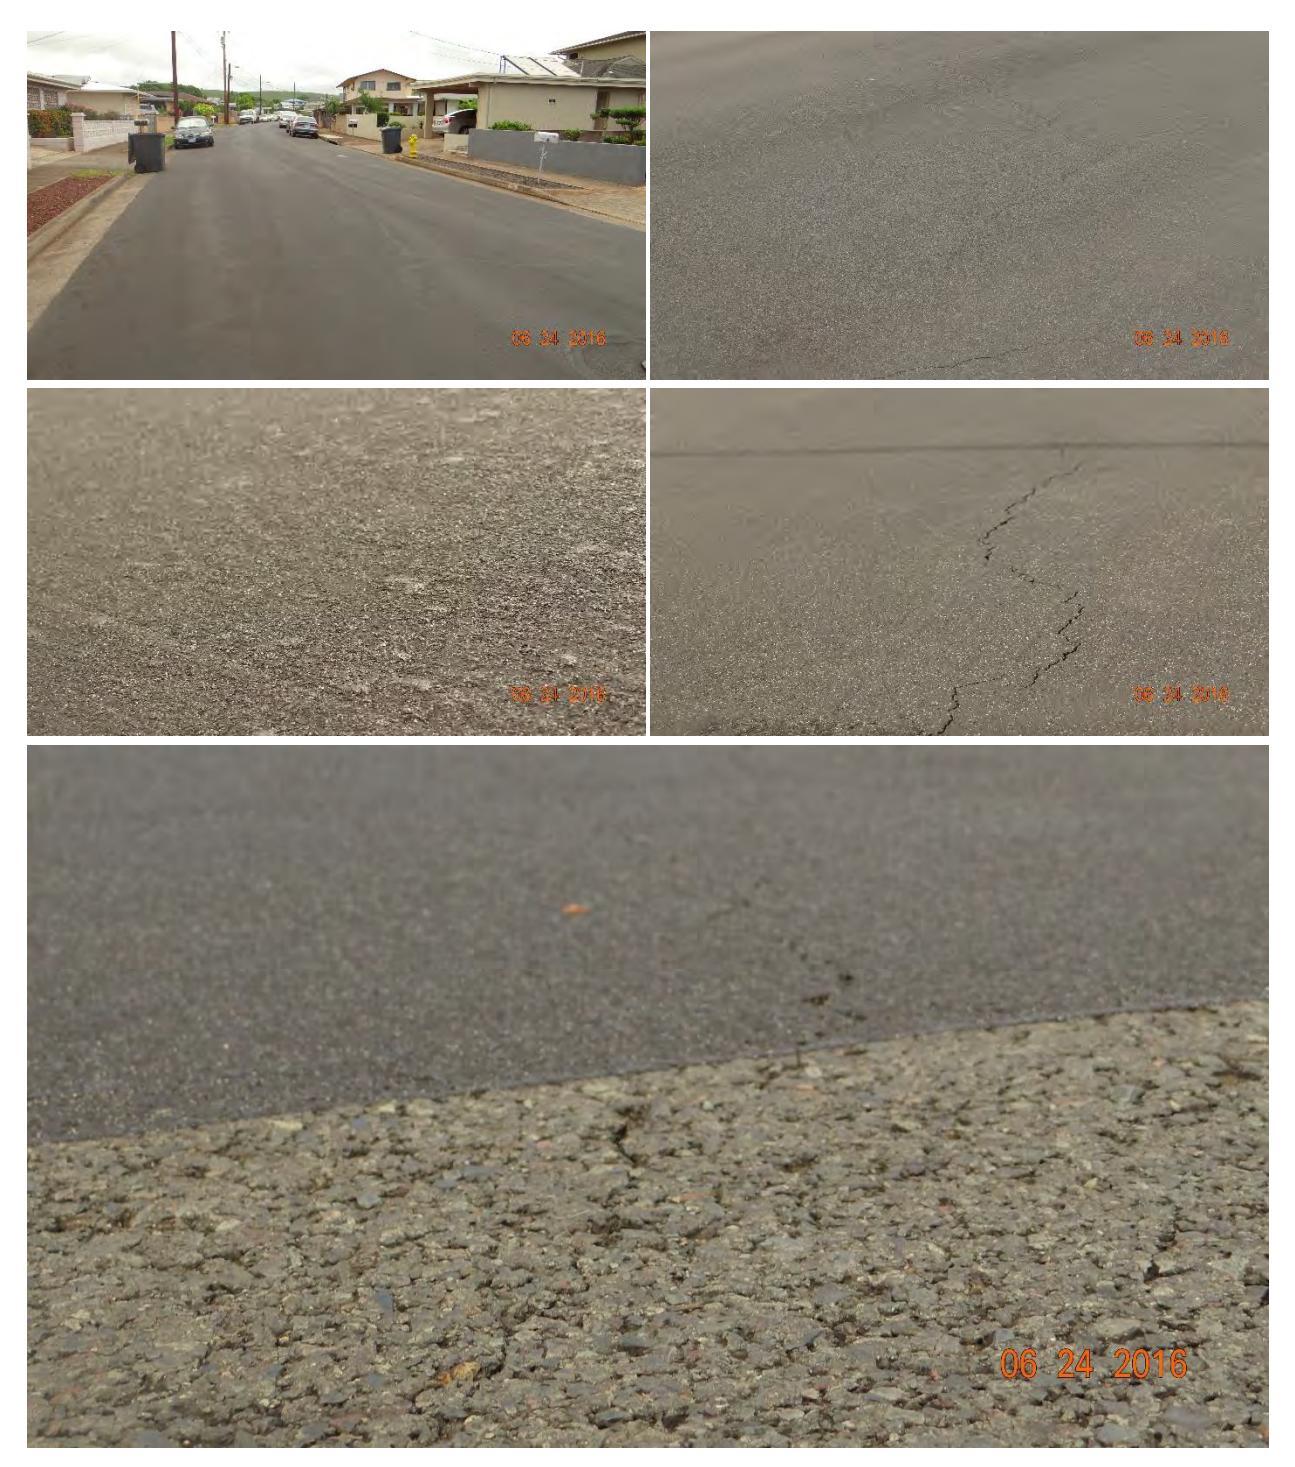
avoiding further oxidation of the binder, which leads to more raveling and eventually disintegration of the mix if left untreated. The last photo illustrates once again that any cracks developing in the existing pavement will simply go through the treatment.

Figure C-64 Condition of Kaweloka Street section 2, treated with Liquid Road, on 6/24/2016.

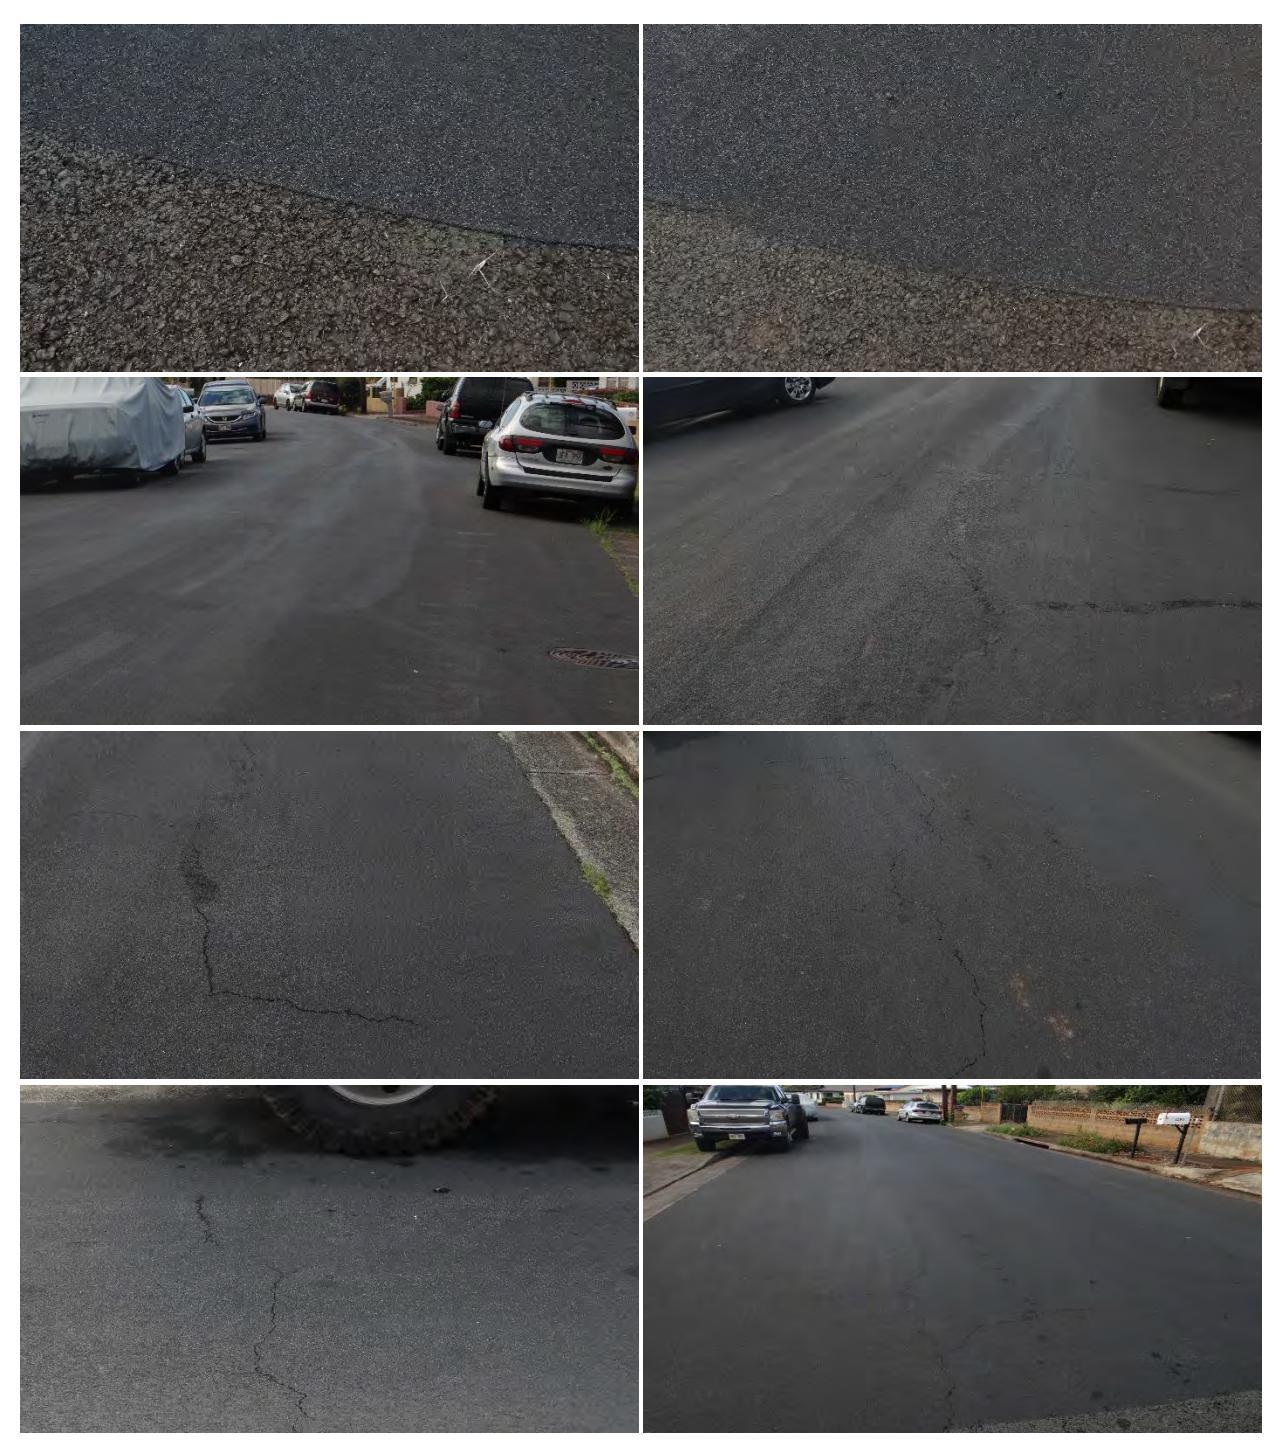
The same observations can be made for the conditions shown on Figure C-65 on 12/13/2016, slightly more than two years after treatment application.

Figure C-65 Condition of Kaweloka Street section 2, treated with Liquid Road, on 12/13/2016.

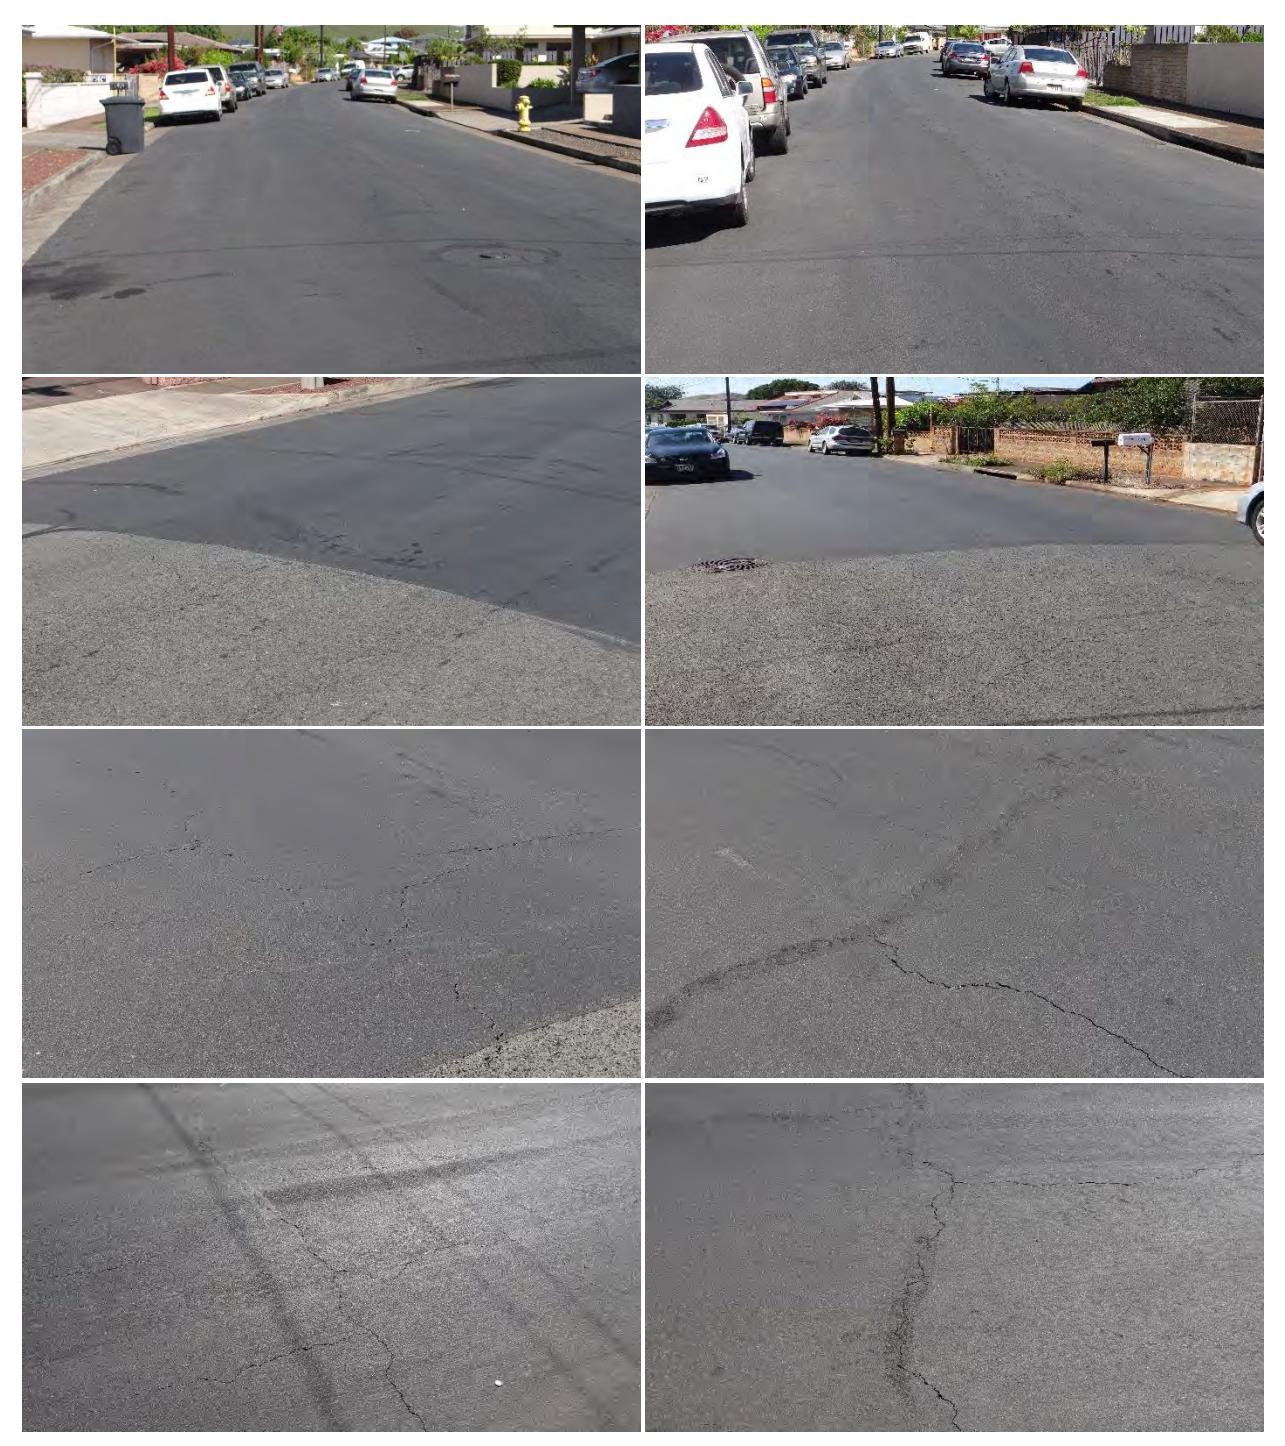
Figure C-66 and Figure C-67 show the conditions on 1/26/2018, 38 months after the treatment application. The two photos at the top of Figure C-66 show an overall good appearance of the treated section. Although the surface was starting to show signs of oxidation, there was still a very high contrast with the existing untreated section, as shown in the second row. The differences in texture between the treated and untreated sections were basically the same as those illustrated in Figure C-64.

Figure C-66 Condition of Kaweloka Street section 2, treated with Liquid Road, on 1/26/2018.

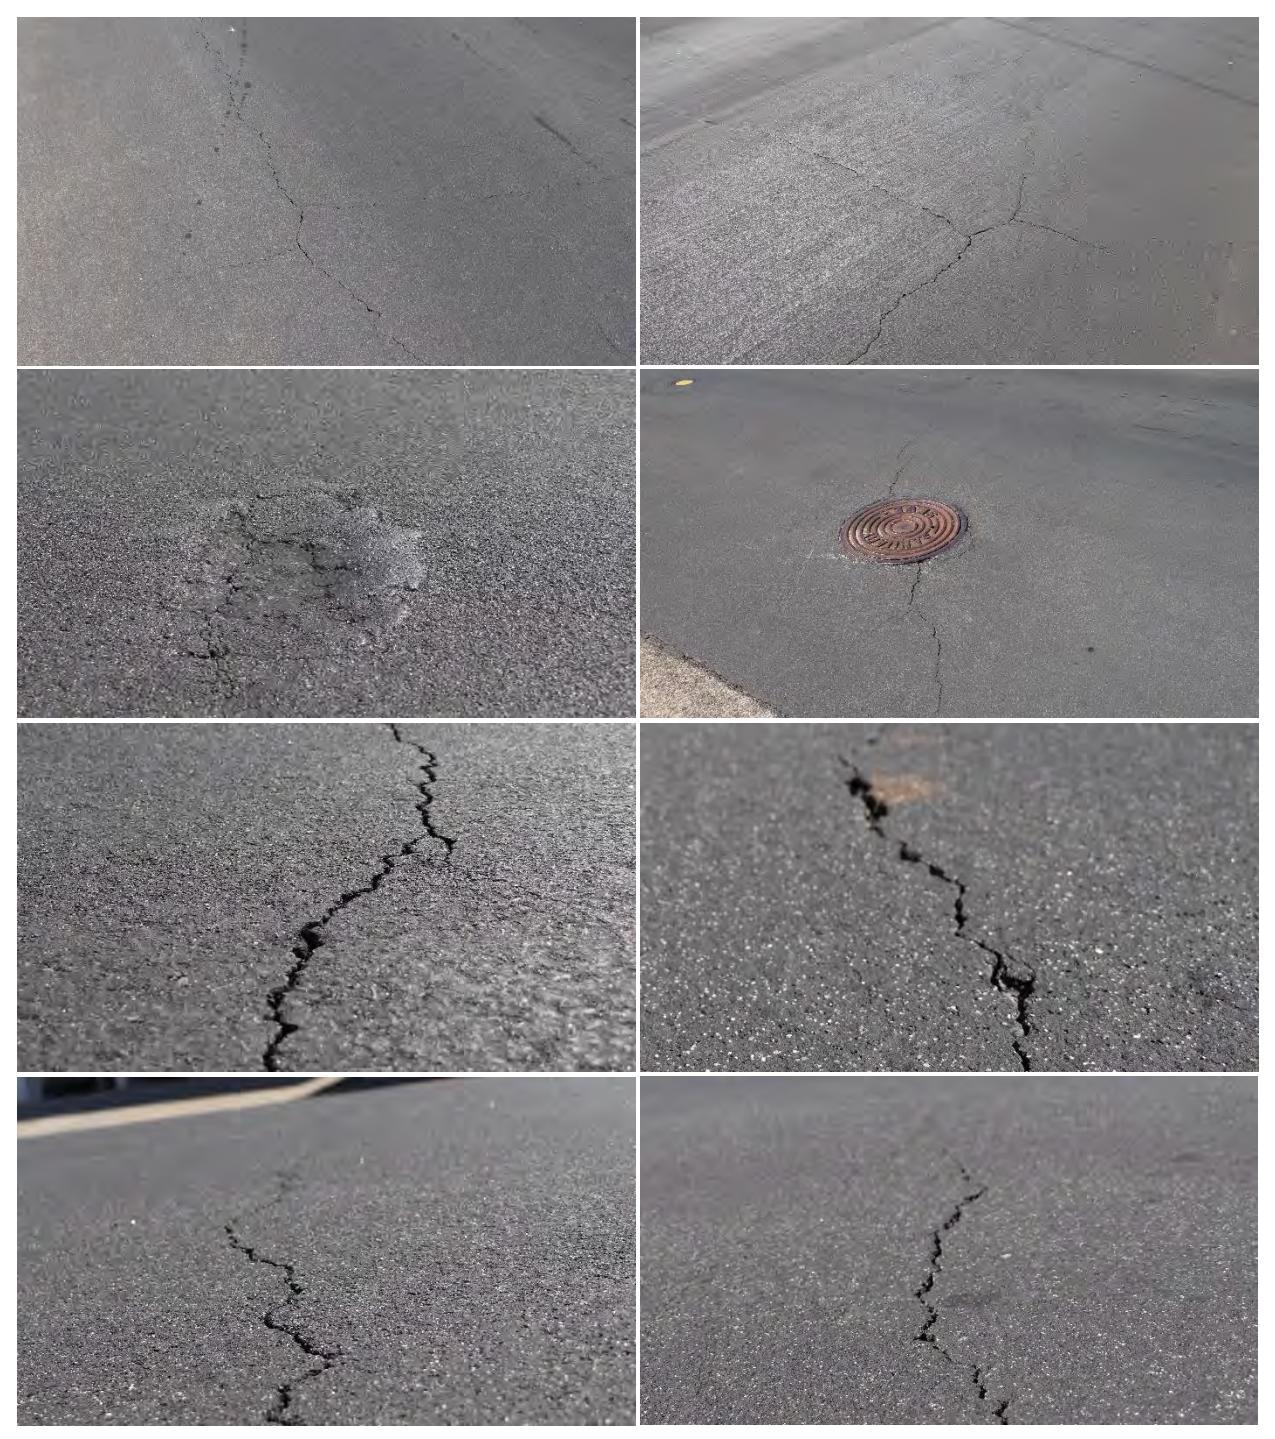
Figure C-67 Condition of Kaweloka Street section 2, treated with Liquid Road, on 1/26/2018.
