PERFORMANCE MONITORING OF PRESERVATION TREATMENTS IN HONOLULU

FINAL PROJECT REPORT

Adrián Ricardo Archilla University of Hawaii at Manoa

May 2019

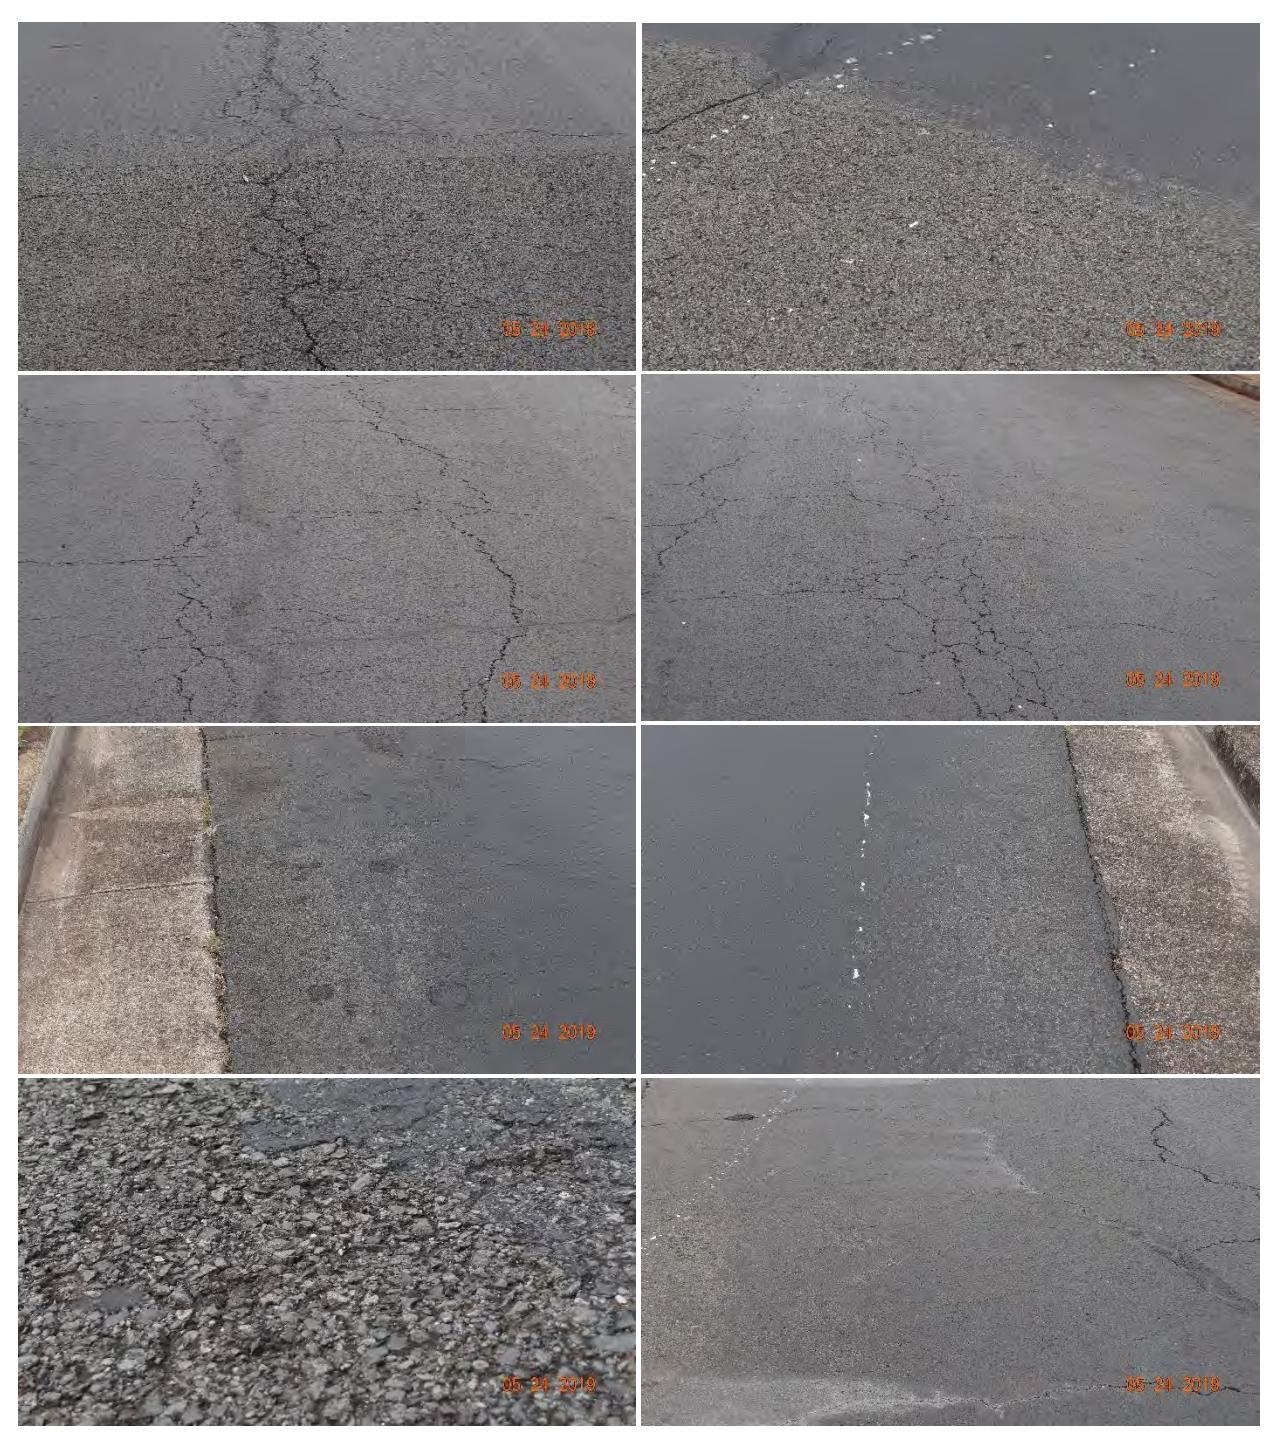
Figure C-82 Cracking on Kaweloka Street section 4, treated with OptiPave PlusTM RTU, on 5/24/2019.
