DAMAGE DETECTION TECHNIQUES FOR CONCRETE APPLICATIONS

FINAL PROJECT REPORT

Lev Khazanovich
Katelyn Freeseaman
Lucio Salles
Aziz Asadollahi
University of Minnesota

Center for Highway Pavement Preservation
(CHPP)

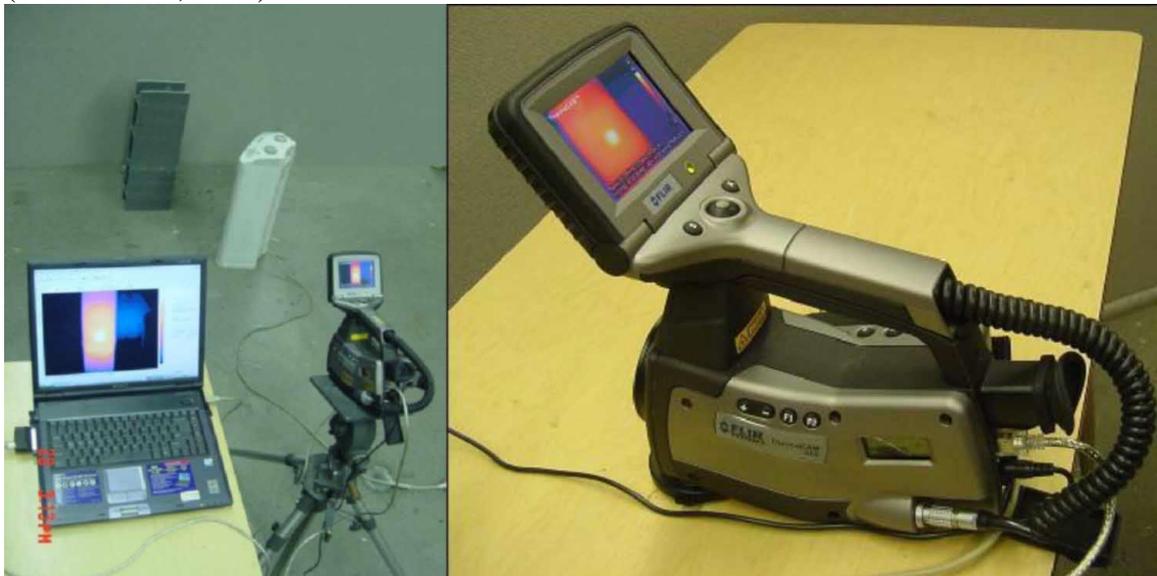
Figure 2. Example infrared thermography and laboratory measurements (Halabe, 2007).

In infrared thermography, the infrared energy emitted from an object is detected via sensors and converted into temperature data. The collected temperature data is used to map the temperature contour of the object. The inhomogeneties would manifest themselves as local hot or cold regions. Based on the thermal anomalies in the obtained thermal color-map, the inconsistencies such as defects or distressed regions existing on the surface of a pavement can be detected (Maser et al., 1990; Al-Qadi et al., 2010; Hoegh, 2013). Example thermography equipment and laboratory measurements are shown in **Error! Reference source not found..** When conducting infrared tests in the field, it is possible to mount the infrared camera using tripods or poles attached to a vehicle, so that large areas can be covered in a short time (Halabe et al., 2007).

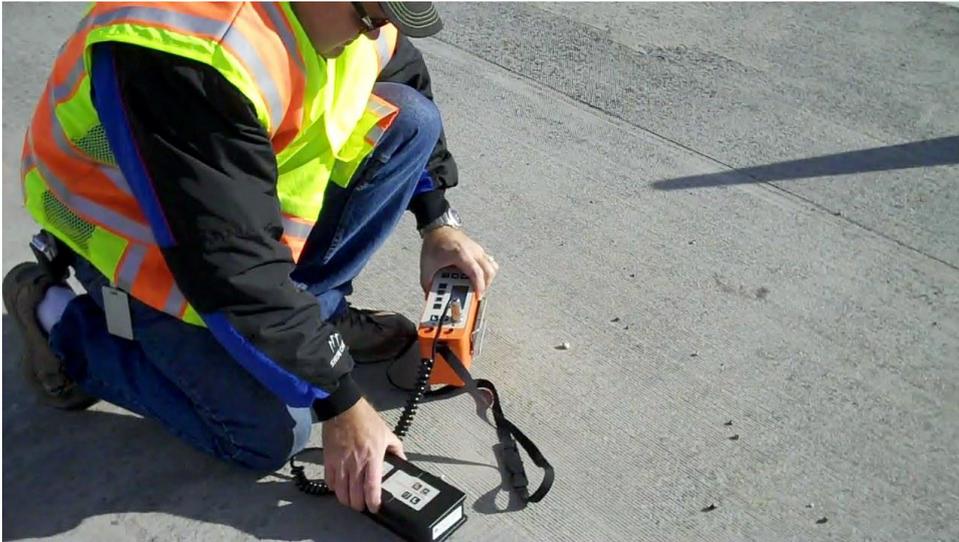
Figure 3. Pachometer: a magnetic pulse-induction device and its application on concrete pavement (adapted from Hoegh, 2013)

Magnetic pulse-induction relates to the detection of conducting metal target objects situated in environments which, through their own magnetic and electrical properties, interact with the fields transmitted by metal detectors (Candy, 1996). In concrete pavements, the embedded metal objects can be detected by analyzing the eddy current distribution induced by the applied magnetic field and the interference caused by self-induction of the metal object. Position, size, shape, and orientation of metal inclusion in concrete pavements can be accurately identified with magnetic pulse-induction (Hoegh, 2013). However, this method cannot be utilized for detecting non-metal defects and surface anomalies (Rao et al., 2009). **Error! Reference source not found.** and Figure 4 provide examples of devices that operate with magnetic pulse-induction method.

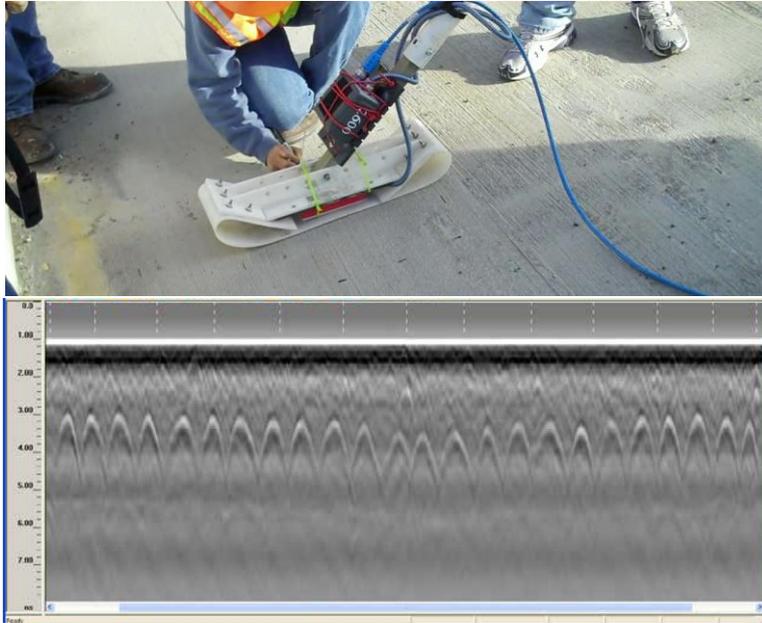
Figure 5. Ground-coupled GPR system and example output at a transverse joint (adapted from Hoegh, 2013).

Depending on the apparatus setup, GPR systems are classified as either air-coupled or ground-coupled systems. **Error! Reference source not found.** shows a MnDOT owned and operated 2.6 GHz ground-coupled antenna as well as an example output of GPR where parabolic reflections can be observed due to the presence of dowels embedded in a transverse joint (Cao et al., 2011; Hoegh, 2013). The ground-coupled antenna is in direct contact with the pavement surface, which allows the EM radiation to penetrate deeper in comparison to

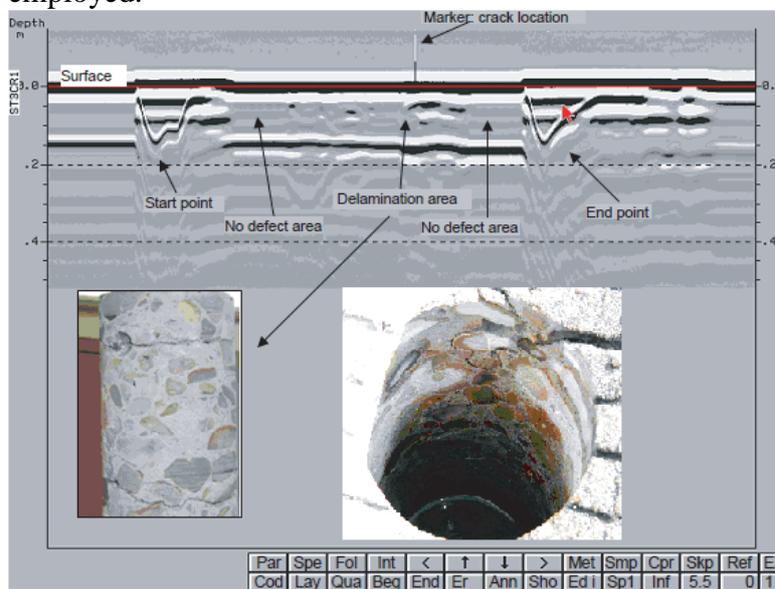
Figure 11. A sample GPR output for a test area with confirmed delamination (adapted from Liu et al., 2008)

The application of GPR for detecting shallow delaminations in continuously reinforced concrete pavement (CRCP) was studied by Liu et al. (2008). Figure 11 illustrates a sample GPR output. The delamination occurred at the obvious disturbance of the signals. However, in some conditions, it is difficult to visually review the GPR graphic output and detect the possibility of the occurrence of delamination. Several reasons are involved. First, concrete has dielectric properties similar to those of granular base, and second, the early-age delamination occurs at shallow depths. Therefore, a three-step analysis was employed by Liu et al. (2008) to improve the quality of GPR data interpretation including (a) a preliminary evaluation, (b) a site-calibration algorithm, and (c) a threshold amplitude difference. Field measurements, coring tests and numerical analysis showed that shallow early-age delamination in CRCP could be easily detected by the application of GPR technique if proper analysis procedure was employed.

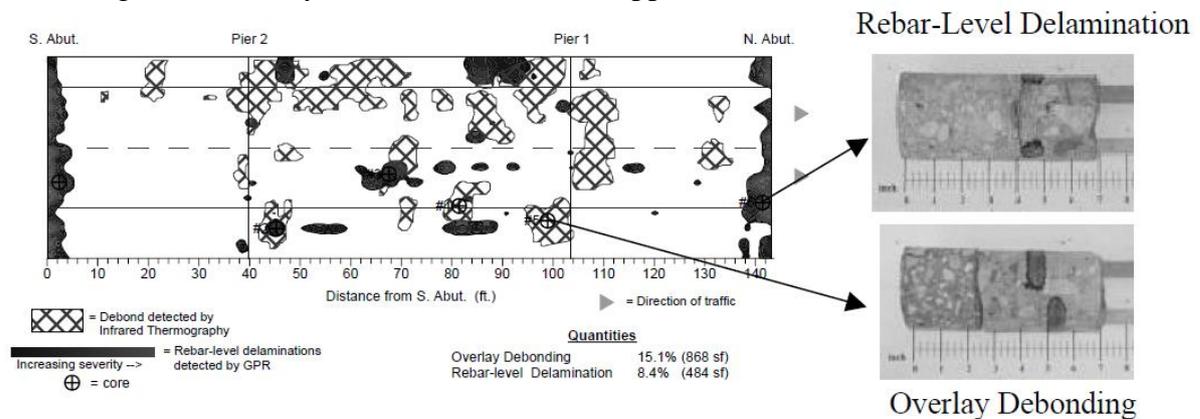
Figure 12. Typical combined GPR/infrared condition map (adapted from Maser, 2009)

In a few studies it was found that a better evaluation of the delaminated area can be obtained by combining the results of both GPR radar and infrared thermography. GPR radar is fast and more susceptible to moisture and chloride associated with deterioration but cannot directly detect delaminations. In contrast, infrared thermography is a relatively slower test which directly detects delaminations but loses its detectability when moisture or thick overlays are present. In one of these studies, the combination of the radar and infrared measurements were capable of predicting total area of deteriorated deck to within 5% of total deck area (Maser et al., 1990). The same combined NDE testing was employed to survey 87 bridge decks in Wisconsin. The collected data was analyzed and some cores were sampled to evaluate the accuracy of this approach. Out of a total of 214 defective cores, 83% of them were correctly identified by this approach. Figure 12 provides an example GPR/infrared condition map. It can be seen that two types of defects, delamination due to reinforcement corrosion and debonding of the overlay, are detected with this approach (Maser, 2008 & 2009).

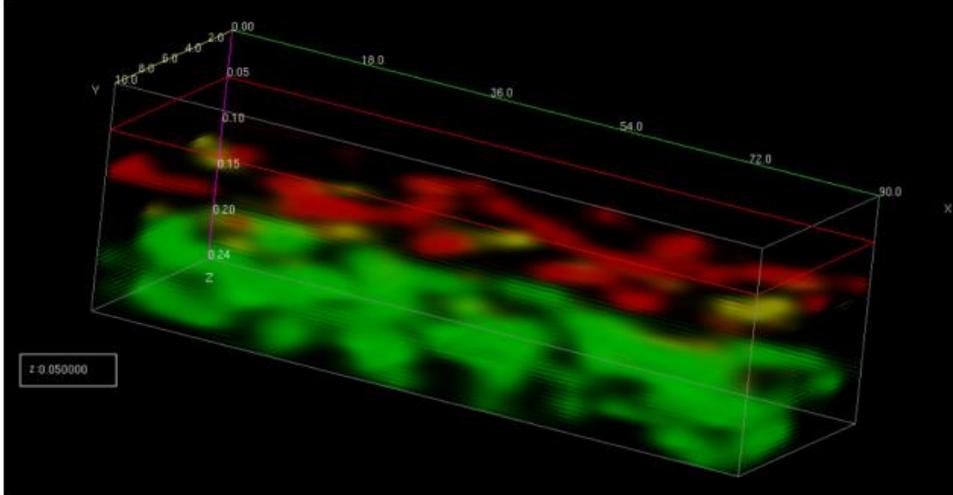
Figure 13. Visualization of the deck of the bridge on interstate I-287 over route 1 in Woodbridge, New Jersey (adapted from Gucunski et al., 2011)

deck. Therefore, an advantage of the IE method is that it allows for detection of delamination zones at various stages of deterioration: from initial to progressed and developed (Gucunski et al., 2006 & 2011). In Figure 13, which is a sample of 3-D IE image of bridge deck located in New Jersey, three distinctive layers can be observed. Green, yellow, and red each represent the good, fair to poor, and serious condition, respectively.

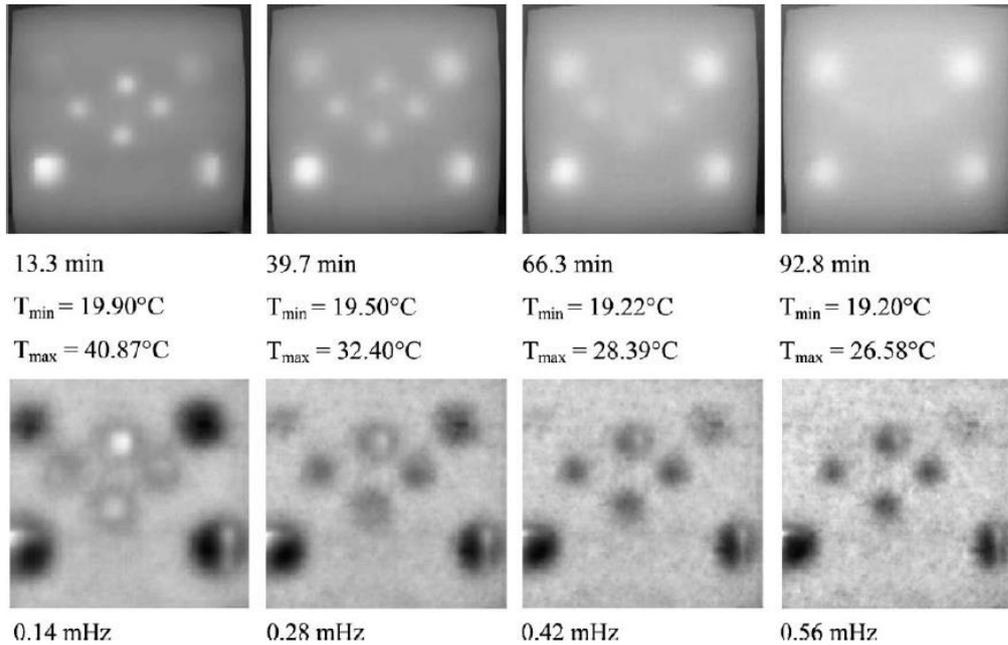
Figure 14. Comparison of thermograms (top) and phase images (bottom) of voids at different depths. The heating time was 30 min, the recording time of the thermograms is related to the switch off time (0 s) of the heating source (adapted from Maierhofer et al., 2006)

Most of the existing NDE methods (i.e. GPR, ultrasonic, and impact-echo) are mainly suited for the detection and characterization of anomalies in concrete and masonry structures at depths between 5 and 100 cm. Infrared thermography, on the other hand, is a useful method for quantitative investigations of the near surface region (0 to 10 cm) of various structures (Maierhofer et al., 2002 & 2004). In one of the studies related to the application of infrared technology in concrete structures, Maierhofer et al. (2005) proposed a computer program for numerical simulation of the heating up and cooling down processes developed based on finite difference concept. This method was tested to investigate its ability to detect voids. Concrete specimens and slabs were fabricated with different reinforcement configurations and concrete type, and artificial voids were embedded. External heating was performed to impose the thermal difference during the warming and cooling process. The results showed that this method is very well suited for the detection of voids and honeycombing in concrete, up to concrete covers of 10 cm. It was pointed out that with increasing rebar density, the temperature contrast of the underneath voids decreases slightly. Also, the effects of increased density and increased thermal conductivity superimpose each other. Figure 14 depicts the produced images using the infrared technique on the fabricated specimens (Maierhofer et al., 2006).

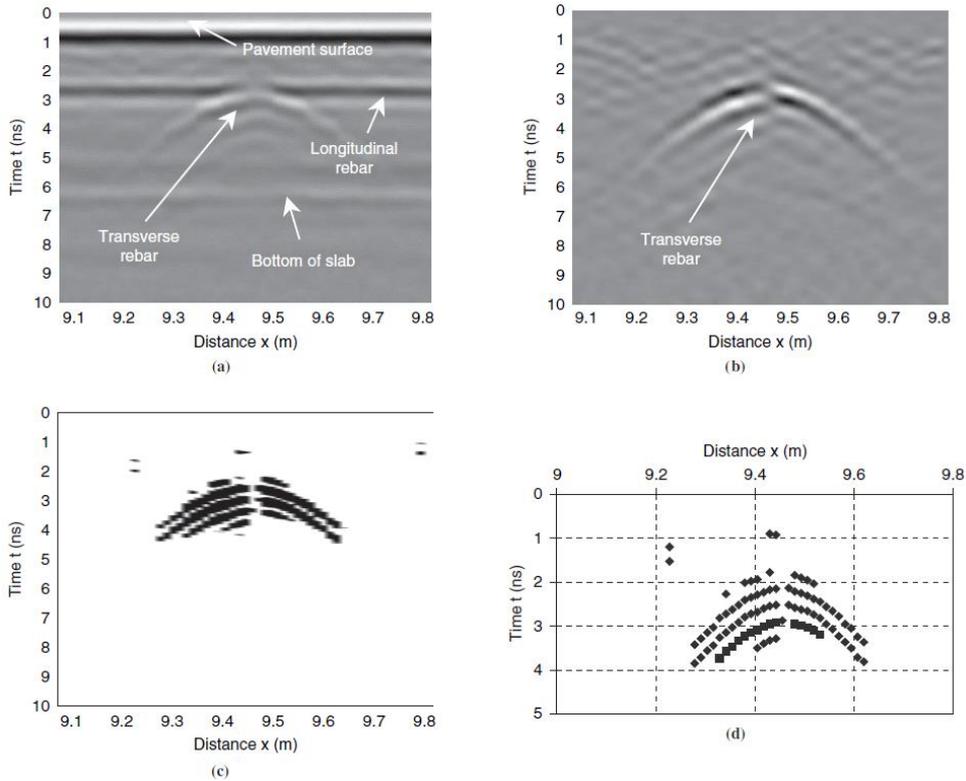
Figure 16. Time delay estimation stages: a) original data; b) difference image; c) thresholded image; d) detected time delays and survey distances (adapted from Al-Qadi et al., 2005b).

Halabe et al. (1993) used an inversion technique to estimate the rebar depth and other parameters on the basis of the measured reflected signal and an empirical reflection model. Bungey et al. (1994) examined GPR's ability to detect round steel reinforcing bars ranging in diameter between 6 mm and 32 mm, and cover depth of up to 280 mm. 250 different configurations were tested by simulating the concrete specimen using an emulsion of oil and water with dielectric and conductivity properties equal to concrete. They reported that as long as the spacing of the steel bars is larger than 200 mm, they are detectable by GPR. Al-Qadi et al. (2005b) proposed image-processing techniques to automatically detect the rebar parabolic signature in GPR data collected with a high frequency ground-coupled GPR antenna. The evaluation of these techniques were performed on a CRCP section with known properties. The results showed an average error of 2.6% on the estimated rebar cover depth. Figure 16 provides the results of a sample analysis of the GPR survey (Al-Qadi et al., 2005b).

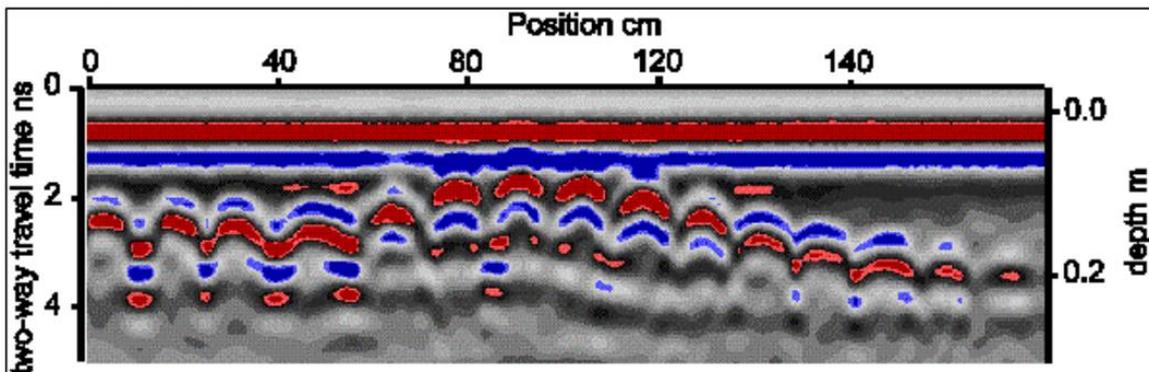
Figure 17. Locating reinforcement at different depths with ground-coupled GPR antenna (adapted from Loulizi, 2001)

Figure 17 shows the result of a GPR survey using a ground-coupled antenna (900 MHz) over a bridge deck. It can clearly be seen that the rebar is located at a depth of 80 to 150 mm, and improper installation during construction was diagnosed by the aid of this NDE technique (Loulizi, 2001).

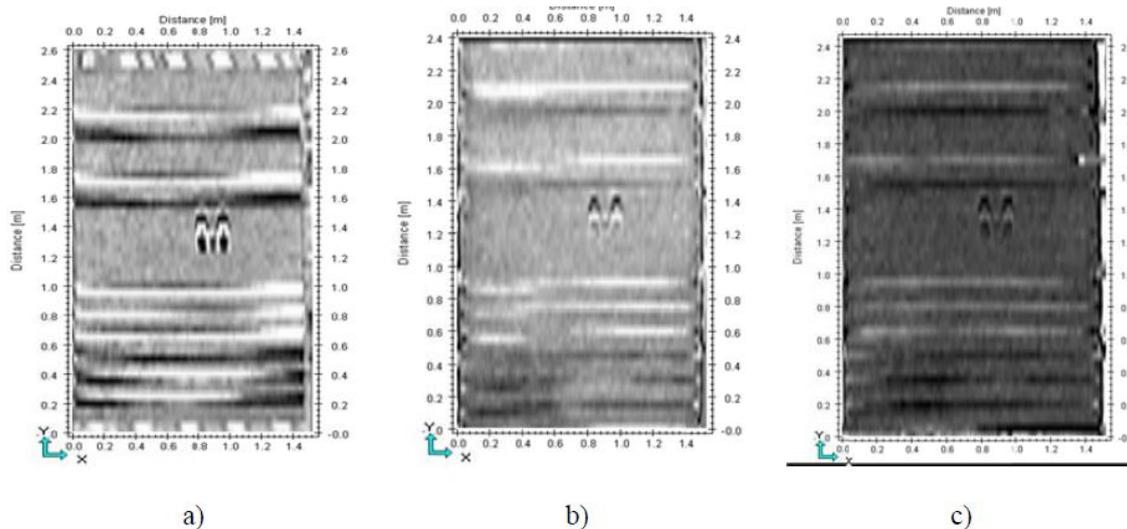
Figure 18. GPR data of the top layer rebar at different times: a) 6 month after casting, b) one month of corrosion experiment, c) three months of corrosion experiment (adapted from Andrt et al., 2011)

GPR is also capable of identifying the corrosion in steel inclusions (Clemena et al., 1992). A study was done by Andrt et al. (2011) to investigate the capability of NDE methods in identifying the amount of corrosion in reinforced concrete structures, bridge deck in particular. The results of this study showed that the GPR signals may distinctly indicate the corrosion in the form of blurring of rebar image features. As shown in Figure 18, the advancement of corrosion blurred the obtained image (Andrt et al., 2011).

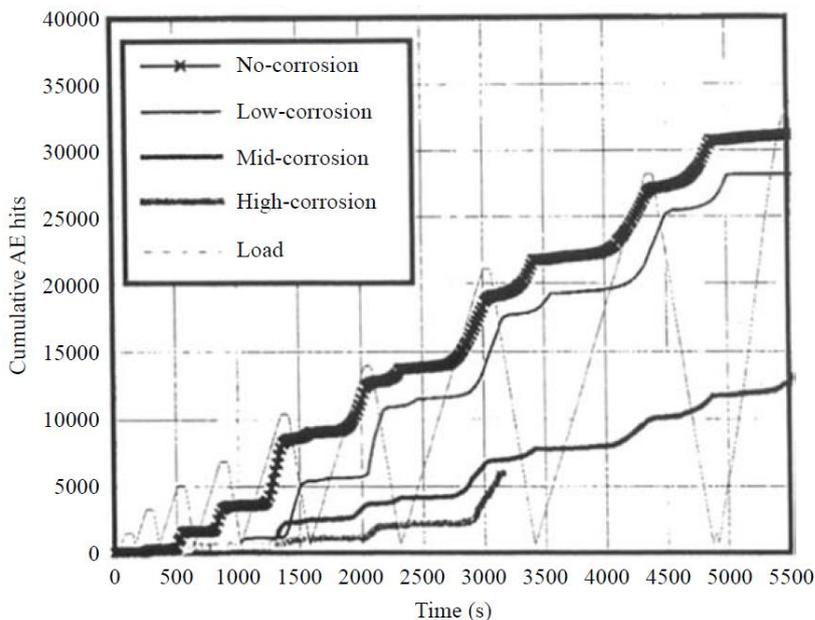
Figure 19. Sample ultrasonic based NDE method used for corrosion detection (adapted from Yoon et al., 2000)

Acoustic emission (AE) monitoring is another non-invasive and passive NDE technique in which ultrasonic elastic waves are generated due to rapid release of energy from a localized source within a material (Sagar et al., 2012). AE monitoring was conducted in reinforced concrete beams subjected to corrosion of reinforcing steel (Yoon et al., 2000; Uddin et al., 2004). In one of these studies carried out by Yoon et al. (2000), it was observed that the degree of corrosion of reinforcing steel greatly influenced the rate of AE hits and the behavior of AE generation. Figure 19 provides the plot of cumulative hits with time under cyclic load. The AE counts decreases with the increase in the degree of corrosion (Yoon et al., 2000; Sagar et al., 2012).

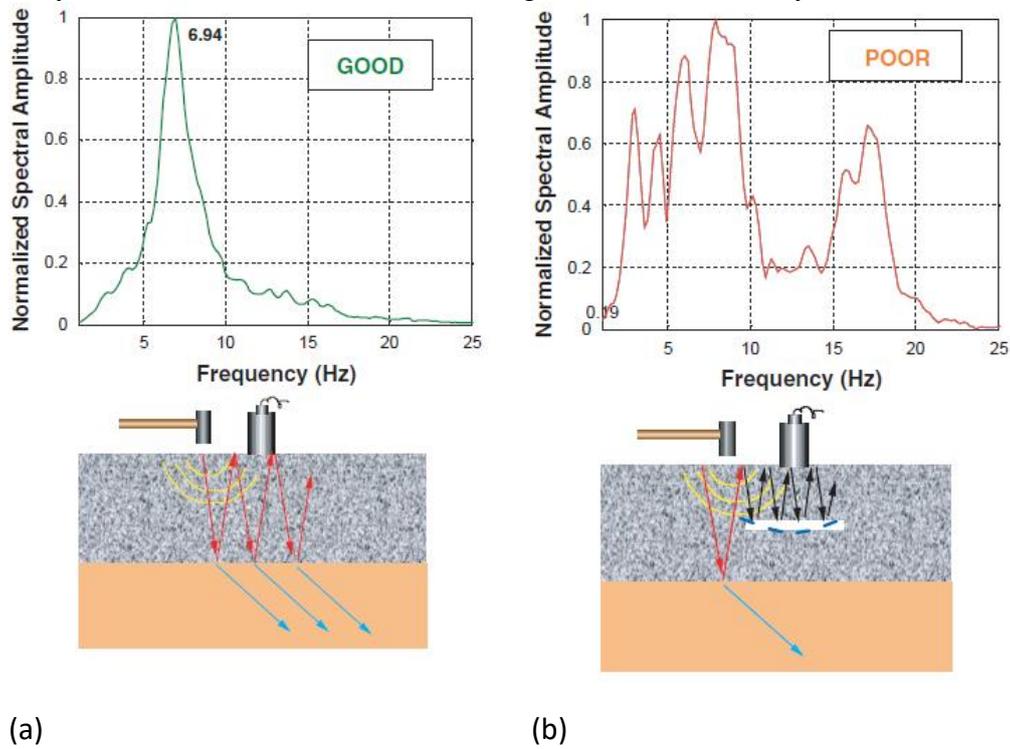
Figure 20. Impact echo technique and the associated normalized spectra analysis: a) good (Test Point D2), (b) poor (Test Point B1) conditions in terms of debonding (adapted from Celaya et al., 2007)

interface. In the case of a debonded slab, a portion of the energy will be reflected from the concrete-air interface created by the debonding. The authors reported that this method was effective in locating and characterizing the intact and fully debonded slabs but was not sufficiently conclusive when the slab is in marginal condition (Celaya et al., 2007).

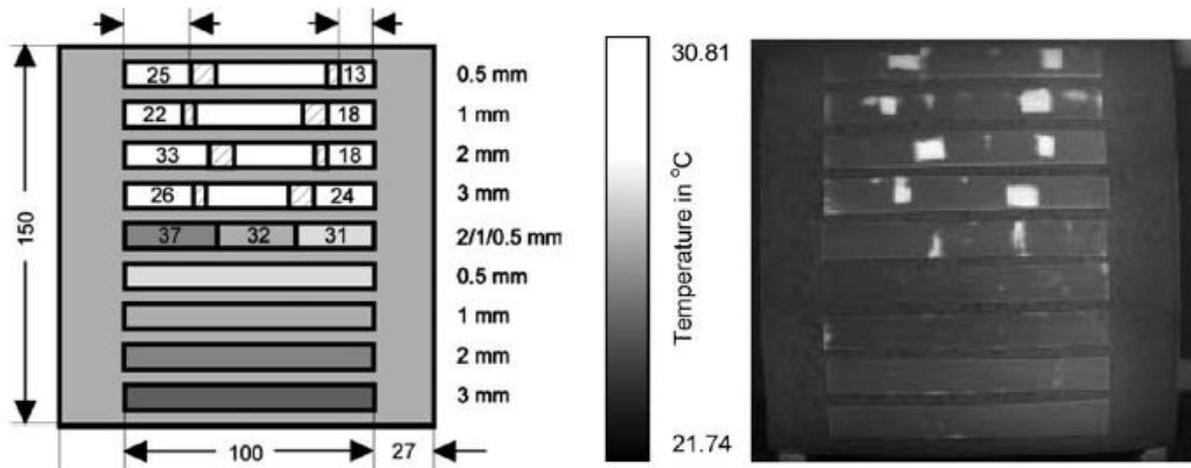
Figure 21. Left: test specimen with CFRP laminates, which have no contact at the shaded areas (nominal glue thickness is written on the right side). Right: thermogram directly recorded after a heating time of 15 s (adapted from Maierhofer et al., 2006).

Maierhofer et al., (2006) investigated the ability of infrared thermography in identifying the bonding between the carbon fiber reinforced plastic (CFRP) laminates and concrete. As Figure 21 illustrates, this method was able to distinguish the artificial unbonded laminates. Also, On-site investigations on a pre-stressed concrete bridge were carried out for the detection of delaminations inside or debonding below the top asphalt layer. The bridge deck consisted of a 5 cm concrete slab, 1 cm mastic for sealing, and 5 cm asphalt layer, and the test was performed using the sun as the heating source. Based on the acquired data, the authors suggested that this method can be useful for evaluating the bonds and detecting delamination in multi-layered systems (Maierhofer et al., 2006).

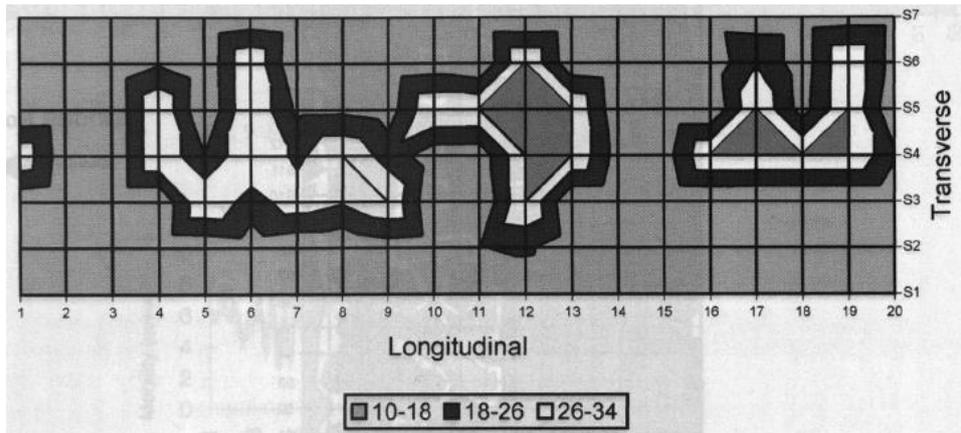
Figure 22. IR testing contour plot for the bridge ramp overlay (Davis, 2003)

The impulse response (IR) test method, a case of impact-echo testing, was used on a 75 mm thick silica fume unreinforced concrete overlay located in Illinois, which suffered early deterioration six months after construction. At certain locations on the slab, debonding of the overlay was becoming apparent. The IR testing, which was completed in 3 hours, determined the exact extent of debonding over the whole 300 m long deck. Figure 22 shows the result of the IR testing analysis for the desired overlay (Davis, 2003).

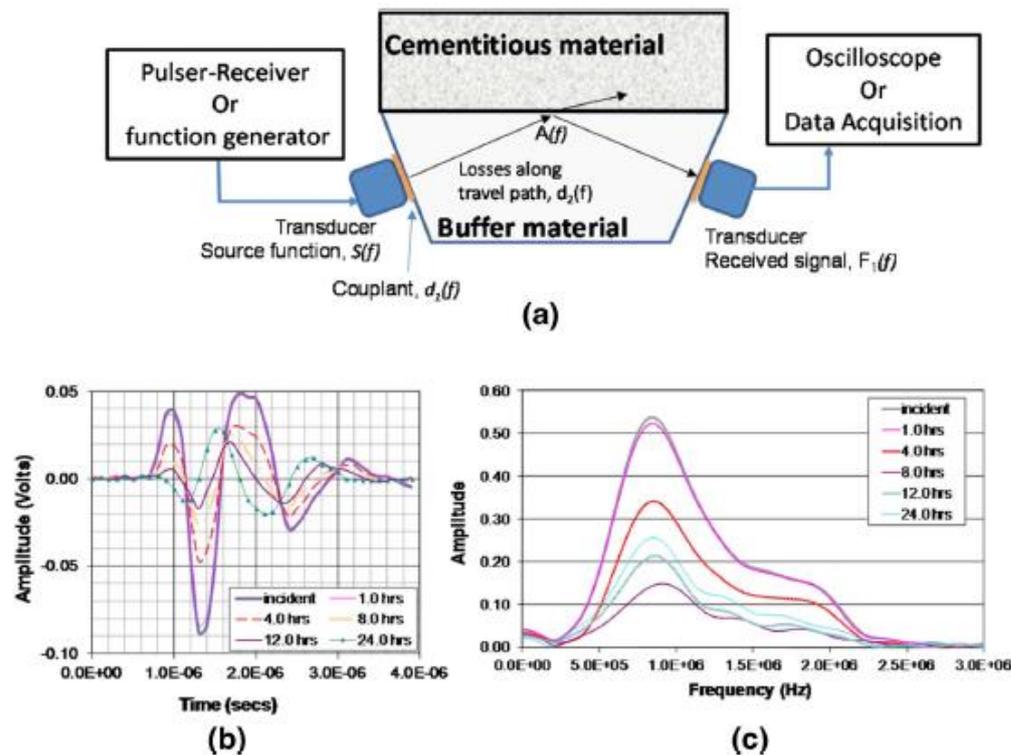
Figure 25. a) Schematic representation of a typical testing configuration to measure reflection at the interface of buffer material and cementitious material; b) Typical reflected signals at different instance of time; c) frequency (amplitude) domain representation of the reflected signals (adapted from Popovics et al., 2014).

The ultrasonic wave reflection (UWR) method, also known as ultrasonic shear wave reflection (USWR), is normally applied to cementitious materials, such as concrete, mortar or cement paste, at early ages (within the first day after mixing cement and water). This method is preferred over other early age test methods for different aspects, including the ability of continuous data collection, one-sided access for measurements, and direct connection to mechanical and microstructural properties of the test medium. However, one disadvantage of this method is its limitation in evaluating the structural properties of the materials at some distance away from the interface between the buffer and test object (Popovics et al., 2014). Figure 25 depicts a schematic representation of the UWR testing device and its outputs.

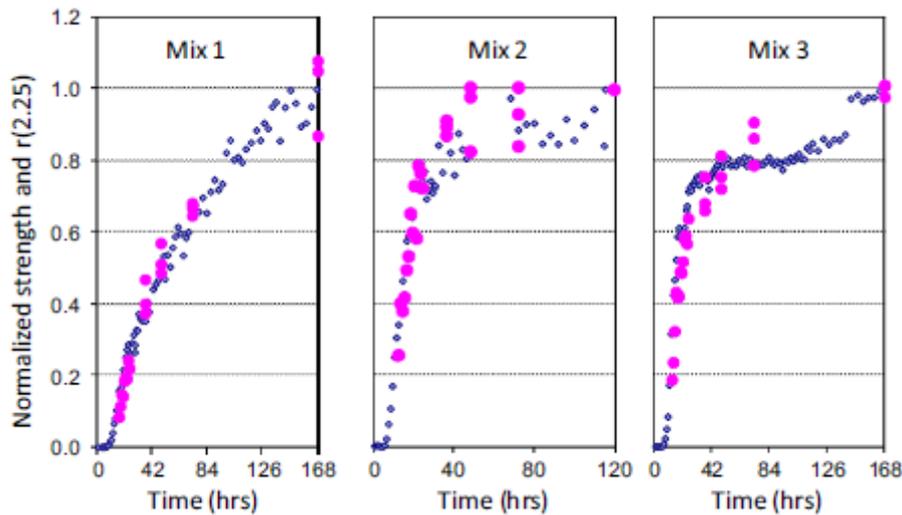
Figure 26. Comparison of normalized S-wave reflection (blue points) and strength gain (magenta points) in slabs with different concrete compositions using a steel buffer. The 7-day strengths of Mix 1, Mix 2 and Mix 3 determined from cores were 26, 37 and 55MPa, respectively (adapted from Subramaniam et al., 2002)

Because this method is very sensitive to phase changes, it has been successfully used for monitoring stiffening and setting behavior of cementitious materials (Rapoport et al., 2000; Öztürk et al., 2006; Chung et al., 2012). This method has been used for monitoring material strength development for in-situ assessment by placing a steel plate as the buffer material inside the concrete slab at the time of casting. The experimental results have confirmed the acceptable relation between the reflected ultrasonic wave and the material strength. Figure 26 presents a sample data that shows a good agreement between the normalized S-wave reflection and the material strength (Subramaniam et al., 2002; Popovics et al., 2014).

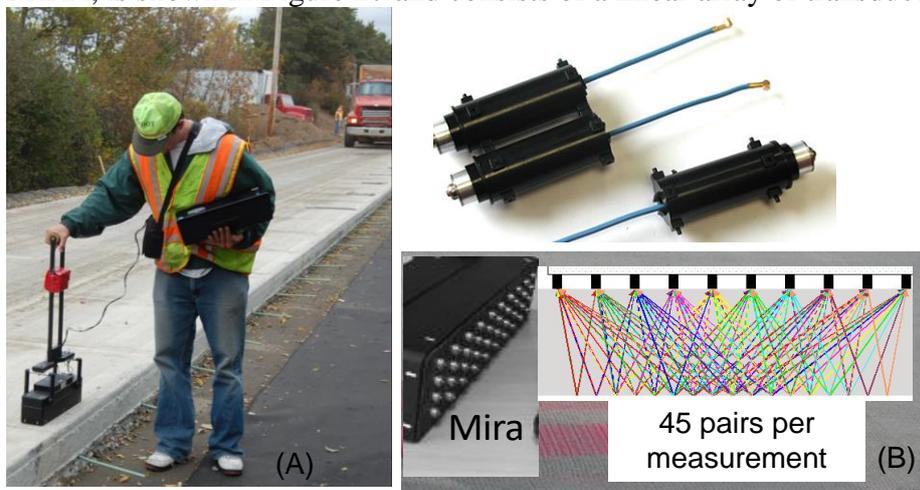
Figure 27. MIRA ultrasonic linear array device (Hoegh 2013).

To allow for field testing of heterogeneous materials such as PCC, dry point contact (DPC) transducers are used, which eliminates the need for a manual mechanical impact and time-intensive surface coupling. The use of DPC transducers also introduces multiple impulse angles that can increase reliability of measurements, allowing for reduced transducer spacing and greater precision (Bishko et al. 2008). One version of DPC ultrasonic array technology, MIRA, is shown in Figure 27 and consists of a linear array of transducers.

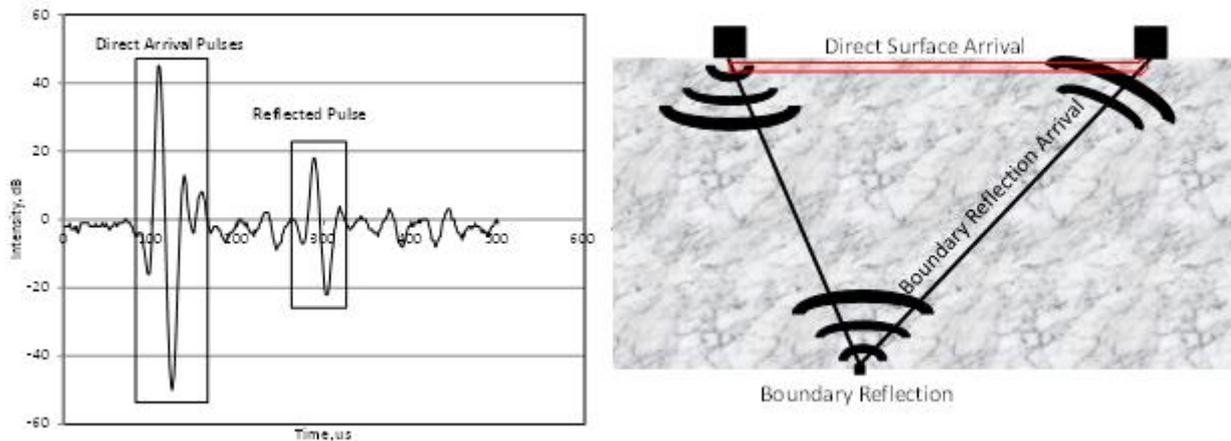
The 45 unique impulse time histories provide valuable information about the specimen. The impulse time histories contain reflectivity information, caused by any change in acoustic impedance that the wave encounters. Changes could be caused by air voids, damage, inclusions, or layer interfaces. An example impulse time history is shown in Figure 29 (left), along with a schematic which would result in this type of time history (right). The direct arrival pulse is the result of a portion of the wave traveling the shortest/fastest distance, in this case along the surface of the specimen, and being received by another transducer. The reflected pulse is the result of the wave propagating through the specimen and encountering a change in acoustic impedance, in this case the bottom surface of the specimen, and reflecting back to the surface. An impulse time history is created by each of the 45 transducer pairs, resulting in a large amount of information and data per scan.

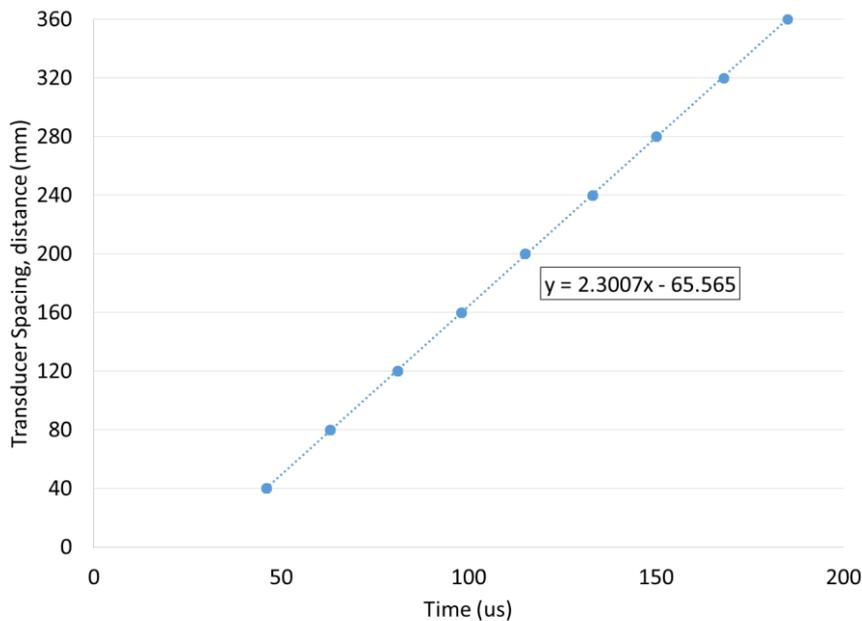
Figure 30. Example array data for calculation of shear wave velocity.

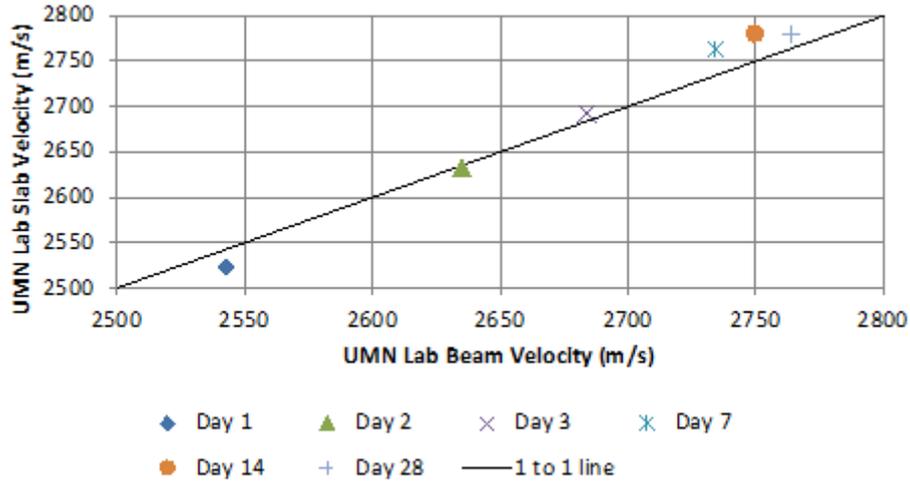
Figure 31. Ultrasonic array measured shear wave velocities for concrete beams vs. slabs at various concrete ages (K. Hoegh, personal communication).

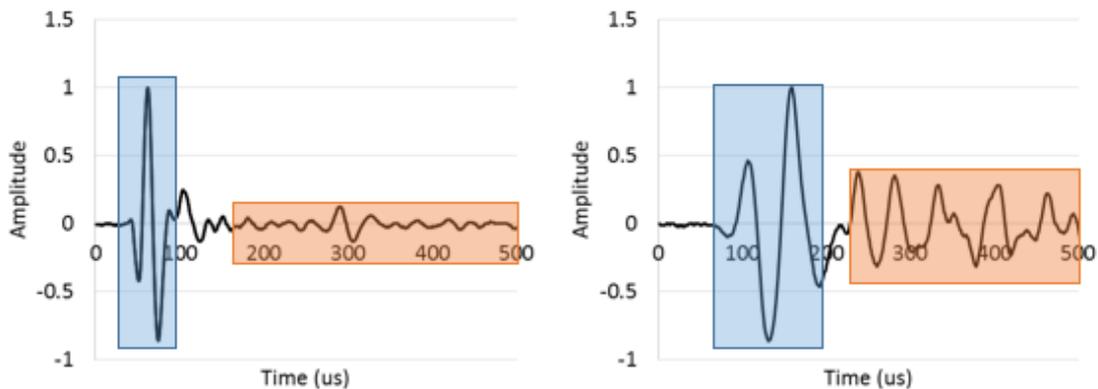
Figure 32. Sample normalized signals for clean concrete (left) and damaged concrete (right) highlighting key differences.

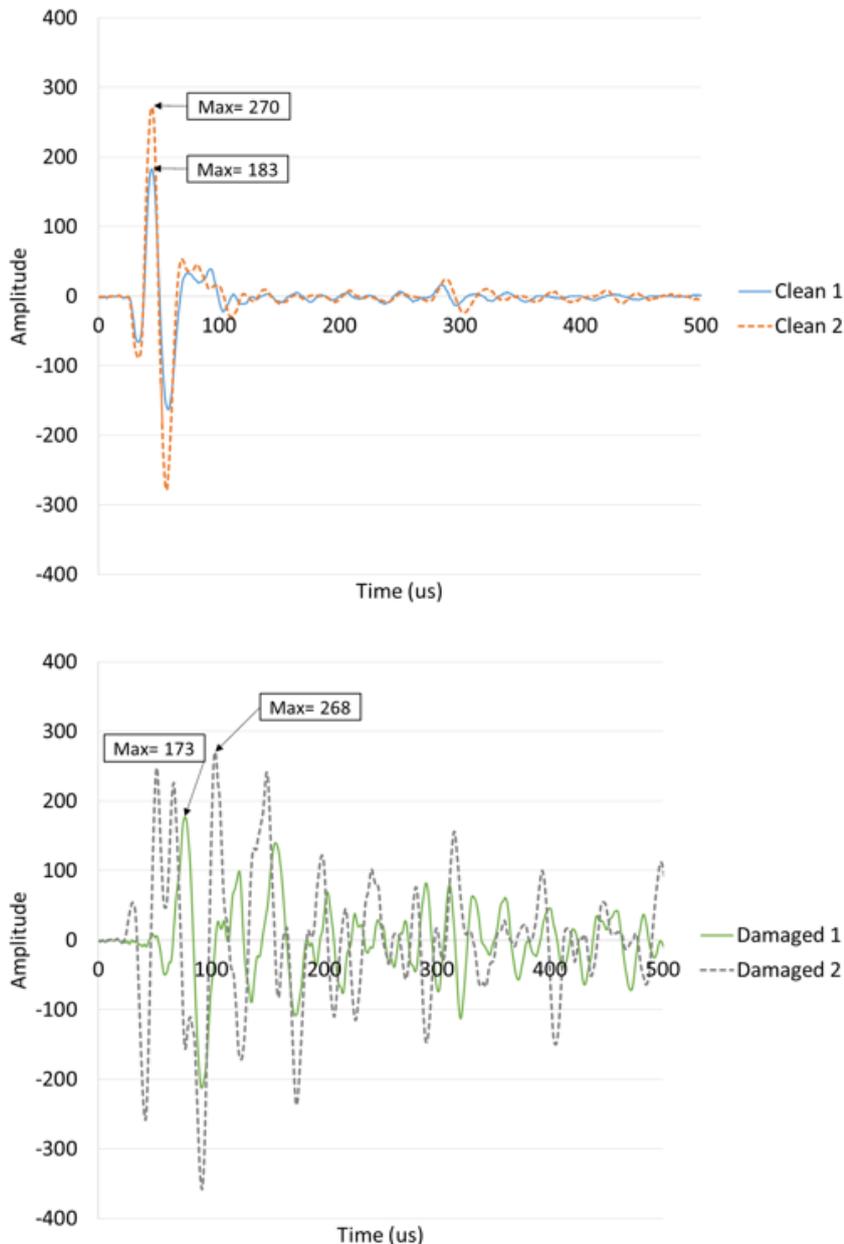
Figure 33. Example raw signals for two clean cases (top) and two damaged cases (bottom).

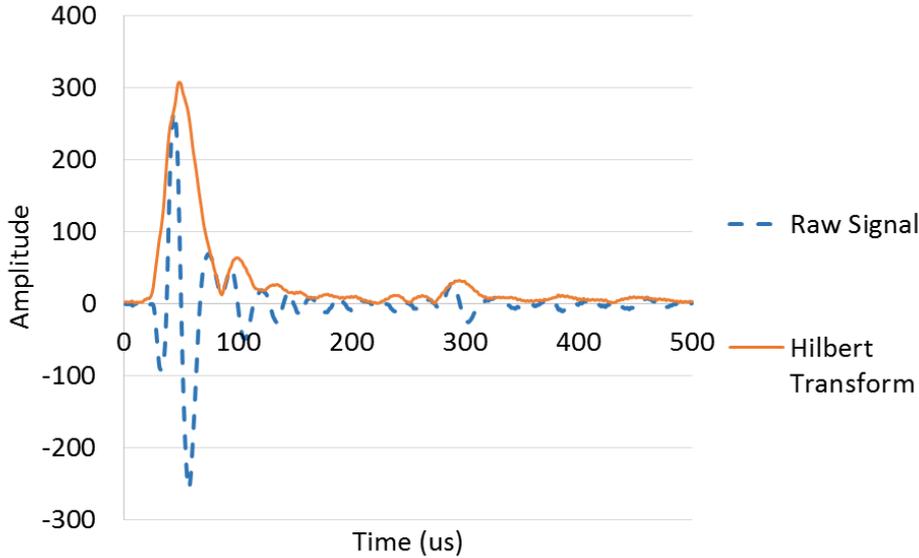
Figure 34. Sample Hilbert transform envelope.

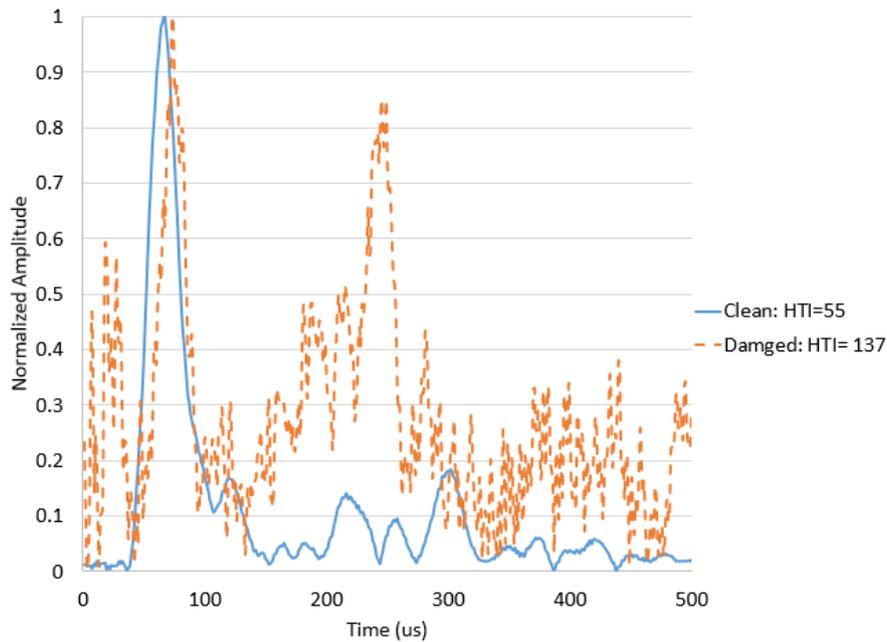
Figure 35. Typical Hilbert transform envelopes for sound and damaged specimens.

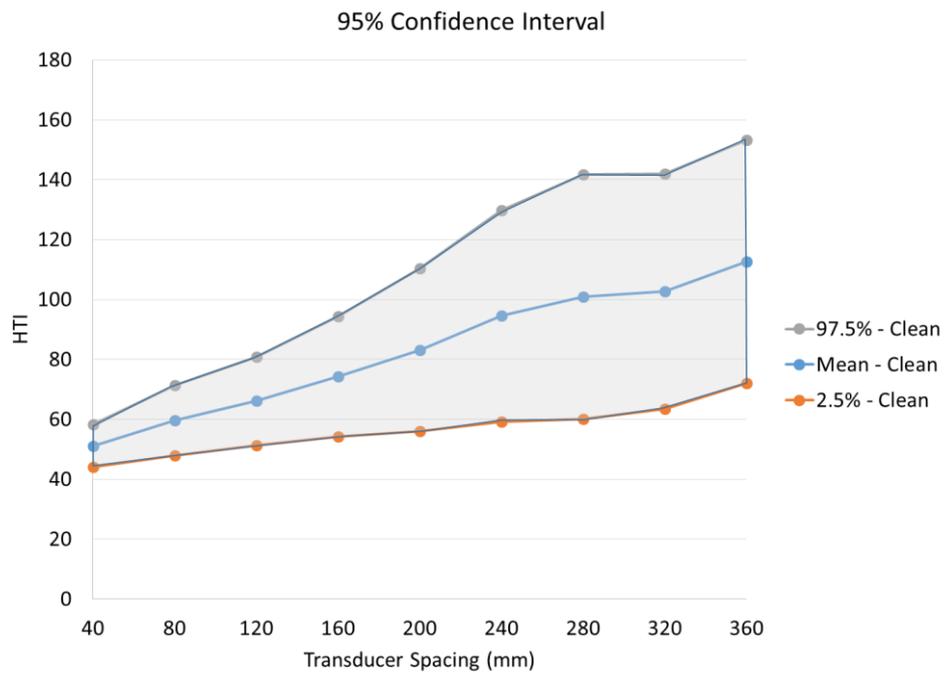
Figure 36. 95% confidence interval for sound concrete.

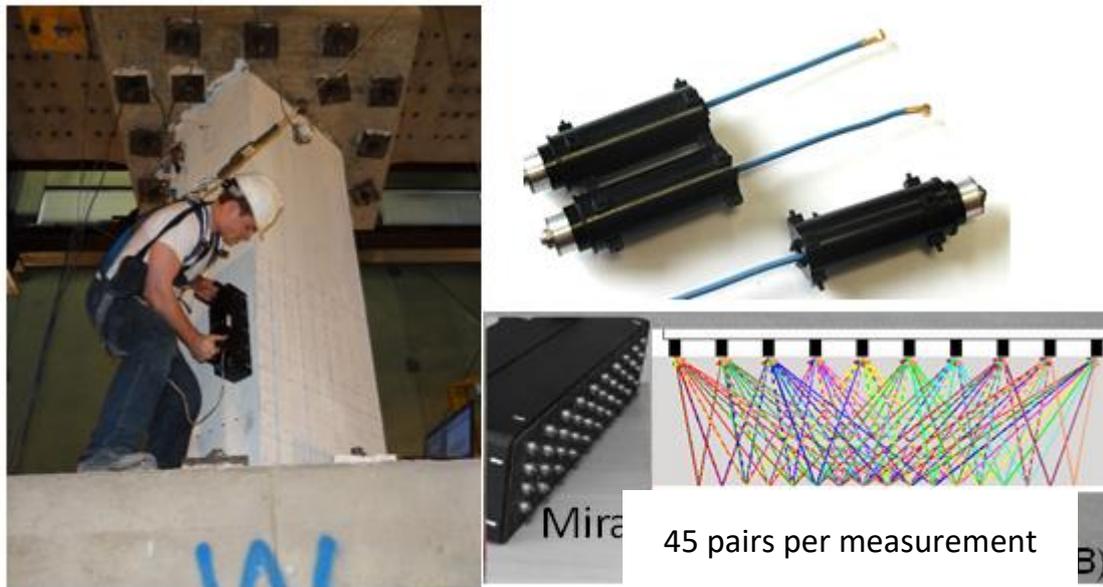
Figure 41. MIRA ultrasonic linear array device

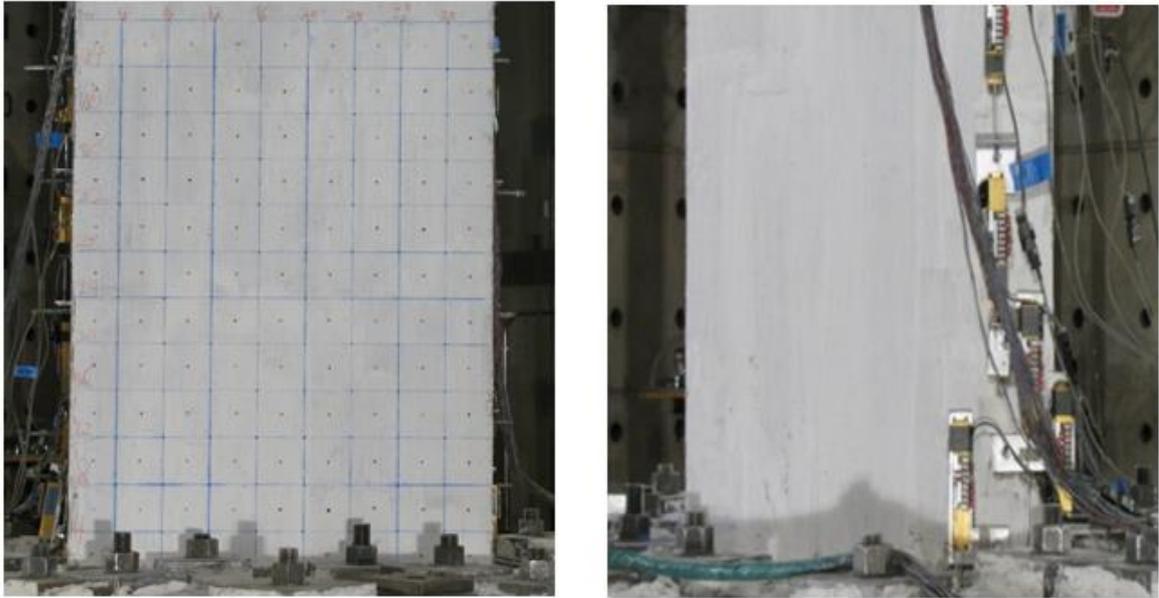
Figure 42. Column condition for 2nd set of MIRA measurements (after 0.5% drift ratio was attained).

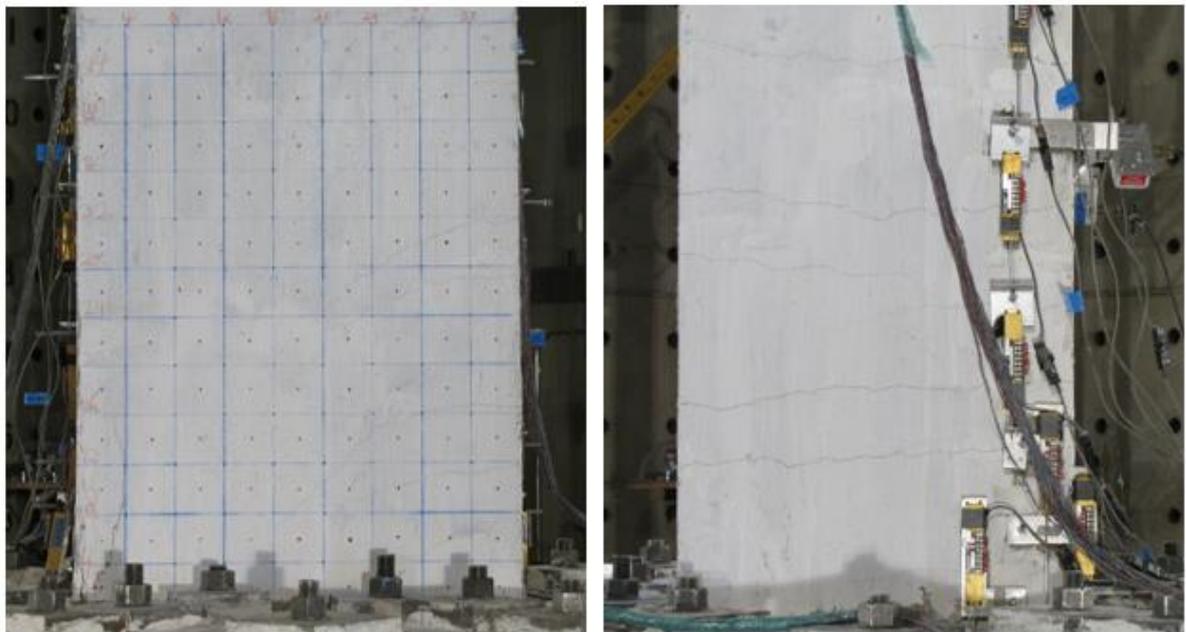
Figure 43. Column condition for 3rd set of MIRA measurements (after 1% drift ratio was attained).

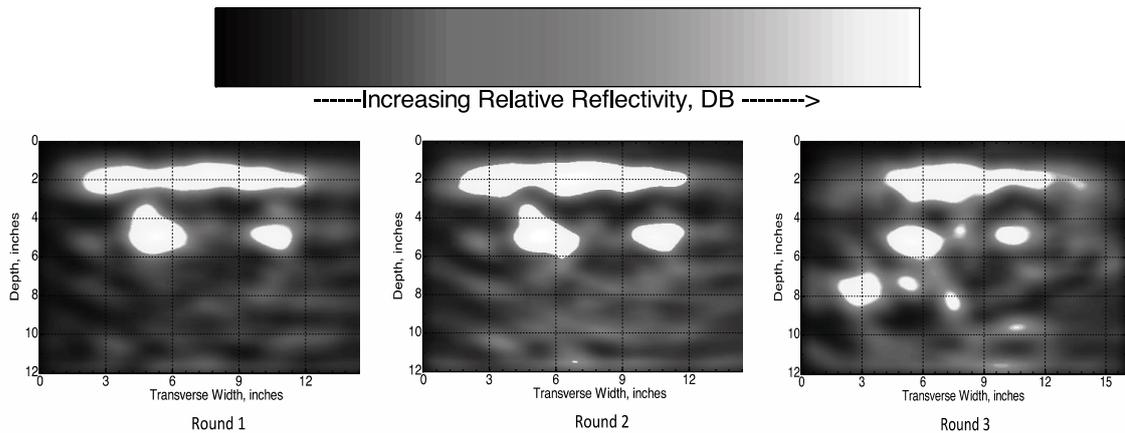
Figure 44. MIRA Reconstructions for 1st round (left) and 2nd round (middle), and 3rd round (right) for a location with relatively low level of damage with loading.

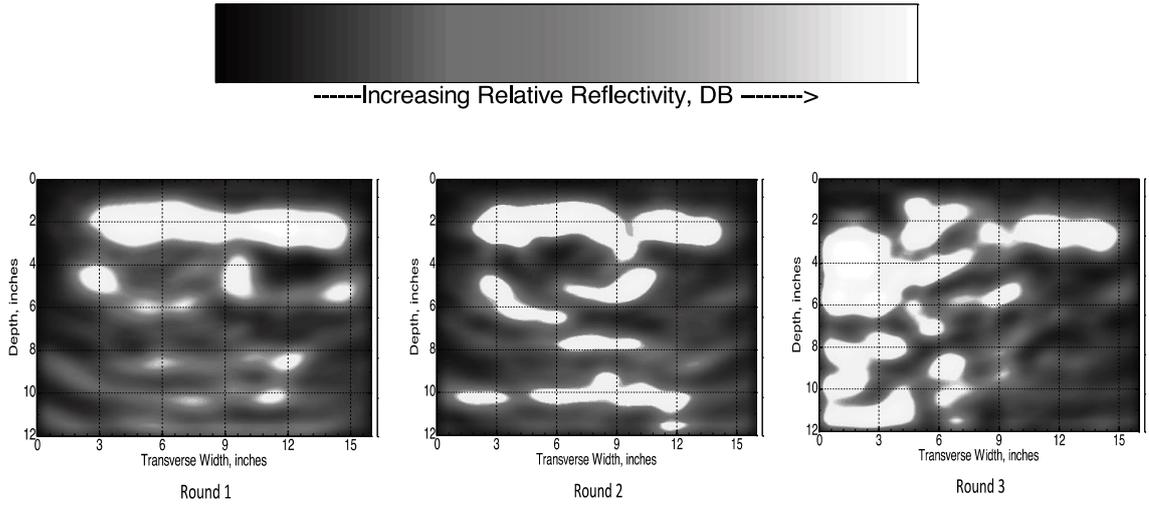
Figure 45. MIRA Reconstructions for 1st round (left) and 2nd round (middle), and 3rd round (right) for a location with relatively high level of damage with loading.

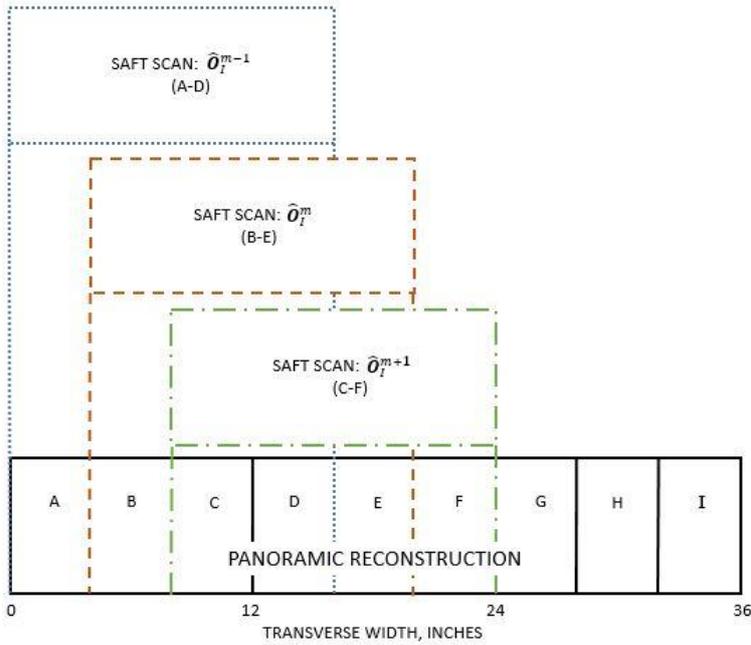
Figure 46. Schematic outlining the merging of 6 individual SAFT scans to create one panoramic reconstruction.
