DAMAGE DETECTION TECHNIQUES FOR CONCRETE APPLICATIONS

FINAL PROJECT REPORT

Lev Khazanovich
Katelyn Freeseaman
Lucio Salles
Aziz Asadollahi
University of Minnesota

Center for Highway Pavement Preservation
(CHPP)

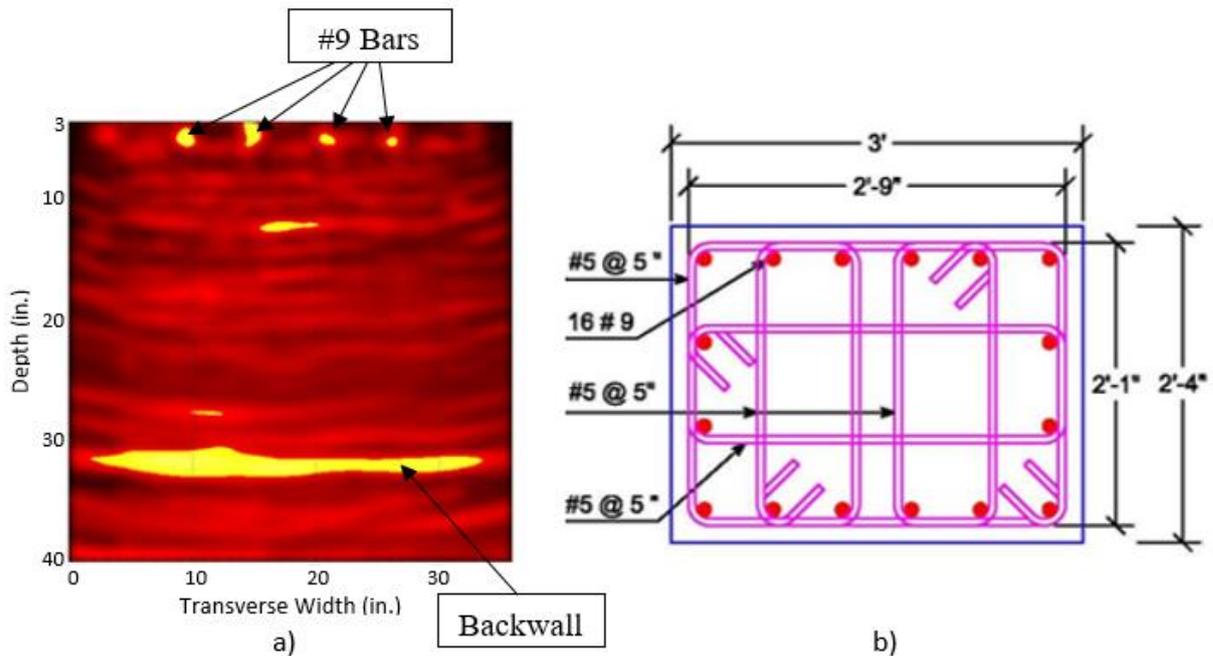
Figure 47. (a) Panoramic reconstructions for 1st measurement showing location of reinforcement and back wall presence, and (b) corresponding design schematic.

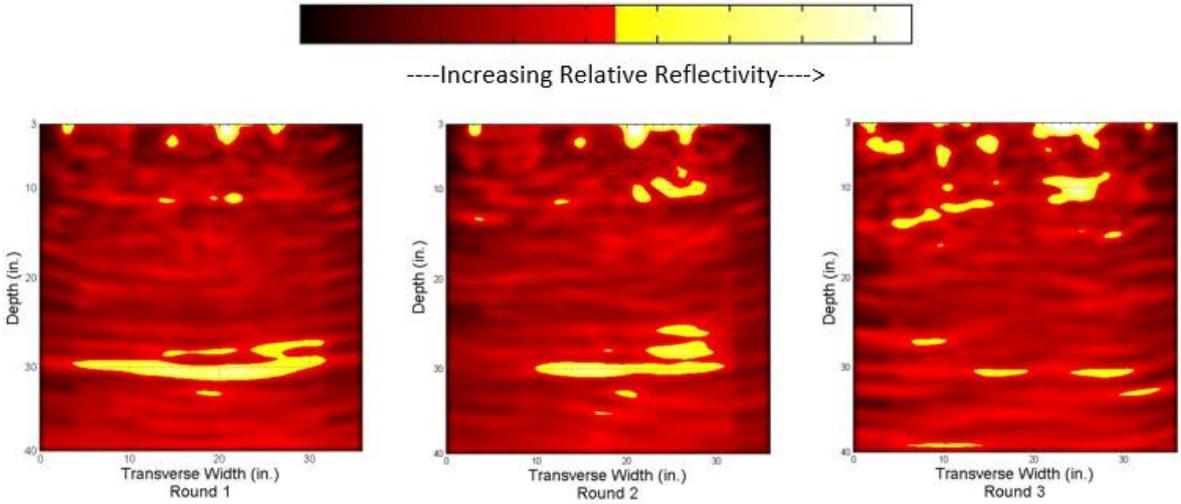
Figure 48. Panoramic reconstructions for 1st measurement (left), 2nd measurement (middle), and 3rd measurement (right) for a location on the bottom of the column.

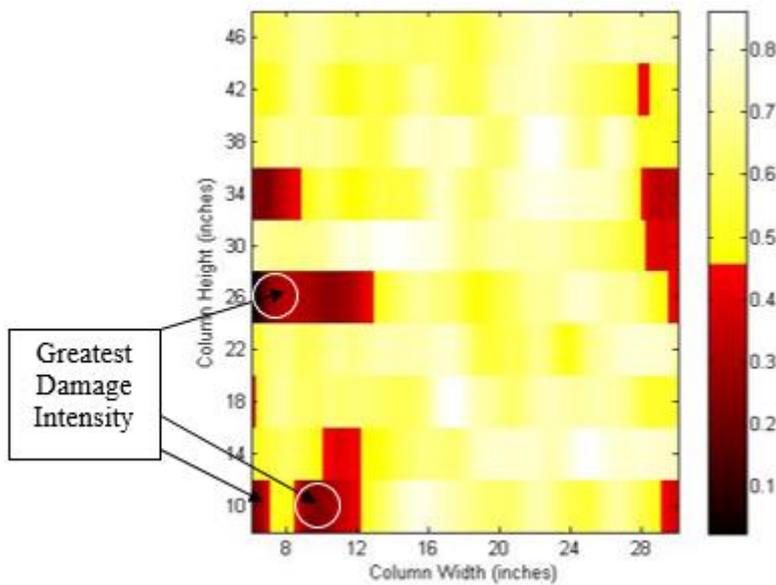
Figure 52. MIRA gradient results after 0.5% drift ratio.

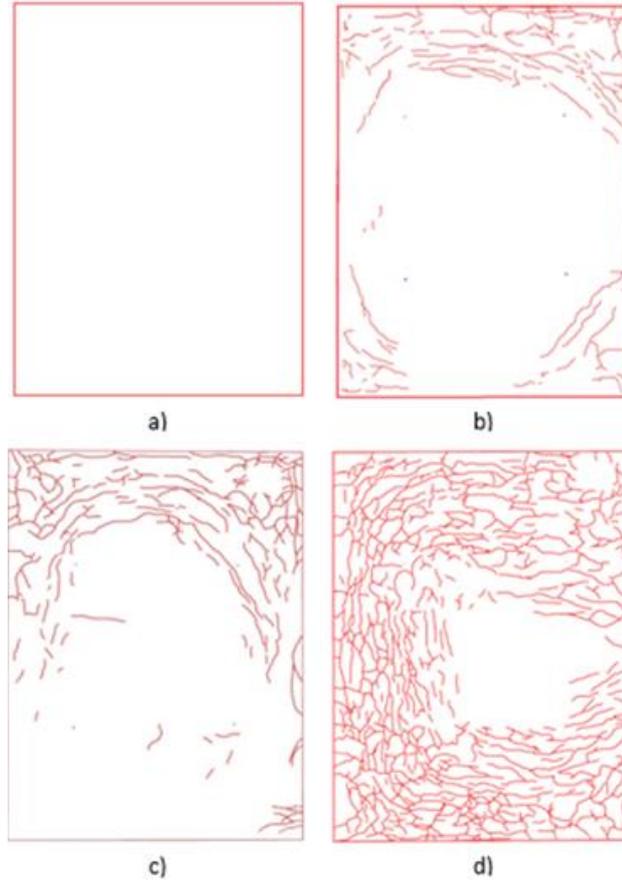
Figure 54. Visual condition surveys of slabs A, B, C and D.

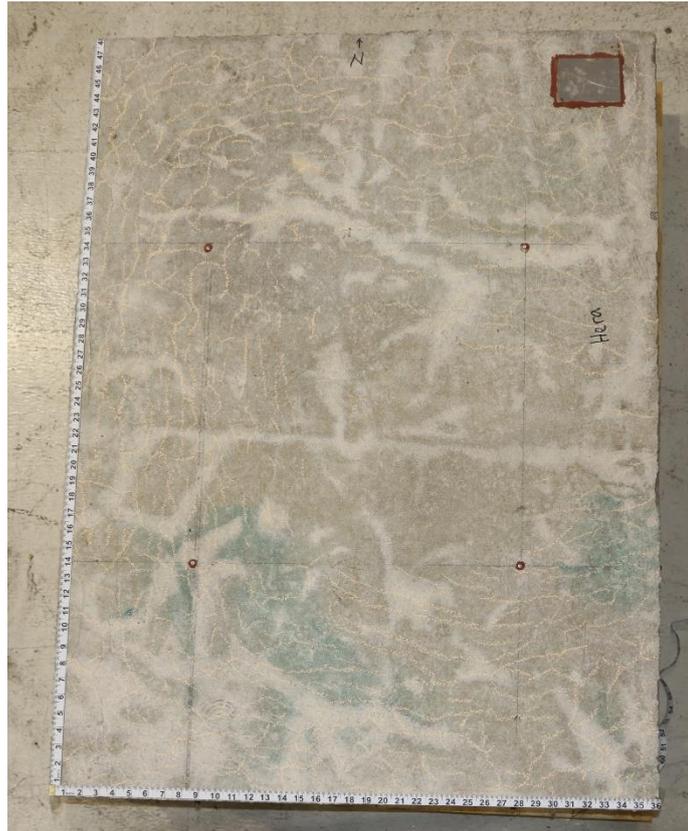
Figure 55. Photograph of condition of slab D.

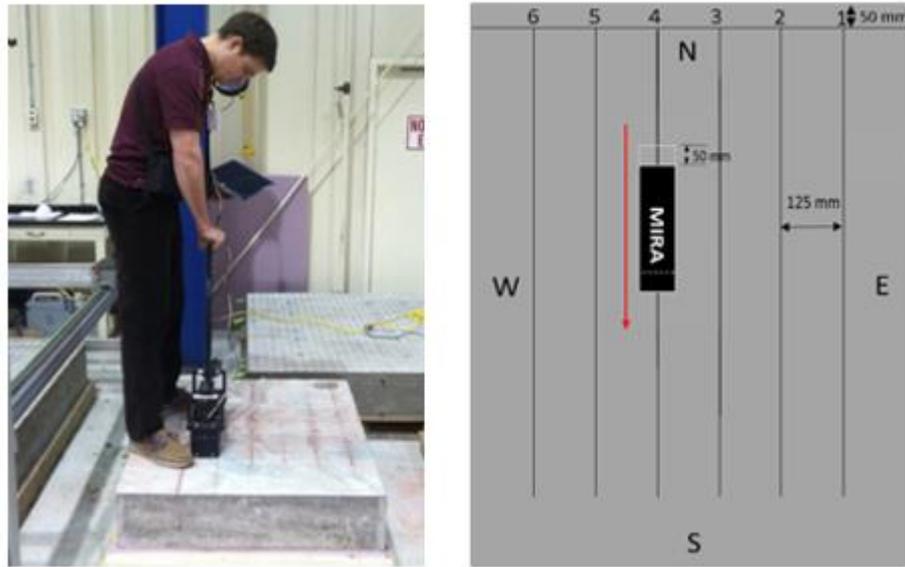
Figure 56. Experimental investigation setup (left), and schematic of measurement locations (right).

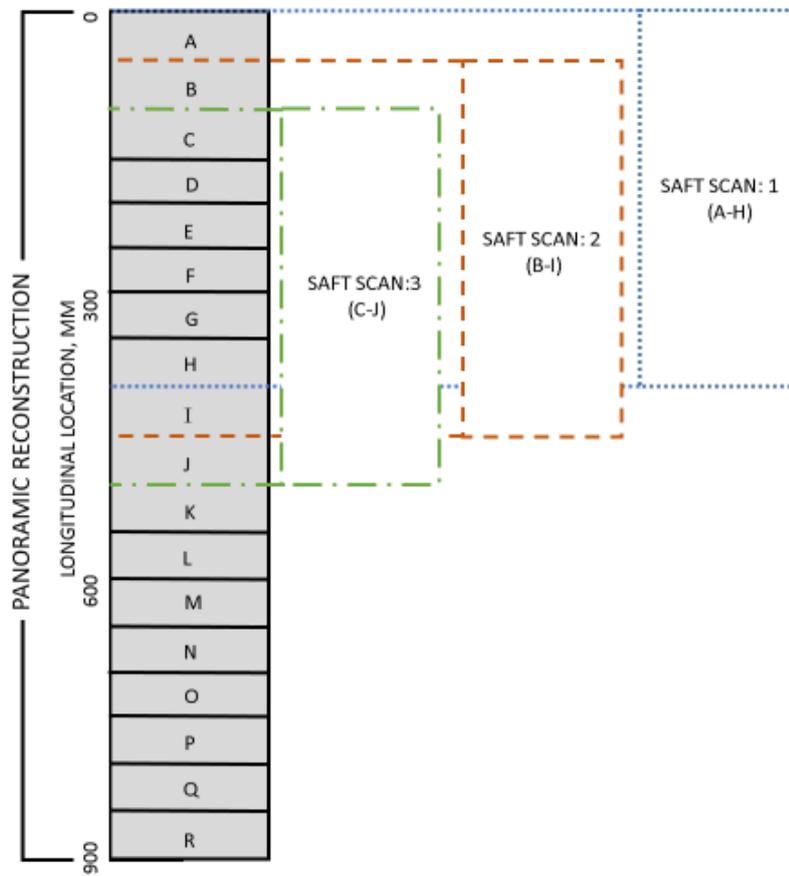
Figure 57. Panoramic reconstruction compilation schematic.

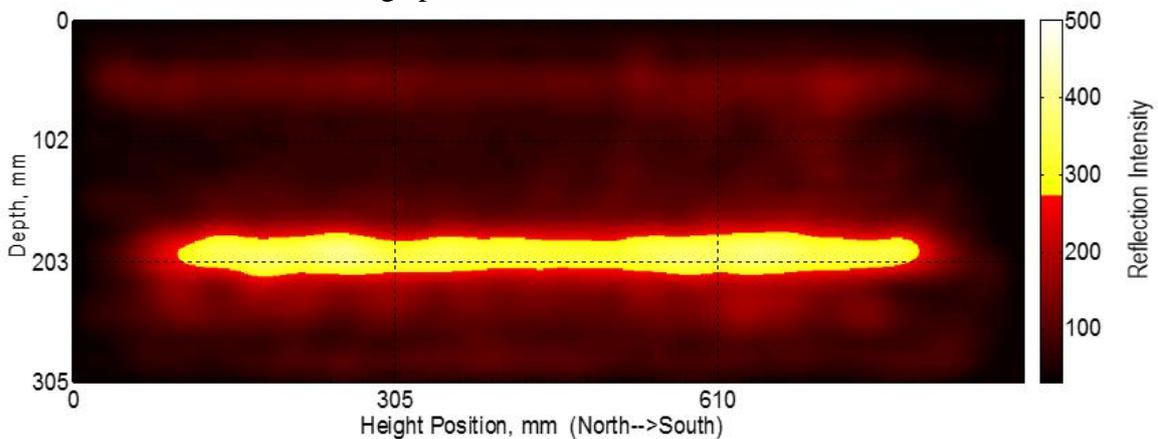
Figure 58. Reconstruction in the middle of slab A indicating sound concrete condition.

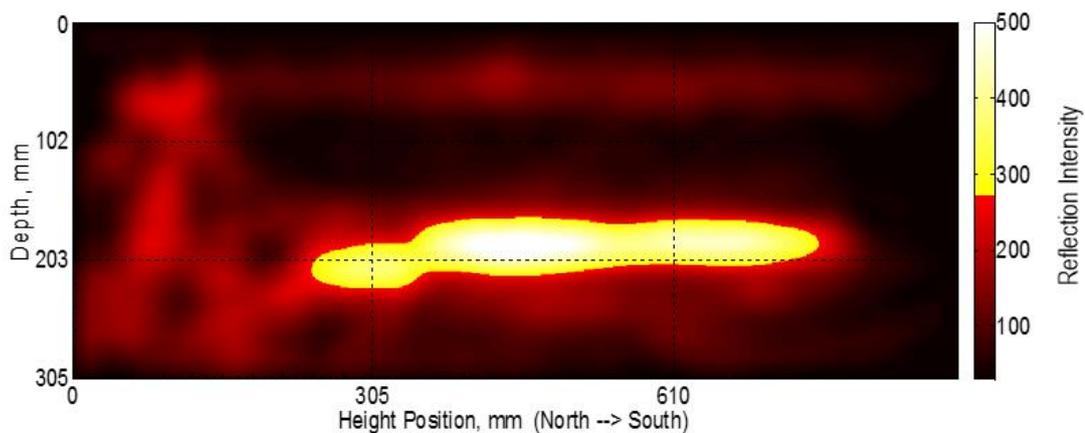
Figure 59. Reconstruction on the west side of slab B, indicating partially damaged concrete.

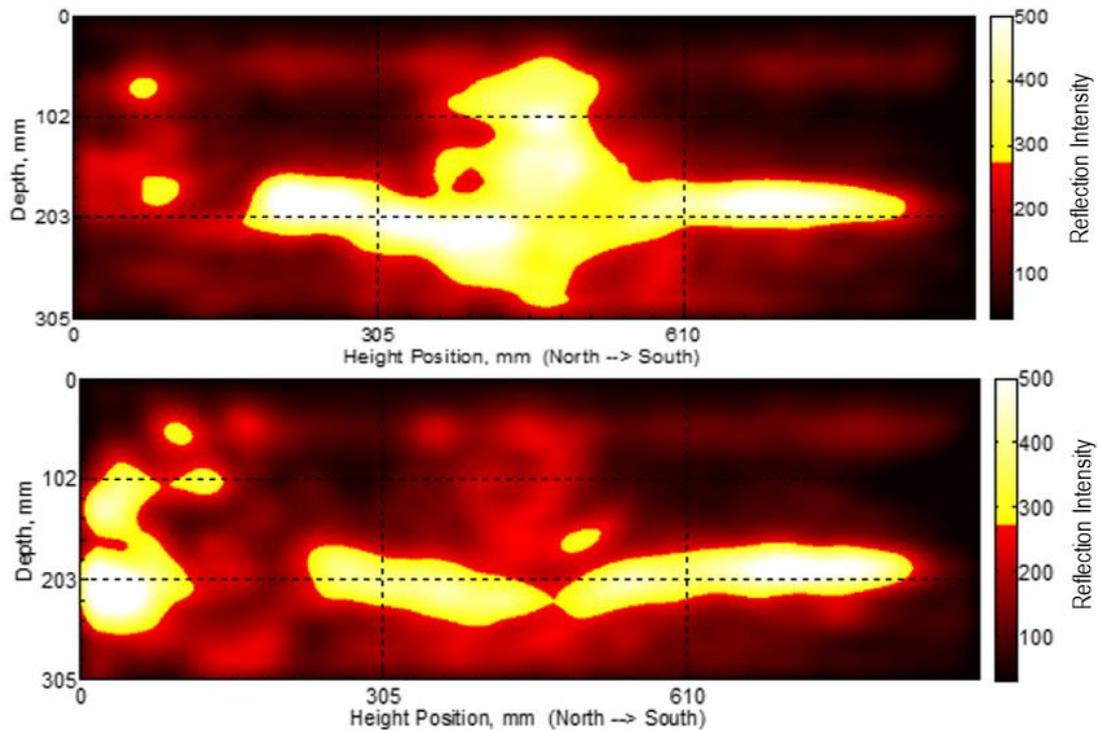
Figure 60. Reconstructions in the middle of slab C indicating partially damaged concrete condition.

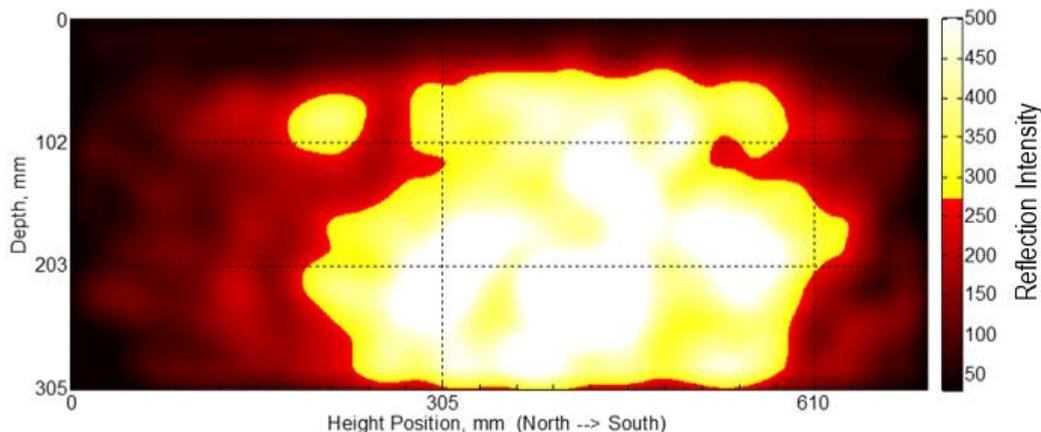
Figure 61. Reconstruction in the middle of slab D indicating damaged concrete condition.

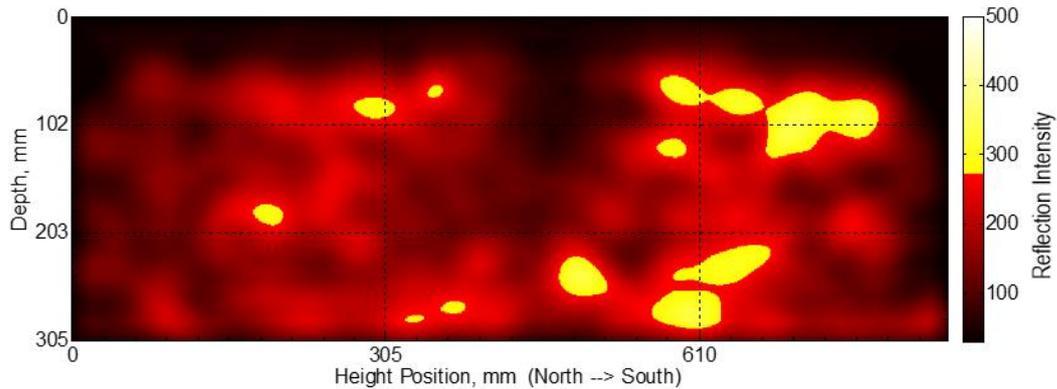
Figure 62. Reconstruction from the west side of slab D indicating damaged concrete condition.

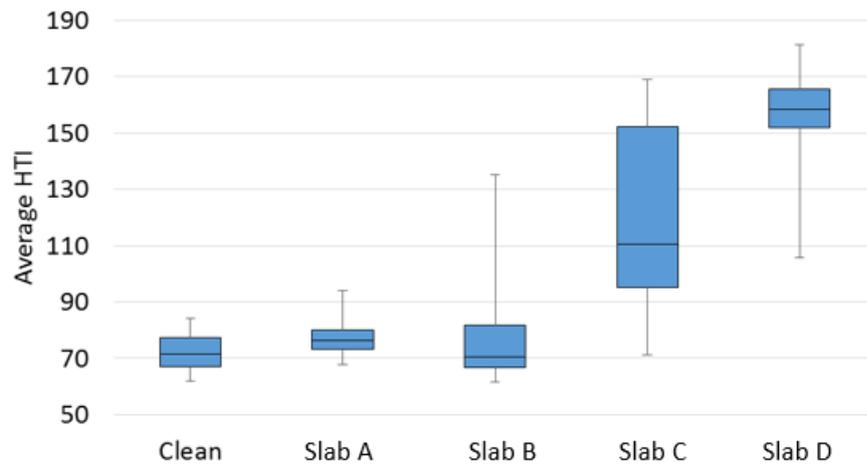
Figure 63. Average HTI values for five cases.

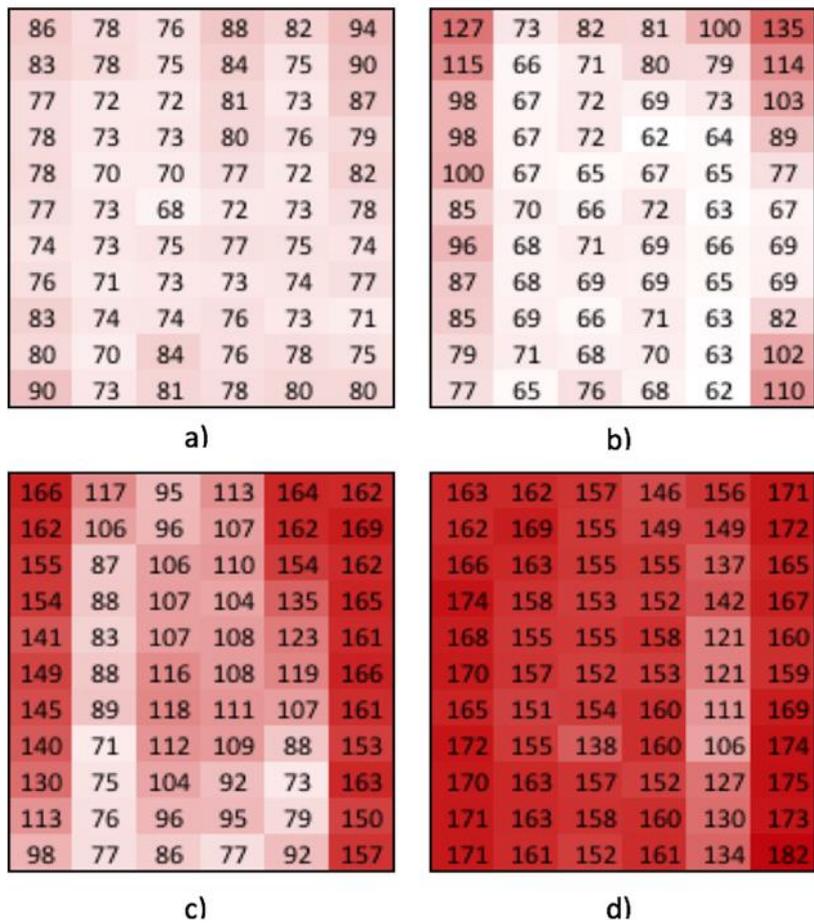
Figure 64. HTI color maps for: slab A, clean slab; slab B, partially damaged; slab C, partially damaged; and slab D, damaged.

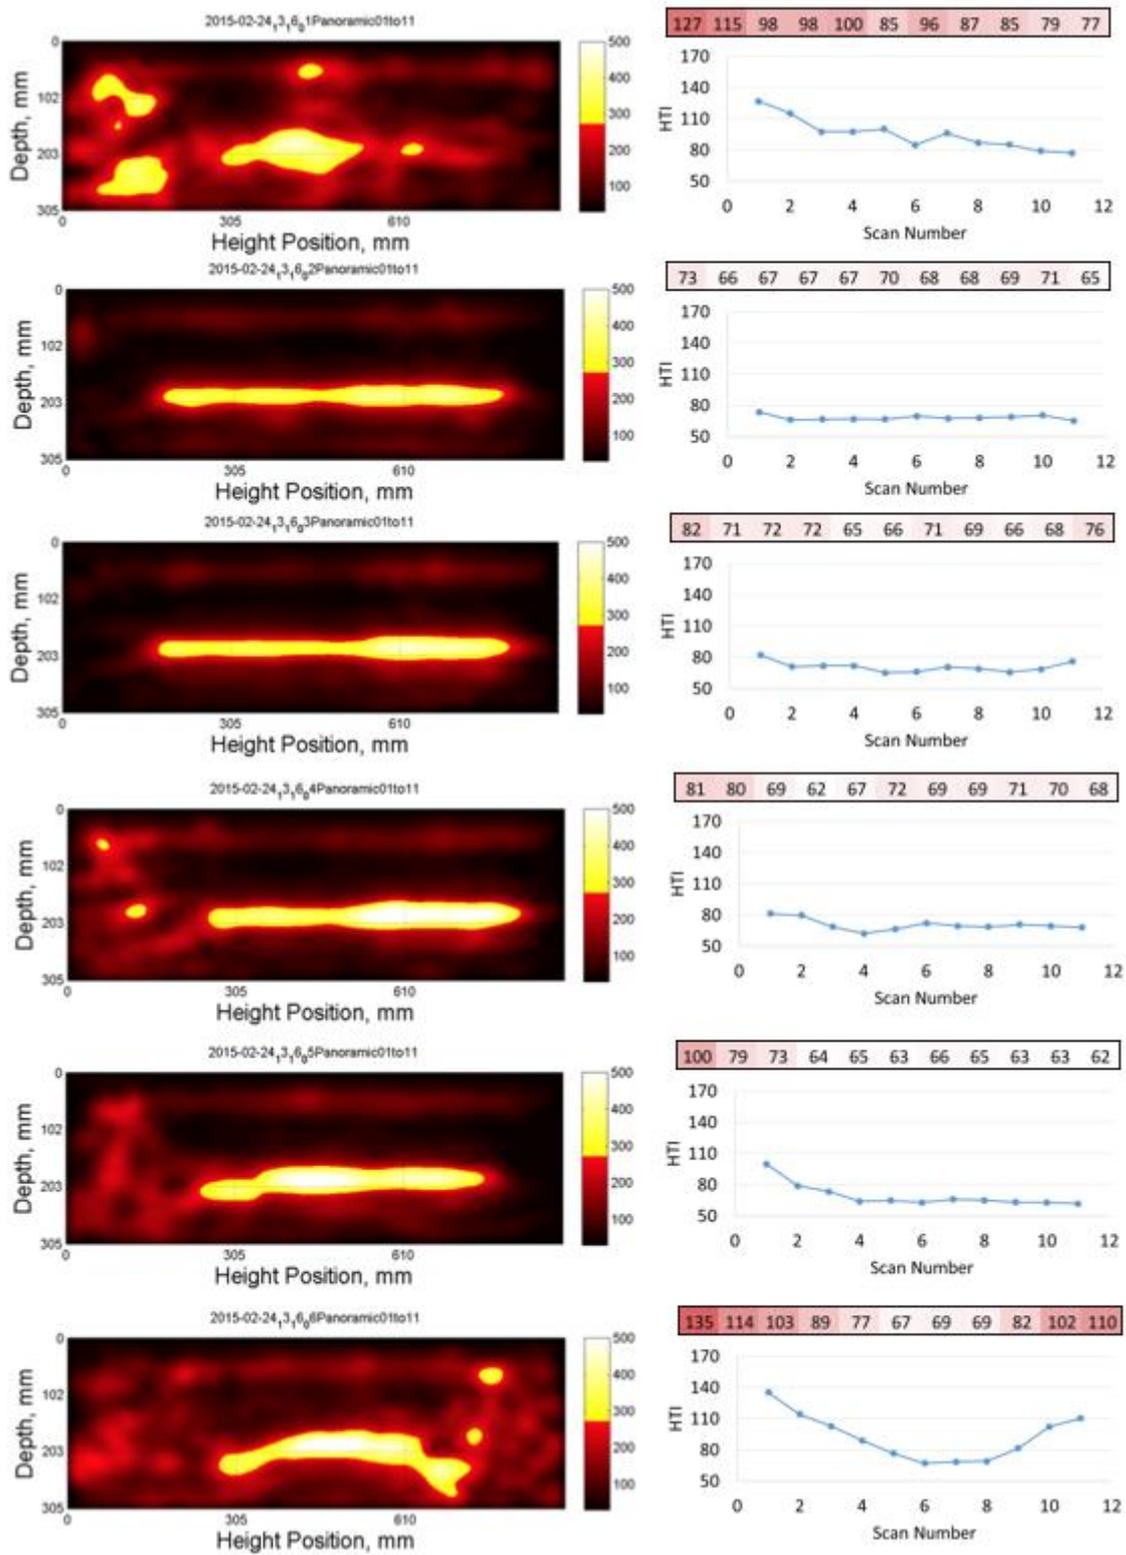
Figure 65. Comparison of panoramic reconstructions (left) and HTI index (right) analyses for slab B.

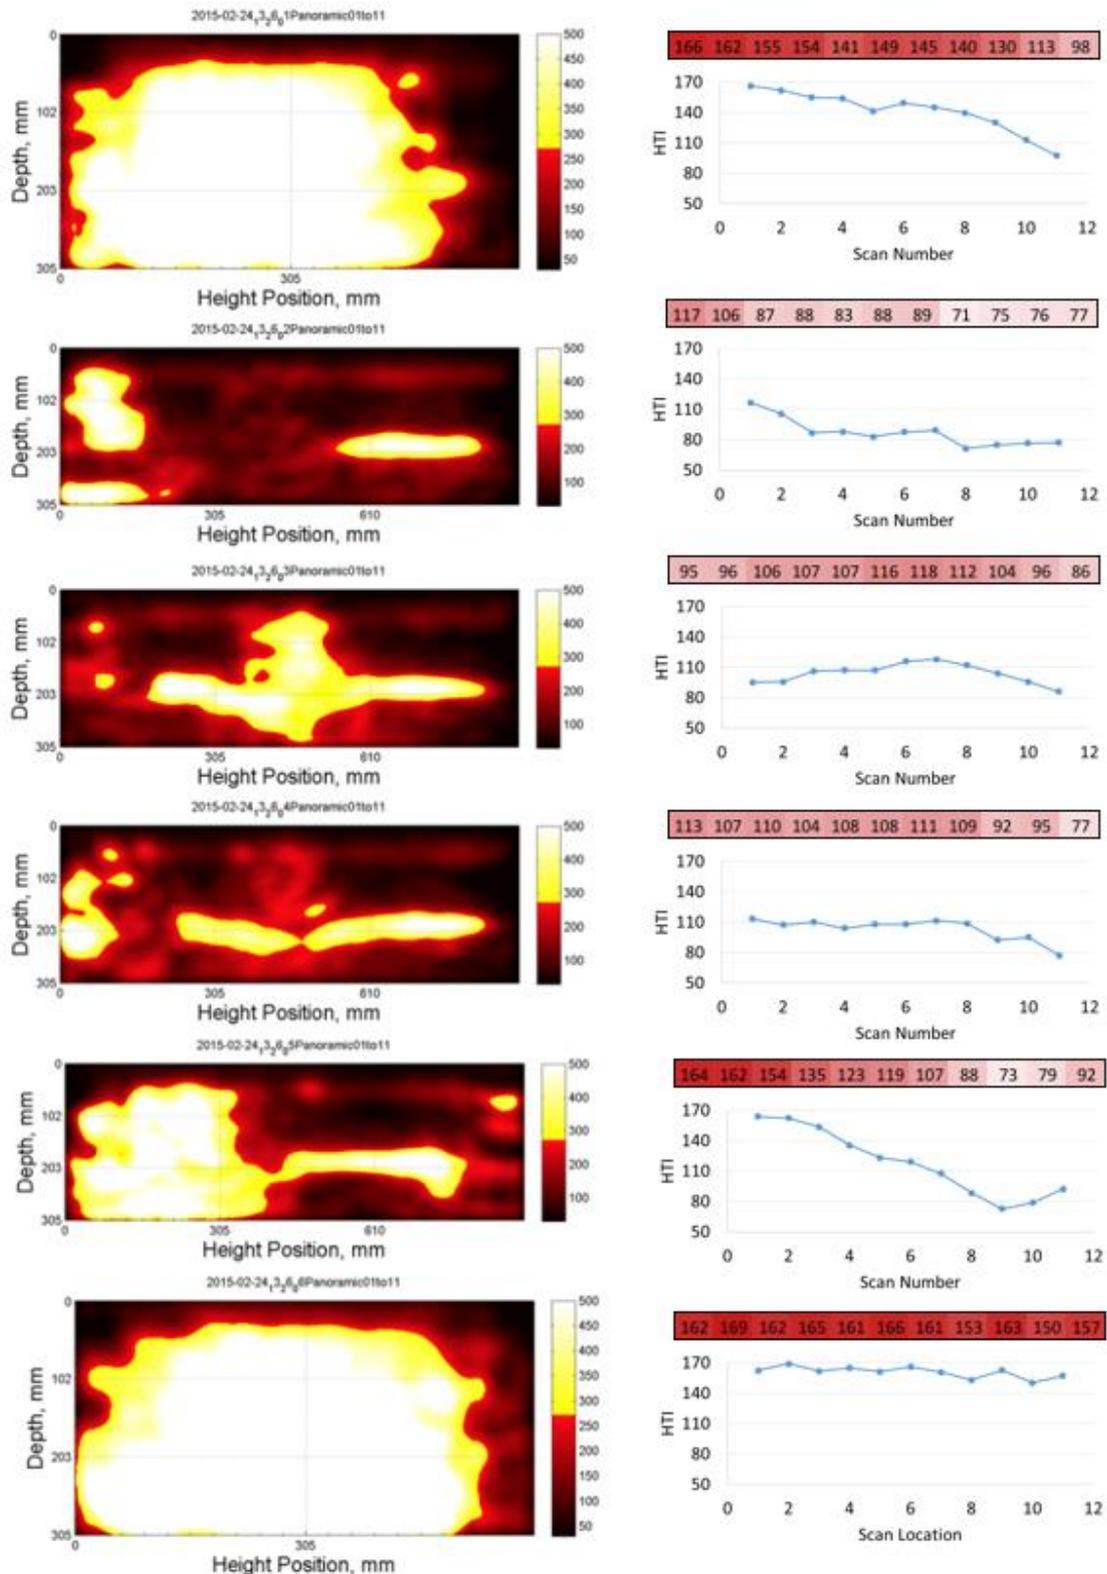
Figure 66. Comparison of panoramic reconstructions (left) and HTI index (right) analyses of slab C.

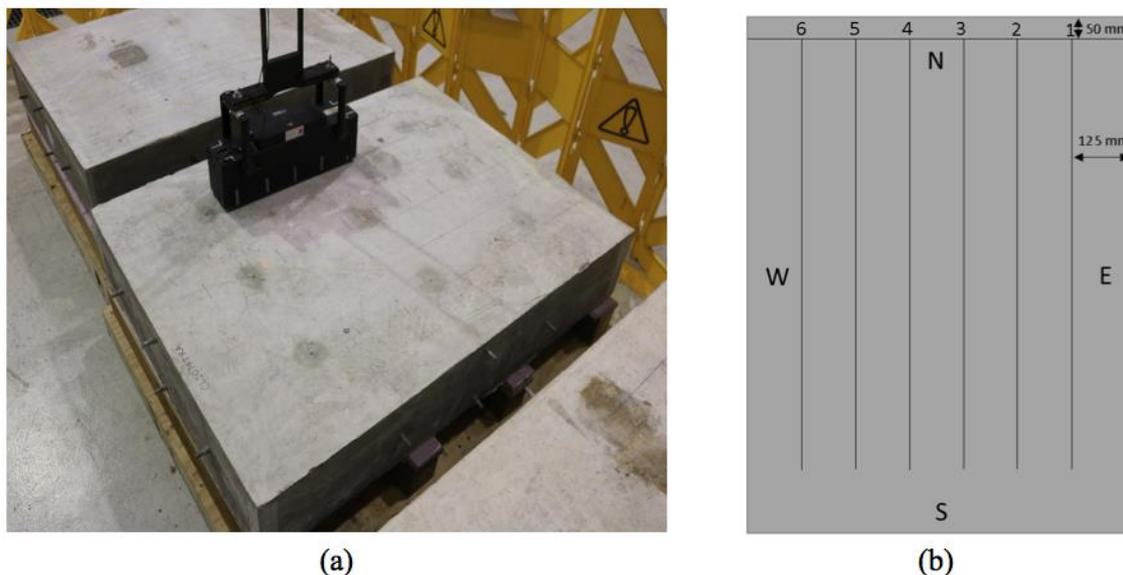
Figure 67. Ultrasonic device positioned on slab 2 (a) and readings location schematic (b).

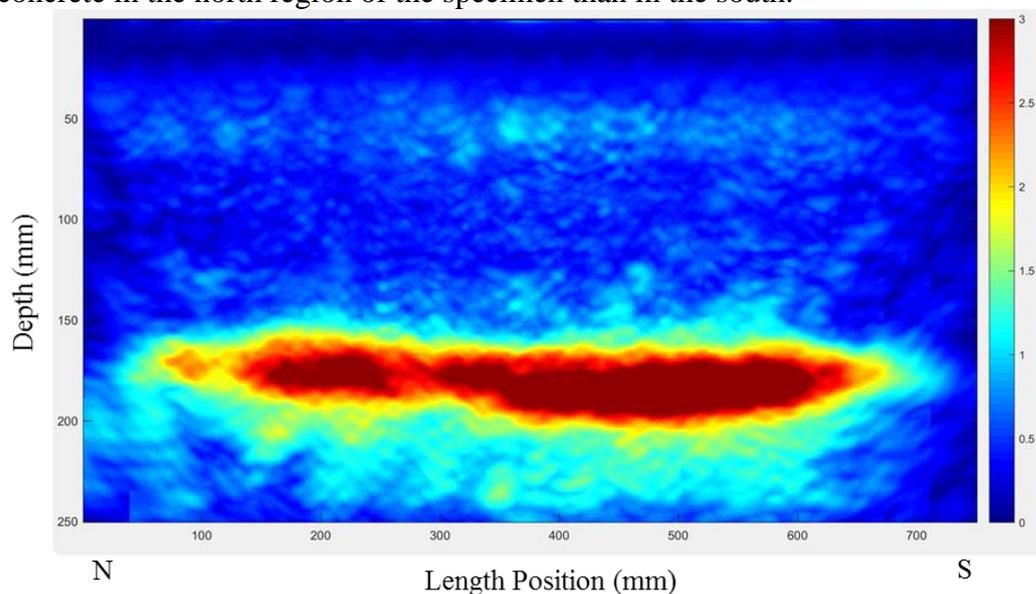
Figure 68. SAFT-Pan Reconstruction of specimen Slab 0, panoramic 3

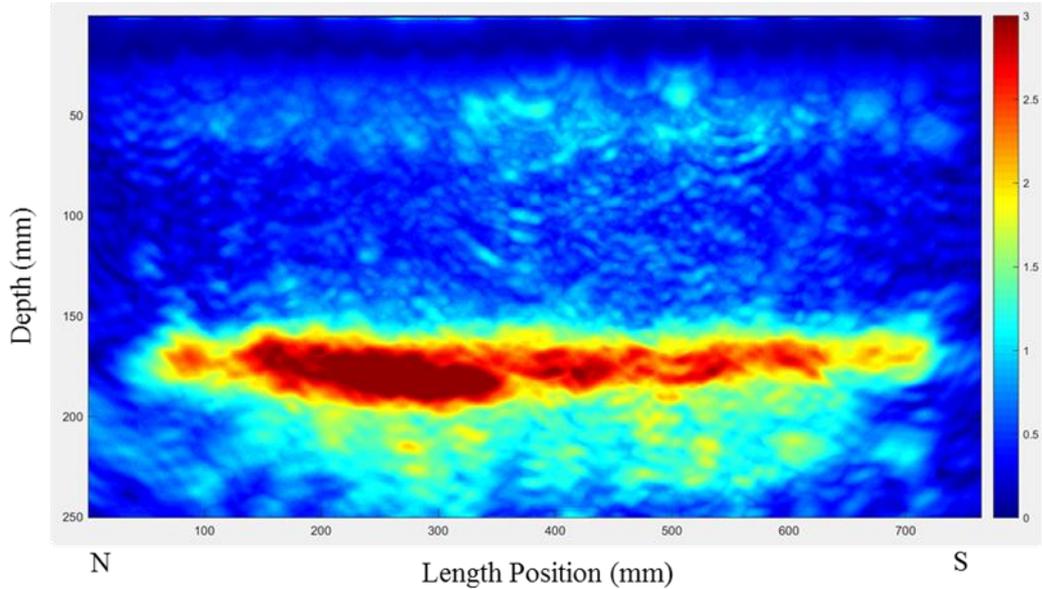
Figure 69. SAFT-Pan Reconstruction of specimen Slab 0, panoramic 5

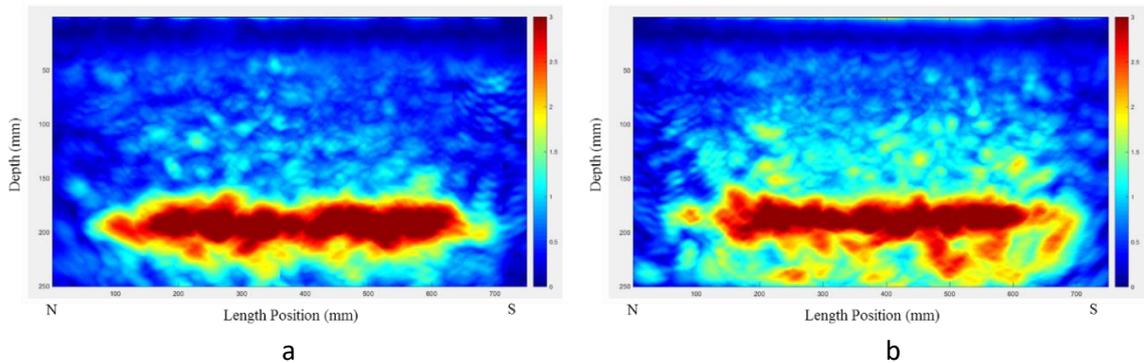
Figure 70. SAFT-Pan Reconstructions of specimen slab 3, (a) panoramic 4 and (b) panoramic 6

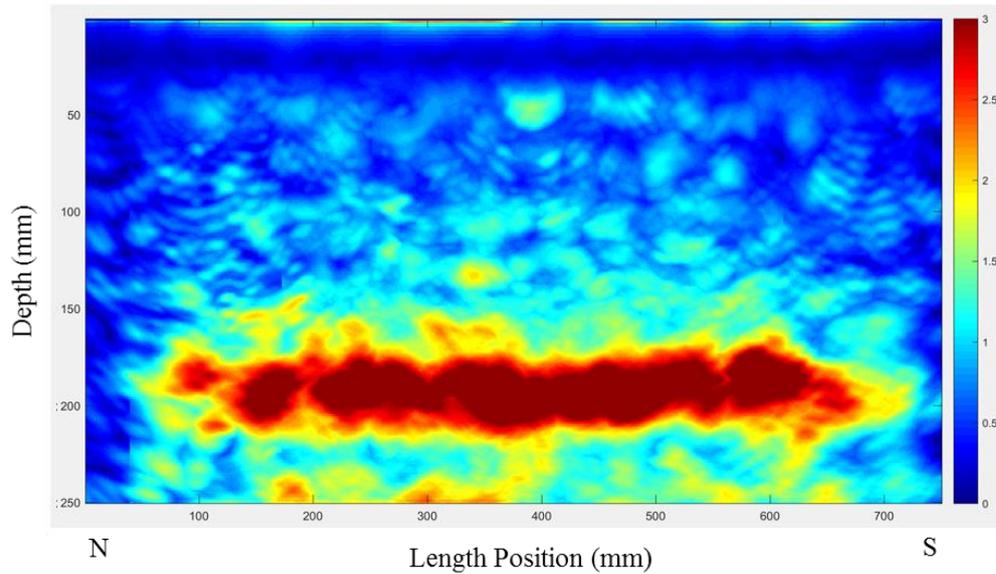
Figure 71. SAFT-Pan Reconstruction of slab 2, panoramic 5

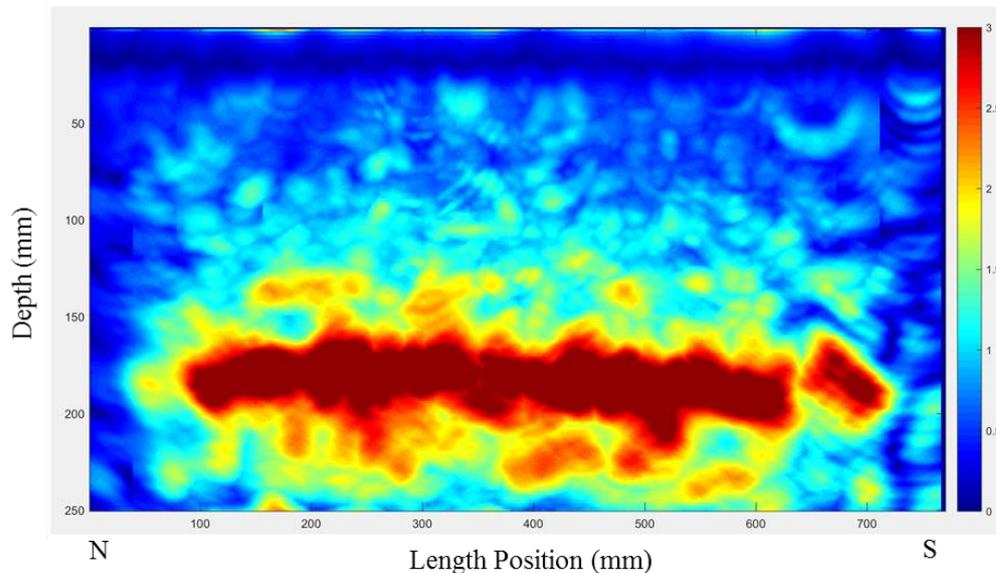
Figure 72. SAFT-Pan Reconstruction of slab 1, panoramic 1

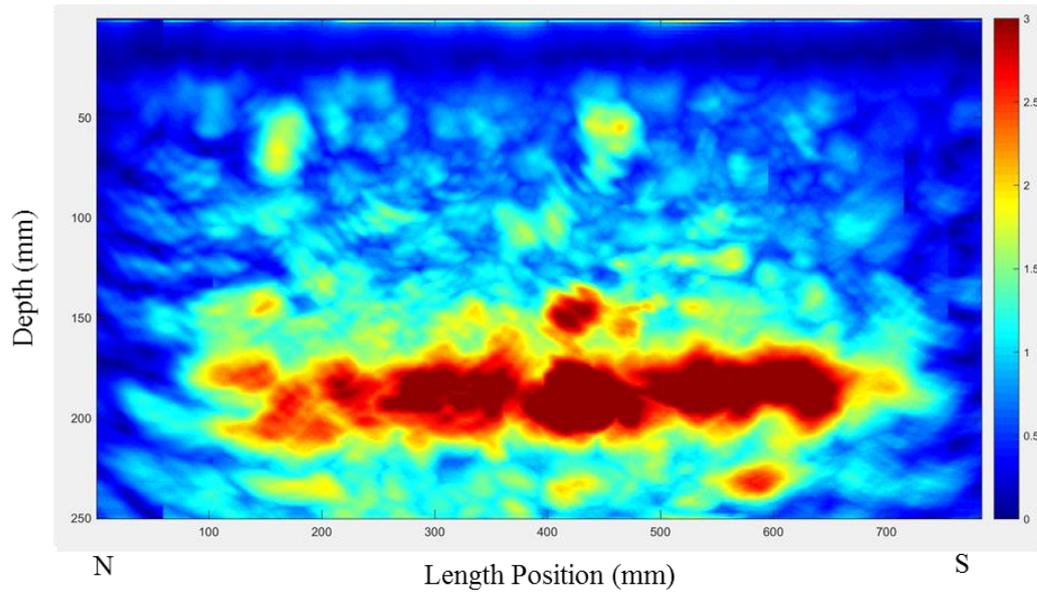
Figure 73. SAFT-Pan Reconstruction of specimen slab 2, panoramic 1

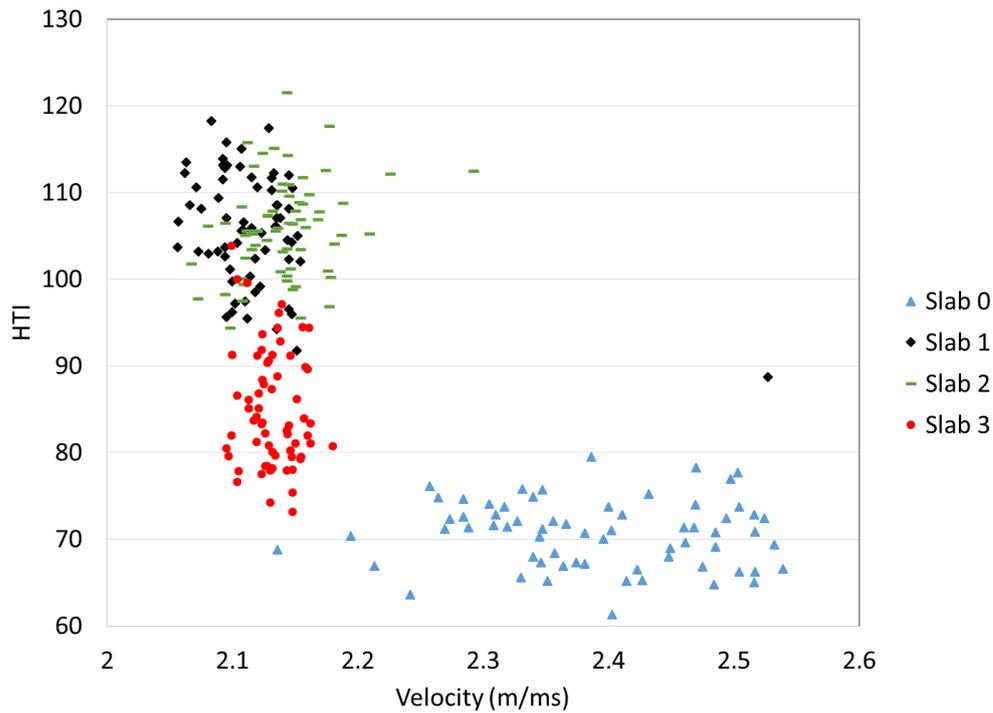
Figure 74. HTI versus shear wave velocity

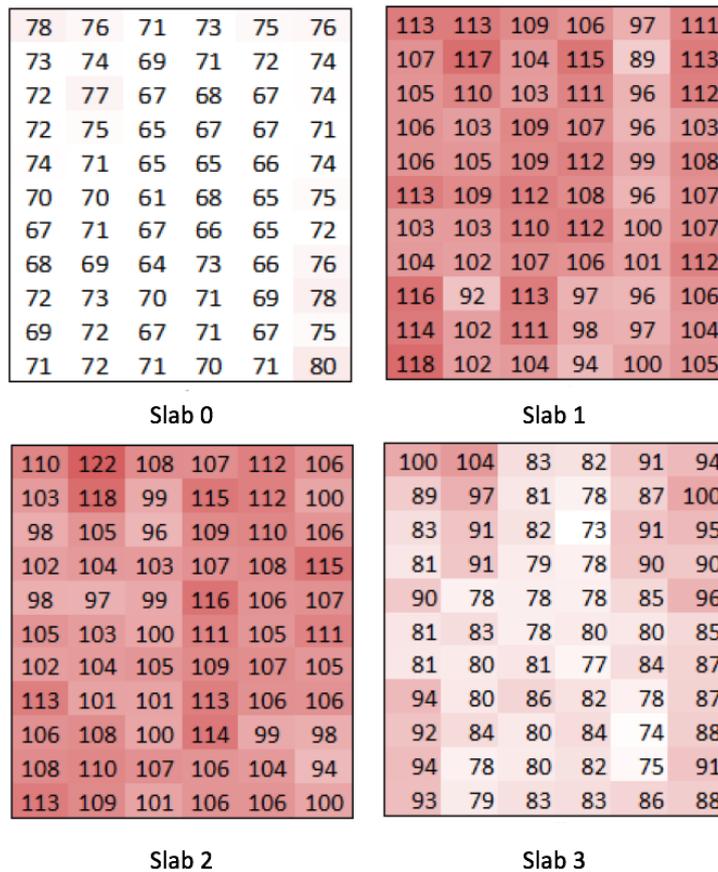
Figure 75. HTI color map for specimens slab 0-3.

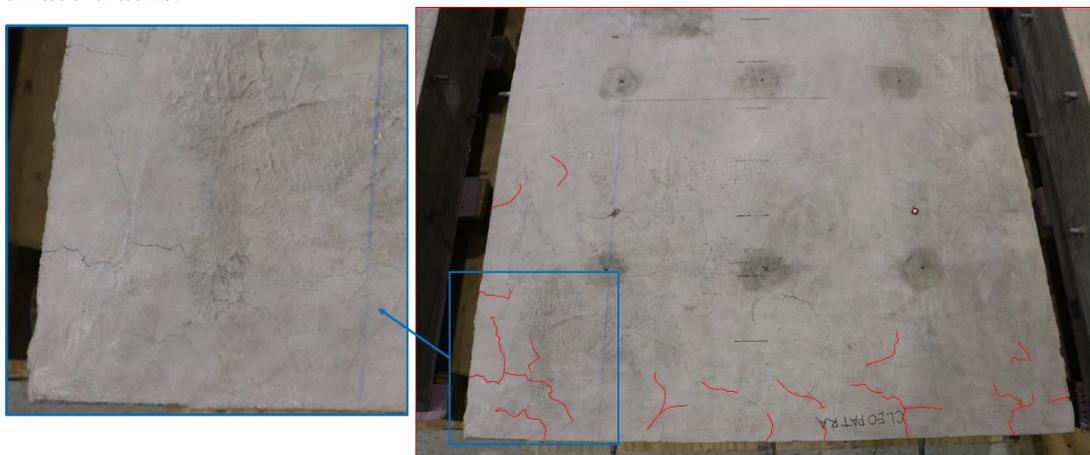
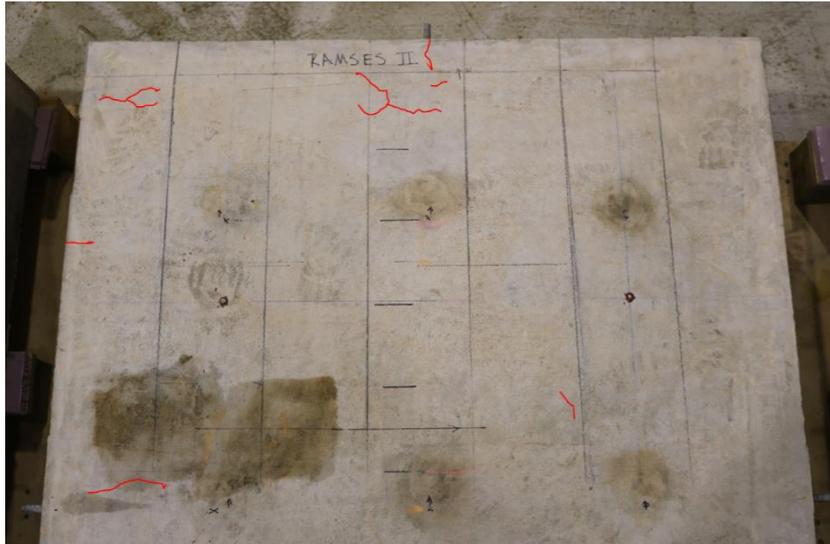
Figure 76. Visible cracking in south portion of slab 2 (top) and north portion of slab 1 (bottom).

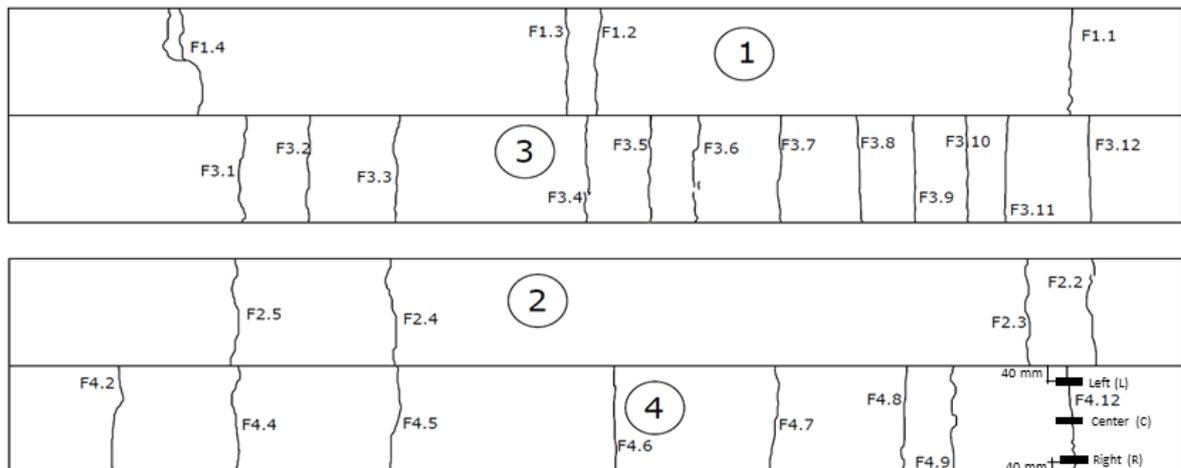
Figure 77. February, 2015 crack map

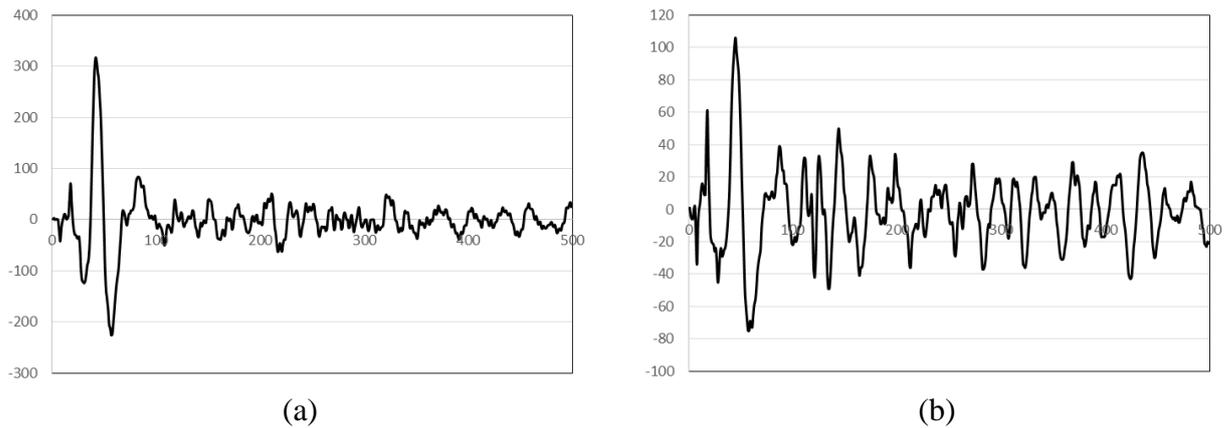
Figure 78. Signals for (a) sound concrete and (b) crack F3.4 (Right).

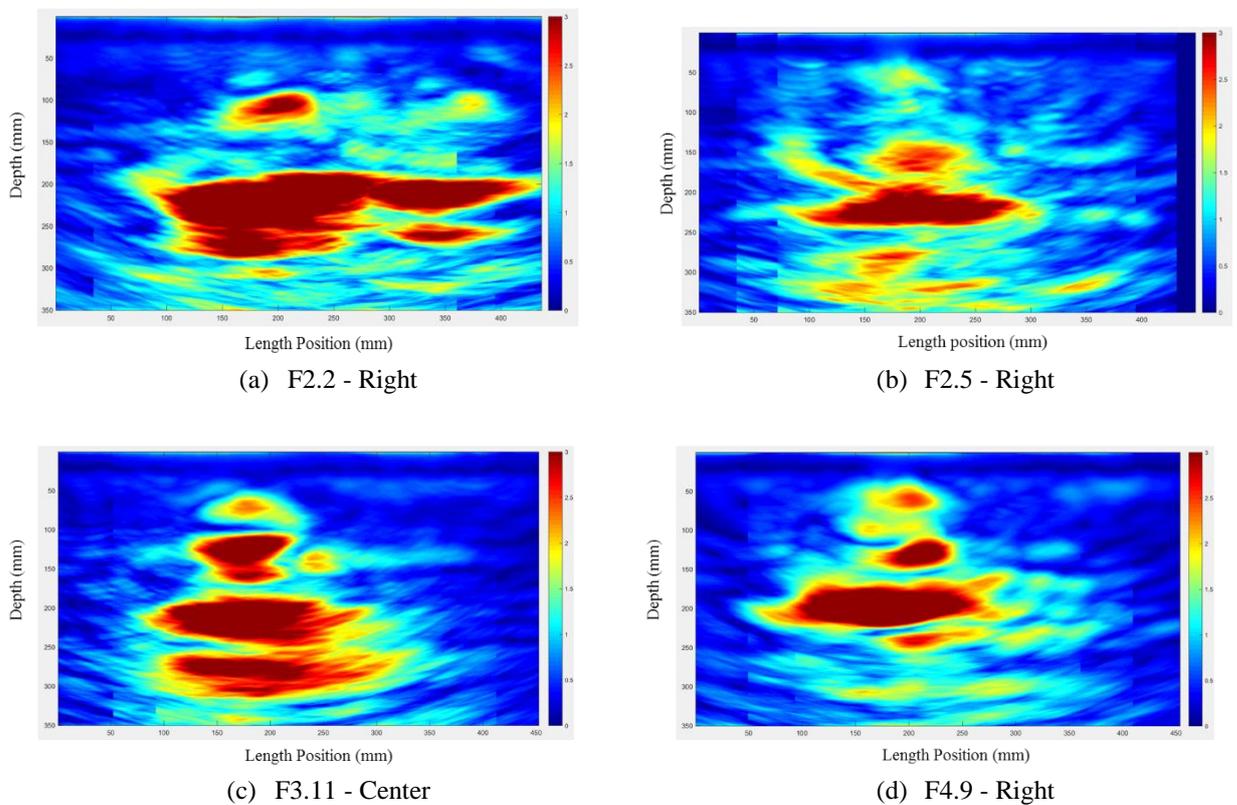
Figure 79. Examples of typical SAFT-Pan reconstructions at transversal cracks

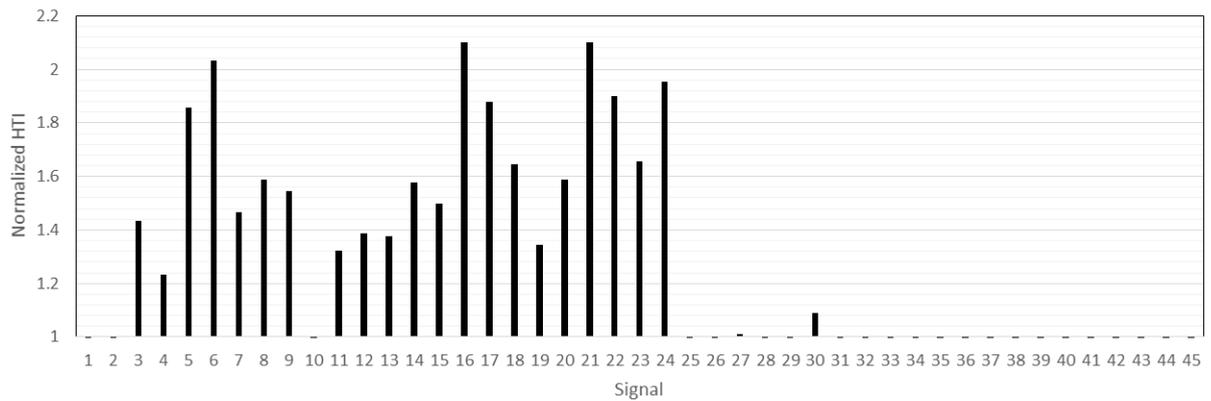
Figure 82. Normalized HTI for every signal in crack F2.5-R (first scan)

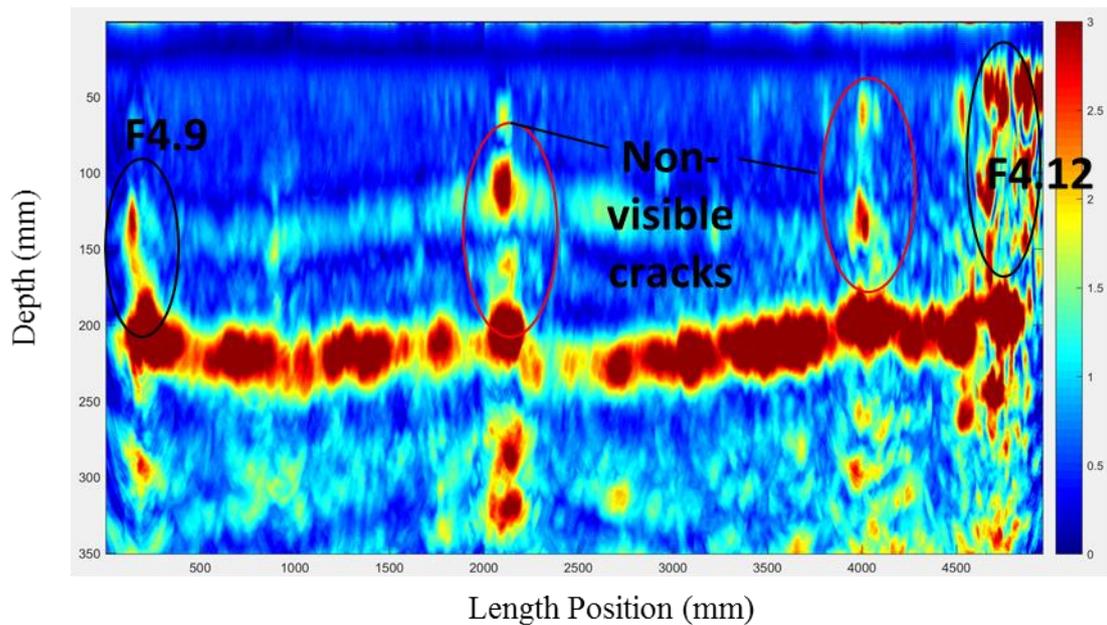
Figure 85. SAFT-Pan reconstruction of the panel between cracks F4.9 and F4.12 in Section 4.

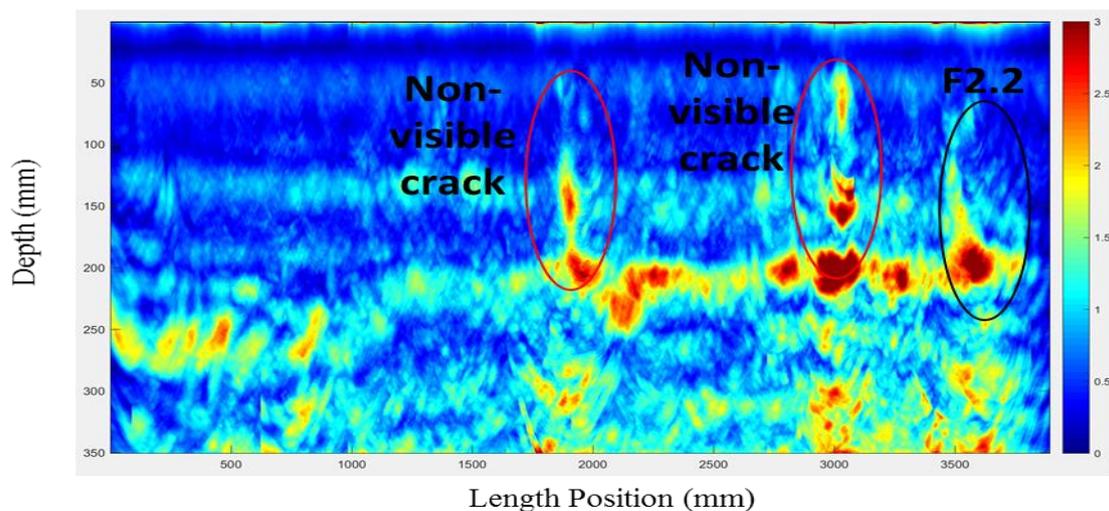
Figure 86. SAFT-Pan reconstruction of the panel between Section 1 and crack F2.2 in Section 2.
