DAMAGE DETECTION TECHNIQUES FOR CONCRETE APPLICATIONS

FINAL PROJECT REPORT

Lev Khazanovich
Katelyn Freeseaman
Lucio Salles
Aziz Asadollahi
University of Minnesota

Center for Highway Pavement Preservation
(CHPP)

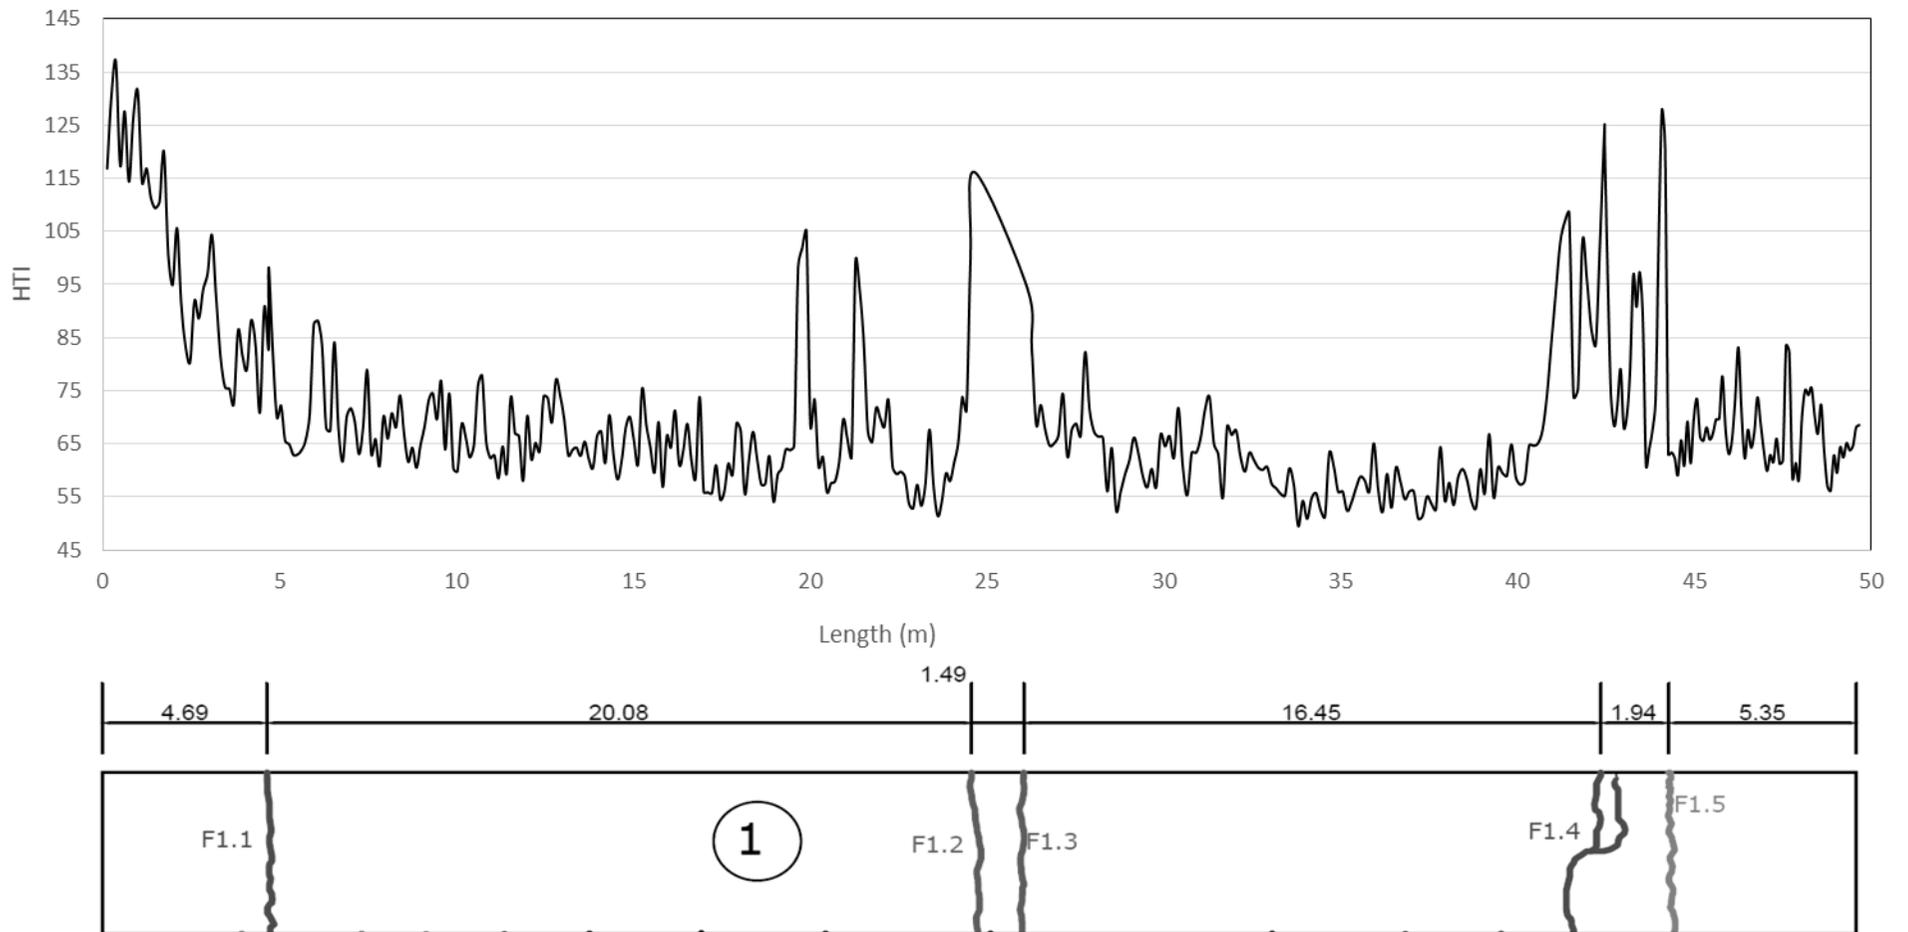
Figure 87. HTI trough Section 1

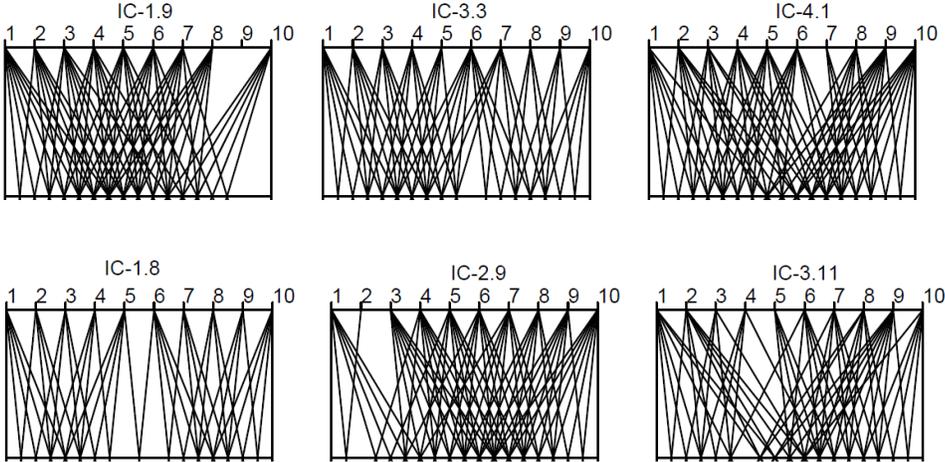
Figure 92. Signal loss due to high HTI in non-visible cracks

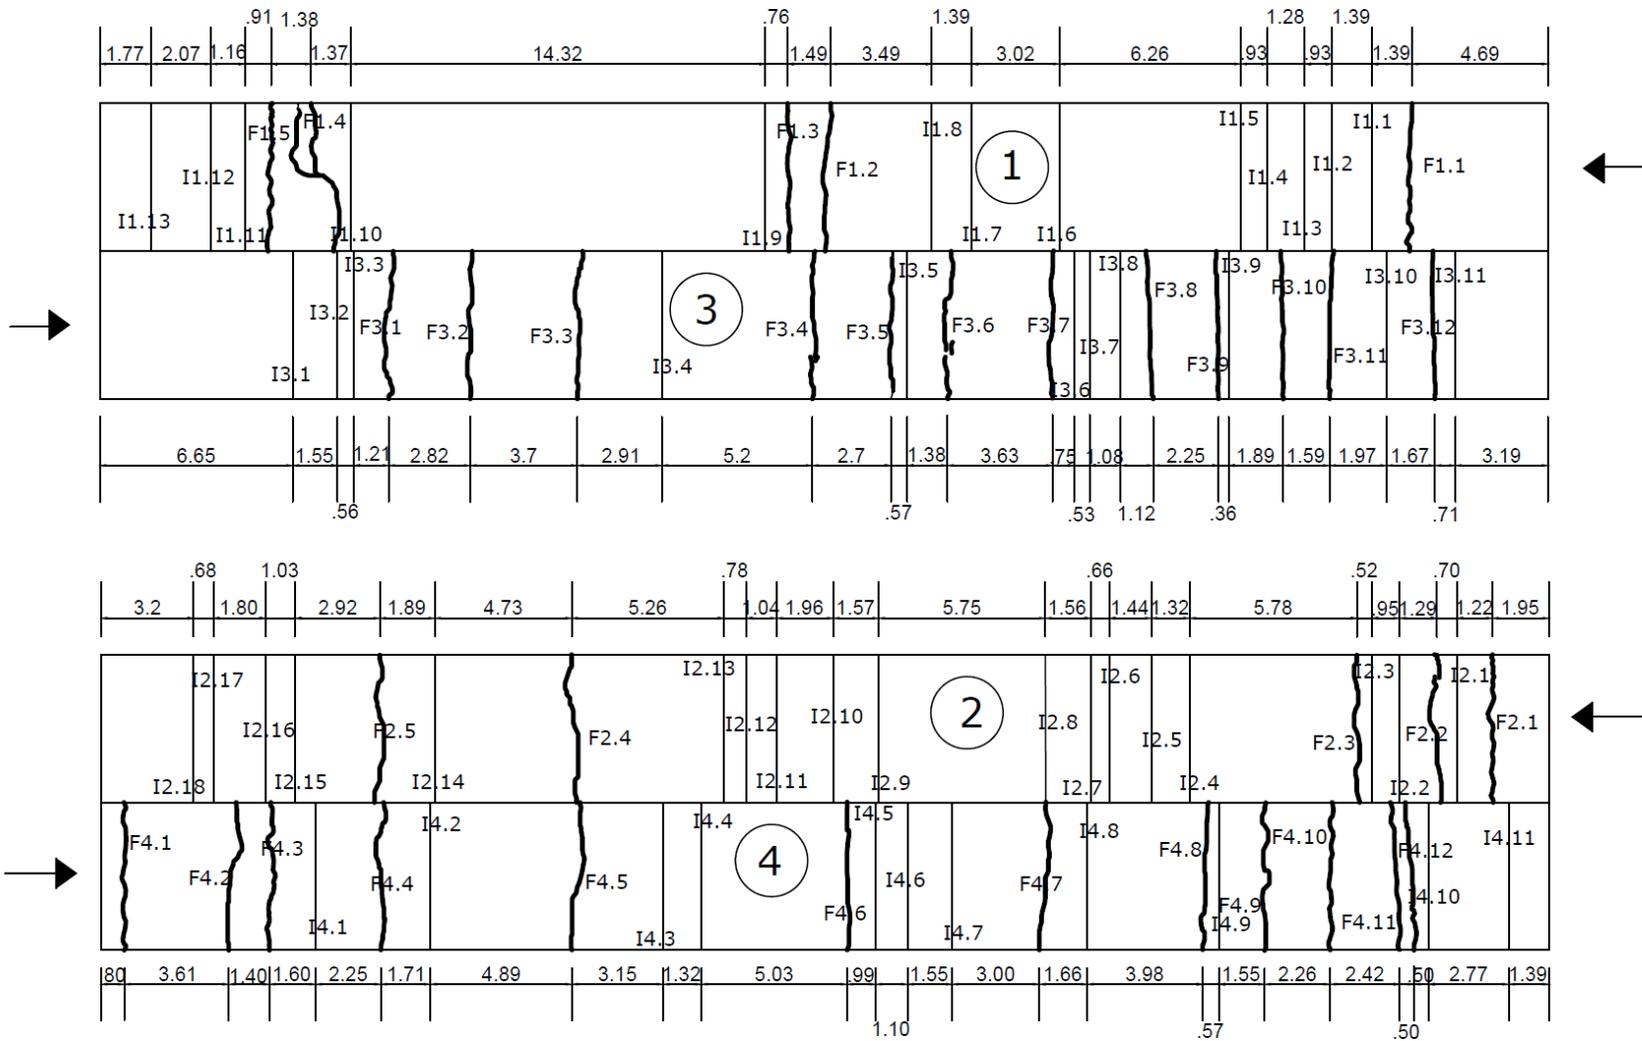
Figure 93. Crack map with non-visible cracks

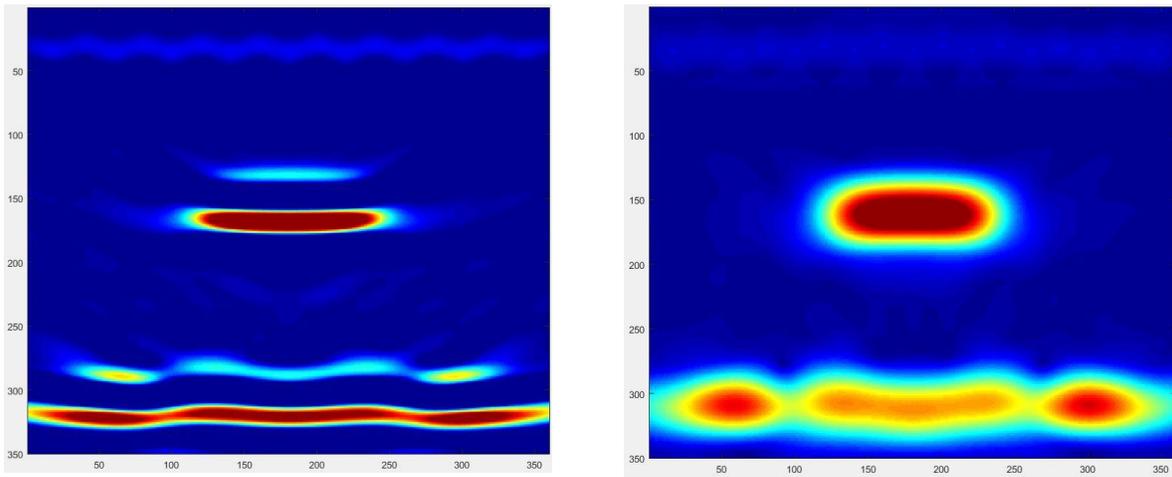
Figure 96. Instantaneous and full wave images for an elastic medium with delamination.

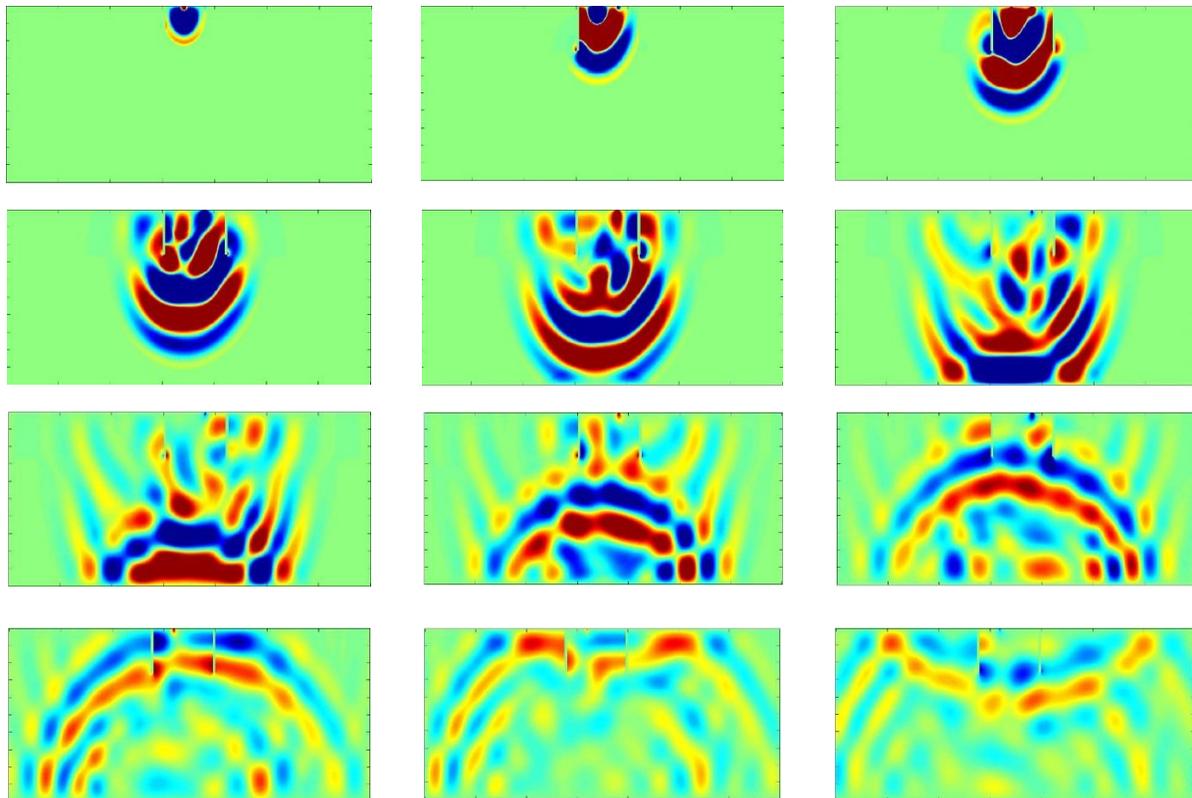
Figure 97. Wavefield Snapshots for a medium with vertical surface cracks.

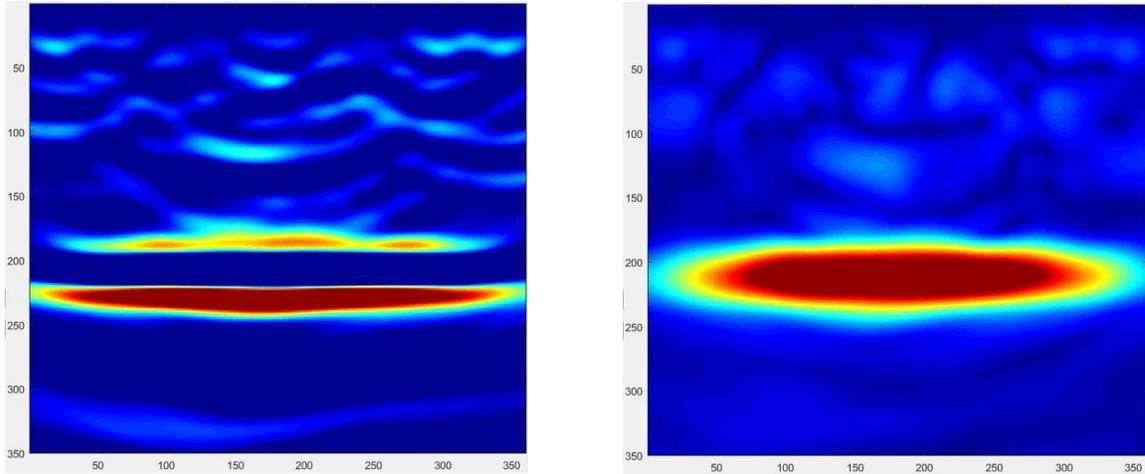
Figure 98. Instantaneous and full wave images for an elastic medium with two vertical cracks.
