PERFORMANCE MONITORING OF PRESERVATION TREATMENTS IN HONOLULU

FINAL PROJECT REPORT

Adrián Ricardo Archilla University of Hawaii at Manoa

May 2019

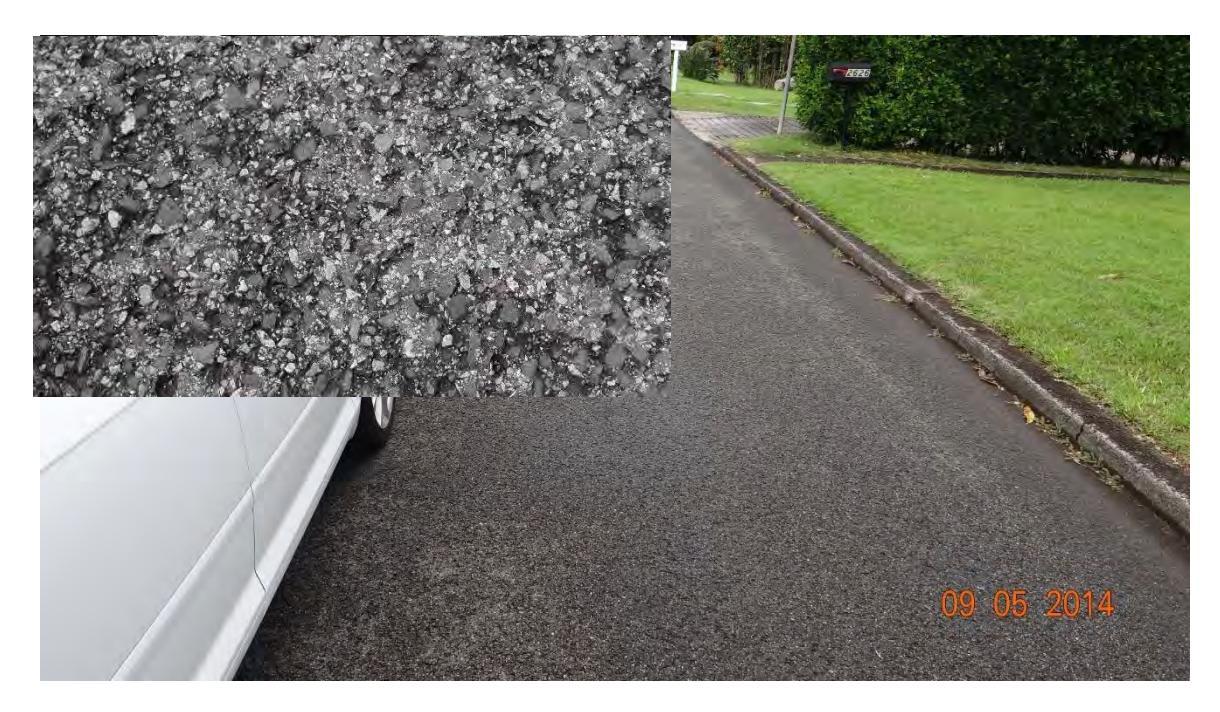
Figure 3-1 Example of a candidate section in Manoa, Honolulu.

- 2. The pavement surfaces themselves were still in relatively good condition. As shown in the close-up of Figure 3-1, in some situations some water damage (binder stripping) and loss of aggregate appeared to be in an initial stage, but this was not entirely obvious without a basis for comparison with the pavement surfaces when constructed.

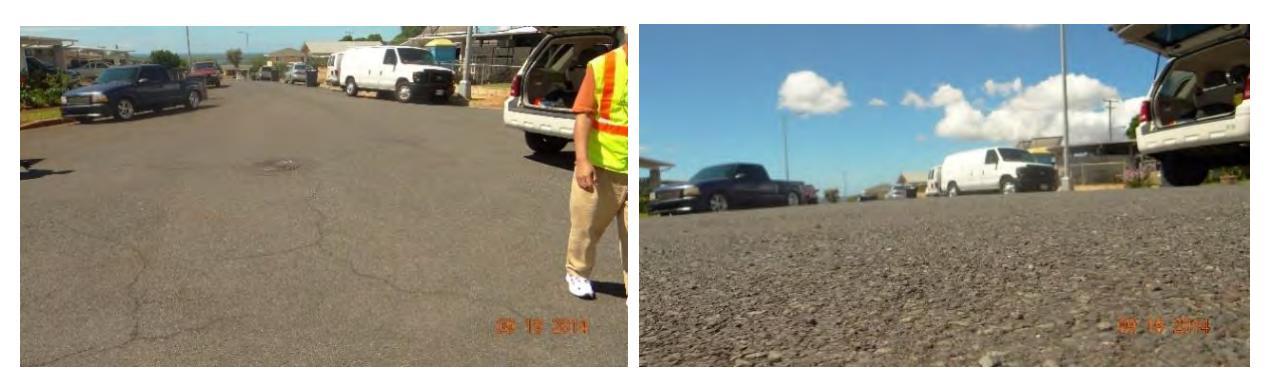
Figure 3-6. Typical conditions of sections in Pearl City.

Figure 3-6 shows examples of two sections in which block cracking and some raveling (see the loose aggregate in the right picture) can be observed.

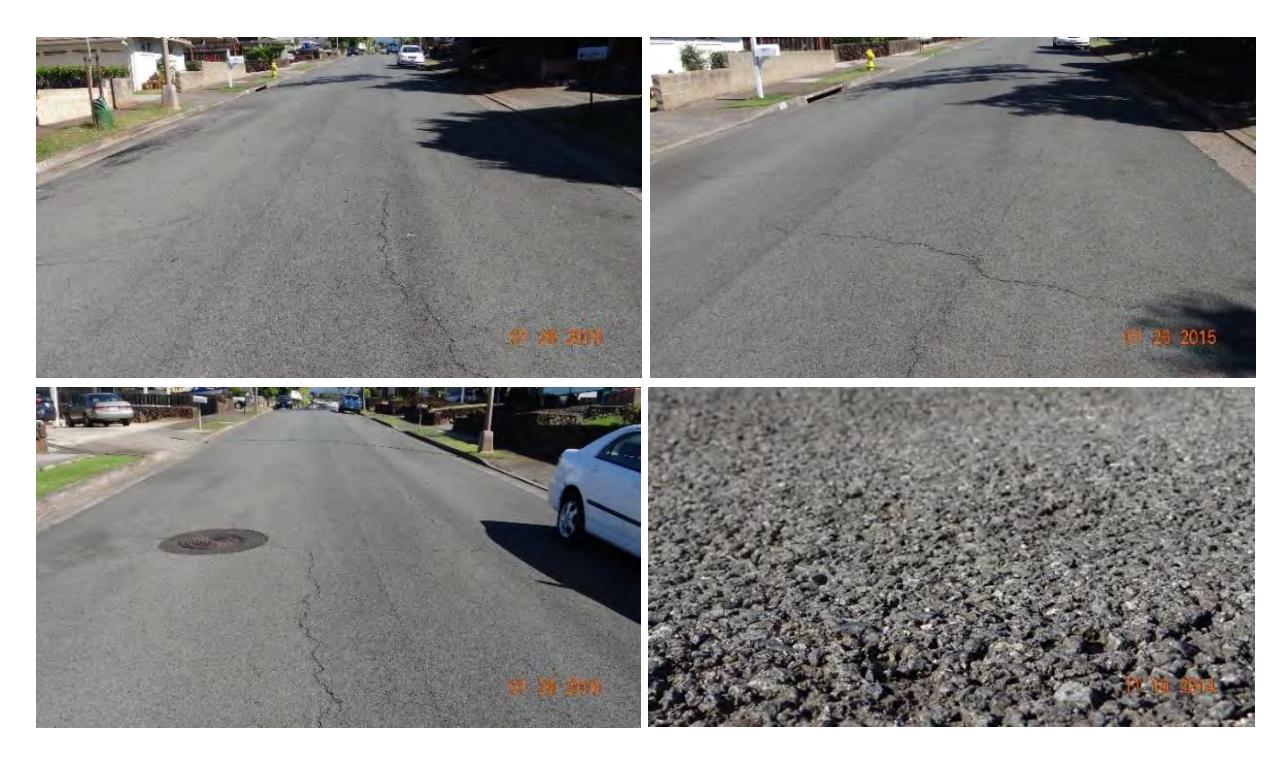
Figure 3-7 Additional examples of existing conditions.

Figure 3-7 shows additional examples of typical conditions on either the control sections or before treatment of the treated sections. As can be observed, most sections exhibited some cracking and, in some cases, an apparent aggregate loss (raveling).

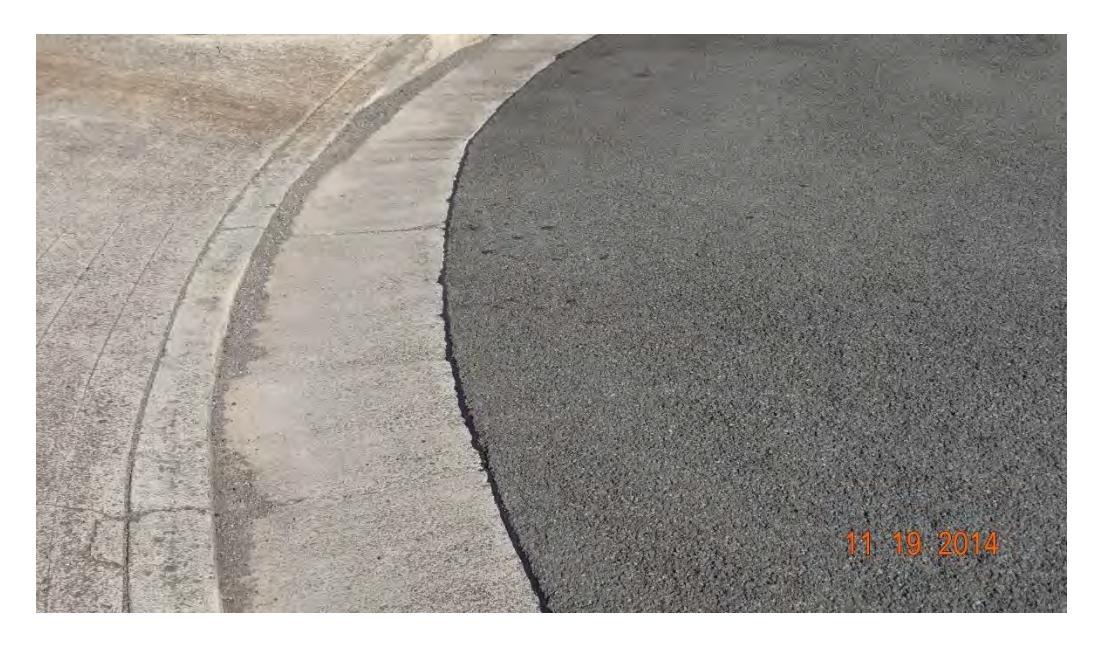
Figure 3-17 Filling of the joint between the pavement and the gutter.

The same contractor chose to seal the pavement/gutter joint. This is considered good practice as a substantial quantity of water can infiltrate into the pavement structure through these joints. It is recommended that sealing of the joint be required in the specifications to decrease the possibility of water ingress through the joint. Figure 3-17 illustrates this practice for a cul-de-sac section before it was sealed. Note also the loose aggregate accumulated in the gutter after cleaning the pavement surface, a clear indication that the pavement surface was raveling before it was sealed.

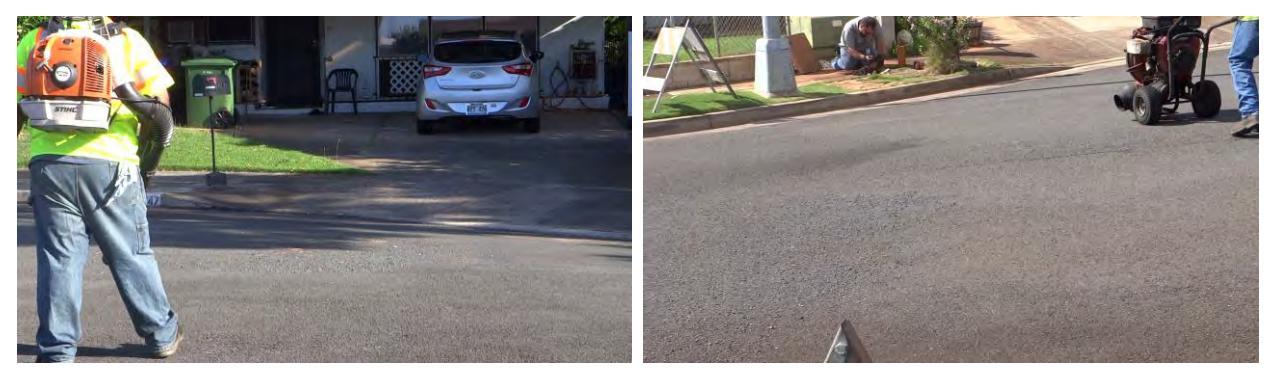
Figure 3-21 Use of blowers to clean the surface of loose aggregate and dust.

Before their application, the pavement surfaces were cleaned either with blowers or in one case by power washing. As shown in Figure 3-21, as the pavement ages, the pavement surface may have a substantial amount of loose aggregate, thus making this operation extremely important. It is important to note that often, the amount of loose aggregate was not as obvious to the naked eye until the cleaning operation started.

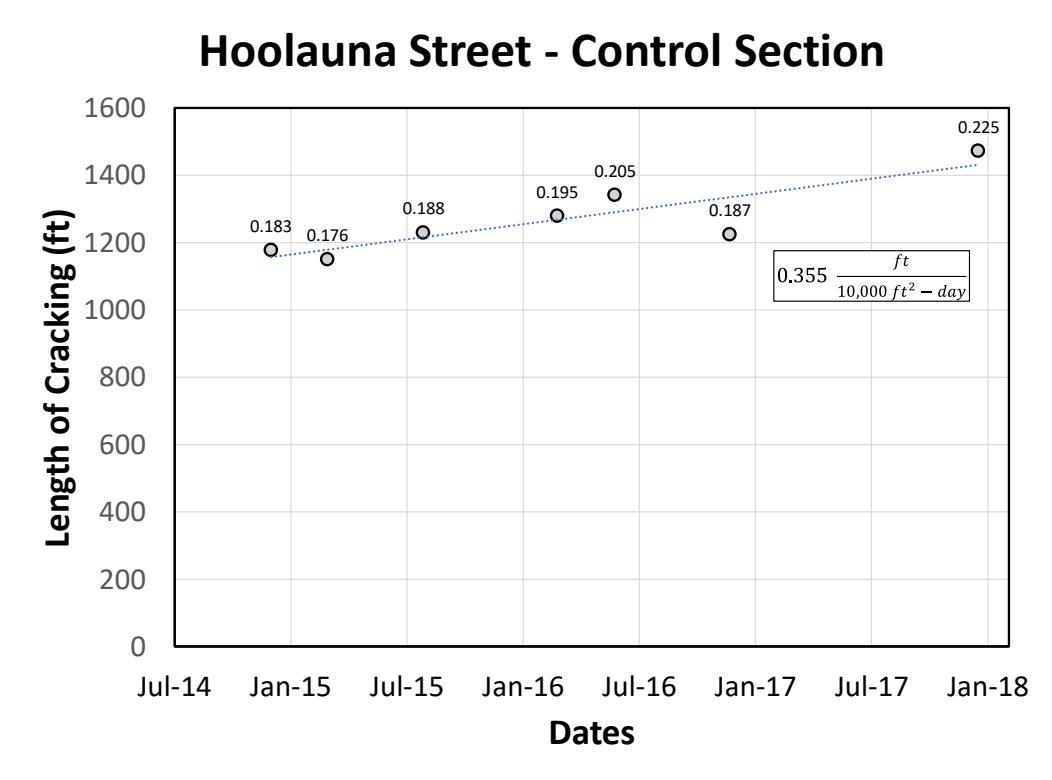
For comparison, it is important to note that the cracking length at the beginning of the study in the Hoowali Street section was about 50% lower than those in the other two sections. Although inference with a single comparison like this is inherently limited, the trends are consistent with the expectation that sealing cracks will have some retardation effect on the appearance of new cracks as less water infiltrates through the pavement surface. Most of the cracking is environmentally induced (as indicated by the block patterns observed), yet some of it can still be accelerated by traffic loads. This is seen by the slope of the trend of cracking length per unit area with time, which indicates that cracking increased at a rate of about $0.355 \text{ ft/day}/10^4 \text{ft}^2$ in the control section (Figure 4-3) whereas it increased at a rate of about $0.264 \text{ ft/day}/10^4 \text{ft}^2$ on the section on Hookano Street (Figure 4-4), with about the same initial cracking.

Figure 4-3 Cracking length progression over time in the control section in Hoolauna Street.

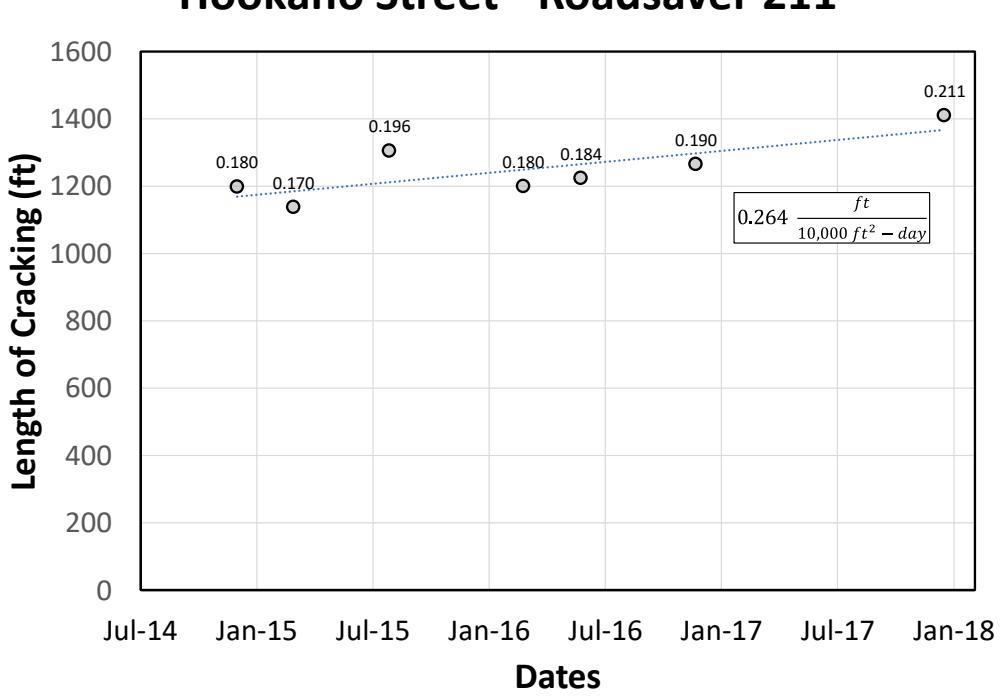
Figure 4-4 Cracking length progression over time in Hookano Street, crack sealed section.

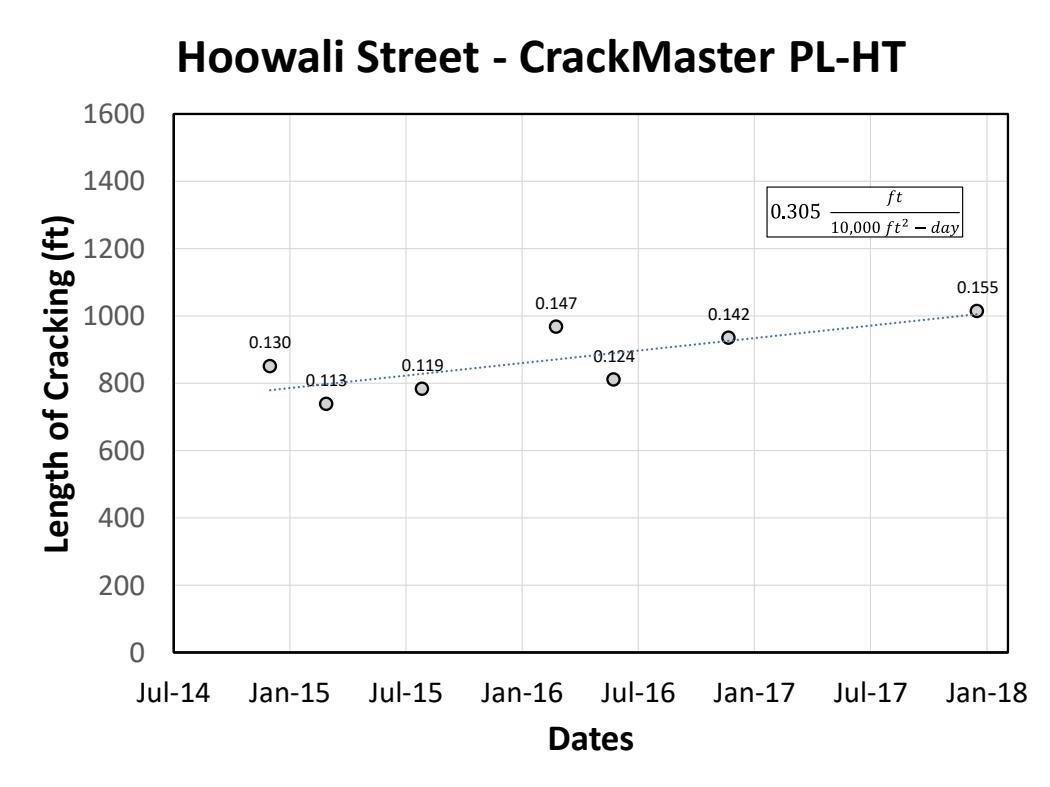
Without detailed information about the asphalt concrete thickness on each section, the characteristics of the mixes used, and the dates on which the sections were built; it is not possible to know the reasons for the substantially lower initial cracking on Hoowali Street. On the one hand, this may be because of better performance of the section (better asphalt mix, thicker asphalt mix, etc.) and on the other hand, it may simply be a question of the timing of paving. Nevertheless, despite the lower level of cracking (that would typically allow new cracking to appear at a higher rate with all else equal), the cracking rate of about 0.305 ft/day/10⁴ft² (Figure 4-5) is still lower than the 0.355 ft/day/10⁴ft² for the control section.

Figure 4-5 Cracking length progression over time in Hoowali Street, crack sealed section.

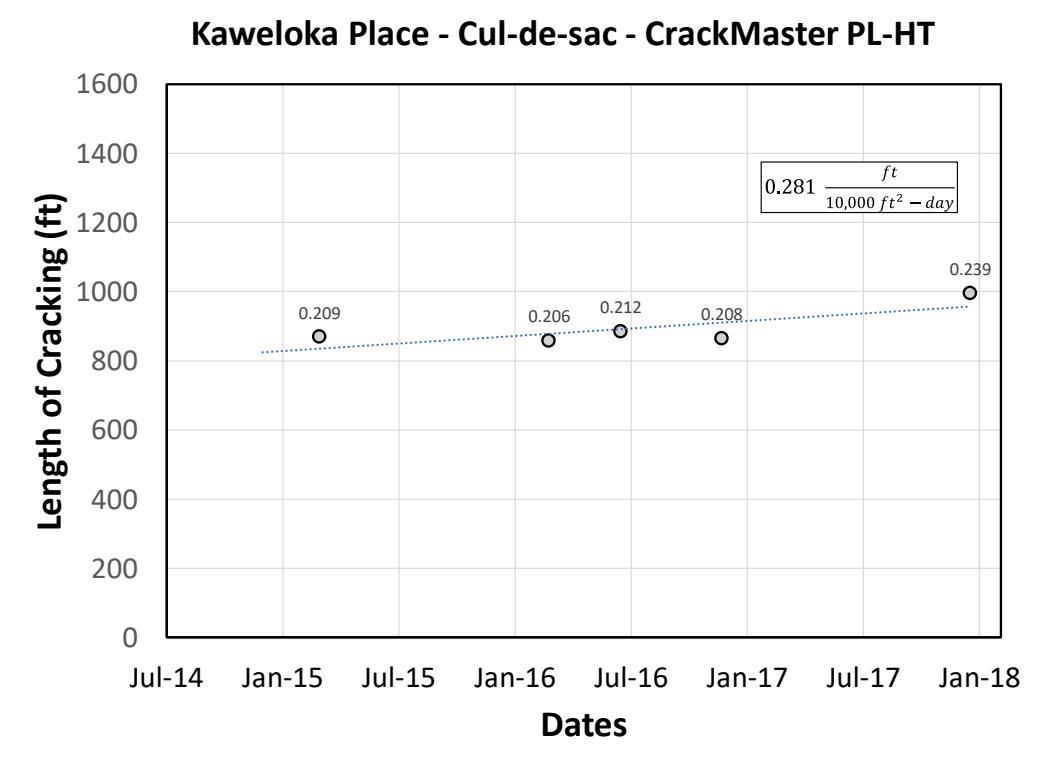
As shown in Figure 4-8, the Kaweloka Place section exhibited a much higher initial cracking per unit area, 0.209 ft/ft^2 . Thus, it is not surprising to see that between the higher initial cracking and the application of the crack sealing, the rate of cracking progression in this section was lower, 0.281 $ft/day/10^4 ft^2$.

Figure 4-8 Cracking length progression over time in Kaweloka Place, cul-de-sac crack sealed section.

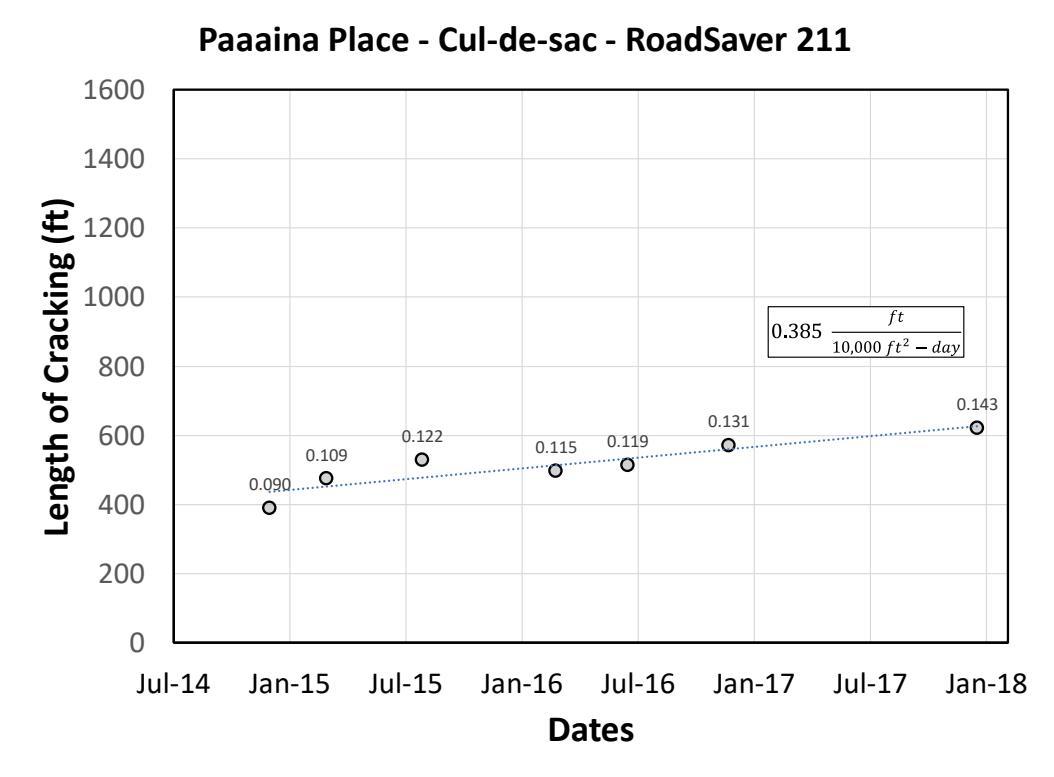
In contrast, as shown in Figure 4-9, the initial cracking in the Paaaina Place section was only $0.090 ft/ft^2$ which is about 40% percent less than the first observation in the control section and less than half the initial cracking in the Kaweloka Place crack sealed section. Therefore, the potential for the development of new cracking in this section is higher than those in the other two. Consequently, it is not surprising to see that the rate of increase of linear cracking with time is the highest for this section, $0.385 ft/day/10^4 ft^2$, though slightly higher than the value for the control section.

Figure 4-9 Cracking length progression over time in Paaaina Place, cul-de-sac crack sealed section.

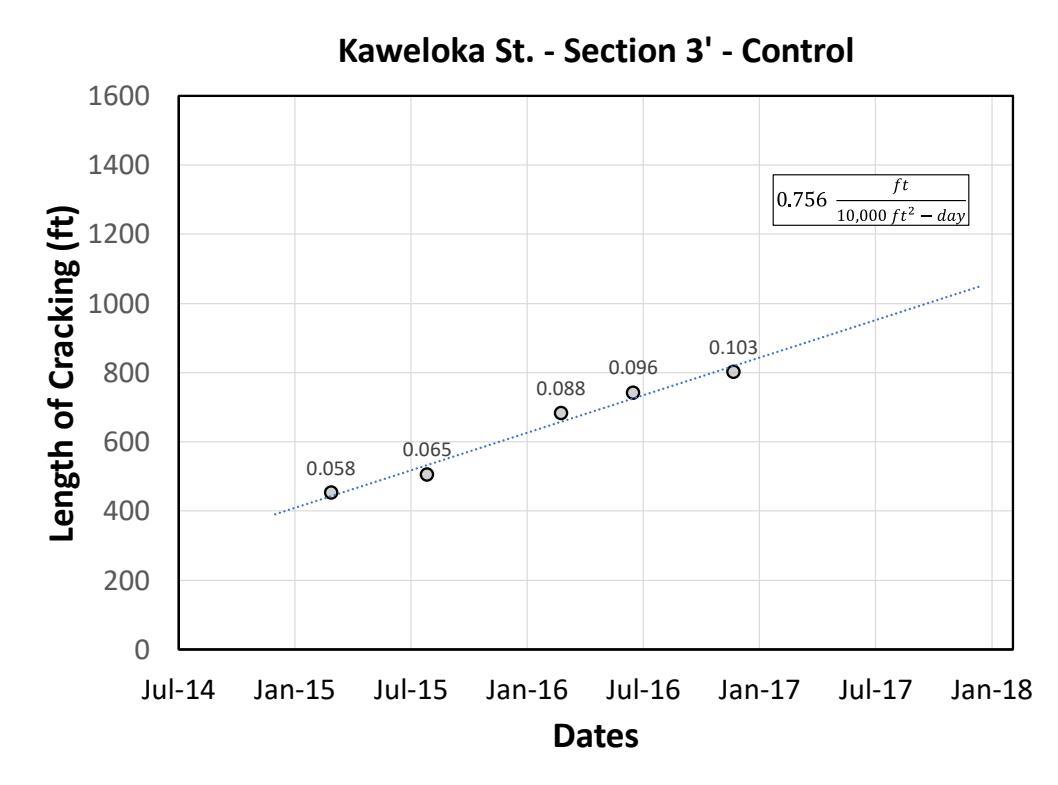
Figure 4-11 shows the cracking measurements with time for section 3', the control section with bus traffic. Bus route 54 is scheduled on this section with 17 trips per day on weekdays and 14 on weekends. Thus, the weighted average number of bus passes per day is 16.1, which is equivalent to about 5900 buses/year. Note that the average truck factor derived in a previous study for buses in the state is 1.62 (9). Although it is likely that in this area the truck factor is lower because of the fewer passenger carried at the end of the route, the value is unlikely to be lower than 1.0 since the bus configuration on this route include articulated buses. Another source of heavy loading in this section are refuse trucks, but this loading is common to all section in the study.

Figure 4-11 Cracking length progression over time in Kaweloka Street - Section 3', control section.

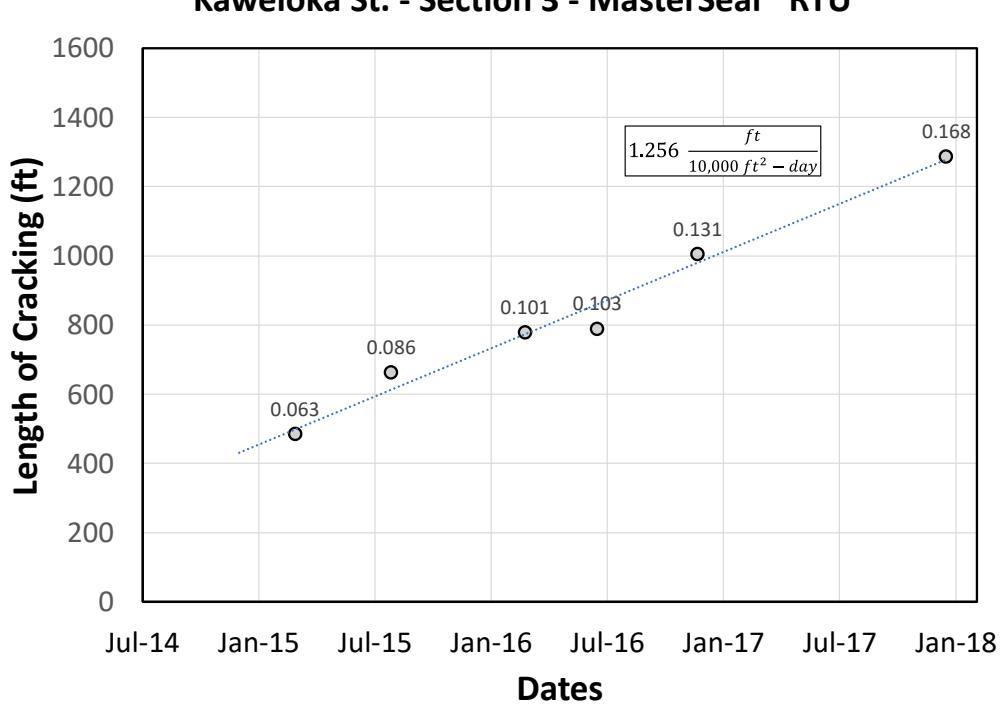
It should be noted that the results for section 3, treated with MasterSealTM RTU, were also affected by a water main break soon after the start of the study (this was noted on the survey of 8/27/2015). Cracking on the portion affected was not collected from that day onward (initially, a provisional patch was performed and then two large patches repairing the affected areas were done). The length of the area affected by those patches was 54 ft or about a sixth of the section's length. However, for public relations reasons related to a request from neighbors when the City and County of Honolulu major visited the site, the application of the first coat on this section was extended 48 ft, which almost compensate the length lost in the patch (albeit with only one coat). Consequently, cracking was not collected on the 54 ft affected by the patches, but it was on the additional 48 ft treated with only one coat. Thus, although additional cracking related to the water main break may have affected the results, it is believed that this was not the main cause for the cracking to be higher than on the control section.

Figure 4-14 Cracking length progression over time in Kaweloka Street - Section 3, treated with SealMasters®/Hawaii MasterSeal Ready to Use.

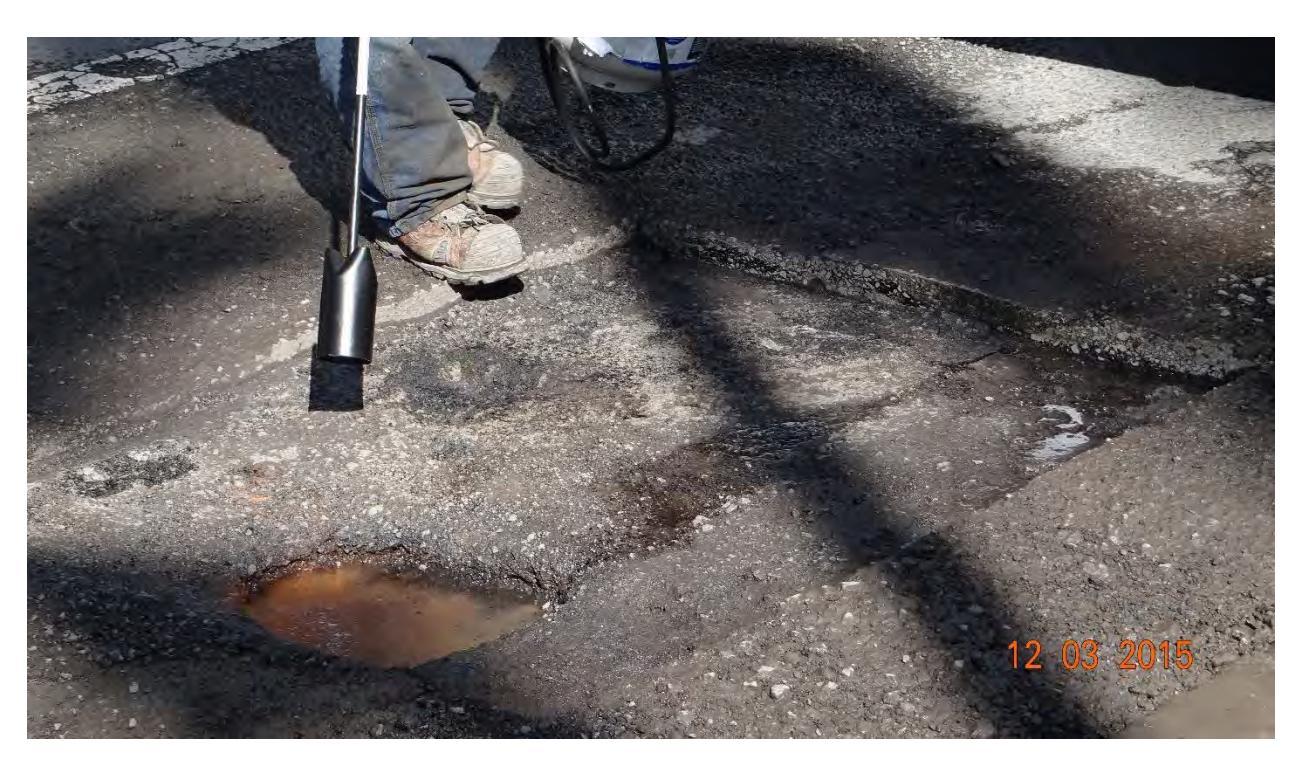
Figure 4-16 Example of water raising from underlying layers through a pothole in a road with high longitudinal slow.

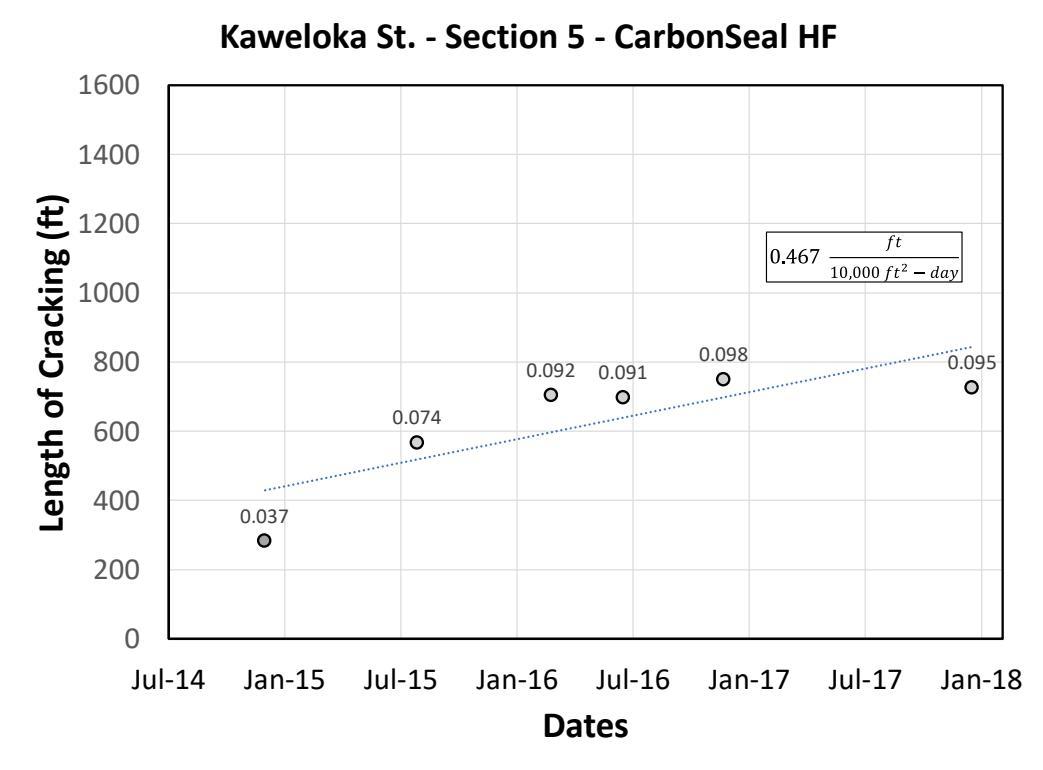
Figure 4-20 shows the cracking trend for section 5, treated with CarbonSeal-HF. Consistent with the control sections 6, 7, and 8, that have no bus traffic, the rate of increase of cracking of $0.467 \text{ ft/day/10^4ft^2}$ was significantly smaller than those observed in the treated sections with bus traffic ($0.756 \text{ ft/day/10^4ft^2}$). Nevertheless, similarly to what was observed for the sections with bus traffic, this rate was higher than any of the values for the control sections in the previous paragraph. However, in this case, the difference was smaller. A few factors are worth mentioning here. On the one hand, the finished color of CarbonSeal-HF is not black but a dark gray. In addition, the treatment started to fade much earlier than other treatments. Thus, the maximum pavement temperature increase should be lower than the corresponding values for the other treatments. This would tend to result in fewer additional environmental cracks. On the other hand, only about half of the section was crack sealed, which would tend to result in additional cracking caused by traffic loading. However, since there was no bus traffic, this is not believed to have been a significant factor.

Figure 4-20 Cracking length progression over time in Kaweloka Street - Section 5, treated with CarbonSeal-HF.

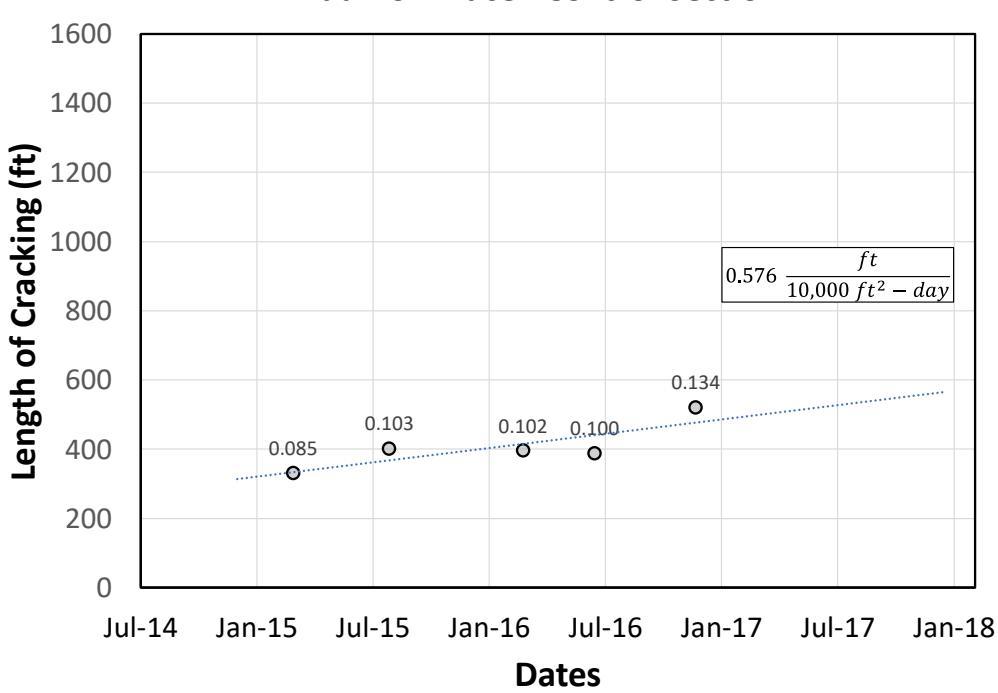
Figure 4-21 shows the cracking measurements with time for the control section on Kaumoli Place. This section was seal coated before the end of the study. Therefore, unlike for other sections, there is no observation for January 2018. The cracking progression growth was 0.576 ft/day/10⁴ ft², which represent a 62% increase with respect to the average rate $(0.349 \text{ ft/day}/10^4 \text{ft}^2)$ of the three sections without bus traffic that were used as control for straight sections. Nevertheless, it is believed that this rate overestimates the actual rate because the last observation in December 2016 was obtained when the cracks in the section already had been sealed. Note that the section on Palamoi Street, which was selected as control for the crack sealing sections, can also be used as a reference here (there is nothing particularly different about this section and it is closer to most of the cul-de-sacs treated with seal coats). Recall that the rate for the Palamoi Street section was estimated as 0.363 ft/day/10⁴ft² but that this value was also estimated with fewer observations. Thus, the rates from the two sections that can be used as reference have more uncertainty associated with them. In summary, based on the information of the two control sections on Kaumoli Place and Palamoi Street, the best estimate of the rate of cracking progression is between 0.363 and 0.576 ft/day/ 10^4 ft². However, based on the values observed for the other sections in the crack sealing study, values closer to the lower end of the range seem more plausible.

Figure 4-21 Cracking length progression over time in the cul-de-sac control section on Kaumoli Place, Pearl City.

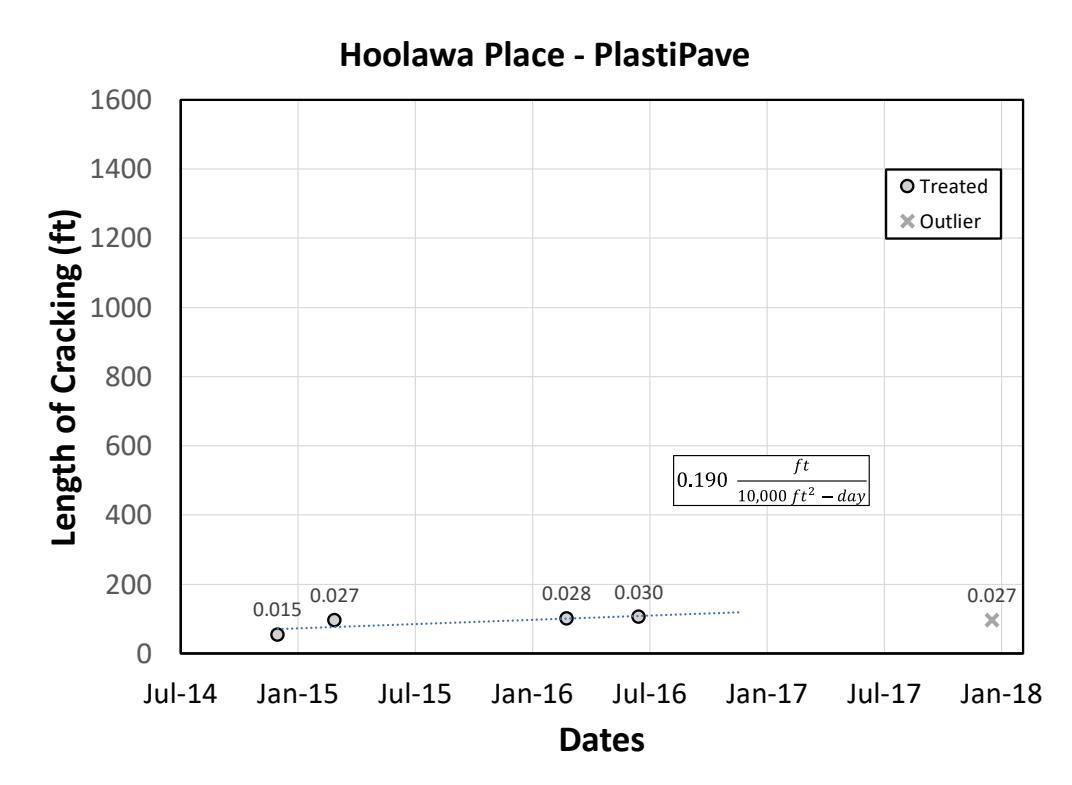
As in the case of the straight sections, the cracking trend on the section with PlastiPaveTM was an exception. In this case, the cracking rate shown in Figure 4-22 came out to be $0.190 \text{ ft/day}/10^4 \text{ft}^2$, which is much lower than that of the control section (about one third lower). The reasons are believed to be the same as discussed for this treatment in straight sections. Another factor in this particular case may have been that the surface was usually dirty with clay material. Although this was thought to be a problem, it may also have altered the amount of solar radiation absorbed. Note that a final measurement on this section on 5/24/2019 resulted in a measurement of 175 ft. When this value was included in the rate calculation, the resulting rate was slightly smaller (0.178 ft/day/10⁴ft²). This measurement was considered important as it verified that rate was not artificially low but a real representation of the cracking rate on the section.

Figure 4-22 Cracking length progression over time in Hoolawa Place, treated with SealMasters®/Hawaii Plasti-Pave.

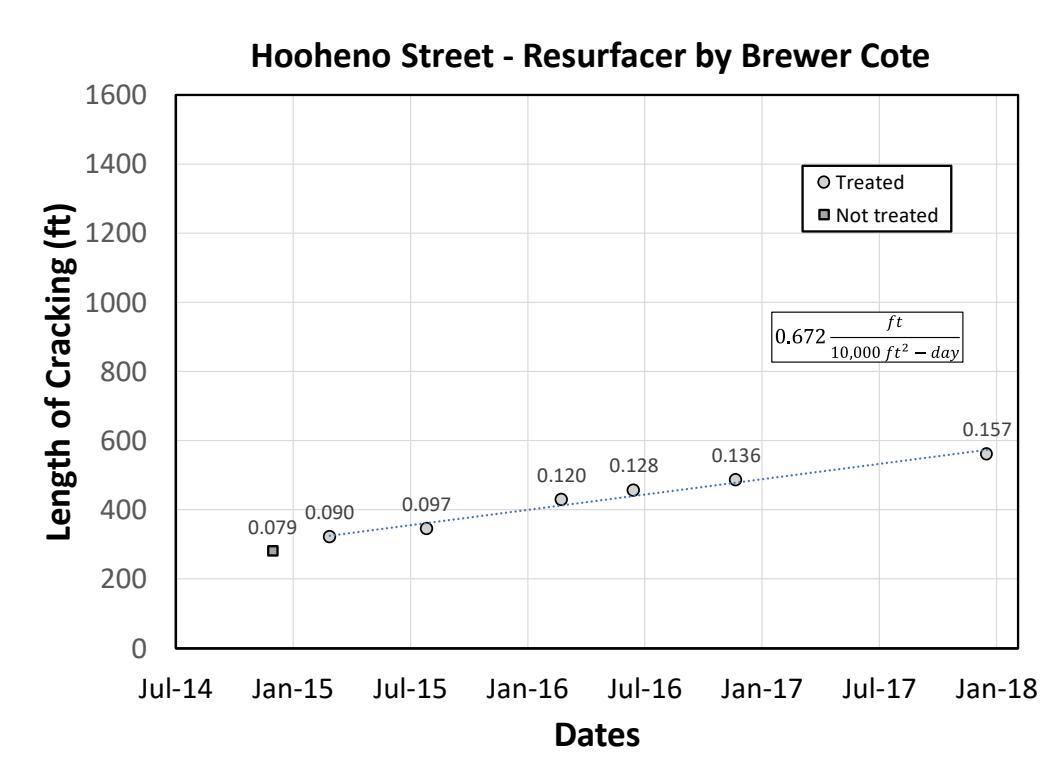
Figure 4-26 shows the cracking trend for the section on Hooheno Street, treated by Oahu Seal Coating and Paving with Resurfacer by Brewer Cote. In this case, a slight increase in the cracking rate to $0.672 \text{ ft/day/10}^4 \text{ft}^2$ is noted in the trend. This observation does not provide evidence that a benefit is obtained by performing power washing of the cracks and the pavement surface as was done on this pavement section.

Figure 4-26 Cracking length progression over time in Hooheno Street, treated with Resurfacer by Brewer Cote (work performed by Oahu Seal Coating and Paving).

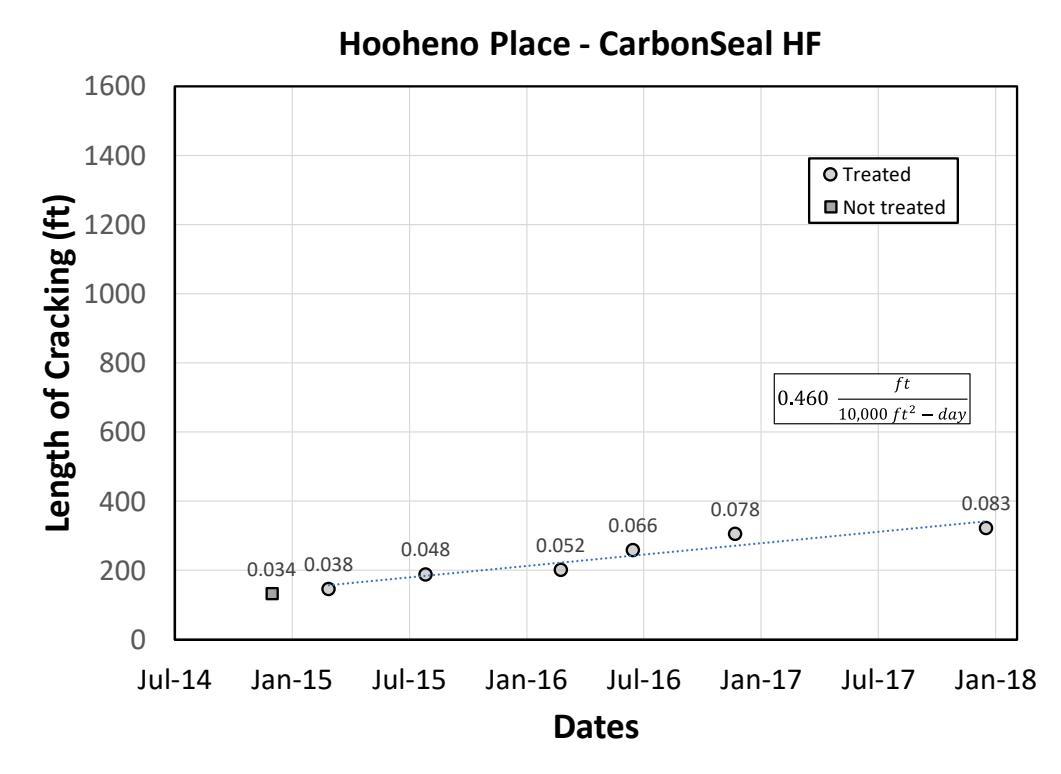
Finally, Figure 4-27 shows that the rate of cracking increase for the section treated with CarbonSeal-HT was 0.460 ft/day/10⁴ft². Since this value is within the range for the control sections discussed above, nothing can be said conclusively about whether the rate of cracking progression is higher or lower than for the control sections. As speculated before, if the values closer to the lower limit were indeed more plausible, this would still indicate a slight increase in the rate with the application of the seal coat. Regardless of how this treatment compares with the control sections, its cracking progression rate is lower than any of the values for the other seal coated sections in cul-de-sacs (except for the value for the section treated with PlastiPaveTM). As discussed before, this may be related to the fact that CarbonSeal-HT has a dark gray color instead of the black color of the other treatments, and that started fading much earlier, which may lead to slightly lower maximum pavement temperatures.

Figure 4-27 Cracking length progression over time in Hooheno Place, treated with CarbonSeal-HF by Carbonyte Systems Inc.

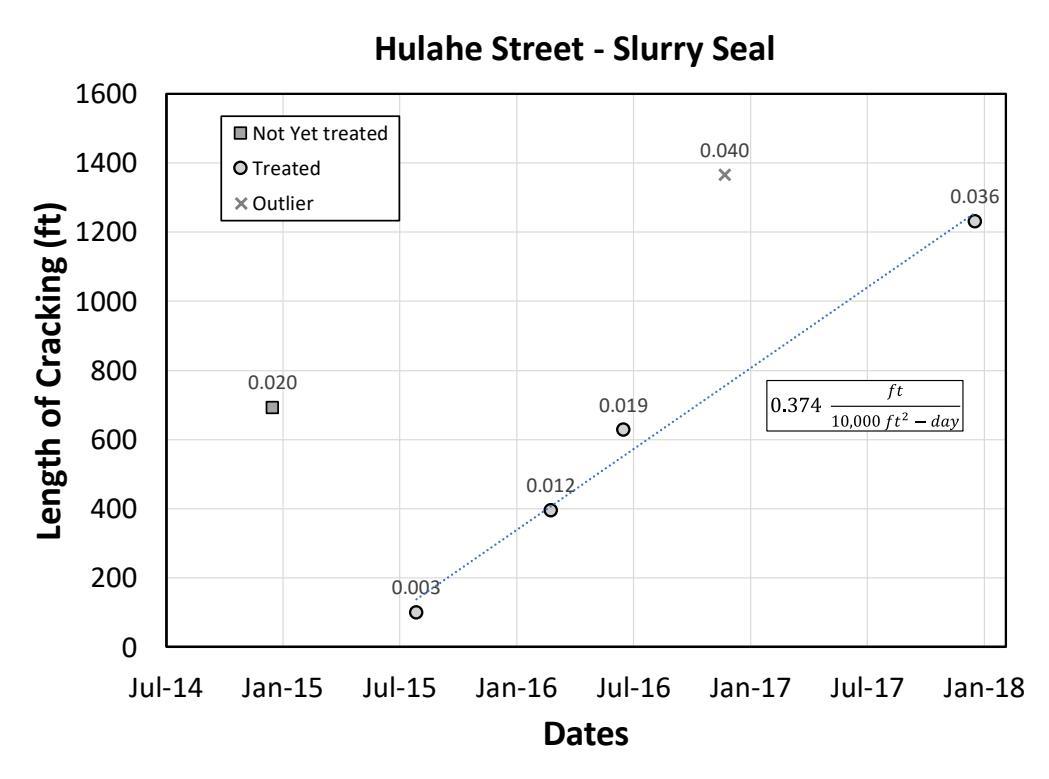
Figure 4-29 shows the cracking trend observed in this section. The big drop in cracking length from the measurement when the section had not yet been treated to the first observation after the slurry seal application is simply a reflection of the fact that, as explained earlier, existing sealed cracks were not recorded in the cracking length.

As shown in Figure 4-29, the observation obtained on 12/13/2016 was considered an outlier since the higher cracking length on that date was believed to be caused by cracking around another water main break. Excluding that observation, the estimate of the cracking progression rate on this section is 0.374 ft/day/ 10^4 ft². This value is of the same order of those estimated for control sections 6 and 7, respectively 0.379 ft/day/ 10^4 ft² and 0.402 ft/day/ 10^4 ft², but higher than the value of 0.250 ft/day/ 10^4 ft² estimated for section 8. These results complicate comparisons with the Kaweloka Street sections. On the one hand, if everything were equal, one could conclude that the slurry seal does not significantly alter the cracking progression rate; but on the other hand, given the initially much lower cracking length in the section, the potential for additional environmental cracking is higher. Of course, other factors could play a role in these comparisons as well. Nevertheless, similarly to what was observed for the other treatments, although the application of slurry seal may alter somewhat the rate at which the cracks appear, it does not seem to alter much the cracking pattern that would have eventually appeared had the treatment not been applied. In this pavement section, most of the cracking was longitudinal. In only a few places, a block cracking pattern was seen.

Figure 4-29 Cracking length progression over time in the Hulahe Street section, treated with Slurry Seal by Alakona Corporation.

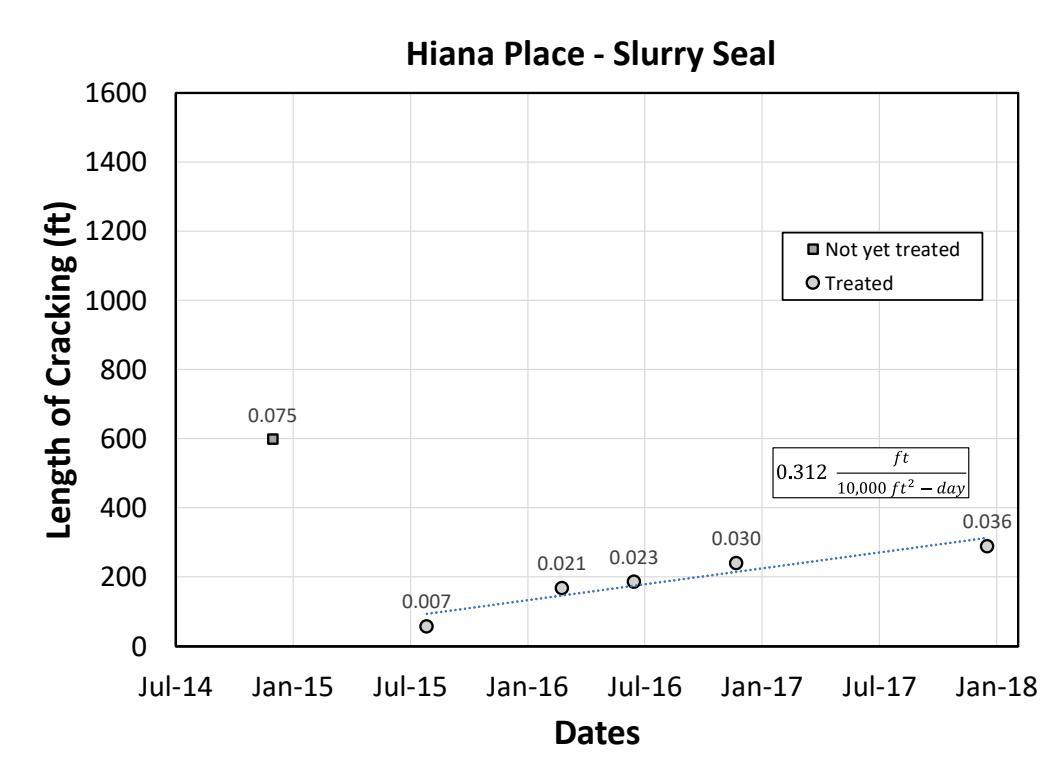
The results are indeed consistent with these observations. For example, the 0.312 ft/ 10^4 ft²/day rate in the Hiana Place section is of the same order but smaller than the 0.374 ft/ 10^4 ft²/day estimated for the Hulahe Street also treated with slurry seal. It is interesting to note that the crack length in the Hiana Place section never got back to the level before the treatment application.

Figure 4-30 Cracking length progression over time in Hiana Place, treated with Slurry Seal by Alakona Corp.

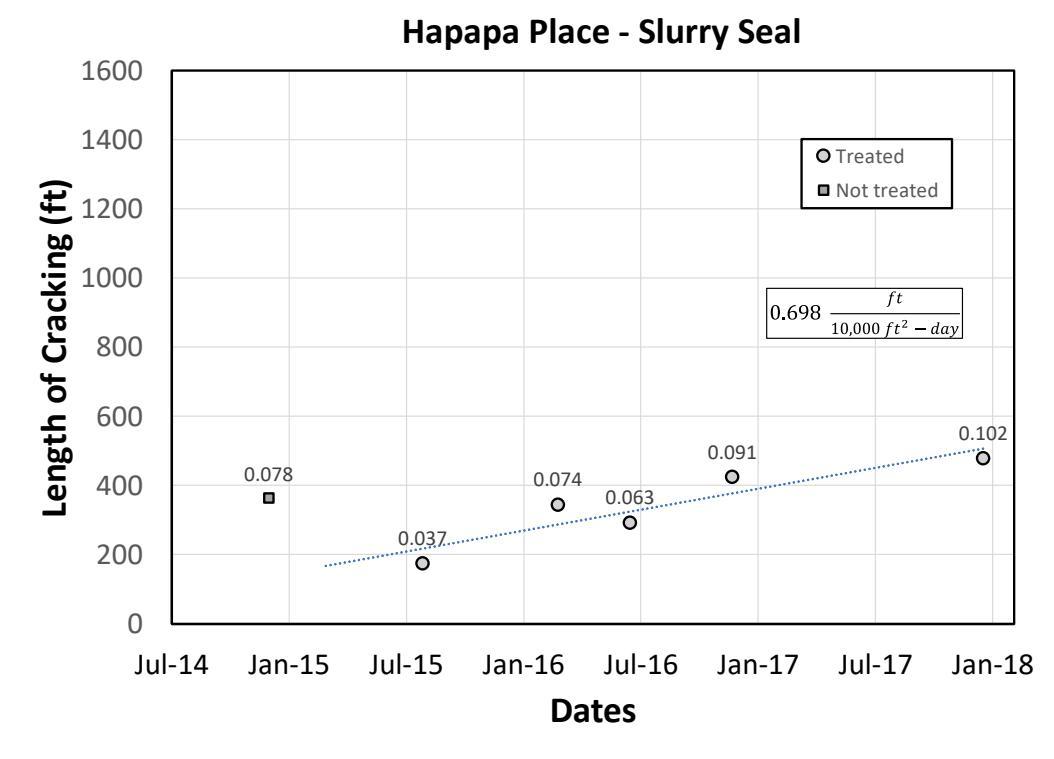
Figure 4-31 Cracking length progression over time in Hapapa Place, treated with Slurry Seal by Alakona Corp.

On the other hand, the value of 0.698 ft/10⁴ft²/day in the Hapapa Place cul-de-sac is strikingly close to several of the values estimated for other cul-de-sac sections treated with seal coats. Specifically, recall that the values estimated for the sections treated with Liquid Road, MasterSealTM RTU, OptiPave PlusTM RTU, and Resurfacer were 0.669, 0.646, 0.638, and 0.672 ft/10⁴ft²/day, respectively.

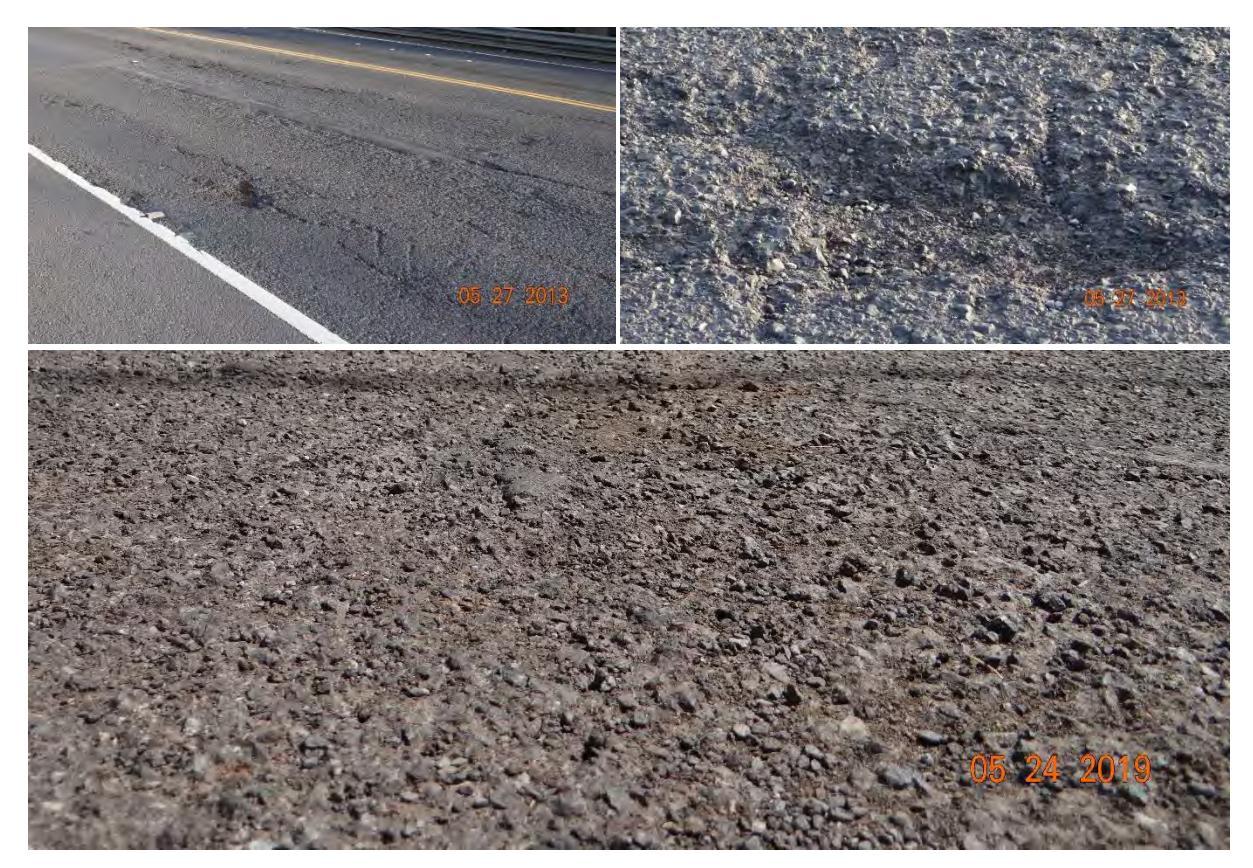
At first sight, the functional condition of treated and untreated sections may appear to be similar. However, as shown for several sections, there were clear indications of some raveling in the untreated sections (loose aggregates, missing coarse aggregates, and loss of fine aggregate/mastic), while no such indications were seen in the treated sections. But what are the benefits of the avoidance of some aggregate loss on the surface? Again, this is difficult to quantify. However, this is akin to quantifying the benefits of a single oil change in a car. One can usually get away with extending the time of a single oil change or even skipping it once, but if no oil change is ever performed or if they are performed on much longer cycles than recommended, the car engine life will be shortened significantly. In the context of pavements, this will be manifested in surfaces reaching states like those shown in Figure 4-32. At that stage, the functional problem requires an expensive solution, which could have been avoided with proper timing of maintenance or preservation activities. Even if the problems arise from mix design of the wearing course, a preservation treatment has the potential to lengthen the useful life of the original surface. These examples illustrate what would eventually happen on roads left untreated.

Figure 4-32. Illustrations of the disintegration of the pavement surface from severe raveling left untreated and the unsightly stop-gap repairs needed.

In this study, a clear benefit was observed on the sections treated with seal coat/slurry seal in terms of protection of the existing surface from developing further aggregate loss or raveling. In all cases, regardless of whether the treatment was applied on a straight segment or a cul-de-sac, any incipient raveling was completely arrested during the study period. Furthermore, the seal coats and slurry seals controlled the effects of oxidation on the existent pavement while providing a new thin sacrificial layer. For most sections, there was still a high color contrast between the treated and untreated pavement surfaces at the end of the study period. Thus, provided the pavement is kept in sound structural condition and water infiltration into the underlying layers is minimized, the life extension of this treatments can be regarded as the life of the treatment itself.
