PERFORMANCE MONITORING OF PRESERVATION TREATMENTS IN HONOLULU

FINAL PROJECT REPORT

Adrián Ricardo Archilla University of Hawaii at Manoa

May 2019

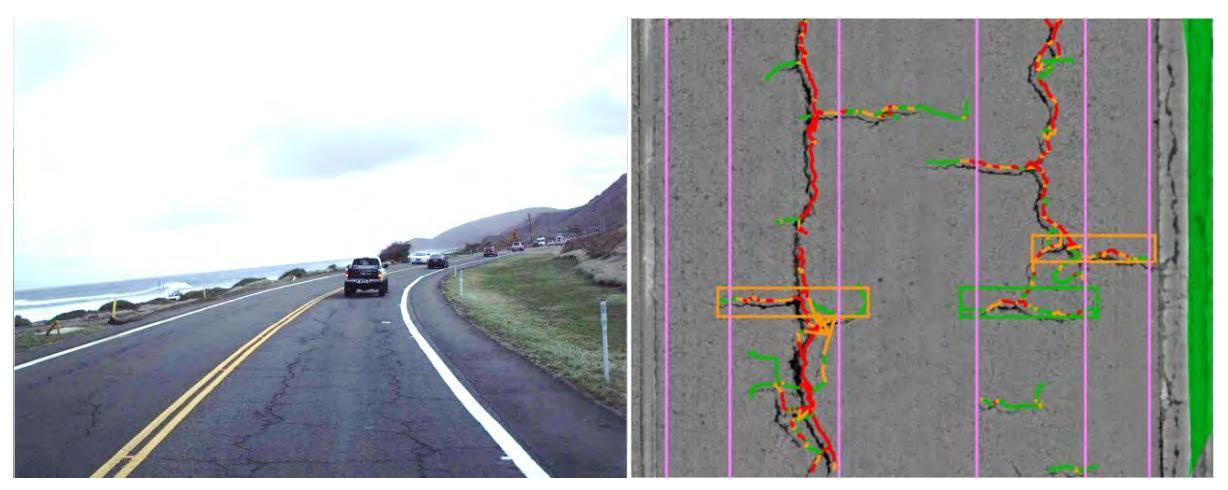
Top-down fatigue cracking (TDFC) is a common type of distress observed in many parts of the US and other countries (9) on heavy duty Hot Mix Asphalt (HMA) pavements. It is also suspected to be common on thick HMA pavements in Hawaii (10). Figure 5-1 shows the cracking pattern observed on a portion of Highway 72, Kalanianaole Highway in Oahu, which is a typical well-developed cracking pattern observed on two-lane two-way (TLTW) state highways in Hawaii. The meandering longitudinal cracks on the wheel paths are quite evident but these are accompanied but other transverse cracks. To some, this pattern may look like that arising from block cracking enhanced by loading. However, as illustrated in Figure 5-2 for a newer pavement surface on another section of the same highway, it is typically the opposite, with the cracks starting mostly longitudinally in the wheel paths because of loading.

Figure 5-1. Cracking pattern commonly observed on TLTW state highways in Hawaii.

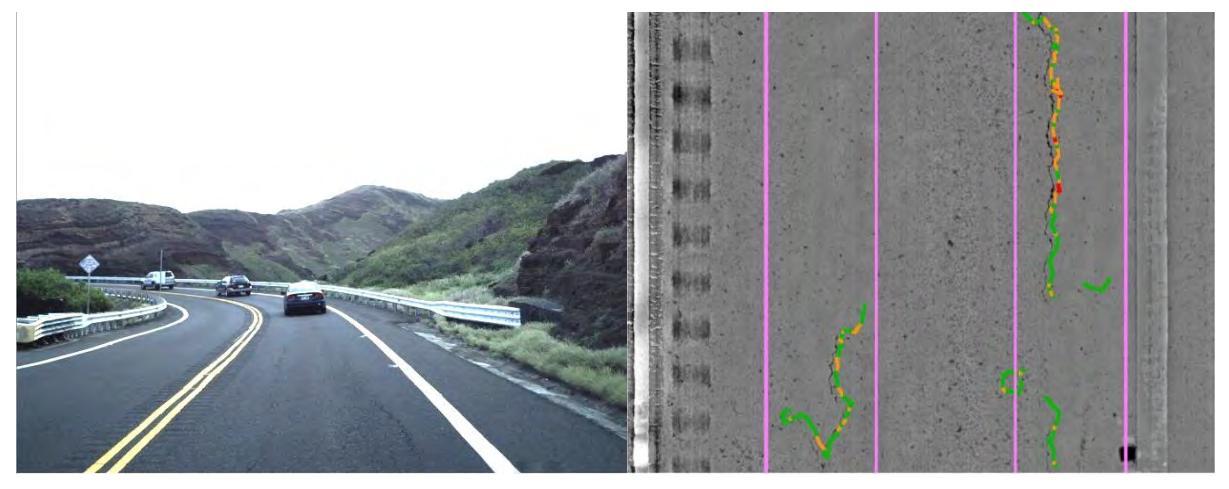
Figure 5-2. Typical early-stage cracking pattern observed on TLTW state highways in Hawaii.

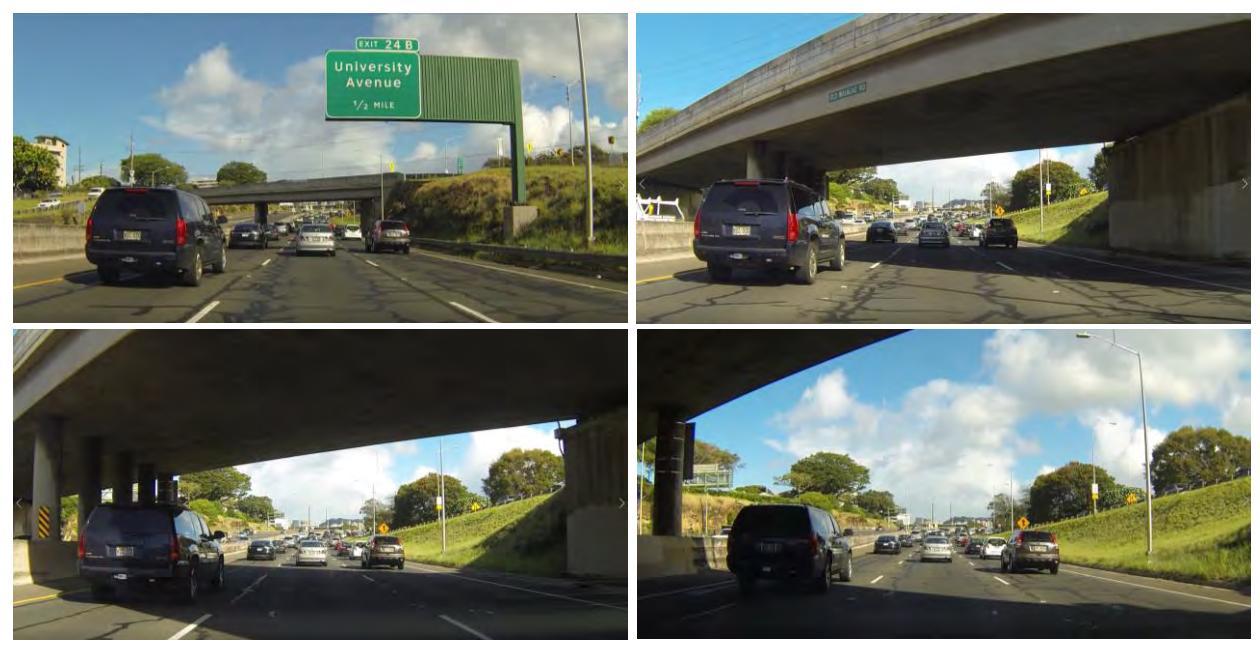
Figure 5-14 Principal and shear stress distributions for the temperature profile corresponding to 2/14/2016 1:40 PM.

This section presents evidence consistent with inverted moduli predictions leading to high tensile and shear strains on the wheel paths near the surface. Specifically, Figure 5-14 to Figure 5-20 show photographs from the H-1 freeway in Honolulu from around mile points 22 to 24. This section of highway has been in service for a long time and it is due for rehabilitation soon. However, sometime around 2015, the extensive cracking in the section was crack sealed. This clearly highlighted the fact that the conditions under the bridges in terms of cracking were substantially better than either the before or after conditions. With rare exceptions, in general, the extensive cracking virtually stops underneath the bridge and resumes after it.

Note that the cracking occurs mostly in the wheel paths with random transverse cracks. Thus, it appears to be for the most part load related.

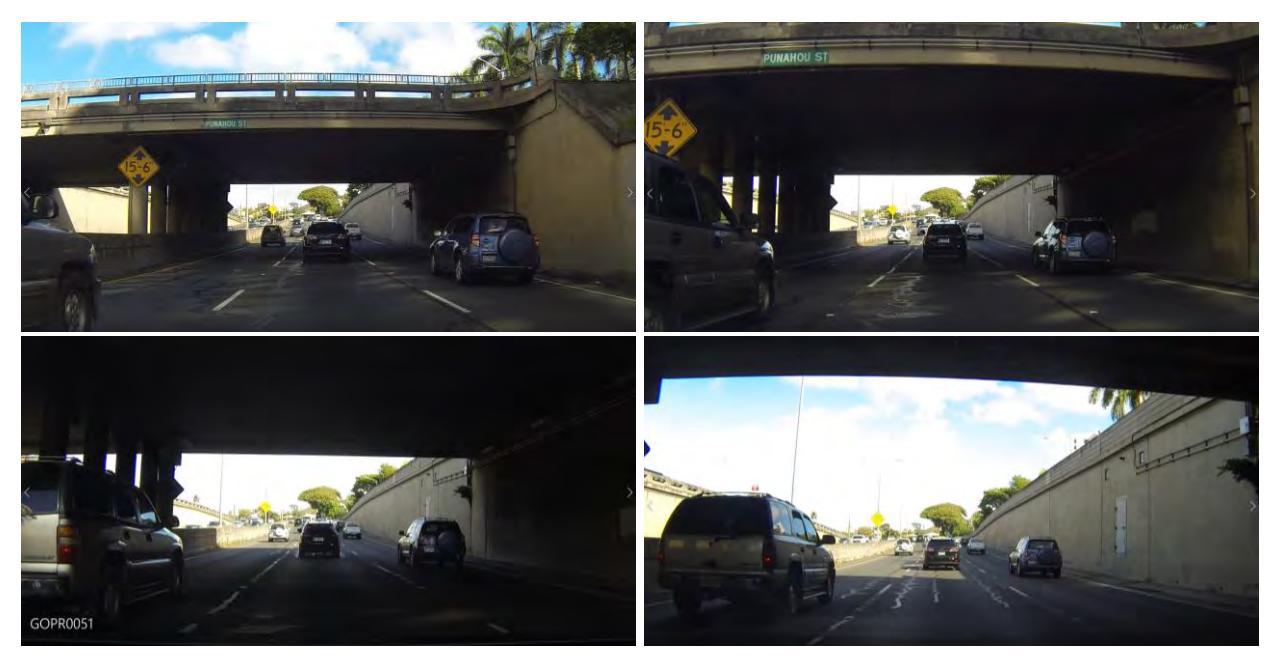
Figure 5-15 Principal and shear stress distributions for the temperature profile corresponding to 2/14/2016 1:40 PM.

What happens under the bridges is that for a large portion of the day, the pavement is shielded from exposure to the sun and thus the temperatures can never reach elevated values. In other words, those inverted moduli conditions never occur under the bridge. The consistency of the pattern from bridge to bridge is quite remarkable, which indicates that this is not an isolated event (in fact, the same has been observed under another bridge on the H-1 freeway several miles away).

In some cases, there was no cracking on the right lane. This is seen in Figure 5-15 but in this case, note that this lane is also shielded substantially from the sun. In other cases, there were indications that the right lane may have been rehabilitated at some point. Another effect of the shade provided by the bridges is that the binder in the mixture suffers less aging. However, it is not clear what mechanism would lead to less "load related" cracking because of this.

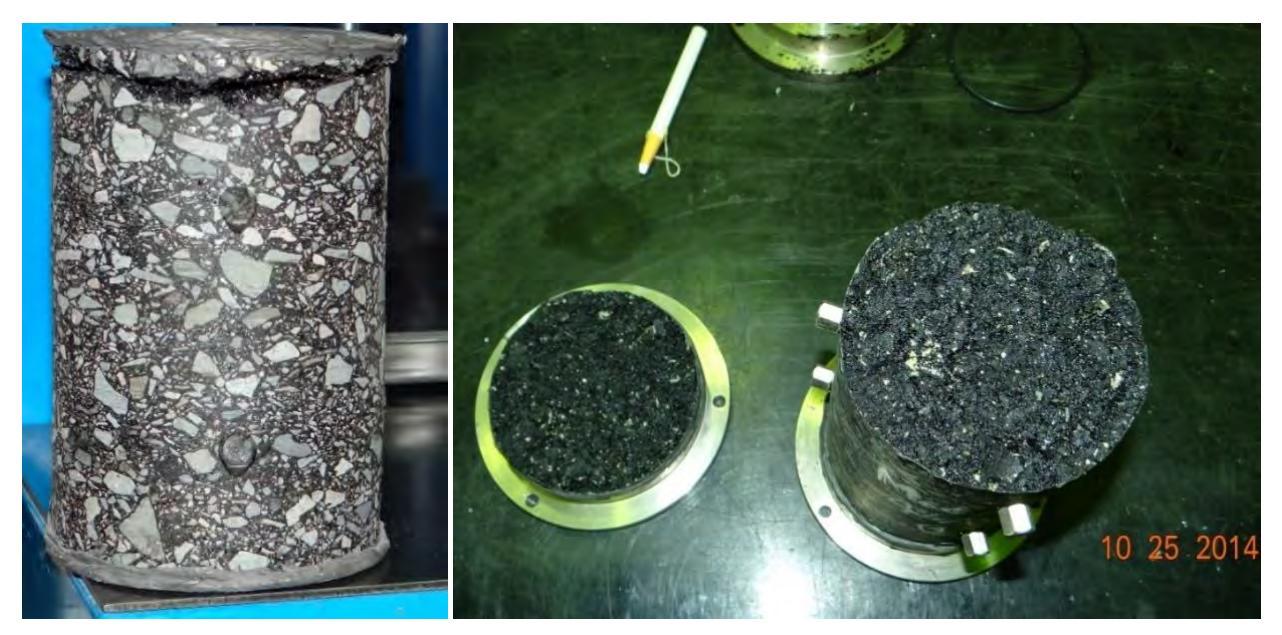
the stress level was incremented by 100 kPa after 1000 cycles and 2000 s rest periods between different load levels.) Notice that since this is not purely a fatigue test, the use of the term fatigue is avoided herein in the test name. Nevertheless, the stress-controlled situation may be representative of conditions inducing cracking at high temperatures in thick pavements. For illustration of strain distributions under these conditions see (14) and the previous chapter. The second problem was that, as shown in Figure 6-1, the specimens tested in either the strain-controlled fatigue test or the repeated tensile load creep-recovery test broke consistently on a section close to the platen (\sim 5-10 mm from the platen).

After testing several specimens, these breaks were so consistent from specimen to specimen that an uneven air voids distribution or an eccentric load were unlikely to be the sole reason for their occurrence. Instead, it was suspected that because of the higher Poisson ratio and lower modulus of HMA at 40°C, there is a larger radial contraction that is restrained by the plates at the sample ends (to which the specimen is glued with steel putty) and that this effect is high enough to induce an early failure.

Figure 6-1 Break occurring consistently 5 to 10 mm from the loading platen.

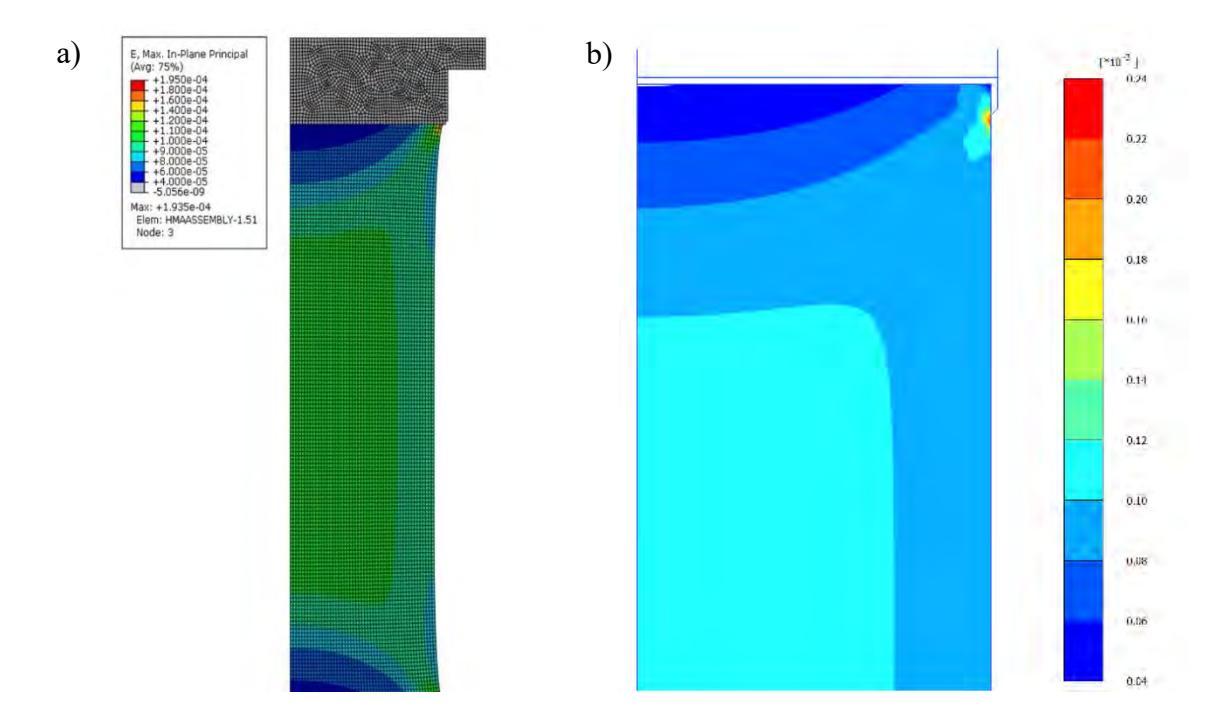
Figure 6-2 Finite element simulations of cylindrical specimens (target strain = (target strain = $100 \ \mu\epsilon$) a) Results with Abaqus Standard with glue flush with the sample (left) and b) Results with Plaxis with glue over sample.

In summary, the finite element analysis confirms that strains in restrained cylindrical samples can almost double the target strains and that therefore strain concentrations are indeed a big factor in the end-failures at 40°C.

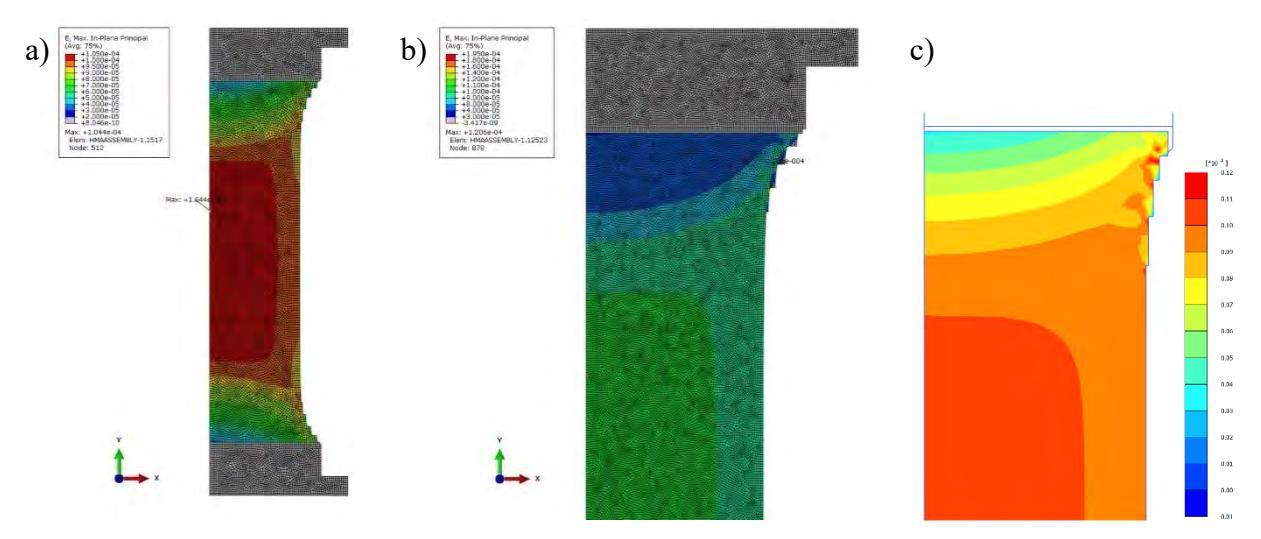
Notice that sharp edges of the trimmed configuration always result in some strain concentration. The results shown in part b) of Figure 6-4 were obtained with Abaqus Standard with the same inputs as before but with a finer mesh. In this case, the maximum strain occurs near one of the

cuts and is more than 20% larger than the nominal strain. The results shown on Figure 6-4 c), obtained with a fine triangular mesh but with Plaxis, also predict strain concentrations of the same order near some of the trimmed edges (the finer the mesh the higher are the predicted strain concentrations).

Figure 6-4 Finite element simulations of trimmed specimens (target strain = $100 \ \mu\epsilon$). Results with: a) Abaqus Standard – coarse mesh (left), b) Abaqus Standard - fine mesh (center), and c) Plaxis - fine mesh (right).

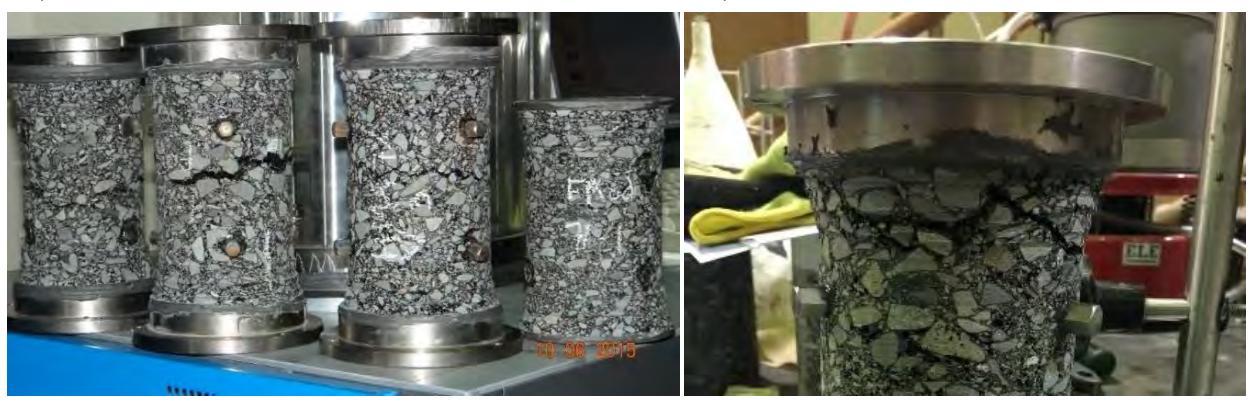
The initial results were very encouraging since the first four specimens tested, shown on Figure 6-6 a), broke in the middle region (the crack on the rightmost specimen is not clearly visible since the specimen was reheated to remove the platens). However, after these initial successes, the following eight specimens tested broke near the ends as shown on Figure 6-6 b). Although these experiences were unsuccessful, they were valuable in that they indicated the middle portion of several samples were being substantially stretched to the point that in several occasions it was believed the sample was failing in the middle until a couple of minutes before the sample failed near one of the sample ends.

Figure 6-6 Successful middle breaks (left) and unsuccessful end breaks (right).

These unsuccessful tests also pointed to the need to pay more attention to load eccentricity. In this study, the plates were glued with the help of the IPC gluing jig. However, careful inspection of the jig showed some play on the rod which is connected to the top plate of the gluing jig that in turn sustain the top platen being glued to the specimen. Any play on this rod may result in lack of parallelism between the faces of the top and bottom platens. Although this problem was solved by machining a replacement part on the gluing jig, the faces of the bottom of the gluing jig and the top are machined within a tolerance that though very small can still result in some eccentricity. The platens themselves and the loading mechanism in the AMPT can introduce some additional small lack of parallelism. Careful observation of this issue showed that for most specimens, when the first load was detected while raising the ram, one side of the top platen contacted the loading plate while on the other side there was a small gap. To minimize the effect of the load eccentricity caused by this small lack of parallelism, shims made with aluminum foil were placed inside the gap using an appropriate number of plies depending on the gaps size (1 to 3 plies were sufficient in most cases). In addition, all the screws used to secure the platens were tighten with the same torque using a torque-wrench. These two precautions together with the smoothing of the staircase pattern discuss next eliminated end breaks in the rest of the tests.

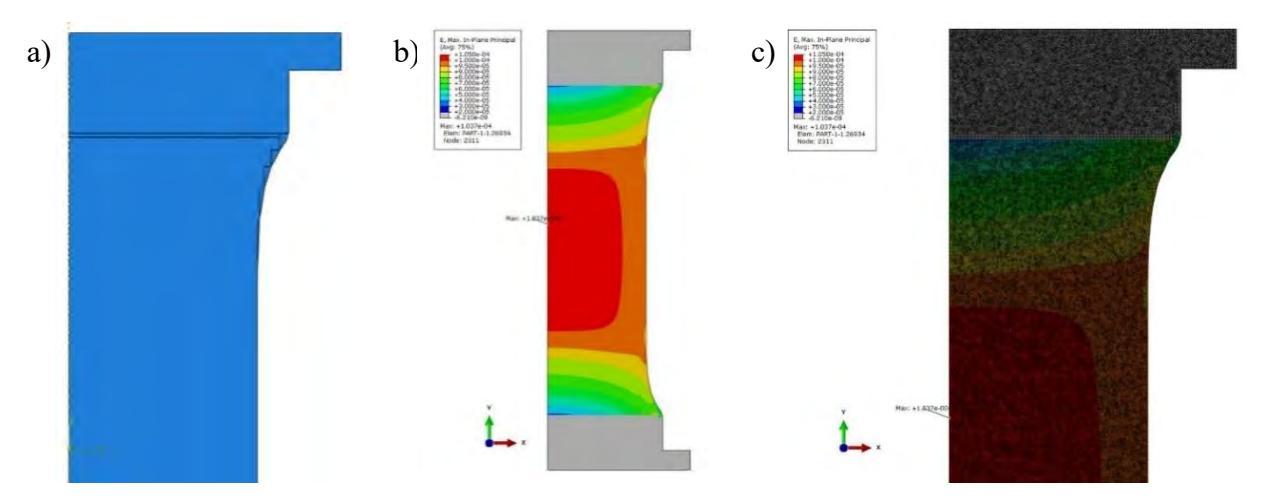
Figure 6-7 Finite element simulations of the trimmed-epoxy smoothed specimens (target strain = $100 \ \mu\epsilon$).

The strain distribution results indicate that the maximum strain occurs in the center of the sample, slightly above or below the mid height of the specimen. They also show that the distribution of strains is not uniform even in the cross-section at mid height. Nevertheless, the maximum strain in this simulation is below 4% higher than the nominal (target) strain in the middle cross-section. Of course, the values and the location of the maximum vary with the assumed epoxy cement modulus and Poisson ratio but even with a simulated epoxy modulus more than 5 times higher than that of HMA, the maximum strain occurs at the axis of symmetry slightly above or below the middle of the sample. Furthermore, even with the use of the very fine mesh shown on Figure 6-7 c), no concentration of strains is predicted.

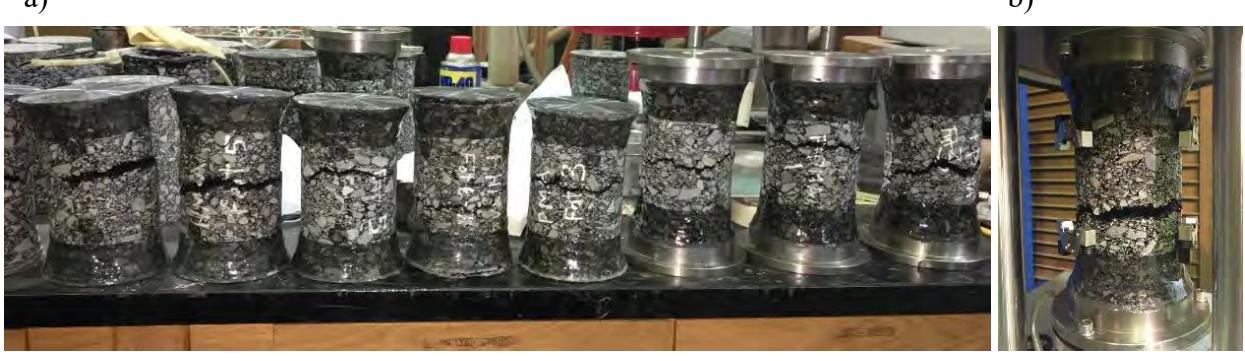
To validate the finite element simulation results, additional specimens were trimmed, smoothed, and tested. Nine specimens were tested with this configuration and all of them fractured within the on-specimen LVDT zone. Table 2-1shows the type of binder, whether the sample contains polyolefin/aramid fibers, whether the sample was smoothed, the air voids, the number of cycles until a crack propagated through a complete cross-section, and the type of break for eight of the nine specimens and a few other tested with the repeated creep and recovery test with a haversine stress of 400 kPa and 0.1 s loading and 1.9 s rest period. The epoxy smoothed specimen not included in this table was tested with a ramping load. Figure 6-8 a) shows eight of the 9 epoxy smoothed specimens. Figure 6-8 b) shows one of those specimens still in the AMPT chamber.

Figure 6-8 Effectiveness of specimen configuration to induce mid-specimen fracture.

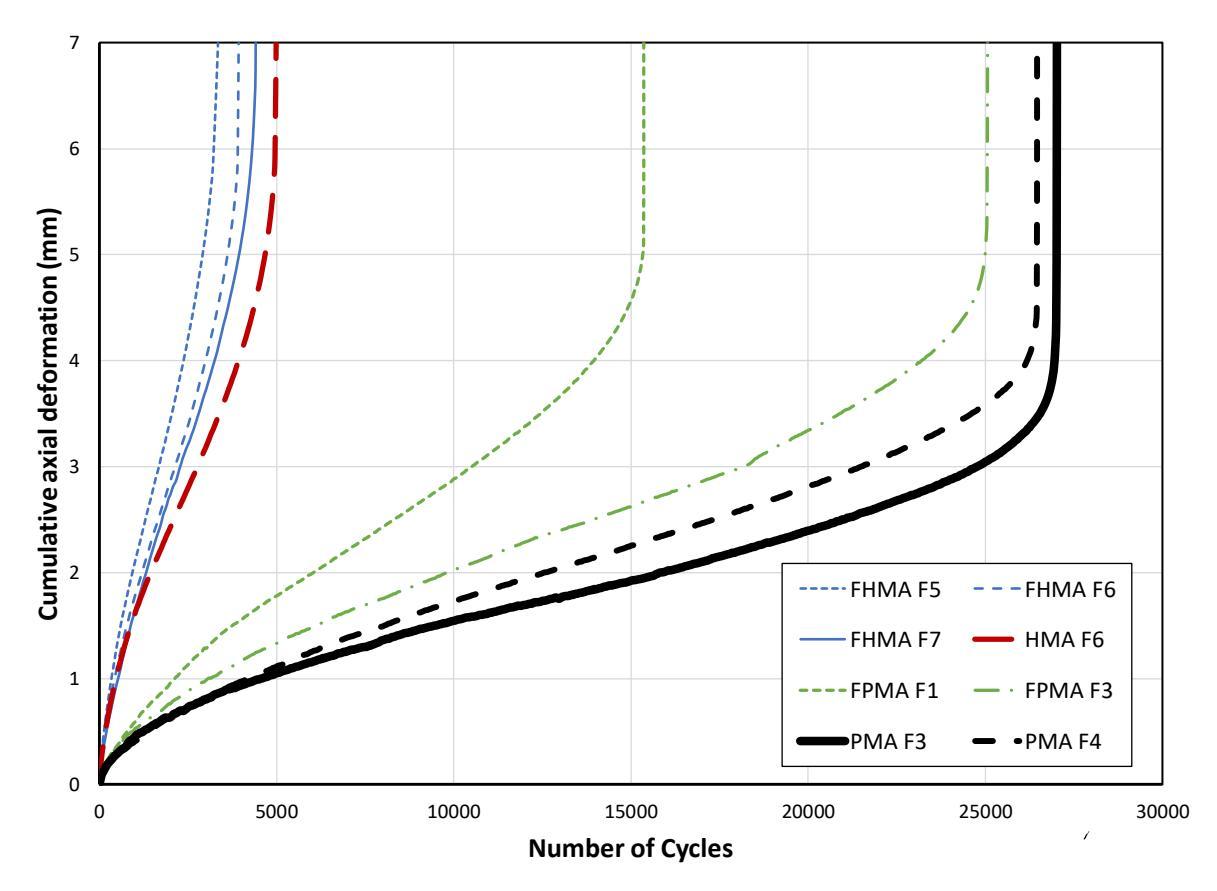
Figure 6-9 shows the curves of cumulative axial deformation at the end of each cycle for 8 of the nine specimens tested with the trimmed-epoxy smoothed configuration. As seen in this figure, the curve for specimen FPMA F3 has a slight discontinuity in slope. This is because the software froze during that test. Thus, the test was interrupted and re-started. The curve shown for this specimen is the best match that could be found between the two parts of the test. All the curves show an initial portion where the cumulative deformation (unrecovered viscoelastic plus plastic)

The first three curves (for specimens FHMA F5, FHMA F6, and FHMA F7) are for specimens prepared with an unmodified PG64-22 binder and polyolefin/aramid fibers. The next curve is for specimen HMA F6, which is a specimen prepared with unmodified PG64-22 binder without fibers. Unfortunately, not much can be said with a single specimen with unmodified binder

without fibers in comparison with three unmodified specimens with fibers. However, it is important to point that the fact that the single HMA specimen lasted longer than any of the FHMA specimens is consistent with the analysis of dynamic modulus testing results obtained with the same mixes in compression (24). The following four curves are for four specimens prepared with polymer modified binders with and without fibers. Specimens FPMA F1 and FPMA F2 were prepared with polyolefin/aramid fibers and specimens PMA F3 and PMA F4 were prepared without fibers. There is a significant difference in performance of specimen FPMA F1 relative to the other three polymer-modified specimens. This specimen had a noticeable lack of parallelism and was tested prior to the adoption of aluminum foil shims and tightening of screws with a torque-wrench to minimize load eccentricity. In addition, the deformations measured by the three LVDTs before going out of range were substantially different from each other, confirming a problem with load eccentricity. Therefore, it is not surprising that this specimen lasted much less than the other three.

Figure 6-9 Cumulative axial deformation at the end of each cycle for specimens with mid height failures.

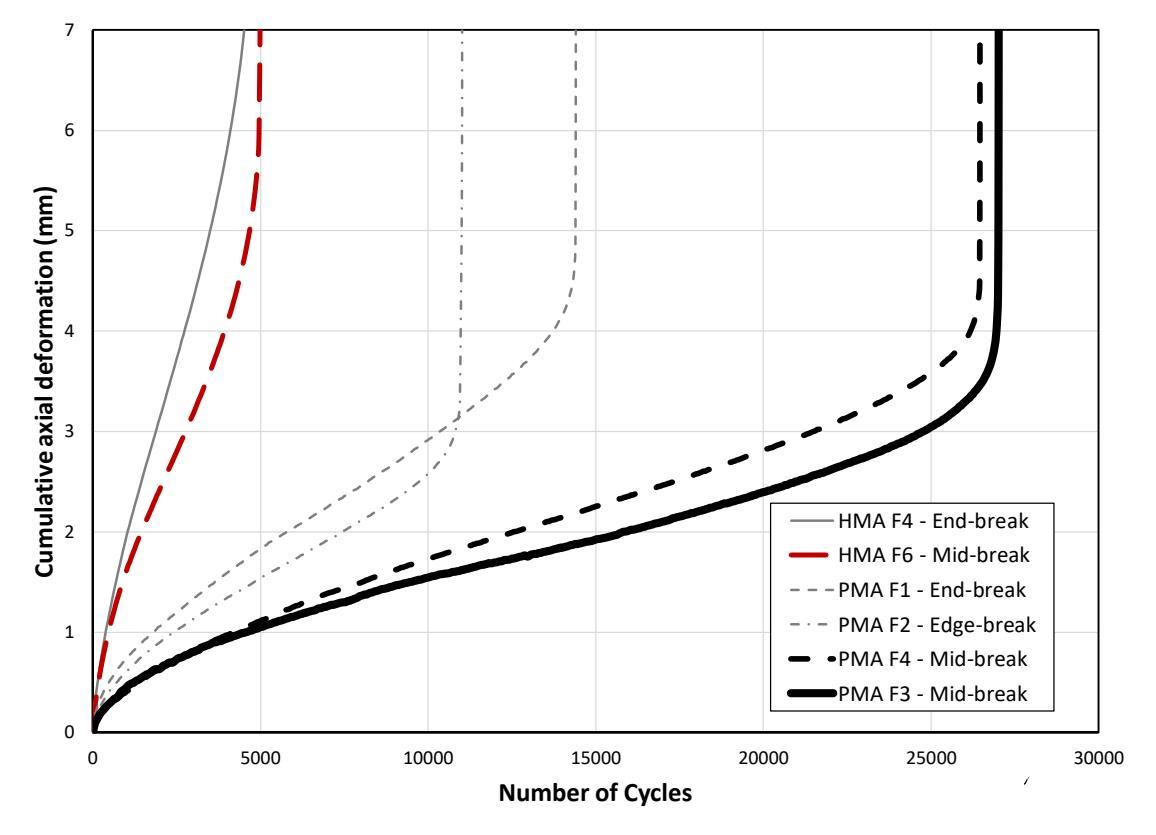
Figure 6-10 shows some of the same curves in Figure 6-9 for mid-specimen breaks together with results for trimmed specimens with end breaks tested before the use of epoxy to smooth out the sharp edges and shims and a torque-wrench to minimize load eccentricity. For both, the HMA and PMA mixes, the performance was substantially reduced without smoothing and the use of shims to minimize load eccentricity. In this figure, the performance reduction because of end breaks is seen more clearly for the specimens prepared with polymer modified binder. Specifically, the number of cycles until complete fracture of specimen PMA F2 is less than half of those specimens PMA F3 and PMA F4. The reduction for specimen PMA F1 was not as large but was still close to 50%. These results stress the importance of minimizing load eccentricity to obtain meaningful results.

Figure 6-10 Cumulative axial deformation at the end of each cycle for specimens with mid height failures.

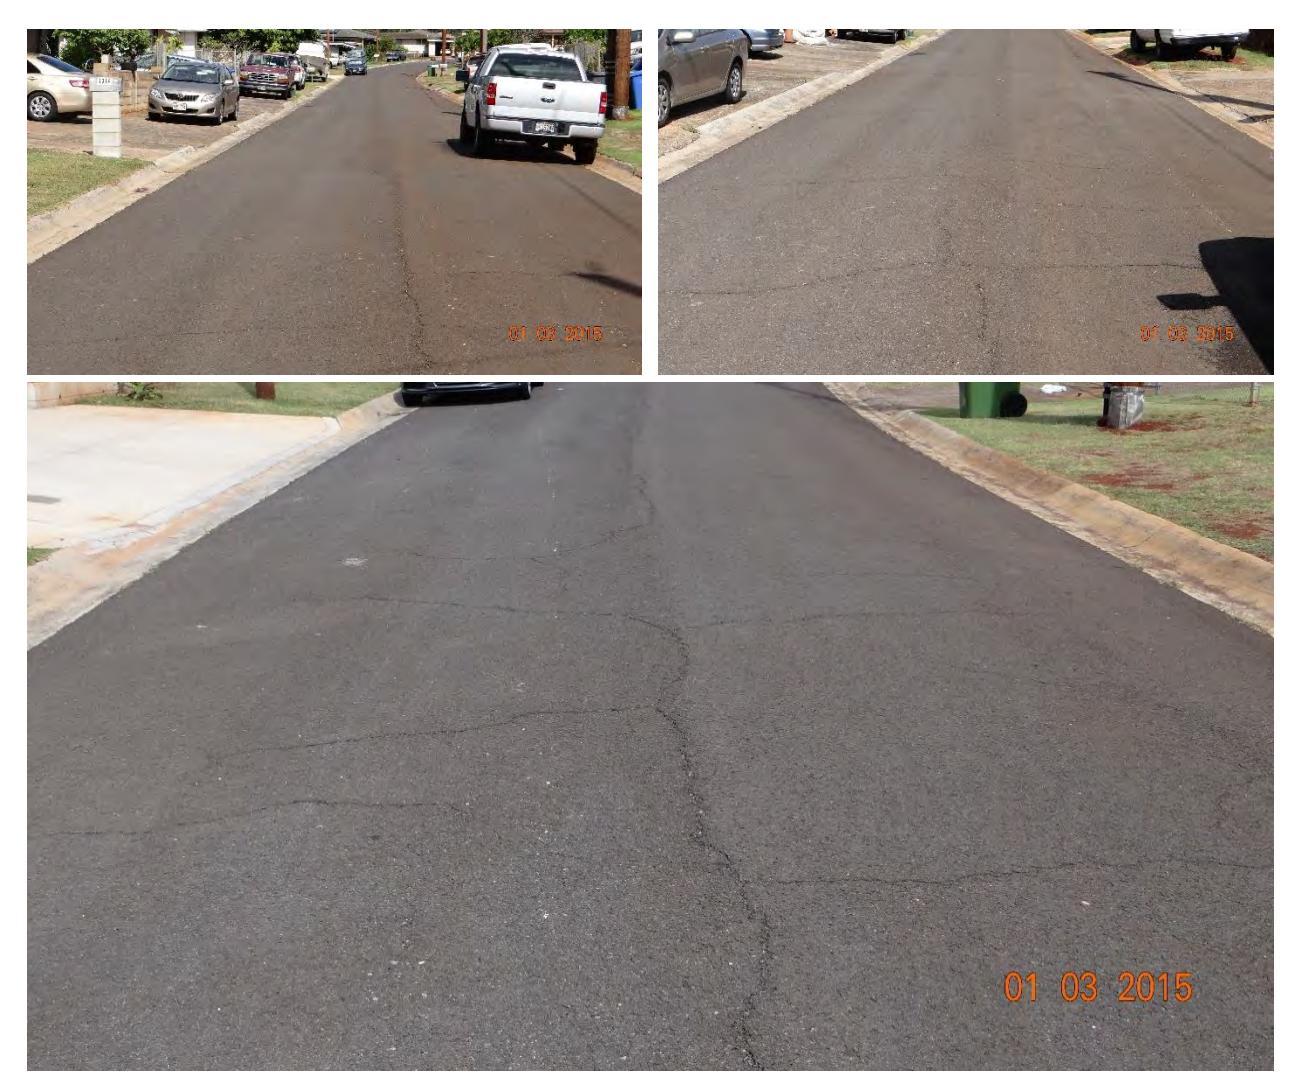
Figure C-1 shows the condition of this section near the beginning of the study. Cracking was composed mostly of large blocks (block cracking). One side of these blocks was typically part of a longitudinal crack along the construction joint. Sometimes the blocks were large enough that the opposite side was the joint with the gutter, but oftentimes other longitudinal cracks appeared between the centerline and the joint with the gutter.

Figure C-1 Cracking patterns observed on the Control Section on Hoolauna Street on 01/03/2015.

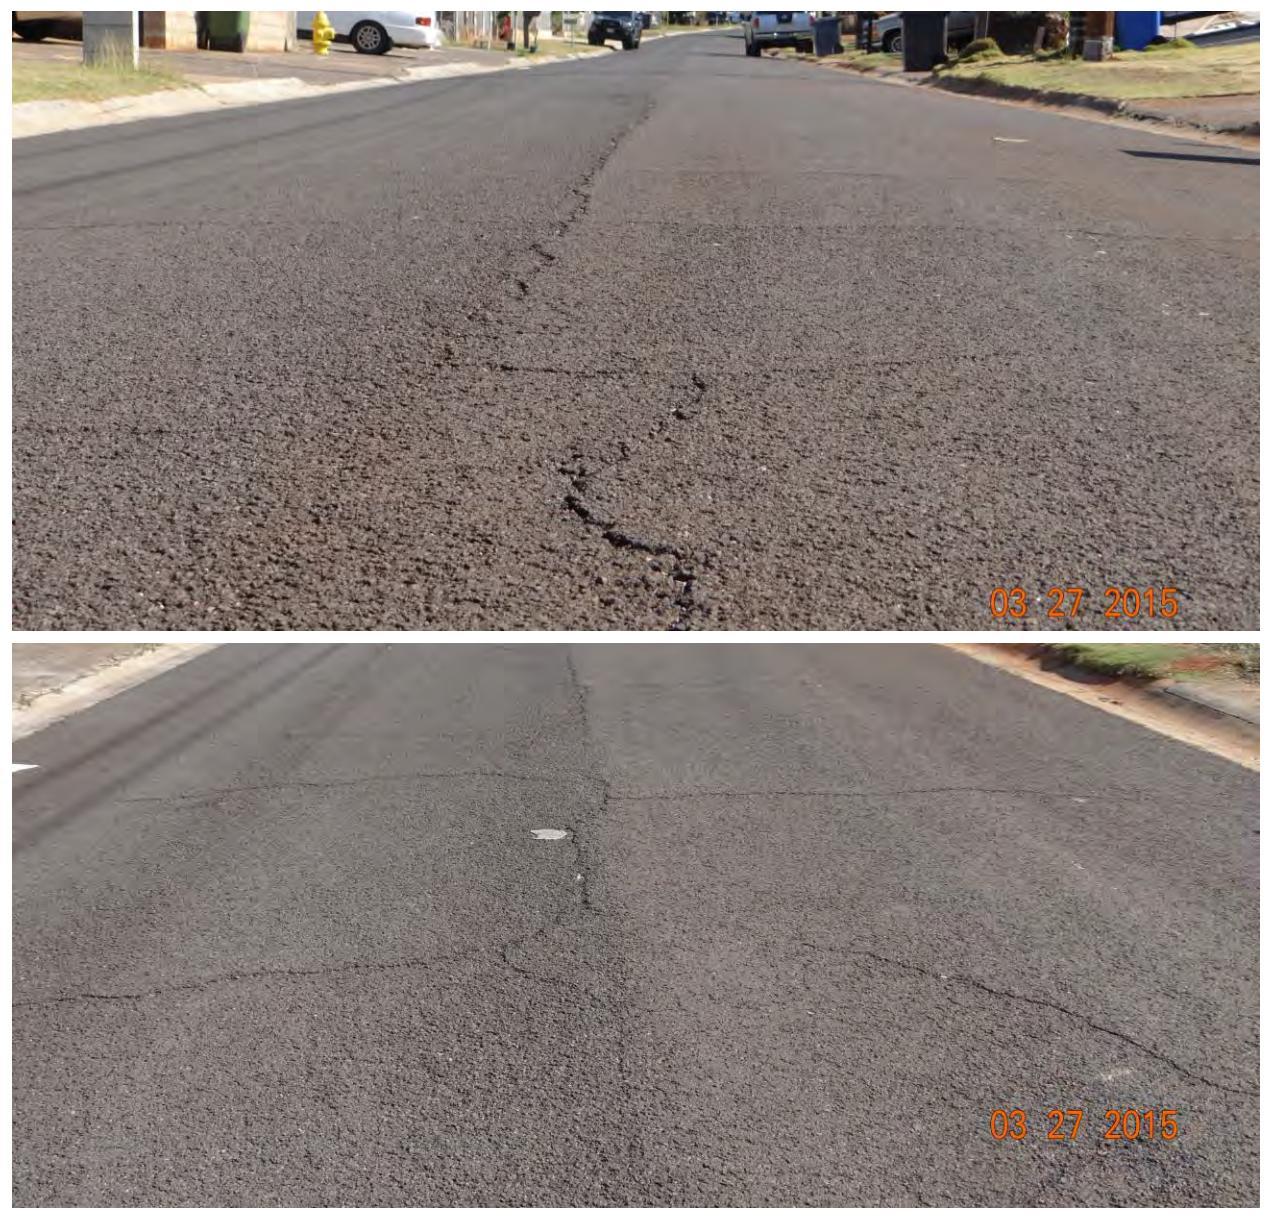
Clearly, not much change could be observed visually from survey to survey. This is illustrated on the photos in Figure C-2, Figure C-3, and Figure C-4, which show the same patterns. After three years, the pattern looks very similar, though as shown by the quantities in Figure 4-3, the total cracking had increased by about 20%. As discussed before, the cracking increase was relatively gradual with the error in measurements being of the same magnitude as the average change between surveys.

Figure C-2 Cracking patterns observed on the Control Section on Hoolauna Street on 03/03/2015.

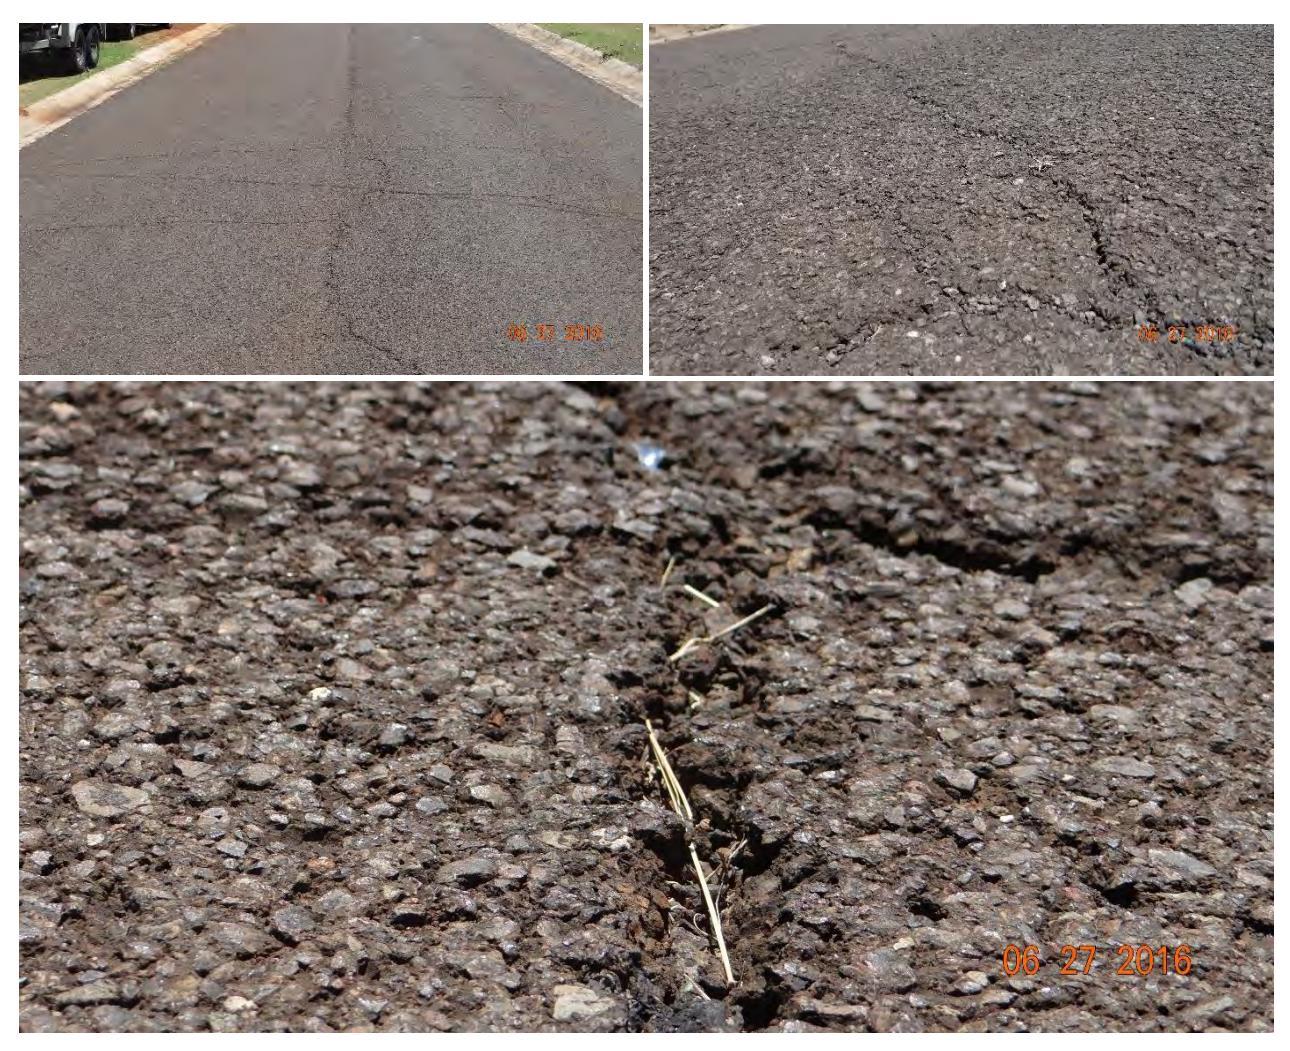
Figure C-3 also shows some of the degradation observed on the surface (loss of mastic and aggregates, some of which can be seen loose in the cracks). Figure C-4 shows raveling developing near the center lane joint and in the joints with the gutter.

Figure C-3 Cracking patterns observed on the Control Section on Hoolauna Street on 06/27/2016.

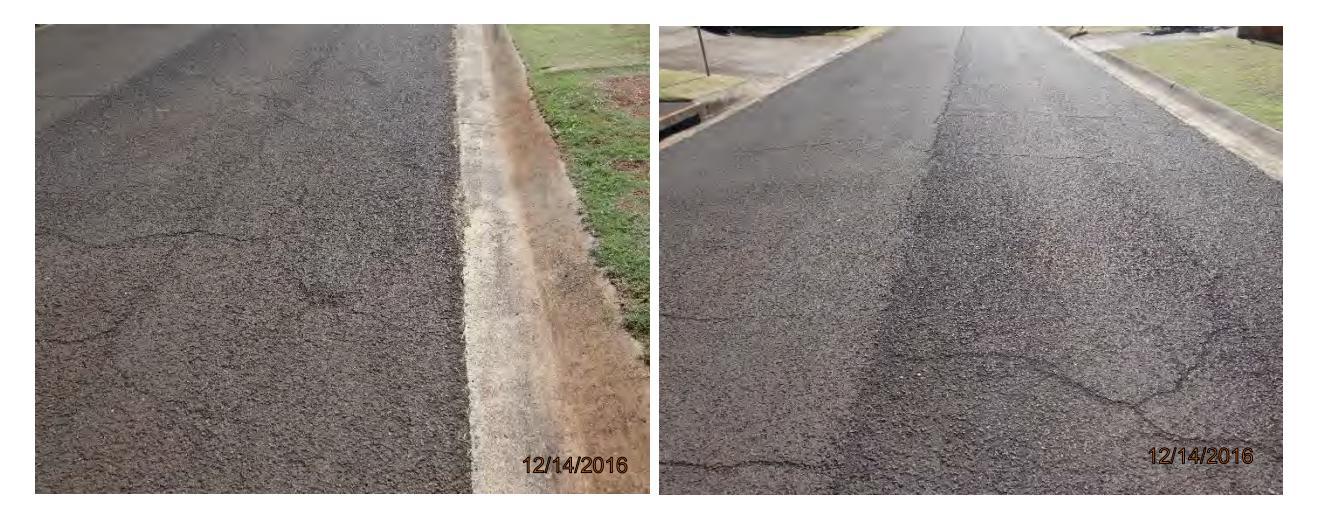
Figure C-4 Cracking patterns observed on the Control Section on Hoolauna Street on 12/14/2016.

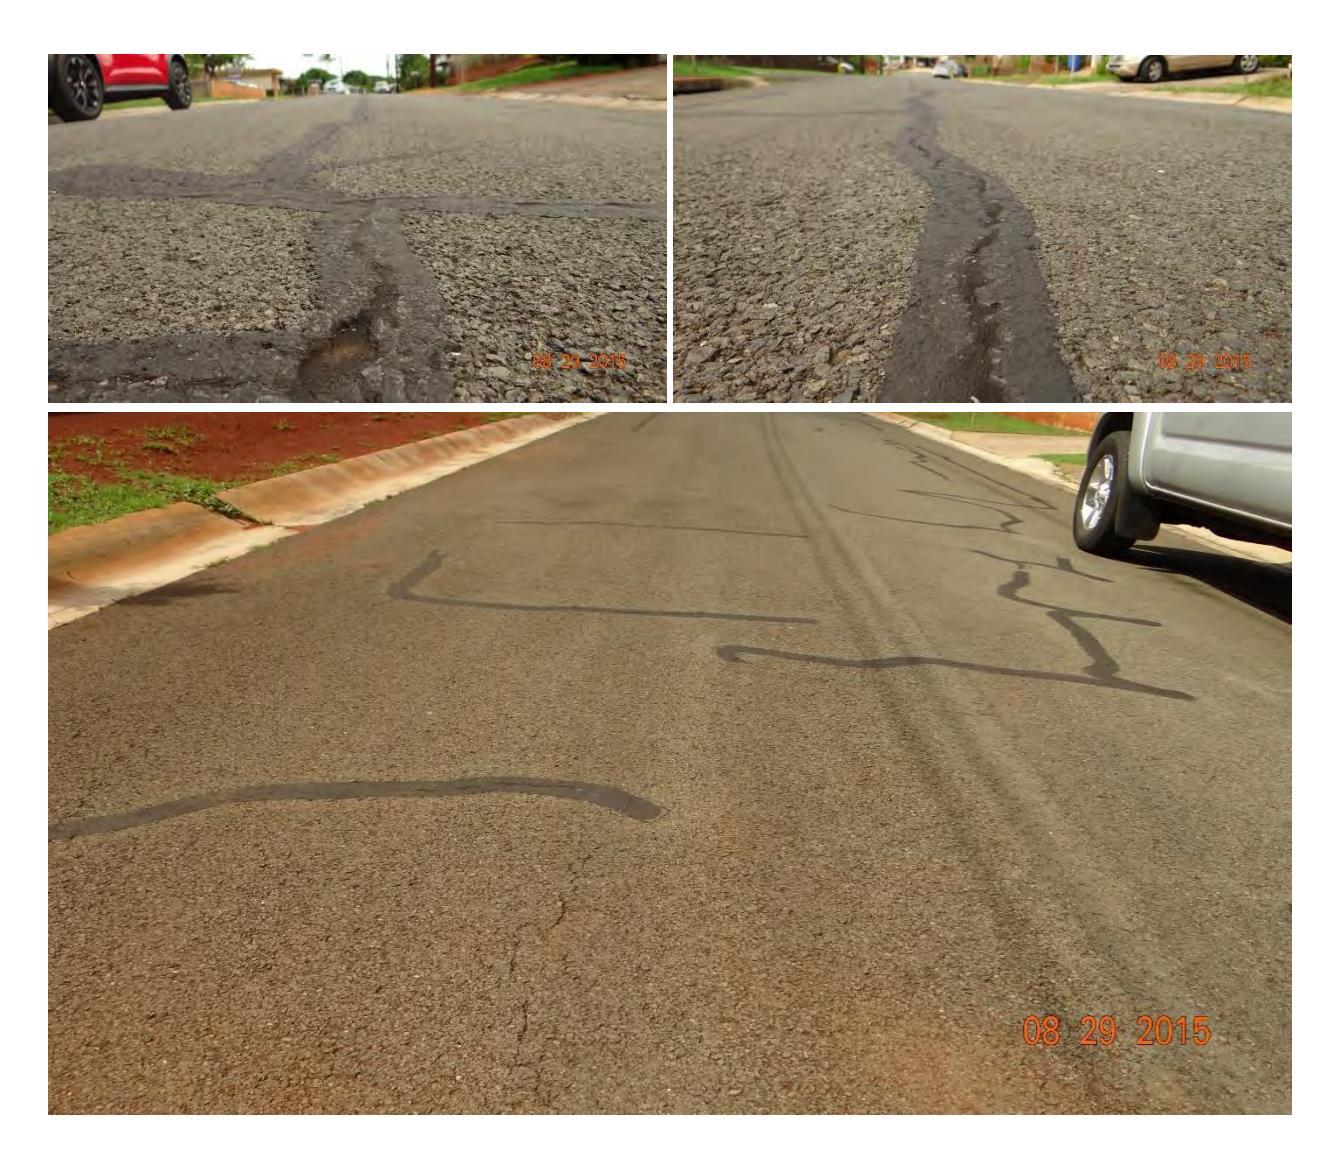
Figure C-5 to Figure C-9 show examples of the condition of the section over time. Figure C-5 shows the condition on 08/29/2015, nine months after the section was crack sealed. As seen on the top two photos in the figure, there is full contact between the sealant and the crack walls. Thus, the sealant is indeed preventing the infiltration of water through the cracks. The photo on the bottom of the figure illustrates that a large part of this section had not developed a longitudinal crack, as seen in the other two sections. This may explain in part the lower cracking observed on this section. This photo also illustrates that a new crack was developing close to the center of the lane.

Figure C-5 Cracking patterns observed on Hoowali Street on 08/29/2015 (sealed with CrackMasterTM PL-HT).

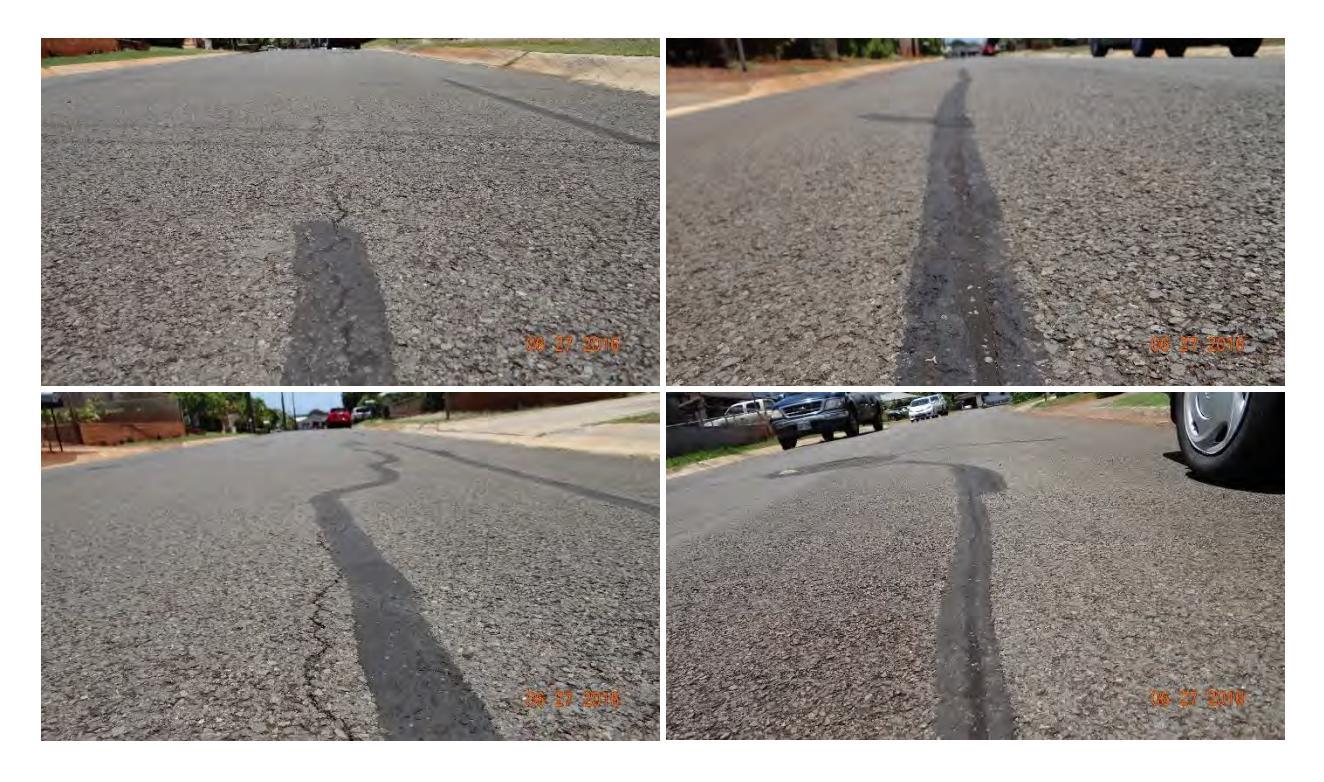
Figure C-7 shows the conditions after 19 months. The top left photo shows the condition of a crack that was not routed. As shown, the sealant was still filling the crack fully. It is also seen that the crack was propagating longitudinally. The photo on the top right shows the same crack that was shown on the top left of Figure C-6. Some loose aggregate incrustations can be seen together with some wrinkles in the surface of the sealant. This was quite common as the sealants aged in all the crack sealing jobs, but it has no consequence as long as the sealant does not stiffen. The bottom left photo shows another common situation in this study. A new crack is formed adjacent to where the sealant was poured with no obvious crack visible. This is typically observed with low severity cracks that are not always visible while sealing. It is likely that the portion of the crack where no sealant was poured had already formed before the sealing operation but that it was not visible to the operator.

Figure C-7 Condition of crack sealing observed on Hoowali Street on 06/27/2016 (sealed with CrackMasterTM PL-HT).

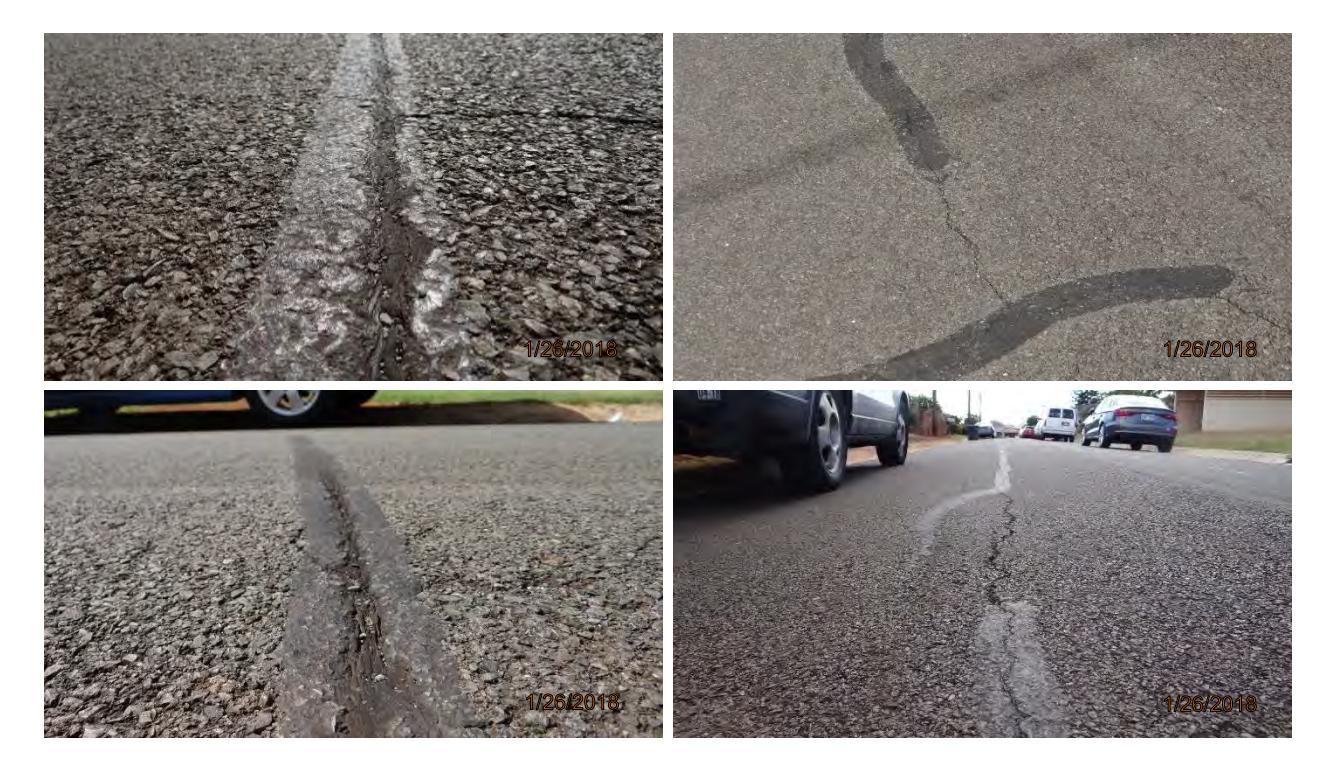
Figure C-8 and Figure C-9 show the conditions after more than 3 years (after about 38 months). The two photos on the left of Figure C-8 show again the typical wrinkles developed on the surface of the sealant. The photos on the right show that the cracking pattern continues developing between the sealed cracks. The top left photo in Figure C-9 shows what happens on low severity cracks where the sealant is subjected to high strains with the crack movement. It is apparent that there are portions were the crack has reopened. The figure also shows further examples of crack propagation and water infiltration through the joint with the gutter, as highlighted with the vegetation growth. Finally, the bottom right photo on Figure C-9 shows that the binder is still soft enough that can be imprinted with a finger.

Figure C-8 Condition of crack sealing observed on Hoowali Street on 01/26/2018 (sealed with CrackMasterTM PL-HT).
