PERFORMANCE MONITORING OF PRESERVATION TREATMENTS IN HONOLULU

FINAL PROJECT REPORT

Adrián Ricardo Archilla University of Hawaii at Manoa

May 2019

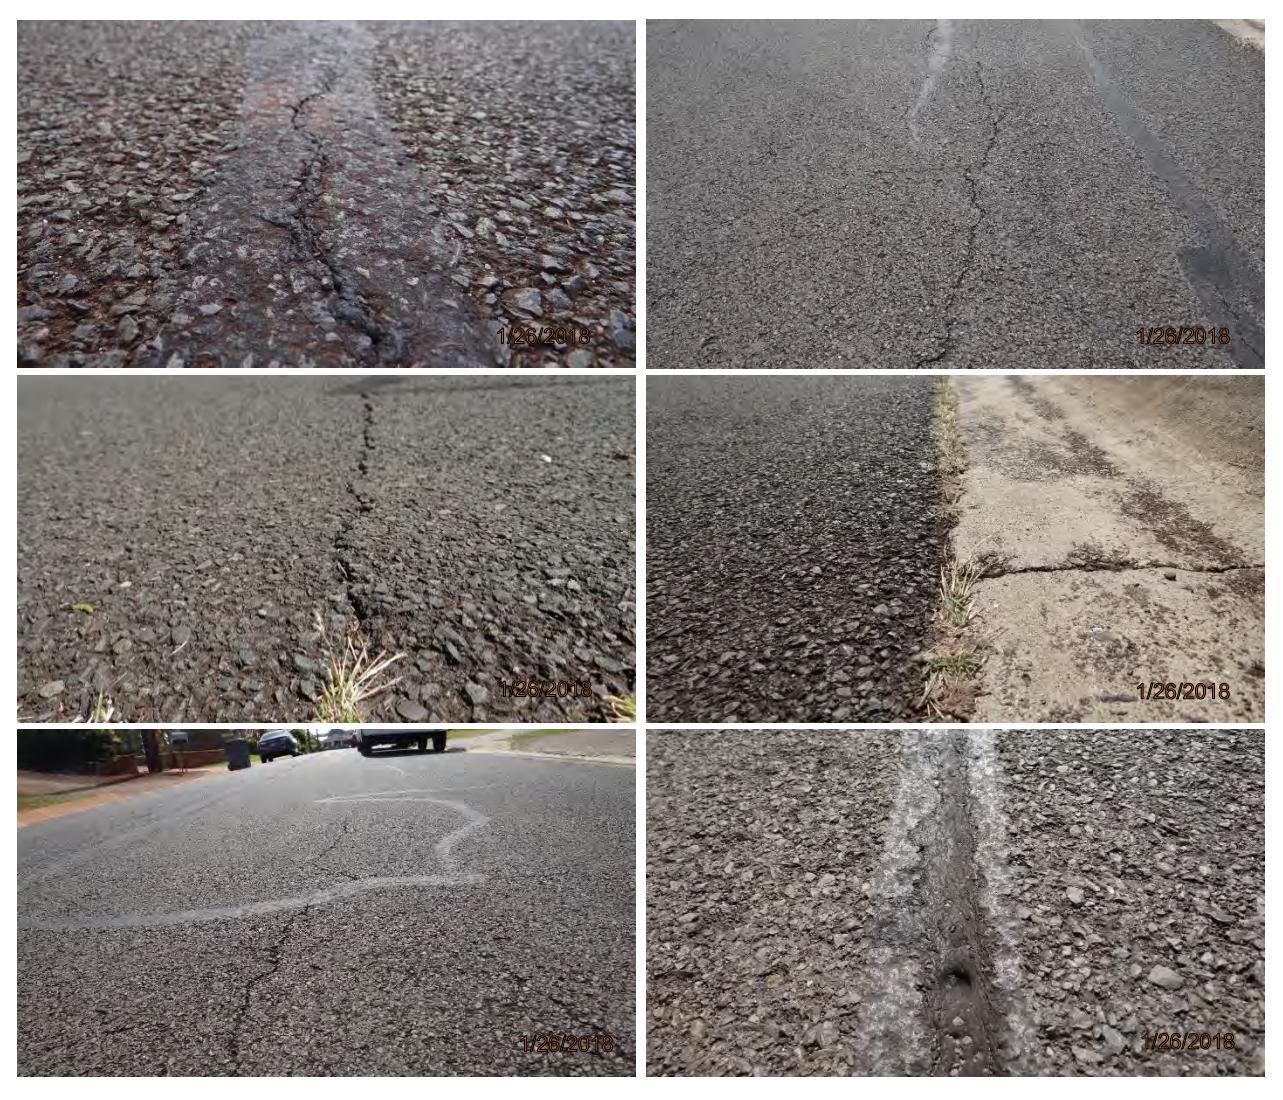
Figure C-8 and Figure C-9 show the conditions after more than 3 years (after about 38 months). The two photos on the left of Figure C-8 show again the typical wrinkles developed on the surface of the sealant. The photos on the right show that the cracking pattern continues developing between the sealed cracks. The top left photo in Figure C-9 shows what happens on low severity cracks where the sealant is subjected to high strains with the crack movement. It is apparent that there are portions were the crack has reopened. The figure also shows further examples of crack propagation and water infiltration through the joint with the gutter, as highlighted with the vegetation growth. Finally, the bottom right photo on Figure C-9 shows that the binder is still soft enough that can be imprinted with a finger.

Figure C-9 Condition of crack sealing observed on Hoowali Street on 01/26/2018 (sealed with CrackMasterTM PL-HT).

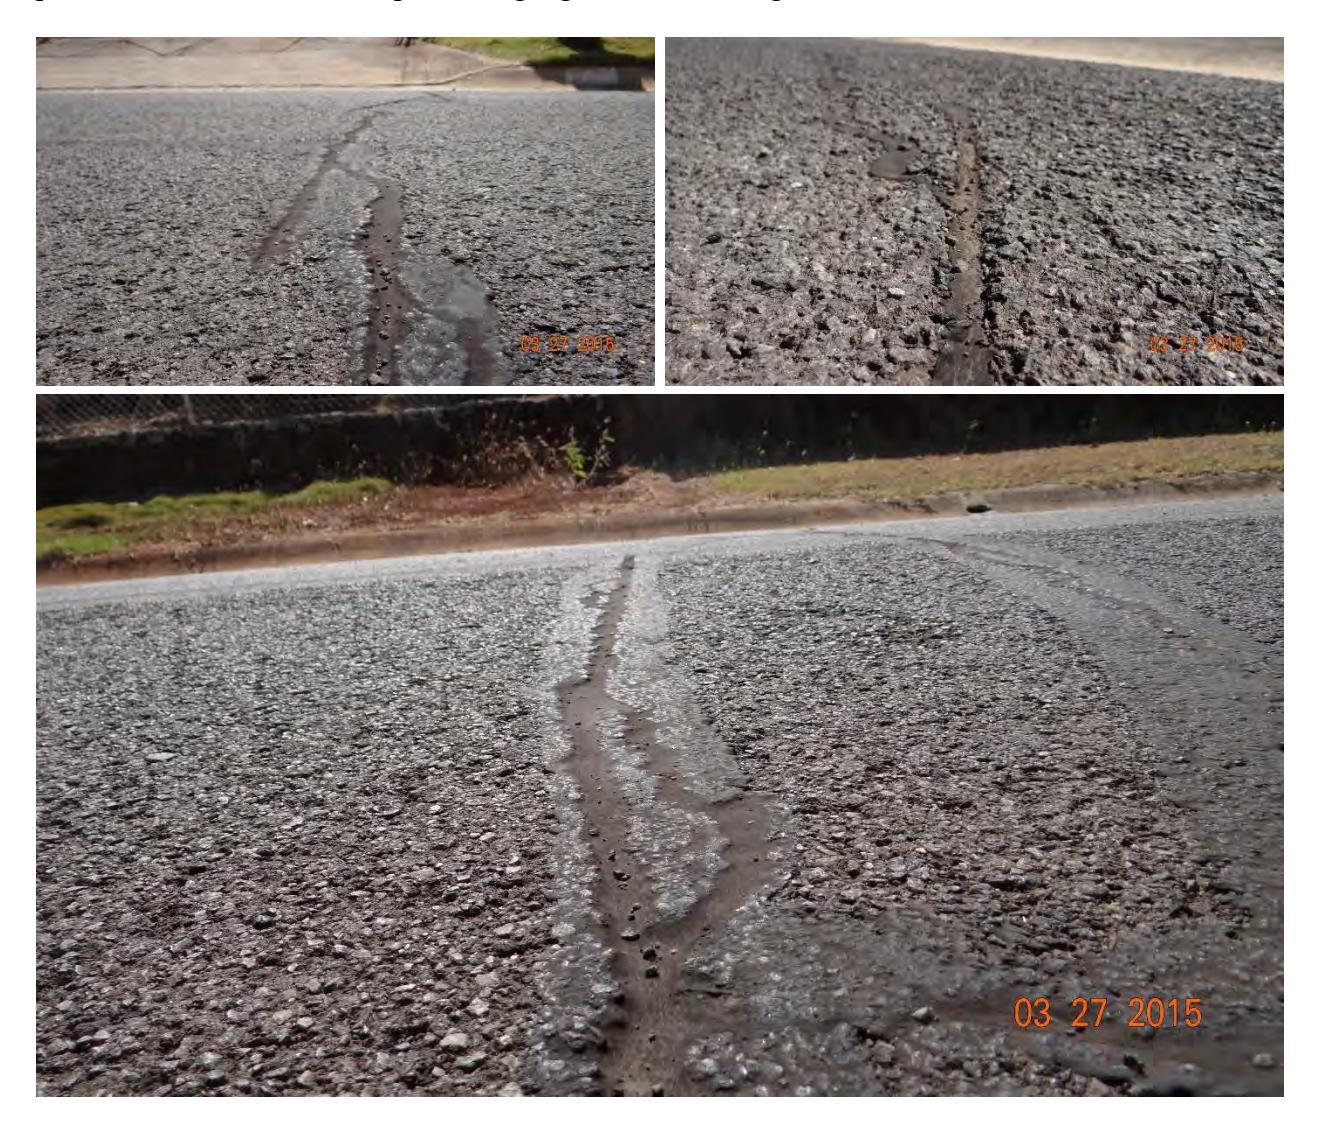
Figure C-11 shows examples of routed cracks soon after they were crack sealed. The sealant in these photos appears to be in perfect contact with the crack walls. The top right photo shows that parts of this section were experiencing significant raveling.

Figure C-11 Condition of crack sealing observed on Hookano Street on 03/27/2015 (sealed with Roadsaver 211).

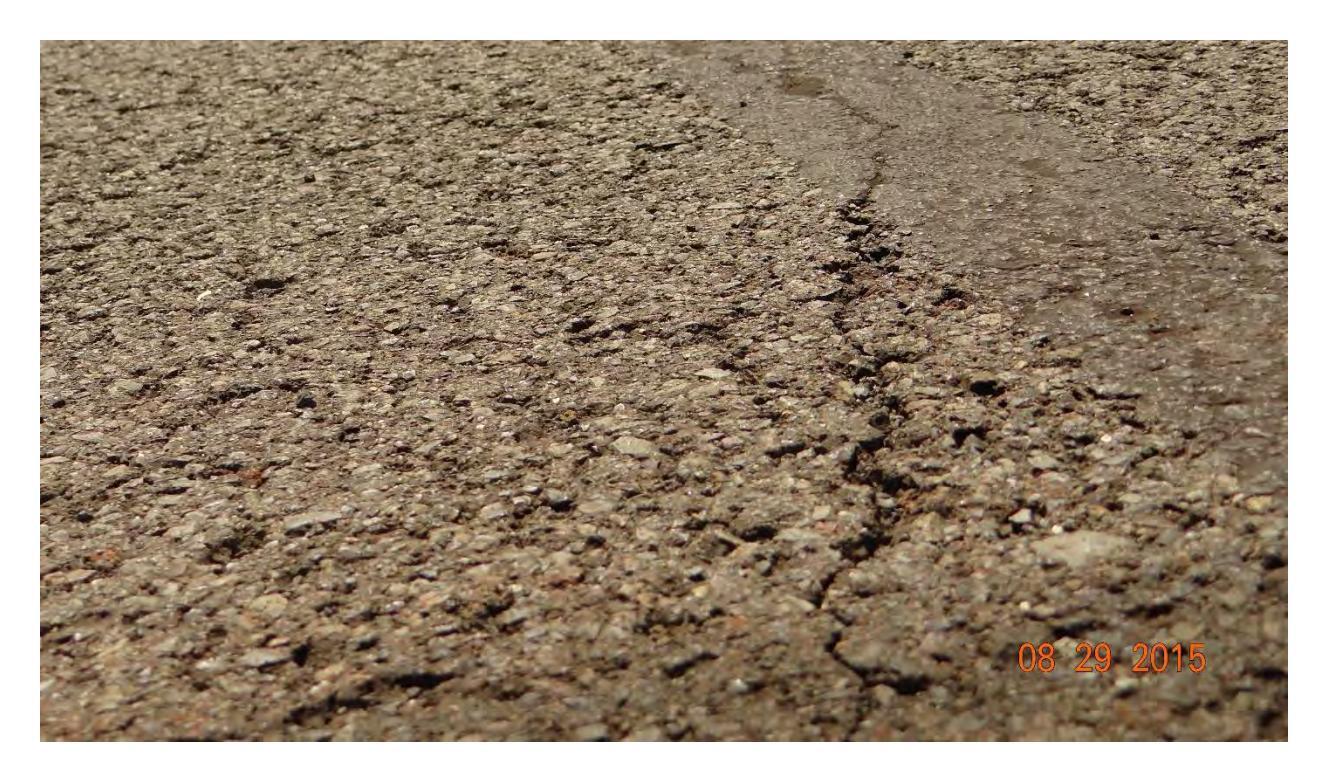
The photo in Figure C-12 shows another example of a crack meandering outside the sealing overband. In this case, the sealed crack is visible. Again, since no such cracks were observed immediately after sealing, it is most likely that they were not formed yet or if they were, they were not yet visible. The photo in Figure C-13 shows that after a year, the sealant in routed cracks was performing as expected.

Figure C-12 Condition of crack sealing observed on Hookano Street on 08/29/2015 (sealed with Roadsaver 211).

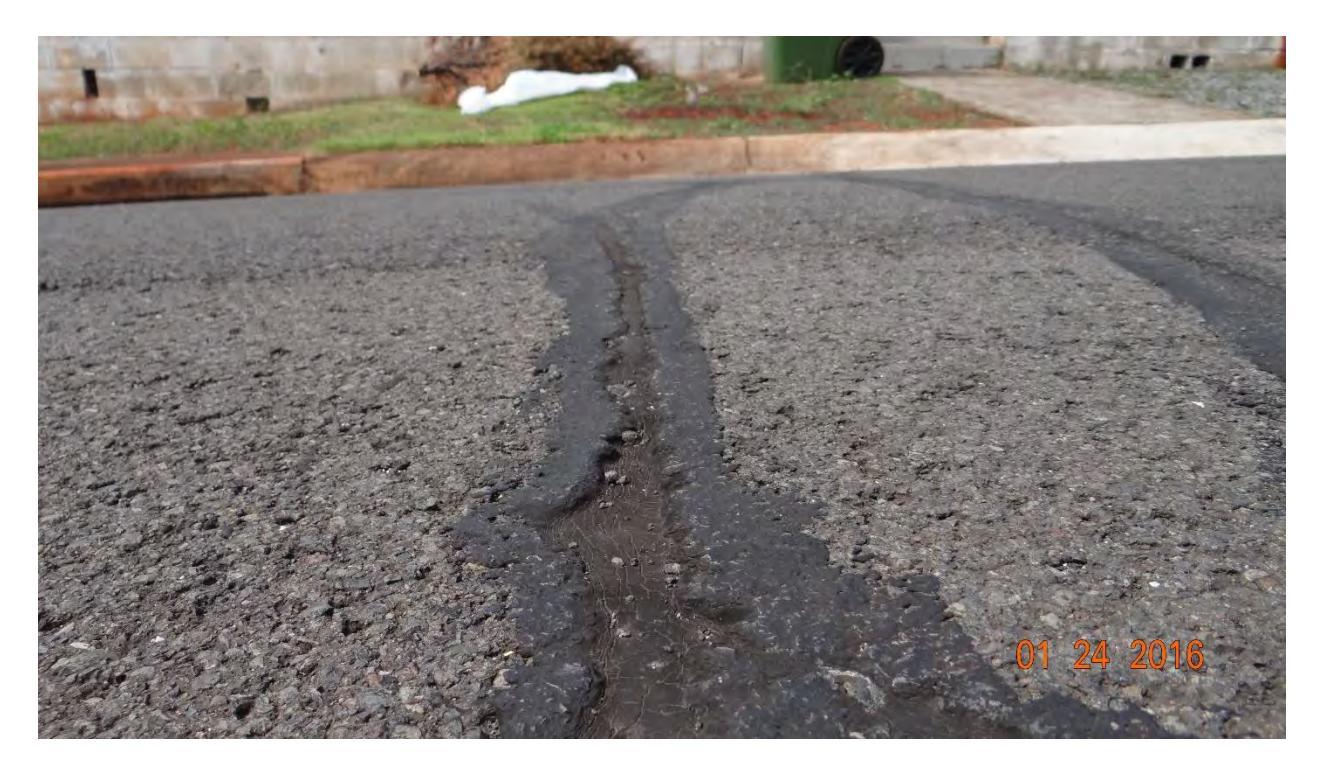
Figure C-13 Condition of crack sealing observed on Hookano Street on 01/24/2016 (sealed with Roadsaver 211).

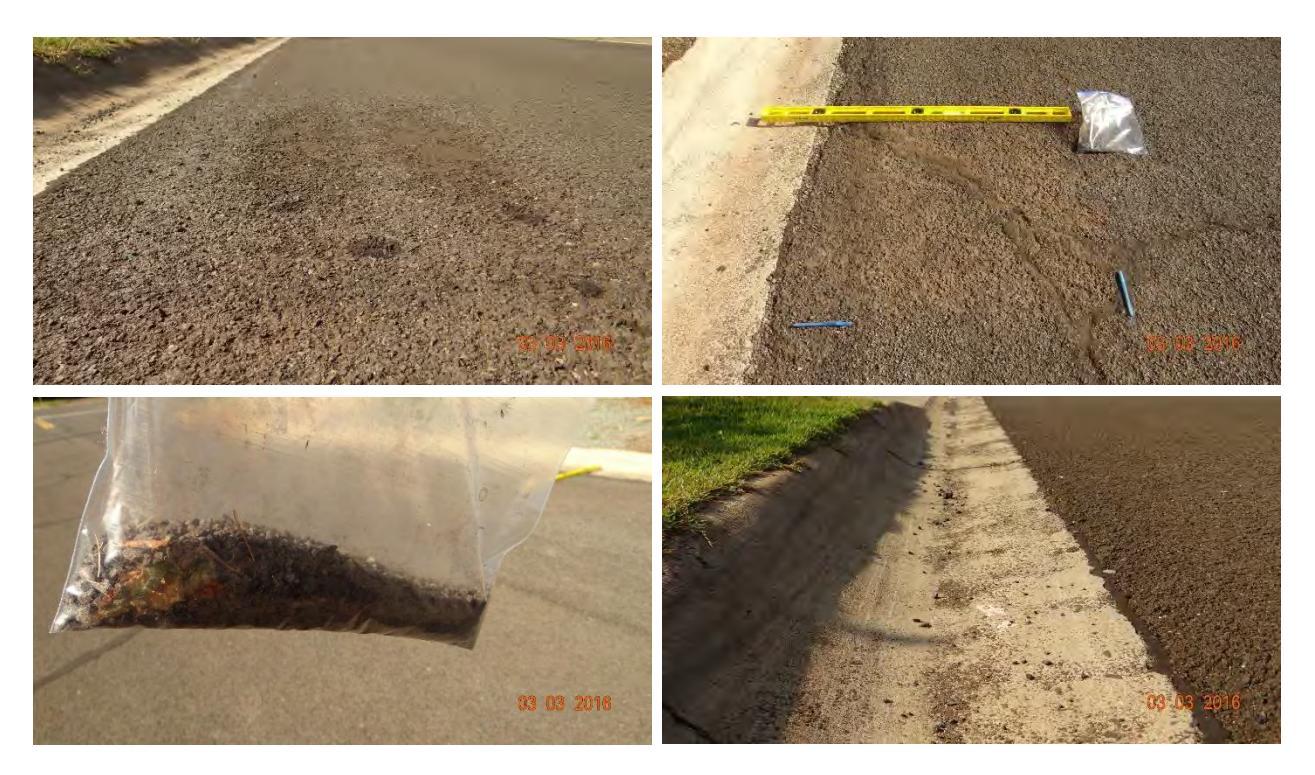
When this section was selected and assigned for the crack sealing study, it was not realized the level of raveling that it was experiencing. In fact, the raveling in this section was widespread. This is illustrated on Figure C-14, which shows the condition in a particularly bad spot. In that area, a pound of aggregate was swept from the marked squared yard shown on the top-right photo. This is common on streets with on-street parking and where some vehicles are parked regularly in the same spot. Vehicles with oil leaks parked regularly on the same spots contribute significantly to this problem. Raveling on other sections was not this obvious, but usually loose aggregates in the gutter were a good indicator of aggregate loss for other sections as well.

Figure C-14 Raveling observed on Hookano Street on 03/03/2016 (sealed with Roadsaver 211).

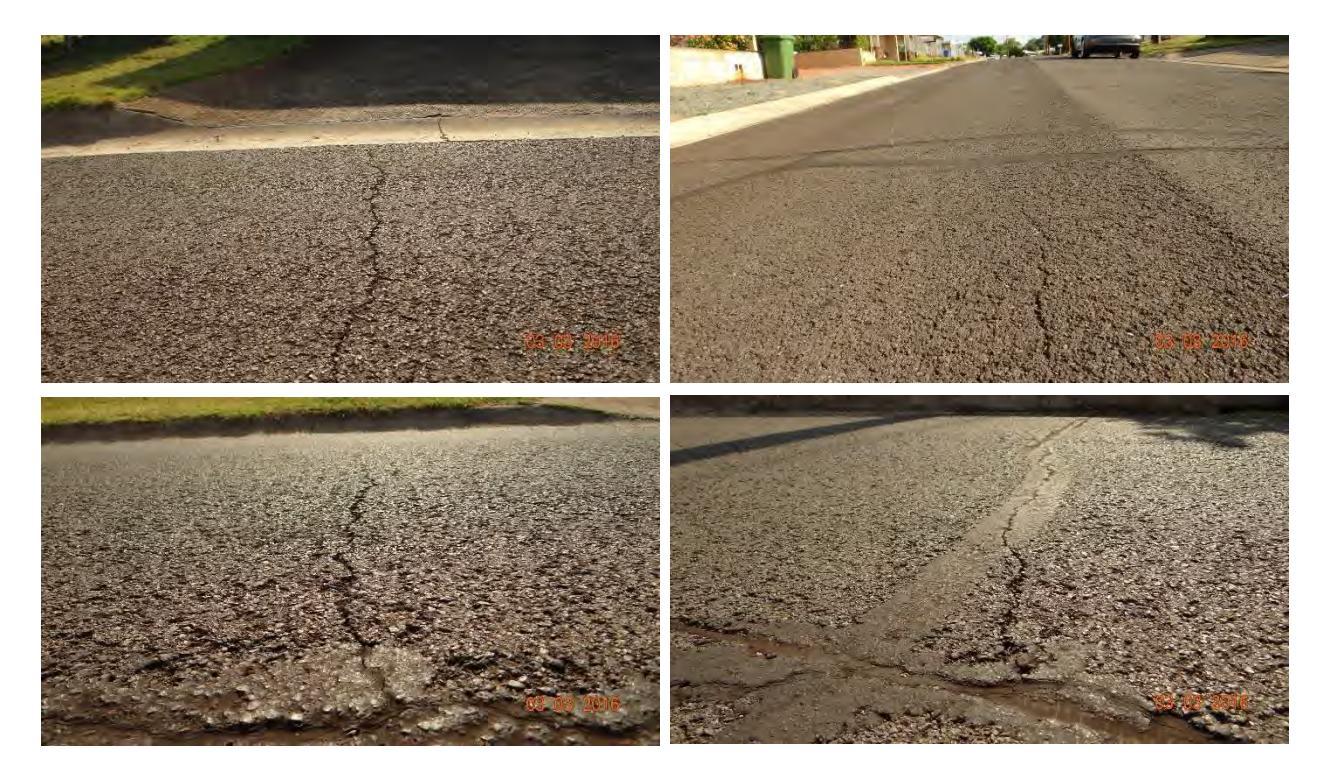
The photos on Figure C-15 show new cracks forming despite the relatively large level of cracking in the section. Notice that most of these are completely new and unrelated to the crack sealing in the section. The photo on the bottom right of the figure is another example of the true path of a crack being exposed after it was sealed.

Figure C-15 Condition of crack sealing observed on Hookano Street on 03/03/2016 (sealed with Roadsaver 211).

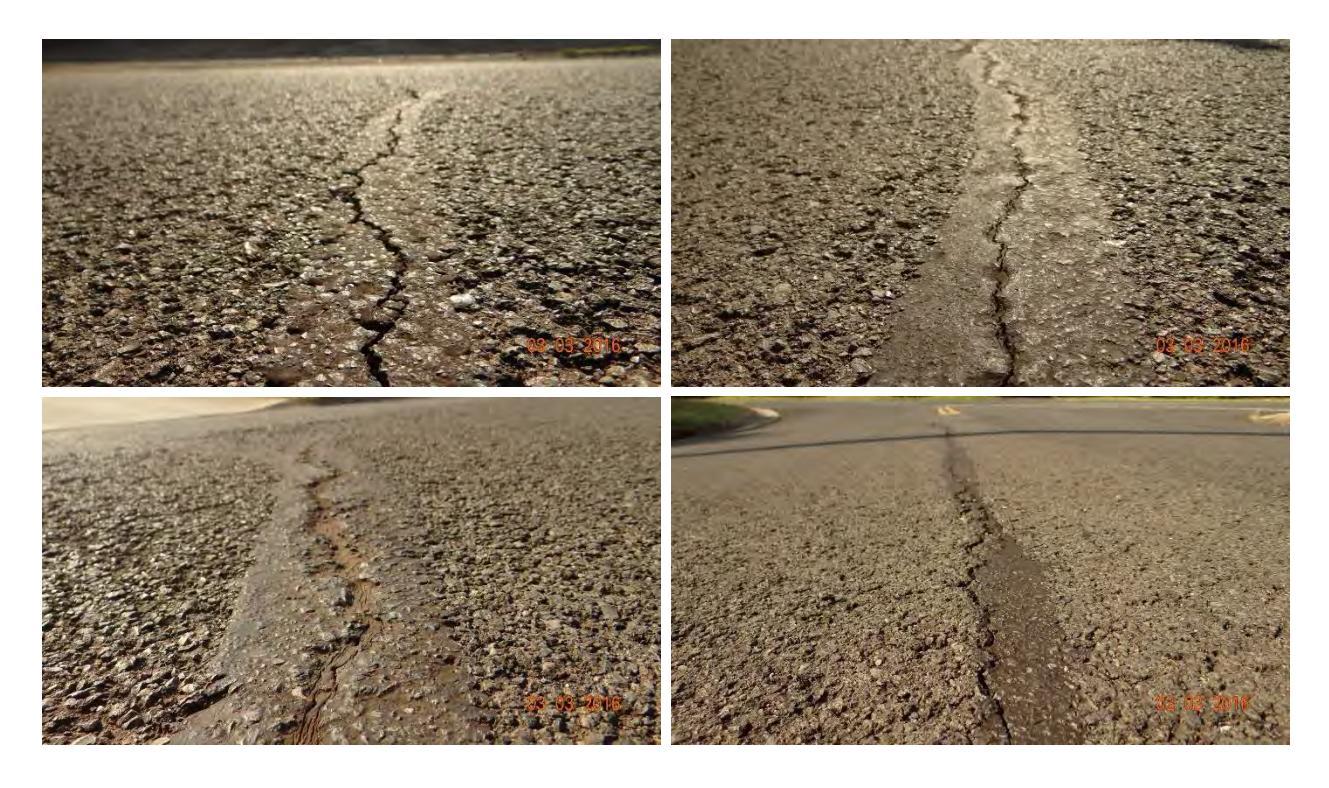
Figure C-16 is more relevant to the performance of the crack sealing. The top left photo in the figure, illustrates a problem with the sealing of relative thin cracks that have not been routed. In this case, the crack sealing is not performing its job after only slightly more than a year. In addition to the high strains induced by the short distance between the crack faces, the crack may have been too thin for the sealer to penetrate it. Thus, any crack movement will simply break the thin film of sealant and expose the crack again. The photo on the top right shows a less severe case but where still the sealing is not performing adequately. In this case, the sealant has penetrated the crack, but its width is too small to absorb the crack movements, thus leading to strain levels that are too high for the sealant or the bond between the sealant and the crack face. Note that the sealer in wider cracks with an adequate reservoir (i.e., not very shallow cracks

where the material can be easily pull out), even when not routed, tend to perform quite well, as illustrated in the bottom left photo of Figure C-16. The bottom right photo shows another example of a crack manifesting adjacent to where the operator probably thought there was a thin/hairline crack.

Figure C-16 More on the condition of crack sealing observed on Hookano Street on 03/03/2016 (sealed with Roadsaver 211).

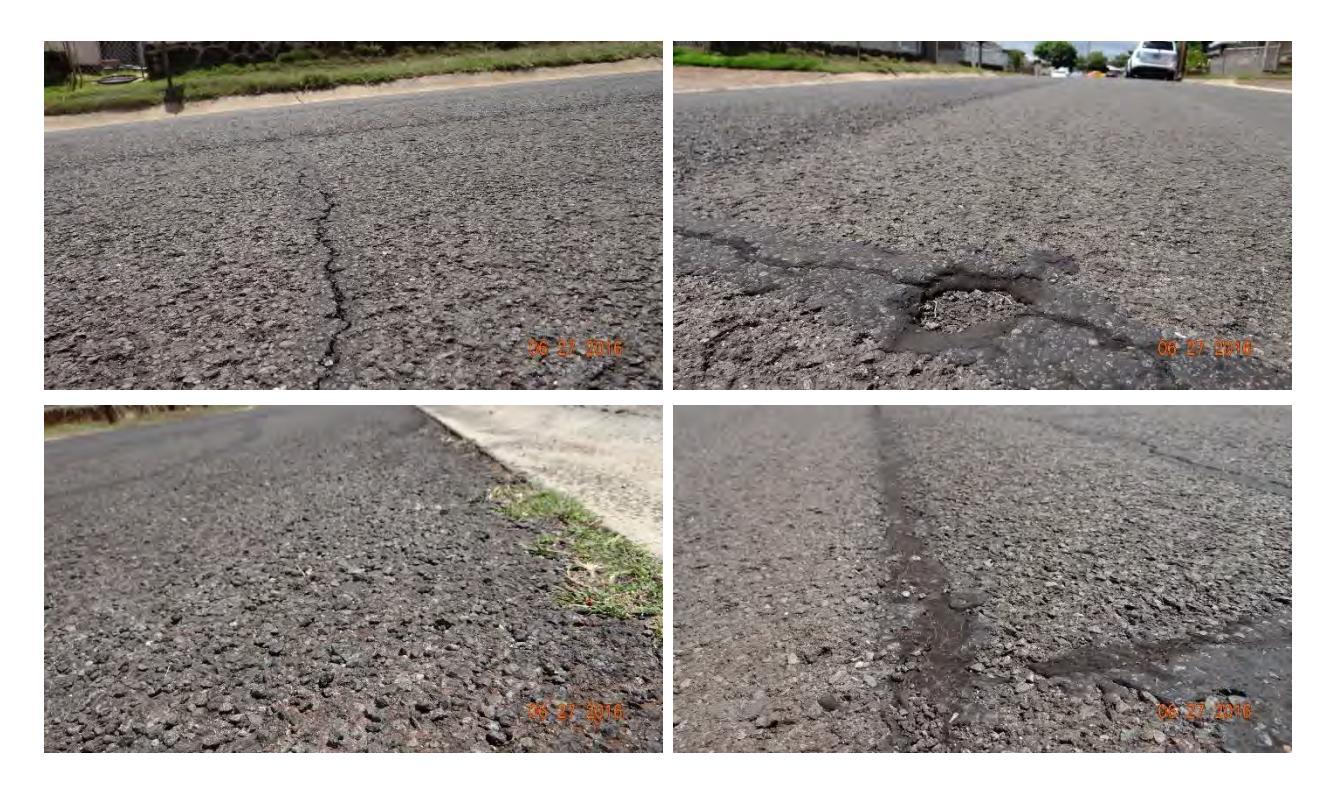
The top left photo of Figure C-17 shows another example of a crack where the sealant is not performing its function after only a year and half. Note that the overband appears worn out and the crack is exposed. In most of these cases, the cracks were originally thin when sealed and they widen afterwards. The top right photo shows a crack that is for the most part still sealed but with a circular defect where the sealant had been lost. This is likely related to tracking combined with a dirty interface. Given the large area of the defect, even with a clean interface, it would be difficult to avoid the sealer been pulled out of the crack. The two photos at the bottom of the figure show again the substantial raveling in this section. This may have prevented good bonding of the sealant at the joint, as manifested by the vegetation growth seen on the photo on the left.

Figure C-17 Condition of crack sealing observed on Hookano Street on 06/27/2016 (sealed with Roadsaver 211).

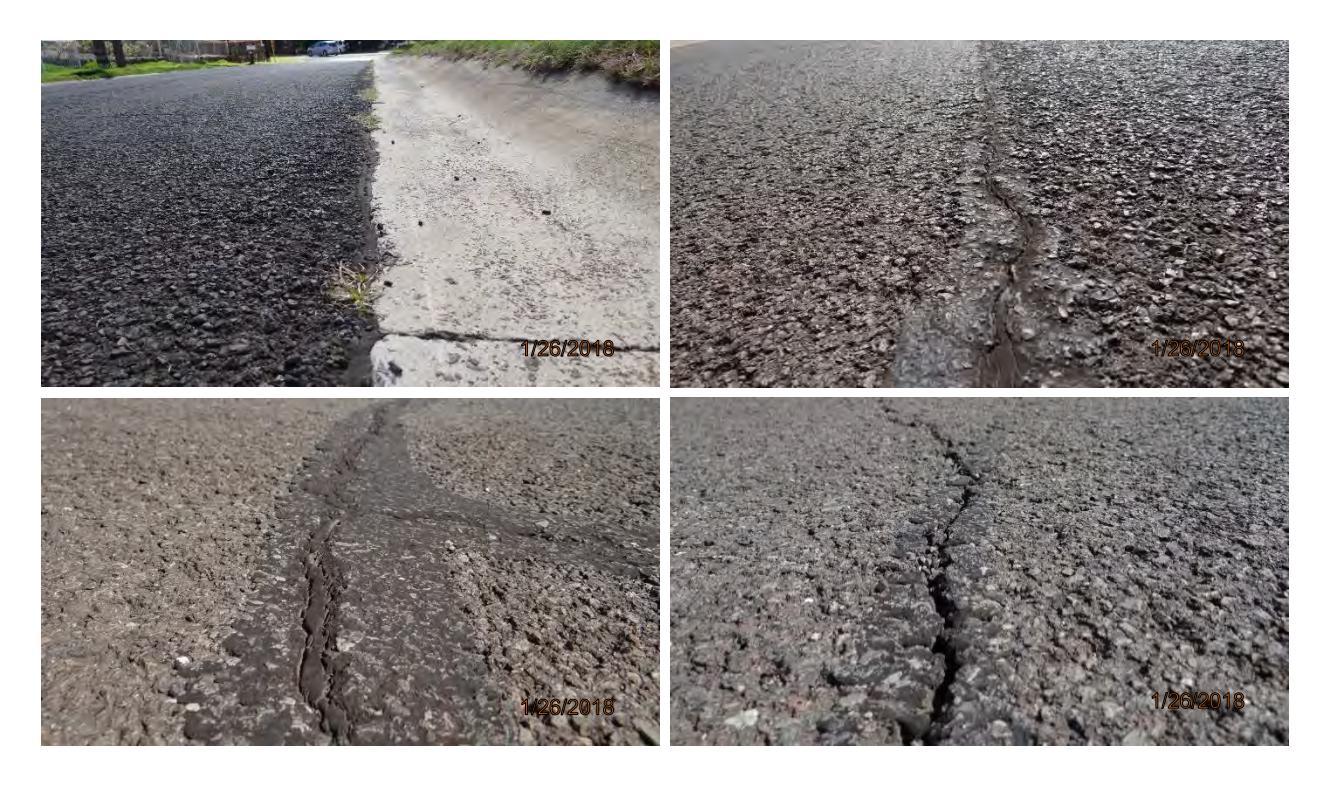
The top left photo in Figure C-18 shows that in places where the sealant at the gutter joint had stayed in place, no vegetation is observed and thus there is no ingress of water into the pavement through the joint. Still, several spots with vegetation growth are seen. As indicated before, this lackluster performance may have been related to the significant raveling of the pavement surface (easily dislodged aggregates leave part of the sealant exposed) together with the tracking produced by parking operations. The other photos in Figure C-18 and in Figure C-19 provide further illustrations of the performance issues about thin cracks that were not routed.

Figure C-18 Condition of crack sealing observed on Hookano Street on 01/26/2018 (sealed with Roadsaver 211).

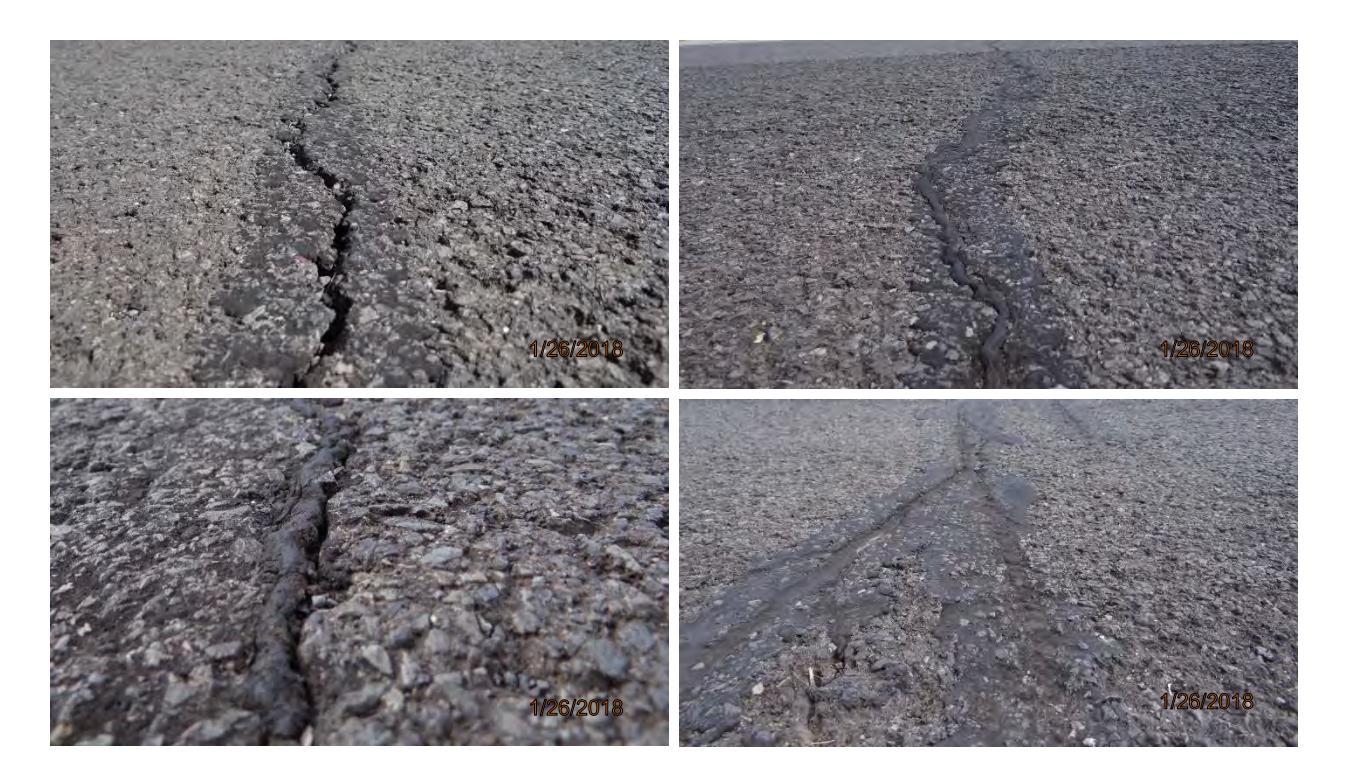
Figure C-19 Condition of crack sealing observed on Hookano Street on 01/26/2018 (sealed with Roadsaver 211).

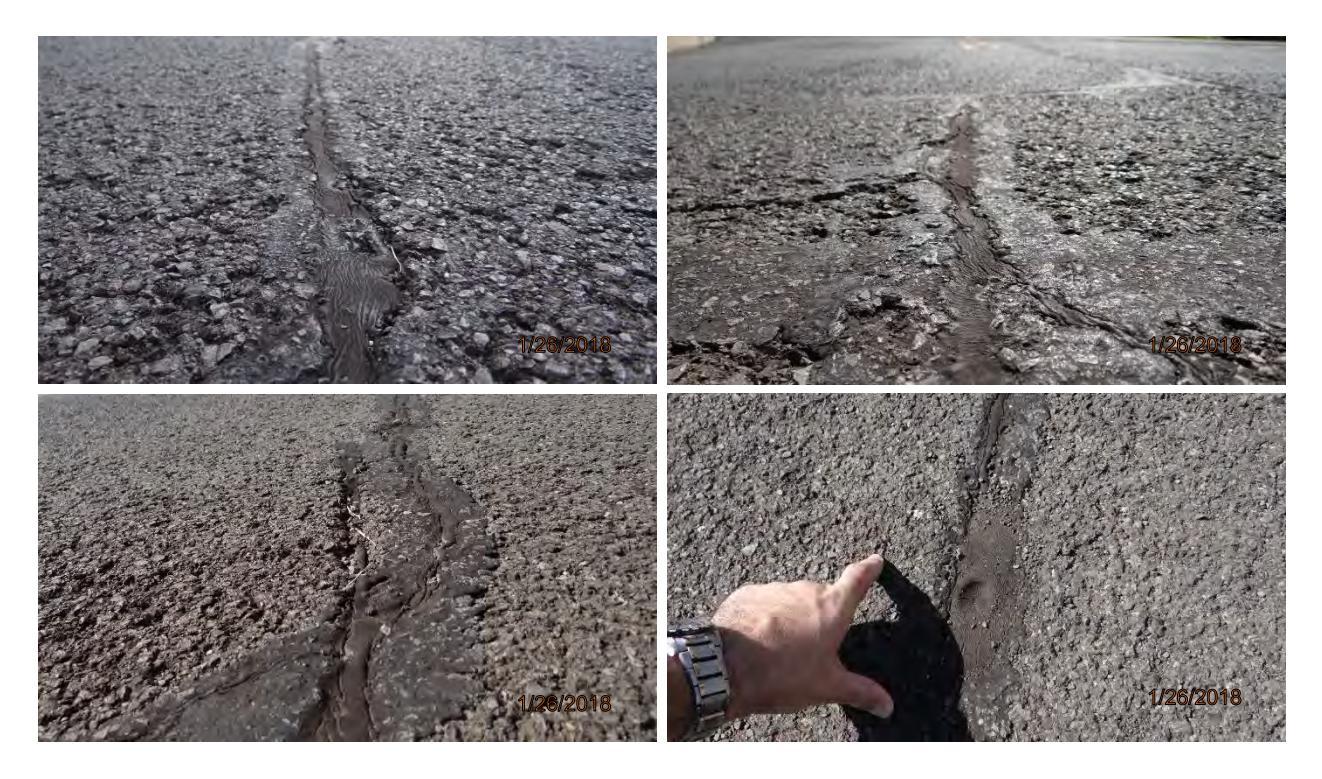
Figure C-20 shows that in the cracks that were routed and/or were wide enough when sealed, the sealant is still performing well. Although on occasion one may find an example like the one in the bottom left photo, where part of the sealant had been lost, for the most part the sealant on routed or wide cracks was performing quite well after three years. As for the other crack-sealed straight section, the binder is still soft to the touch after three years (see the finger indentation in the bottom right photo).

Figure C-20 Condition of crack sealing observed on Hookano Street on 01/26/2018 (sealed with Roadsaver 211).

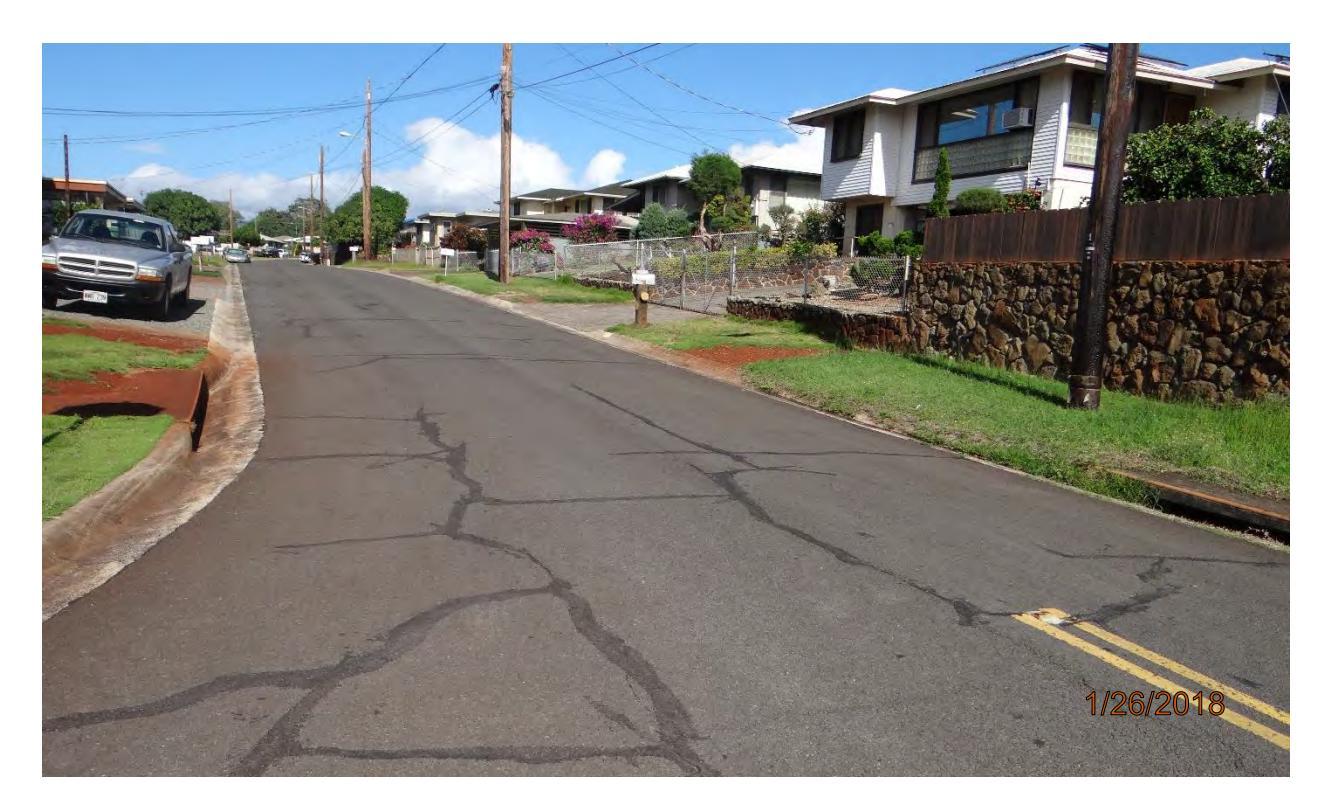
Figure C-21 provides an overall view of the section about three years after having been crack sealed.

Figure C-21 Condition of crack sealing observed on Hookano Street on 01/26/2018 (sealed with Roadsaver 211).

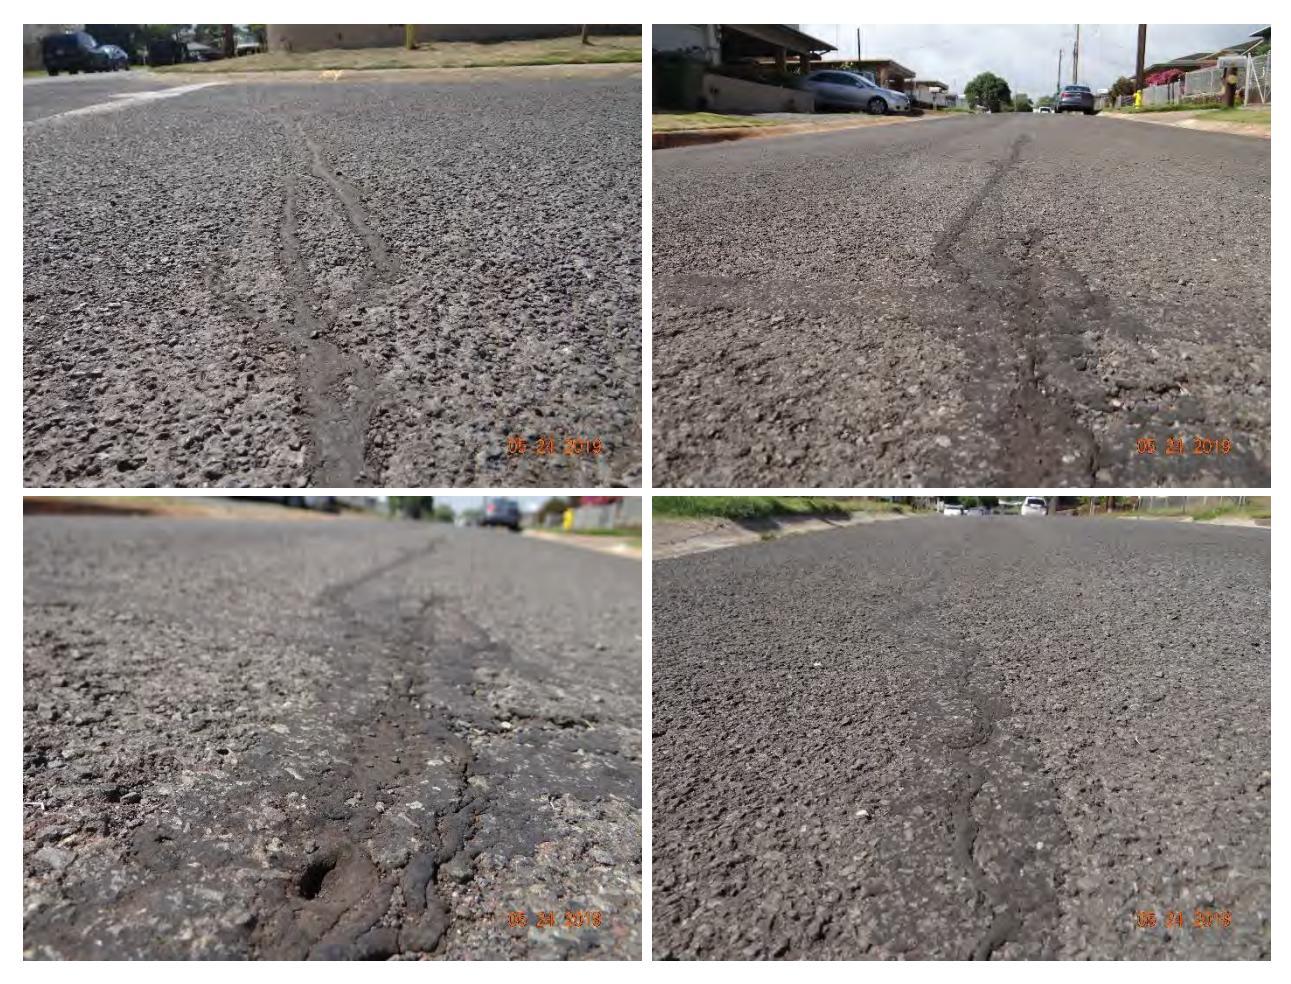
Finally, Figure C-22 shows that as of 5/24/2019, 4.5 years after the cracks were seal, the sealer is still performing well. Note again how it can still be indented.

Figure C-22 Condition of crack sealing observed on Hookano Street on 5/24/2019 (sealed with Roadsaver 211).

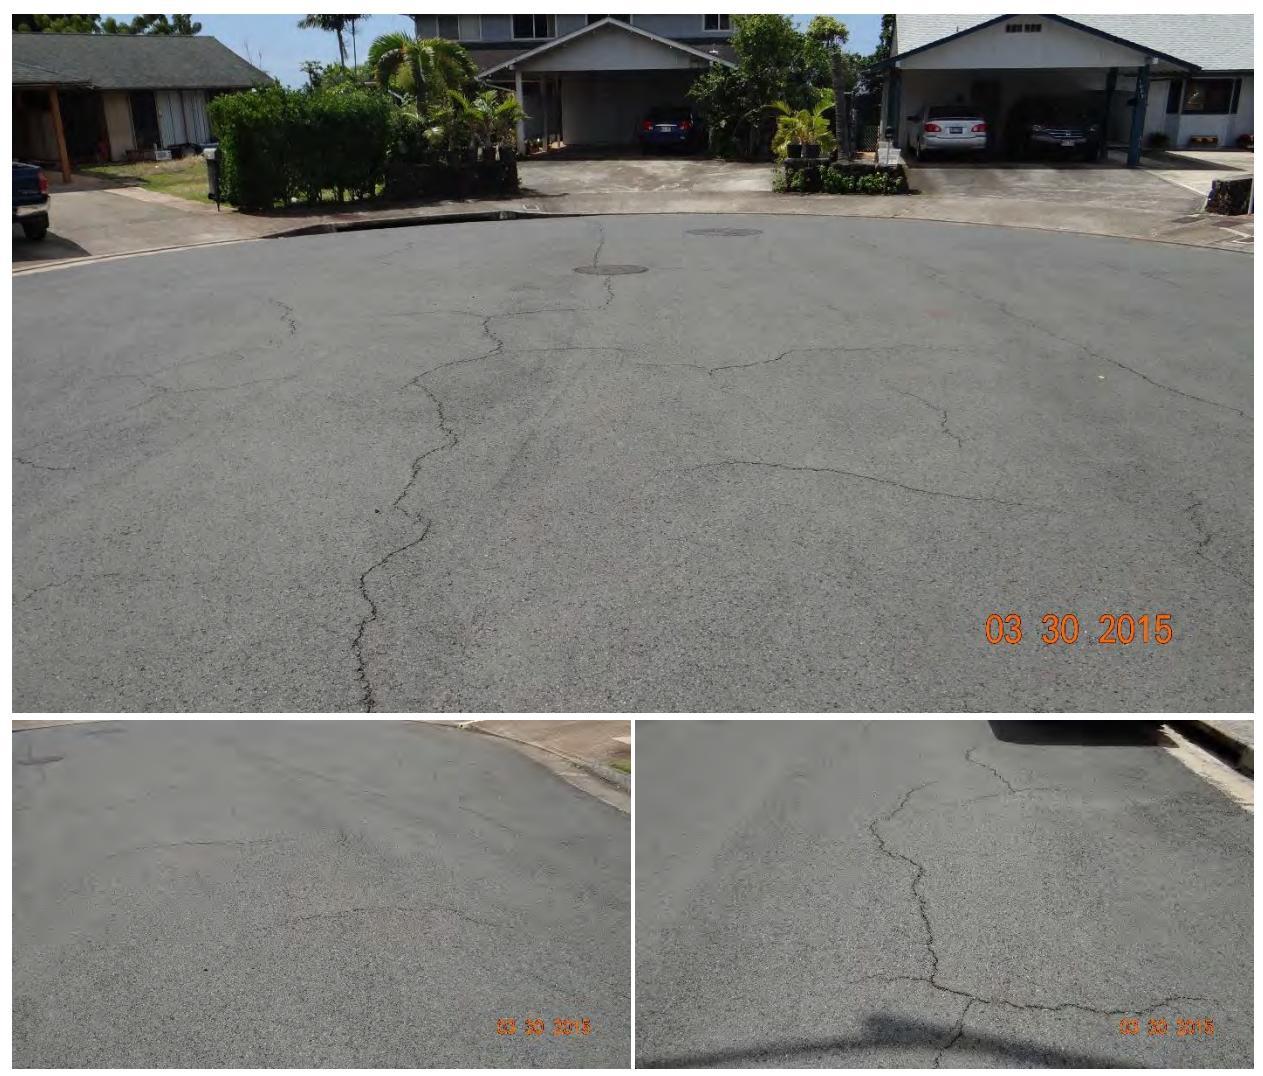
Figure C-23 shows the condition of this section near the beginning of the study. Cracking was composed mostly of large blocks (block cracking) with some of the cracks accompanying the curvature of the cul-de-sac. This pattern is typical of what was observed in all cul-de-sacs included in the study. As shown in Figure C-24, little had changed after more than a year (which is also a reflection of the slight increase in cracking noted on Figure 4-7).

Figure C-23 Condition of the Palamoi Street section on 03/20/2015 (three months into the study period) used as control for crack sealing.

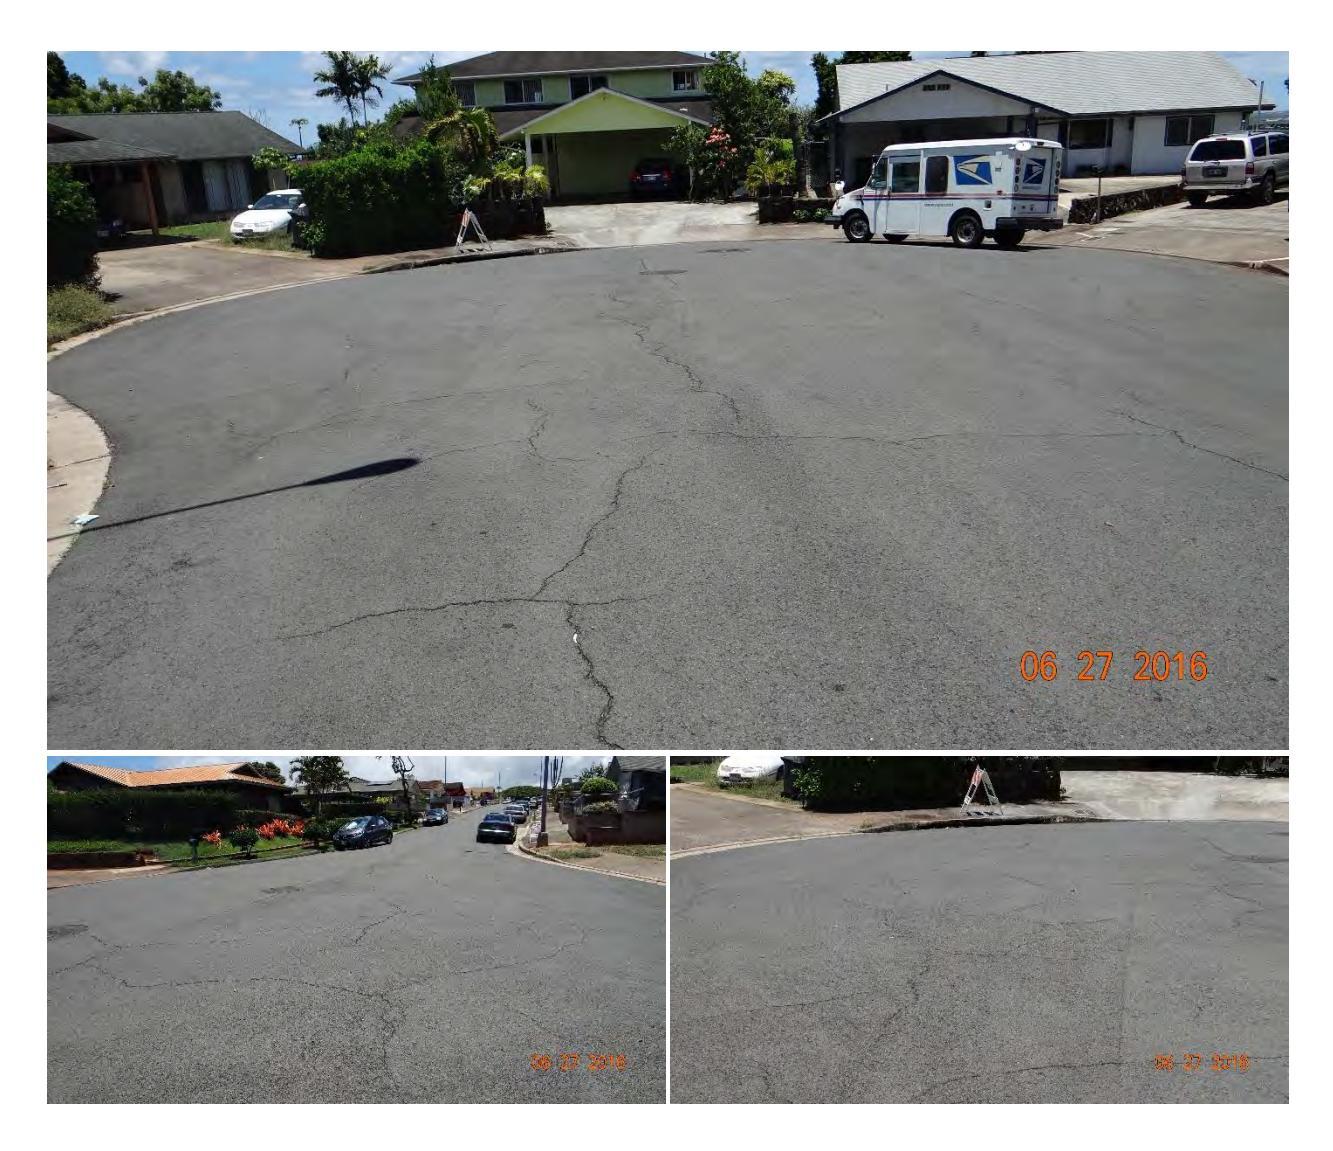
Figure C-24 Condition of the Palamoi Street section on 06/27/2016 (sixteen months into the study period) used as control for crack sealing.

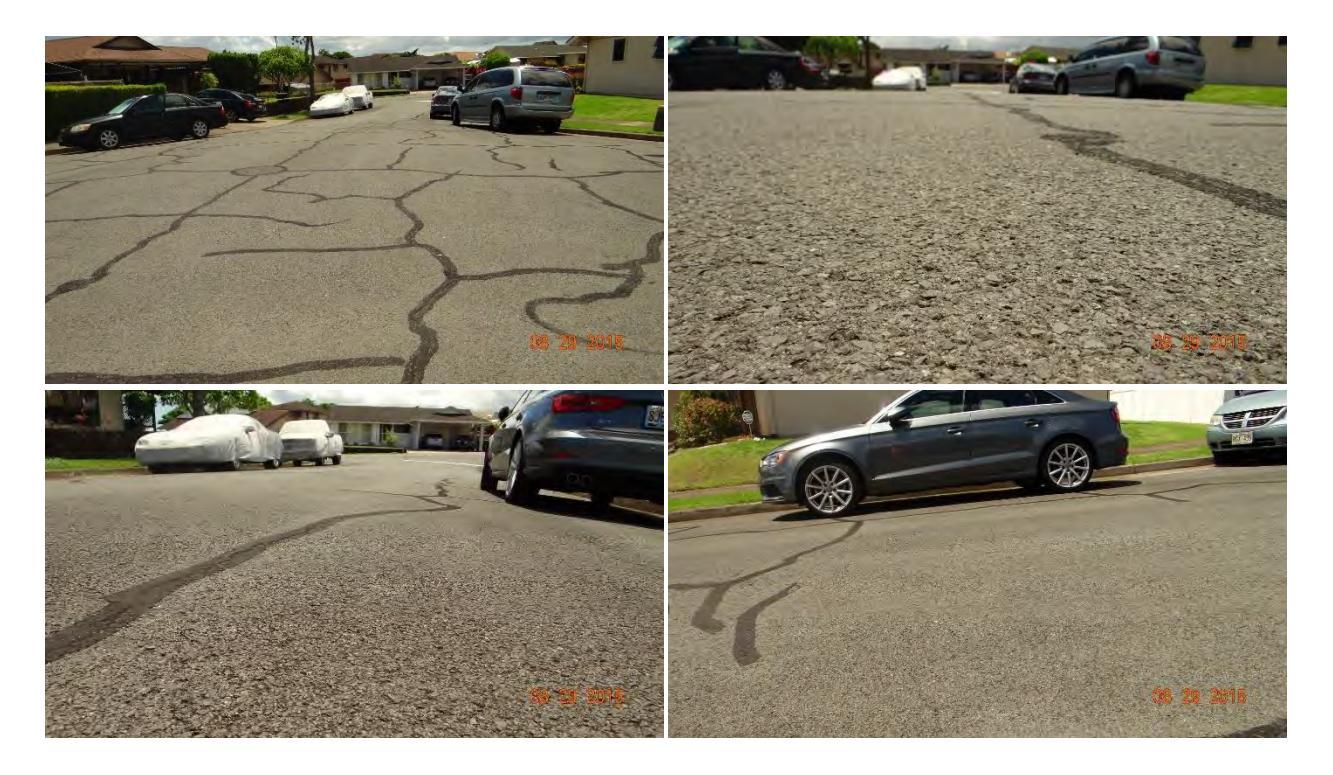
Figure C-25 shows the condition of the section on 08/29/2015, about 10 months after the crack sealing application. The top left of the figure illustrates the pattern on this section, which is quite typical of the pattern observed in other cul-de-sac sections. The other photos in the figure show that the pavement surface already had a coarse texture because of some binder and aggregate loss.

Figure C-25 Condition of the Kaweloka Place section on 08/29/2015.

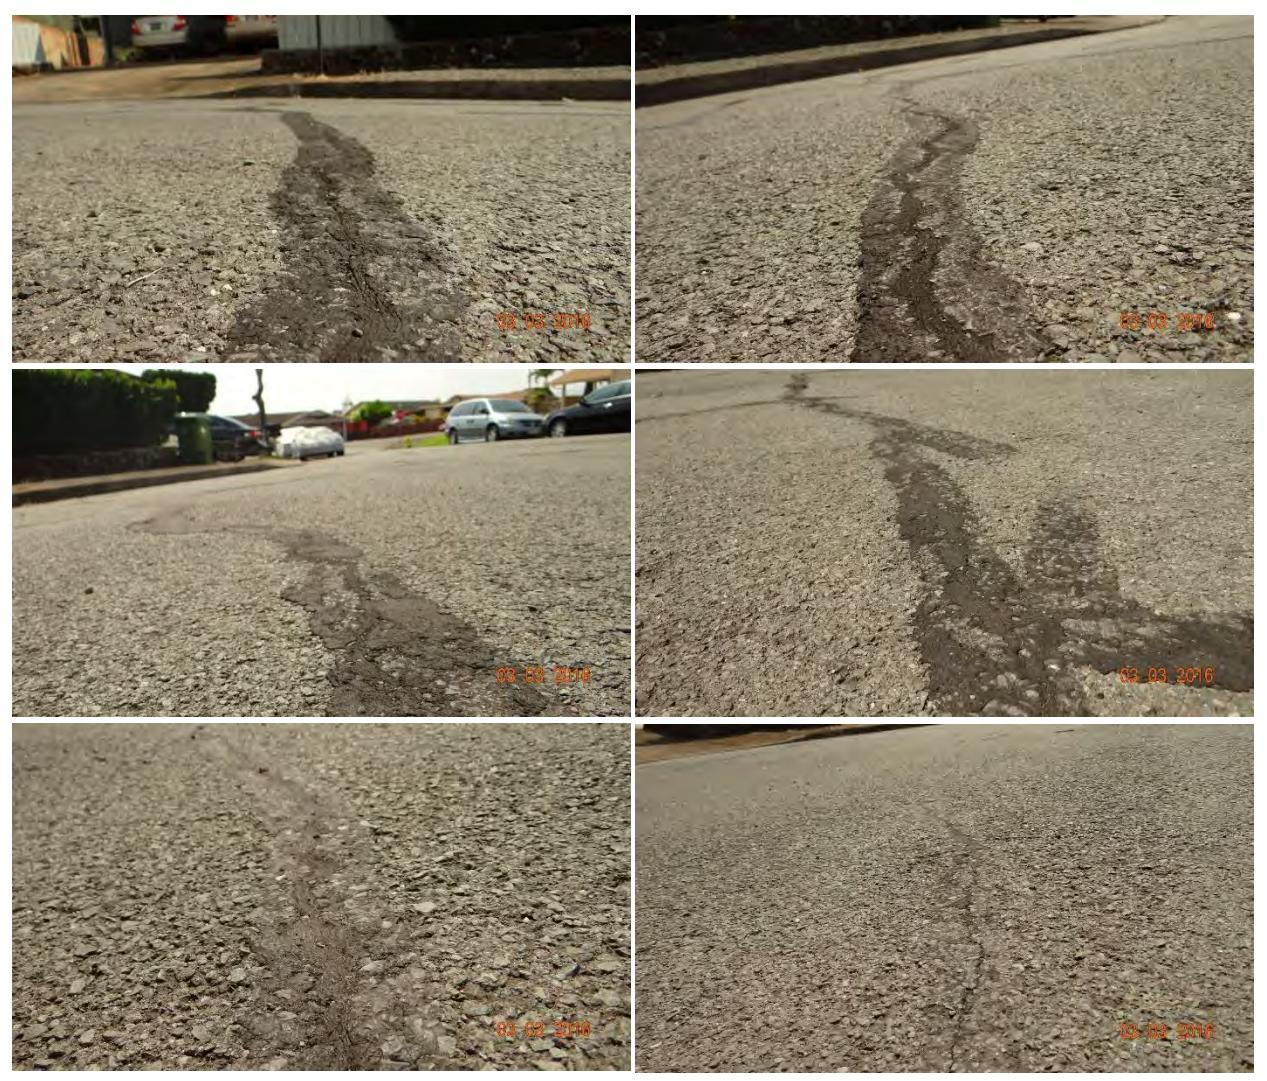
Figure C-26 and Figure C-27 show the condition of the crack sealing on 03/03/2016. These figures illustrate that the overband after about a year and four months showed significant loss of material because of tracking. This, in part, may have been helped by the coarse texture, which makes dislodging of aggregates easier and bonding of the crack sealant with the existing surface more difficult.

Figure C-26 Condition of the Kaweloka Place section on 03/03/2016.
