PERFORMANCE MONITORING OF PRESERVATION TREATMENTS IN HONOLULU

FINAL PROJECT REPORT

Adrián Ricardo Archilla University of Hawaii at Manoa

May 2019

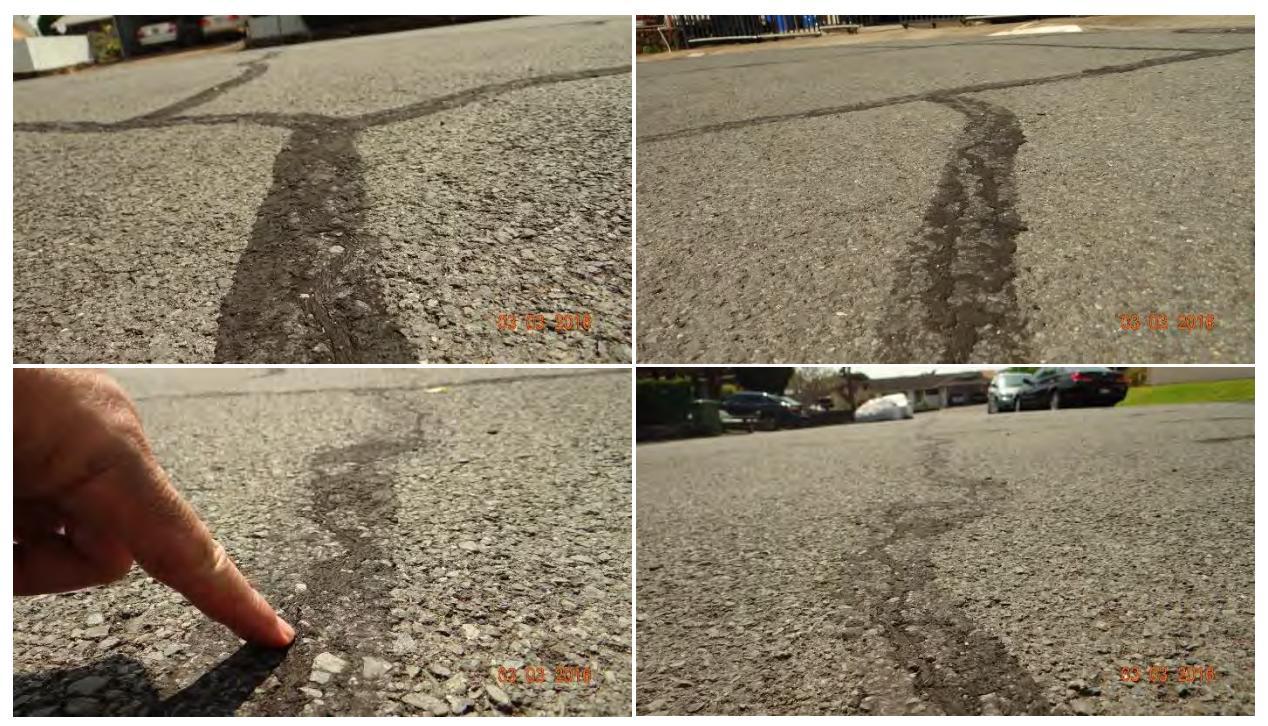
Figure C-26 and Figure C-27 show the condition of the crack sealing on 03/03/2016. These figures illustrate that the overband after about a year and four months showed significant loss of material because of tracking. This, in part, may have been helped by the coarse texture, which makes dislodging of aggregates easier and bonding of the crack sealant with the existing surface more difficult.

Figure C-27 Condition of the Kaweloka Place section on 03/03/2016.

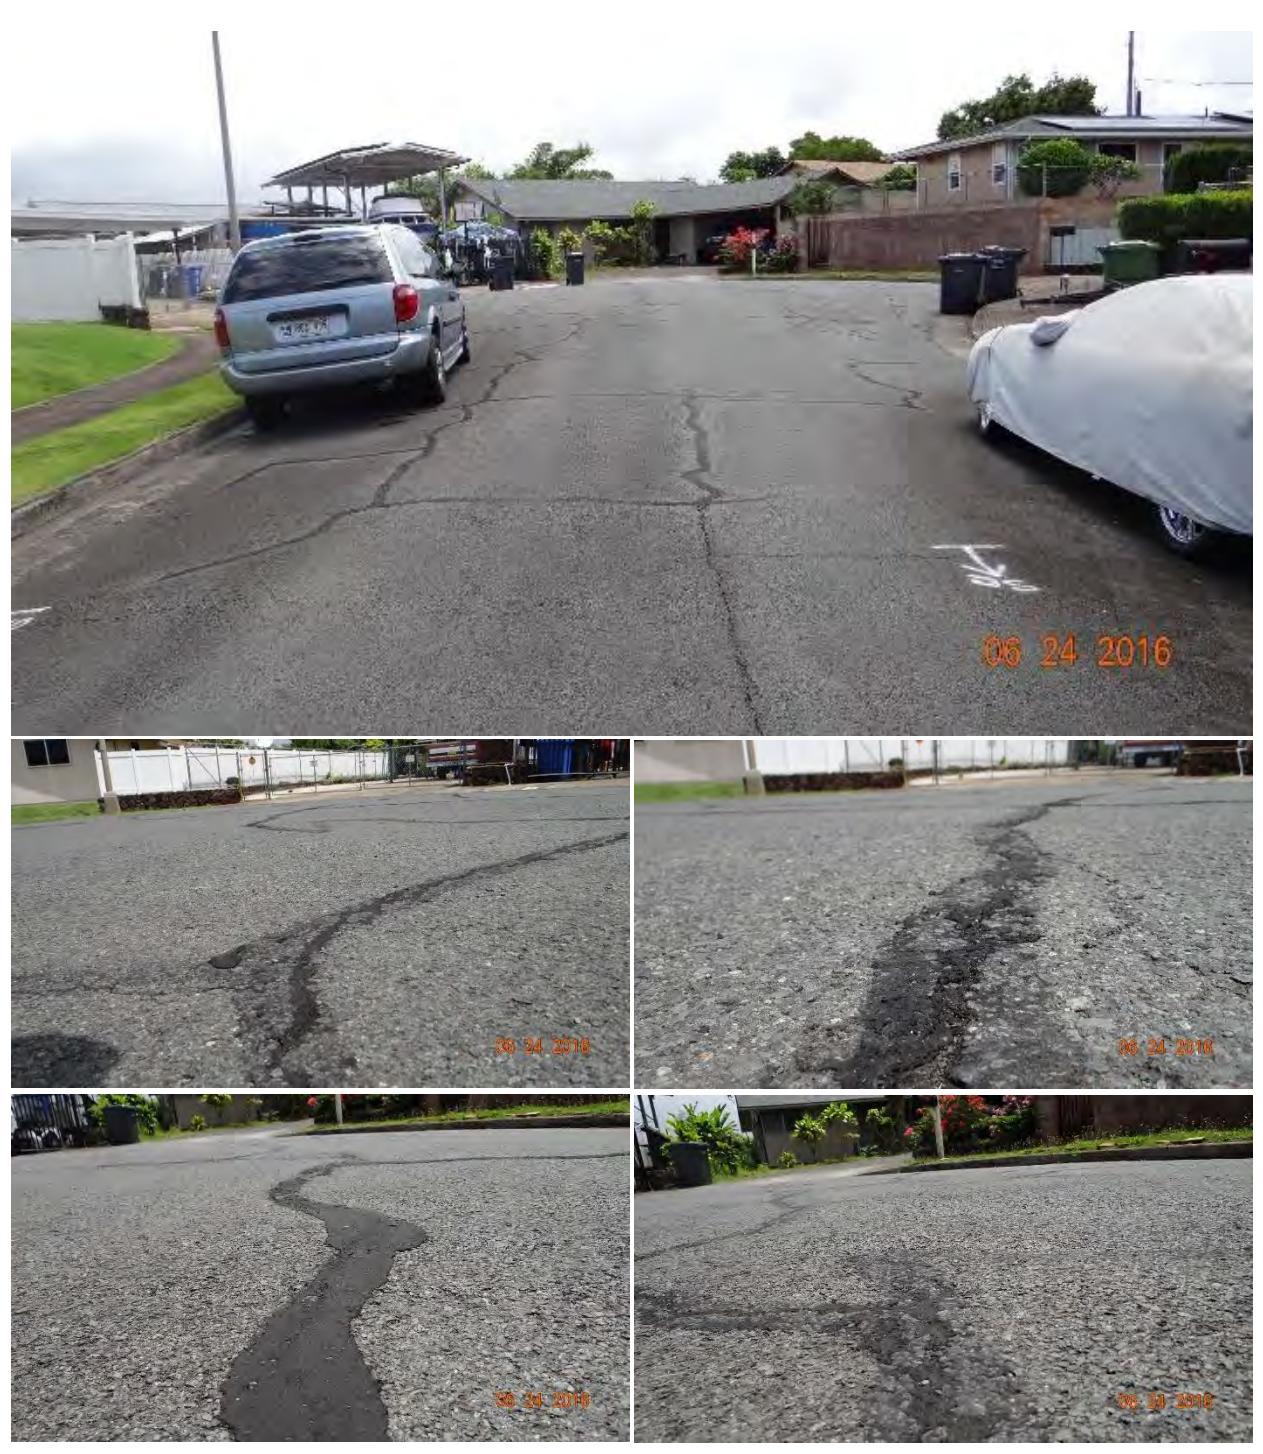
Figure C-28 and Figure C-29 show little change four months later, but it is also clear that the overband material was barely visible in some cracks. Also, as shown on the top right photo in Figure C-29, some low severity cracks were exposed either because of straining of the sealer or its complete loss inside the crack. In this type of crack, the sealer cannot usually go too deep. Thus, the small vertical cross-sectional area available to transmit a force by adhesion of the sealer to the crack walls together with the large strains on the sealer produced by the daily crack movements facilitates the separation of the sealer with one of the walls or even cracking on the sealer.

Figure C-28 Condition of the Kaweloka Place section on 06/24/2016.

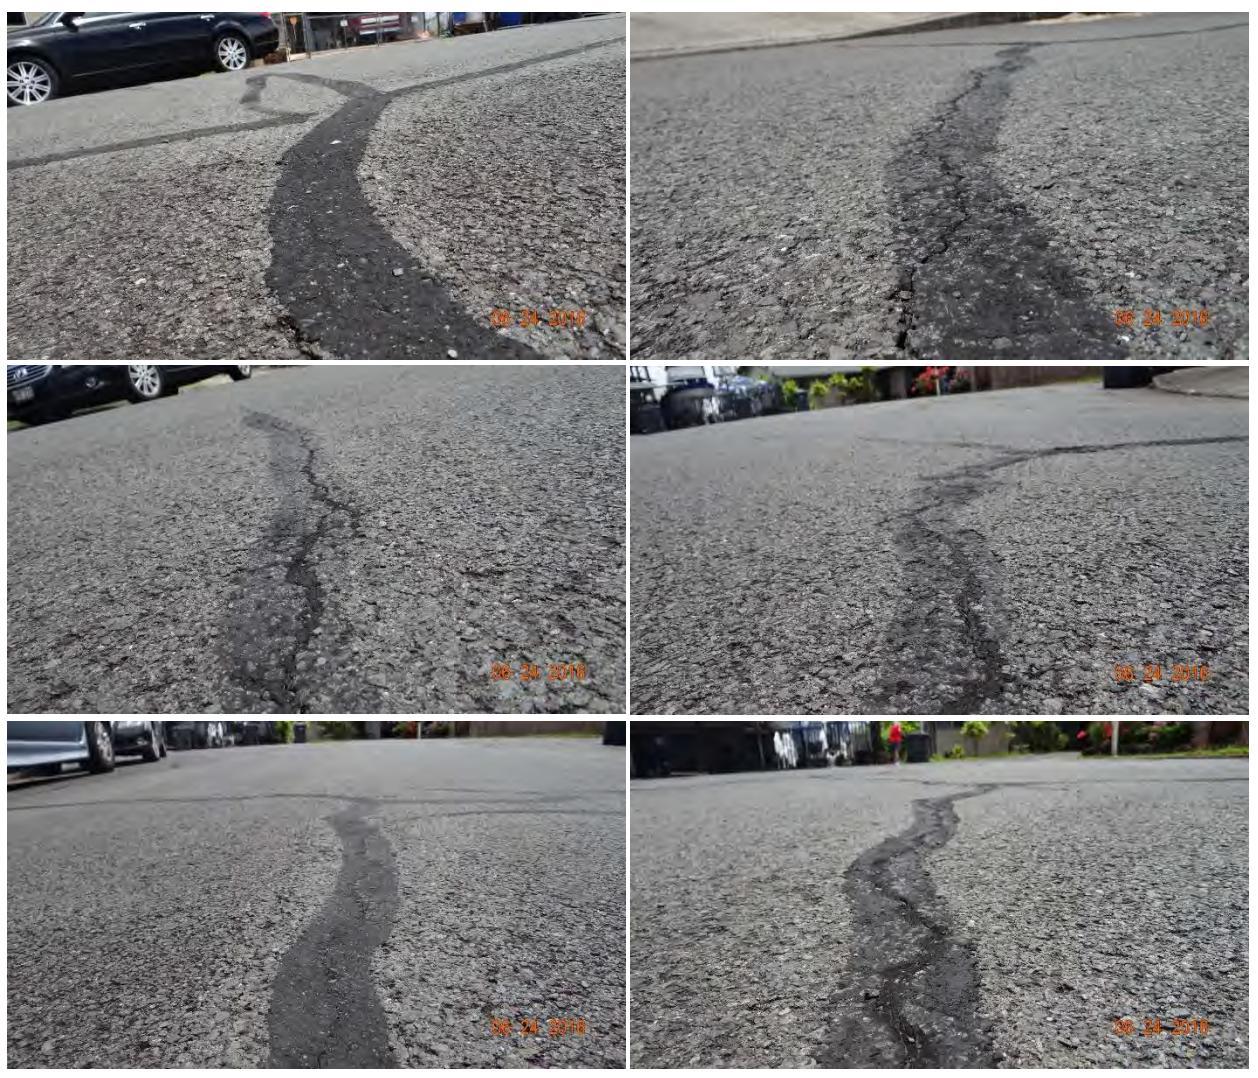
Figure C-29 Condition of the Kaweloka Place section on 06/24/2016.

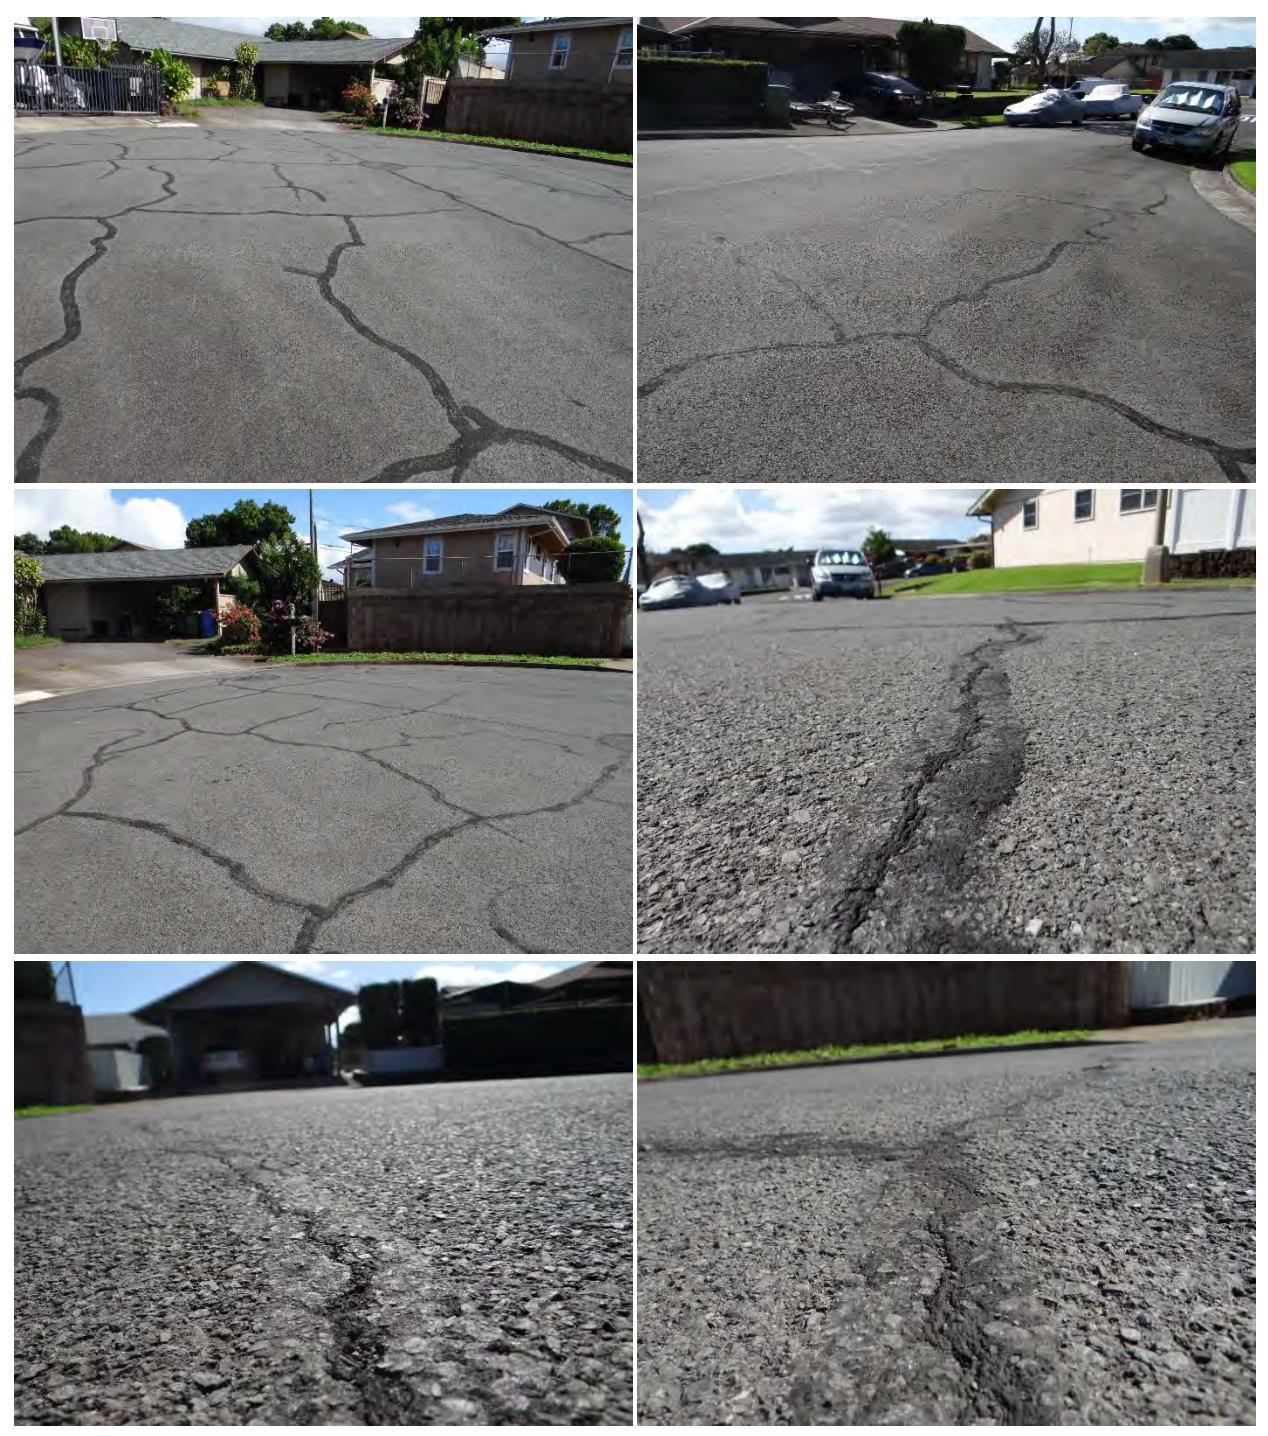
As shown in Figure C-30 through Figure C-32, by December of 2016 (six month later) the conditions were again very similar (which is consistent with the cracking progression shown in Figure 4-8).

Figure C-30 Condition of the Kaweloka Place section on 12/14/2016.

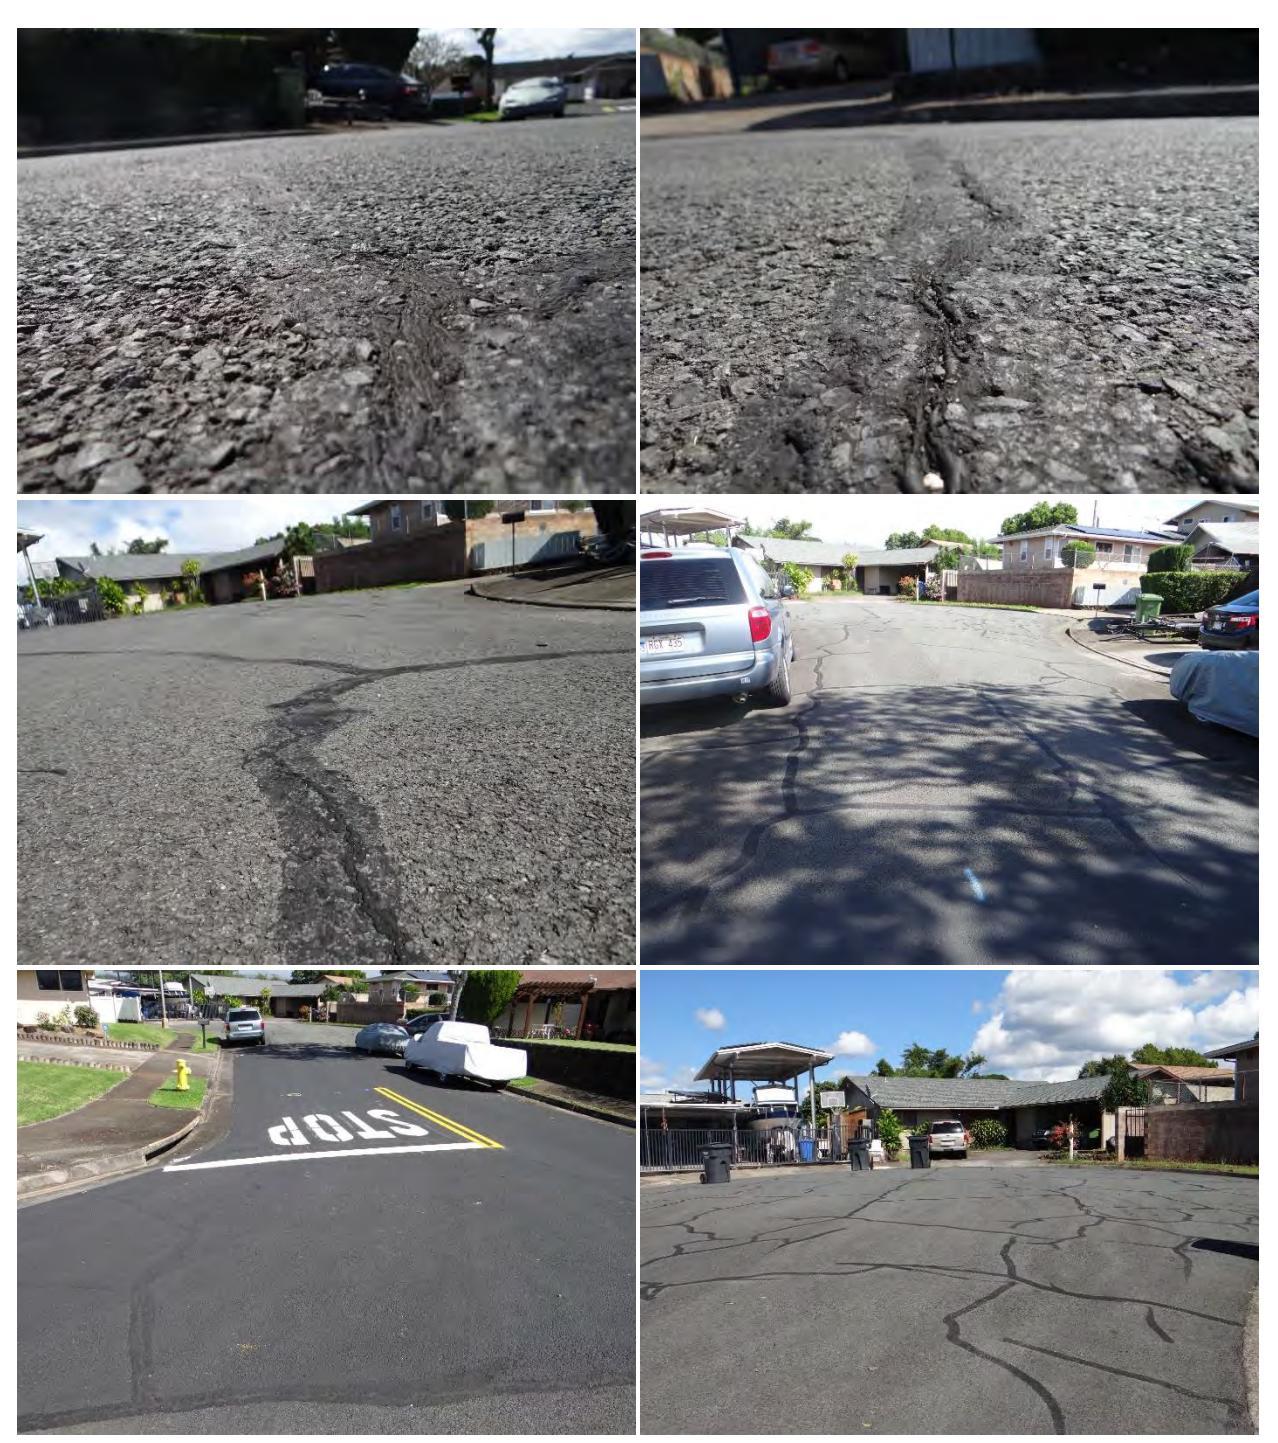
Figure C-31 Condition of the Kaweloka Place section on 12/14/2016.

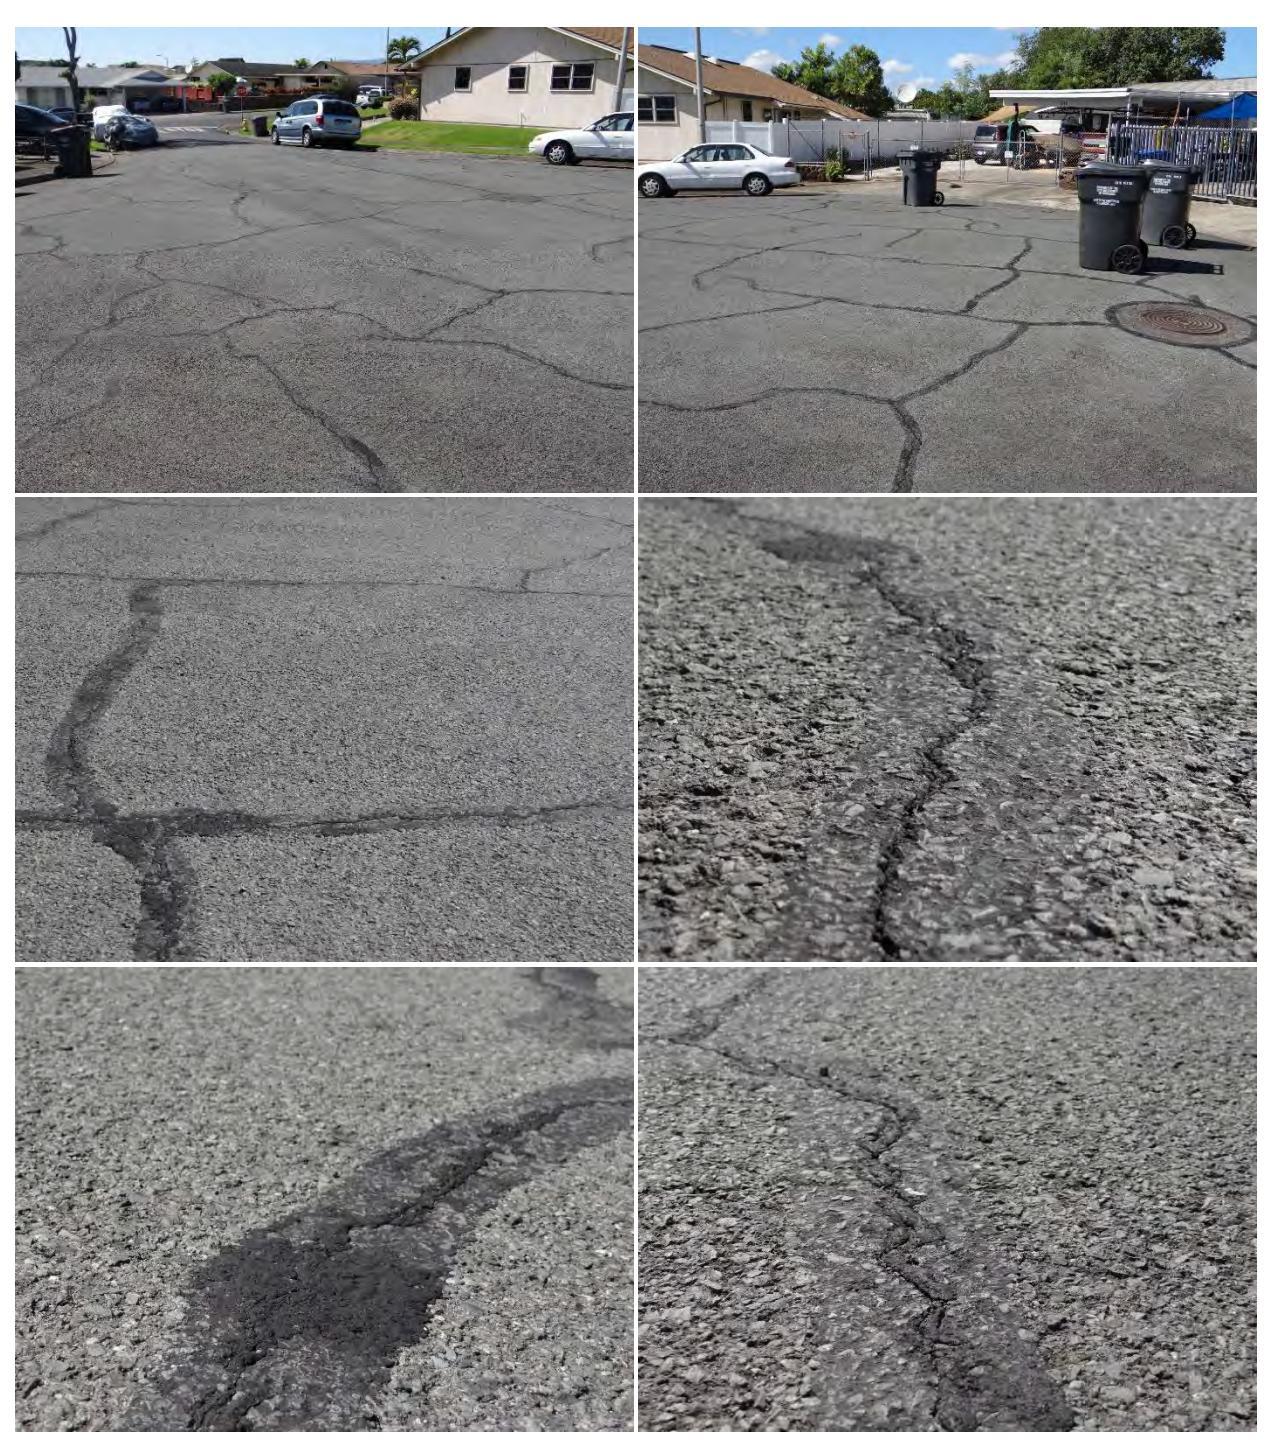
Figure C-32 Condition of the Kaweloka Place section on 01/26/2018.

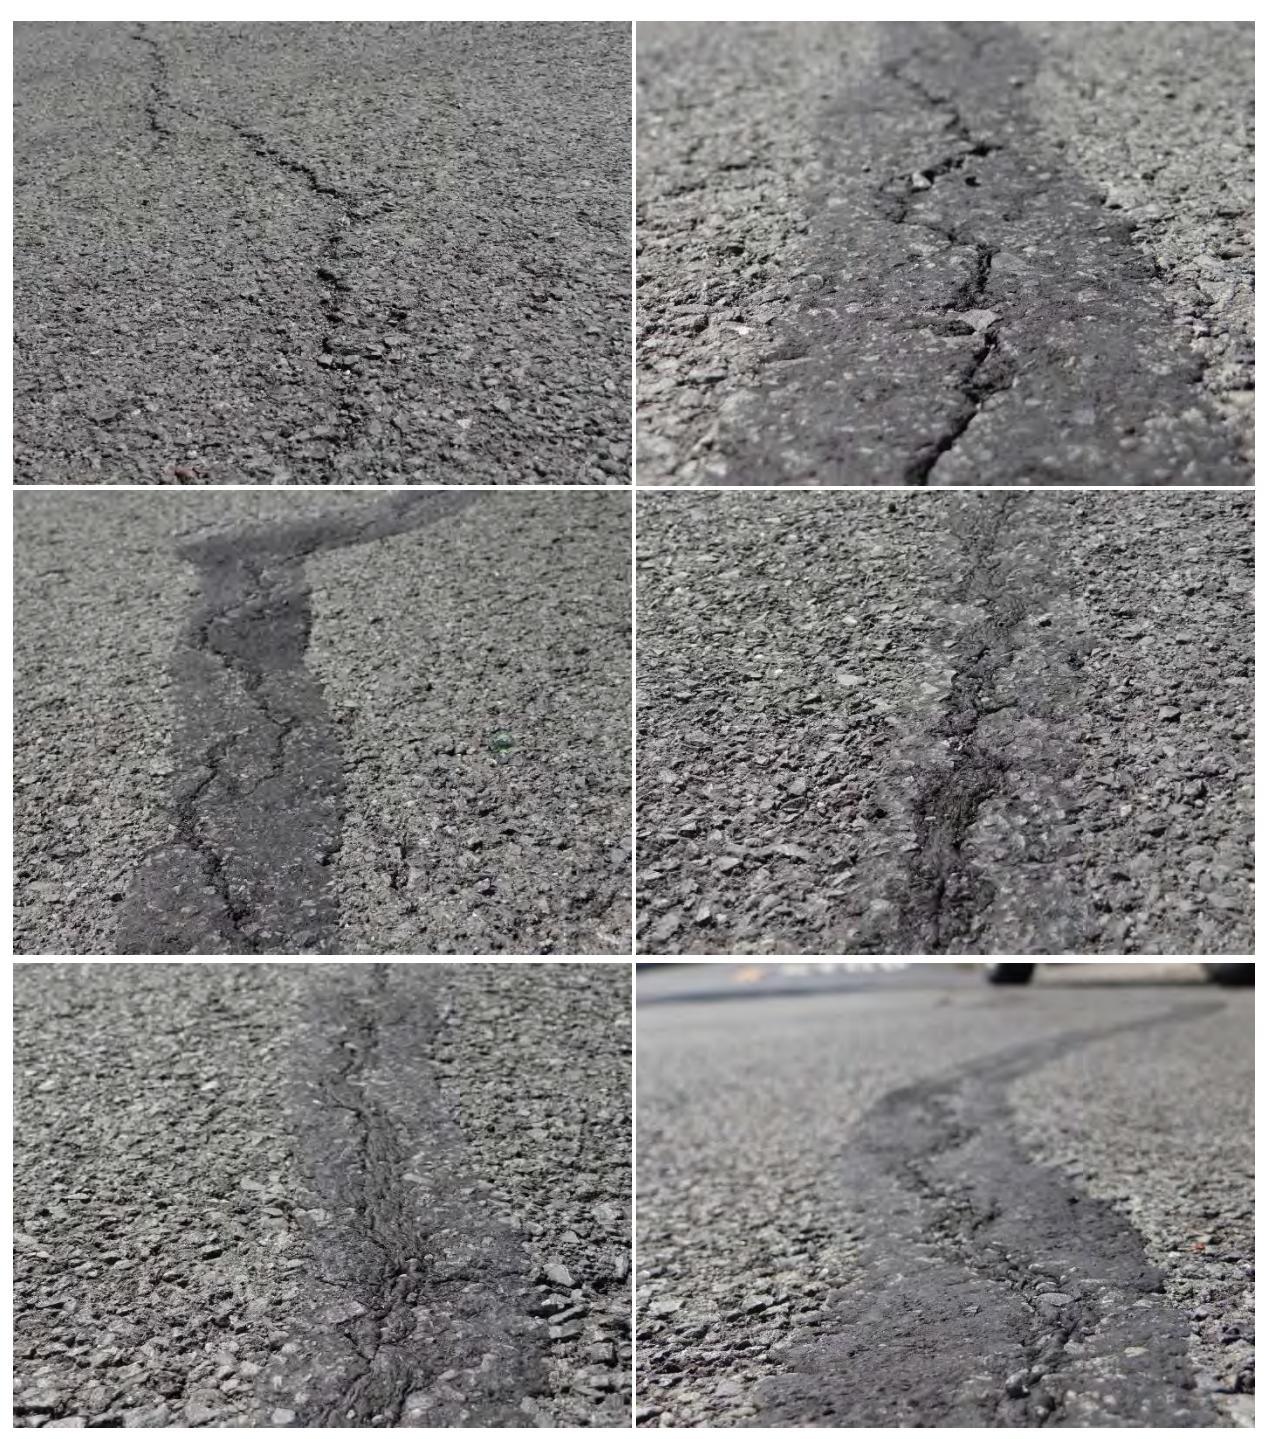
Figure C-33 and Figure C-34 show the condition after 14 additional months (January 2018). Figure C-33 shows, consistently with the trend shown in Figure 4-8, some additional cracking (top left). There are also thin cracks with hardly any sealer on them (top right and mid left). The other photos show cracks with the sealer exhibiting a considerable wrinkled surface and with loose aggregate incrustations into the sealer. Nevertheless, the sealer may still be helping to reduce the amount of water infiltration. Figure C-34 provides a view of the condition of the section in January 2018, more than 3 years after the treatment application.

Figure C-33 Condition of the Kaweloka Place section on 01/26/2018.

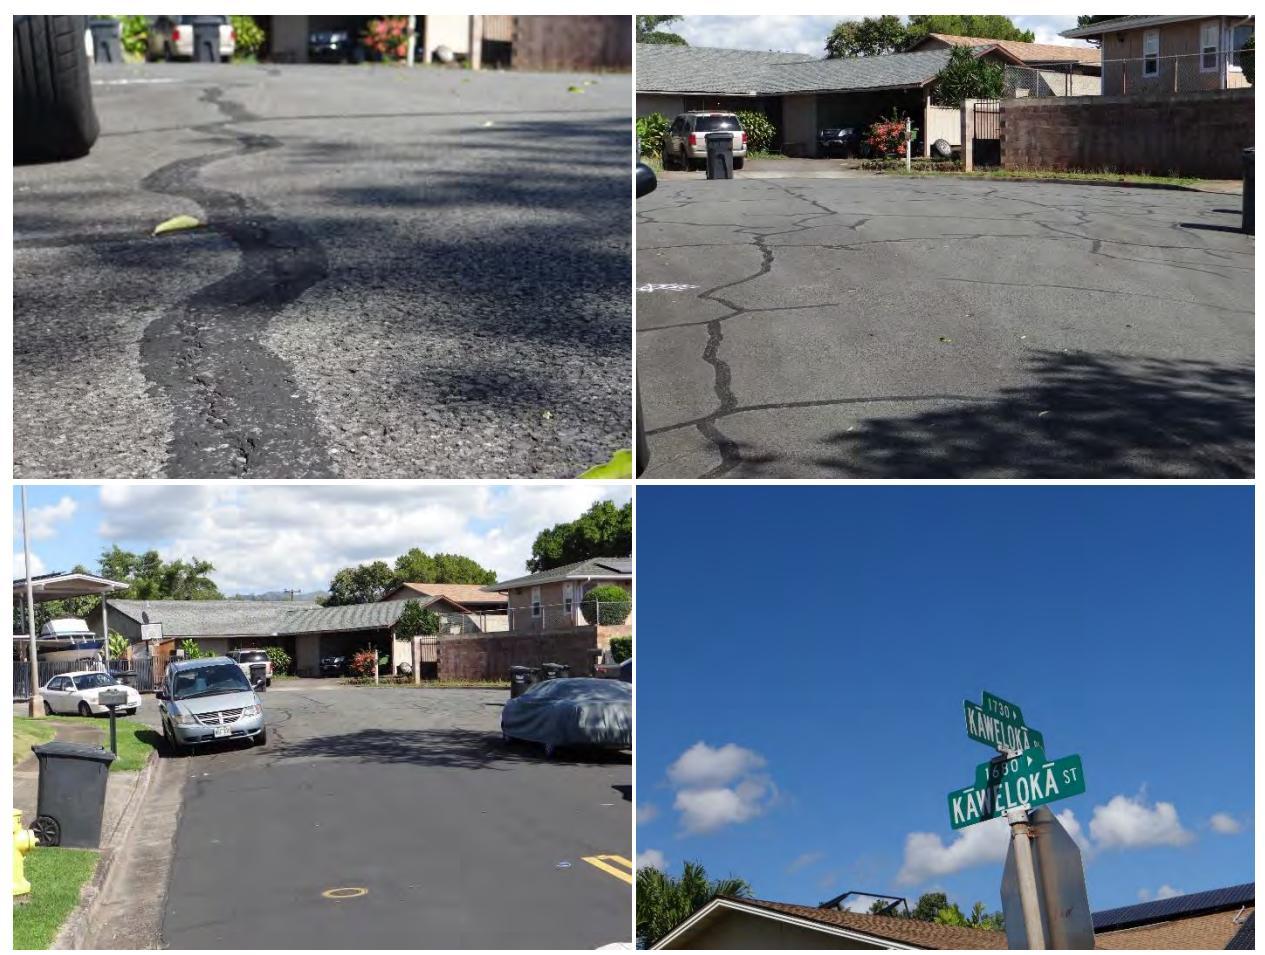
Figure C-34 Condition of the Kaweloka Place section on 01/26/2018.

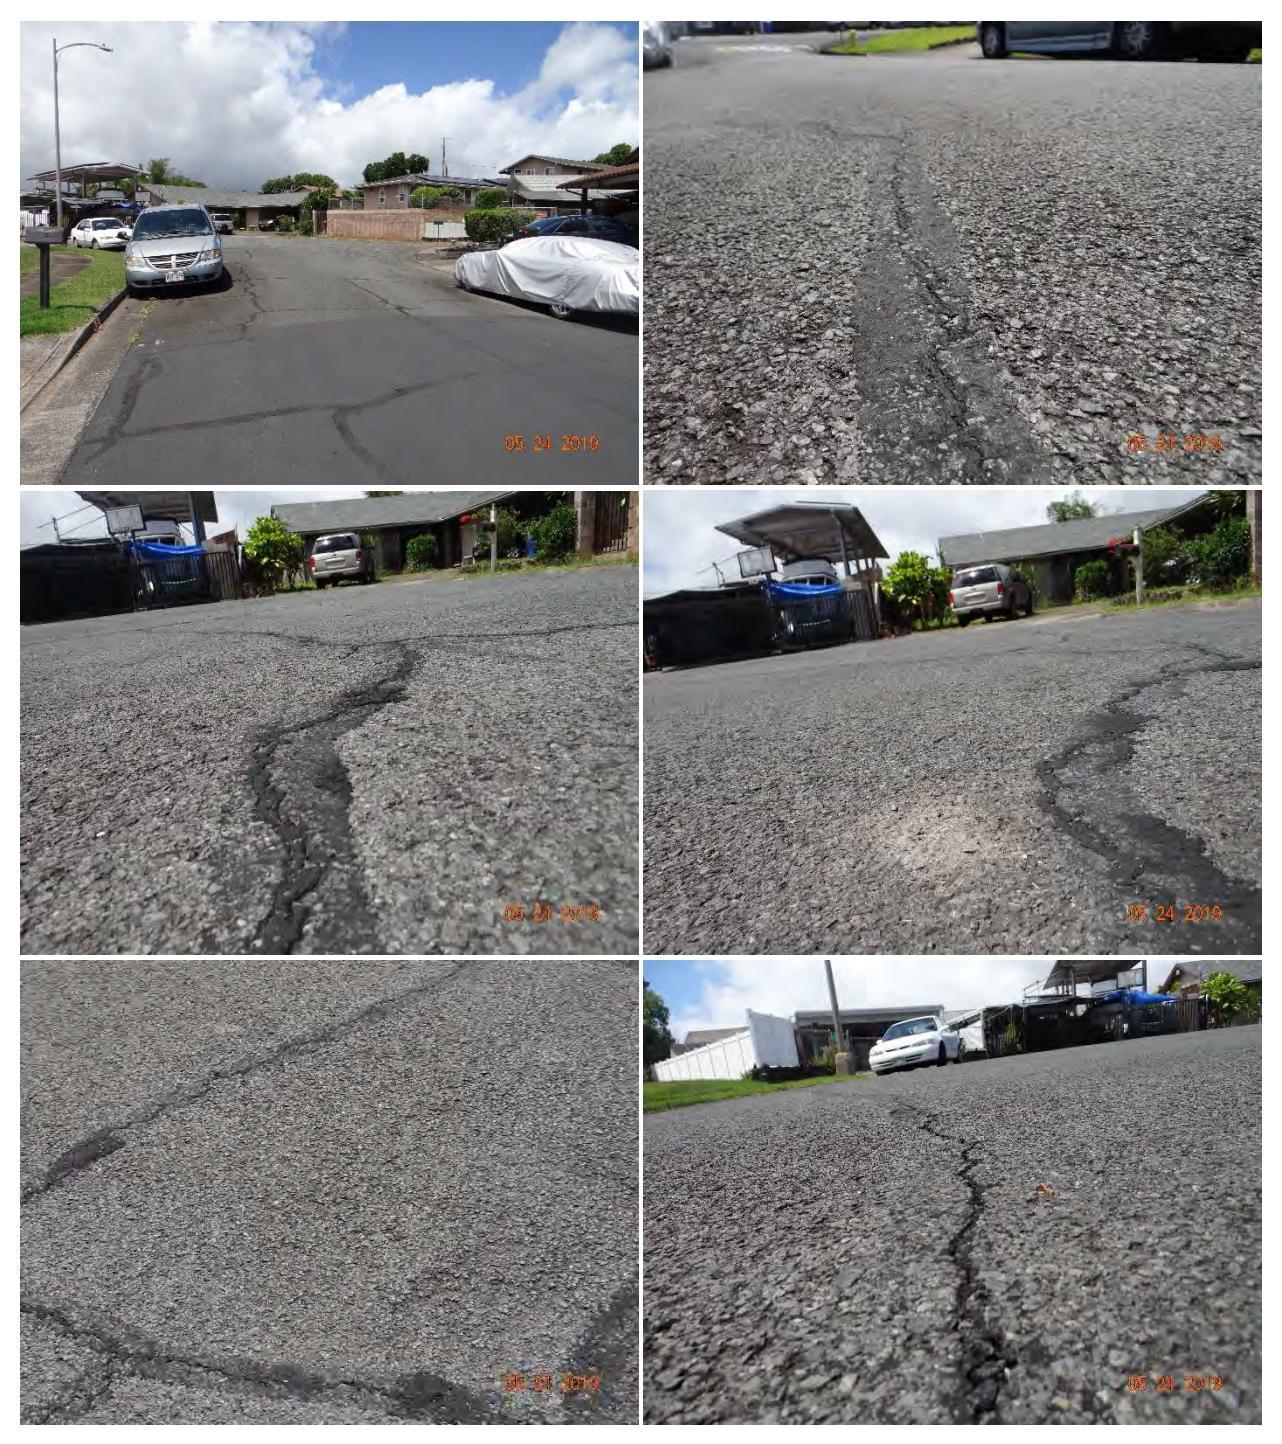
Finally, Figure C-35 shows the conditions on 5/24/2019. No significant changes were observed.

Figure C-35 Condition of the Kaweloka Place section on 5/24/2019.

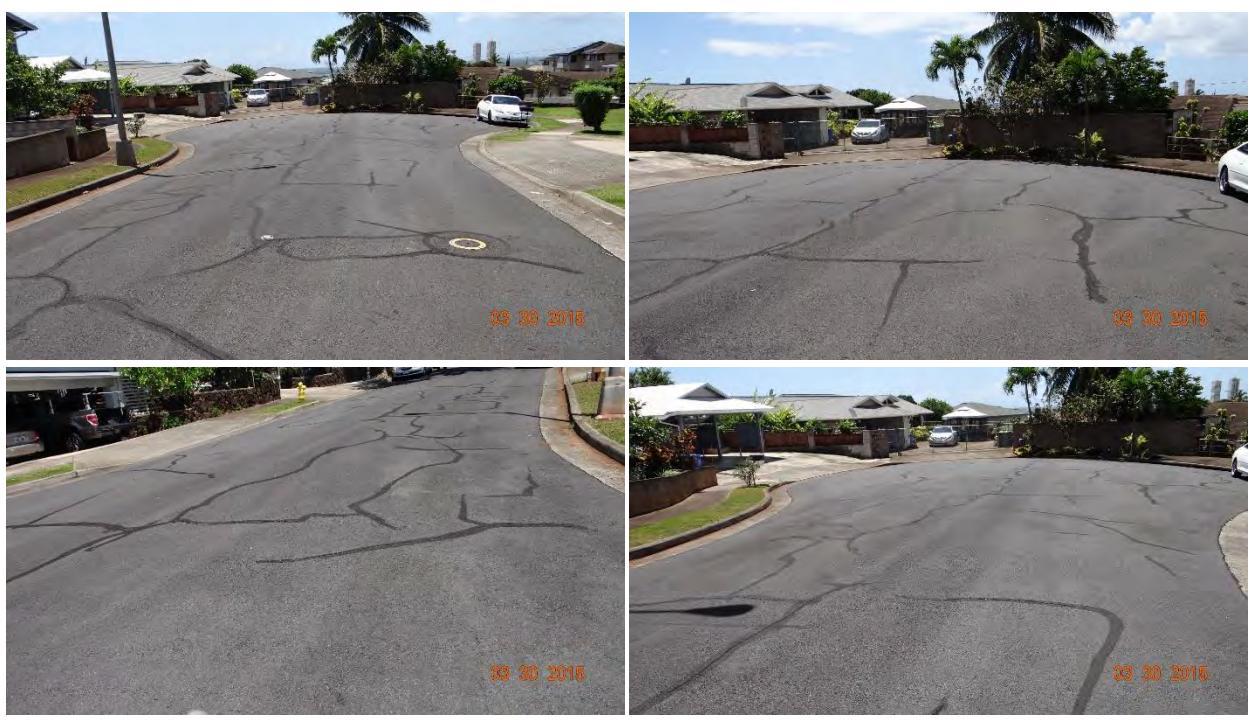
Figure C-36 and Figure C-37 show the condition of the section on 03/30/2015, about 4 months after the crack sealing application on 11/19/2014. Figure C-36 shows that the pattern on this section conforms to the typical pattern observed in other cul-de-sac sections, with a crack running mostly longitudinally near the centerline and blocks radiating from it and becoming approximately parallel to the curves of the cul-de-sac. Clearly, the cracking appears to be for the most part environmentally related.

Figure C-36 Condition of the Paaaina Place section on 03/30/2015.

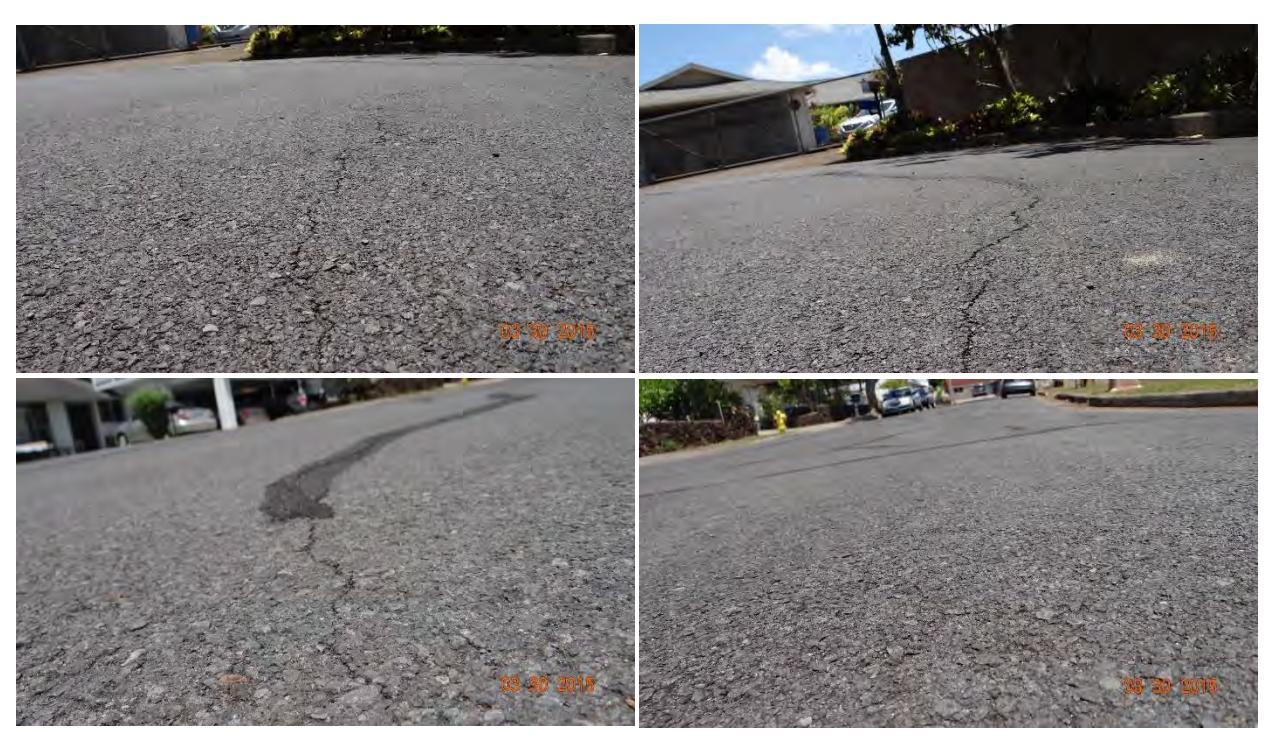
Figure C-37 shows the texture of the surface, where some loss of aggregates and mastic is noted (note the loose aggregates in the top photos). Some unsealed thin cracks are also seen in these photos.

Figure C-37 Condition of the Paaaina Place section on 03/30/2015.

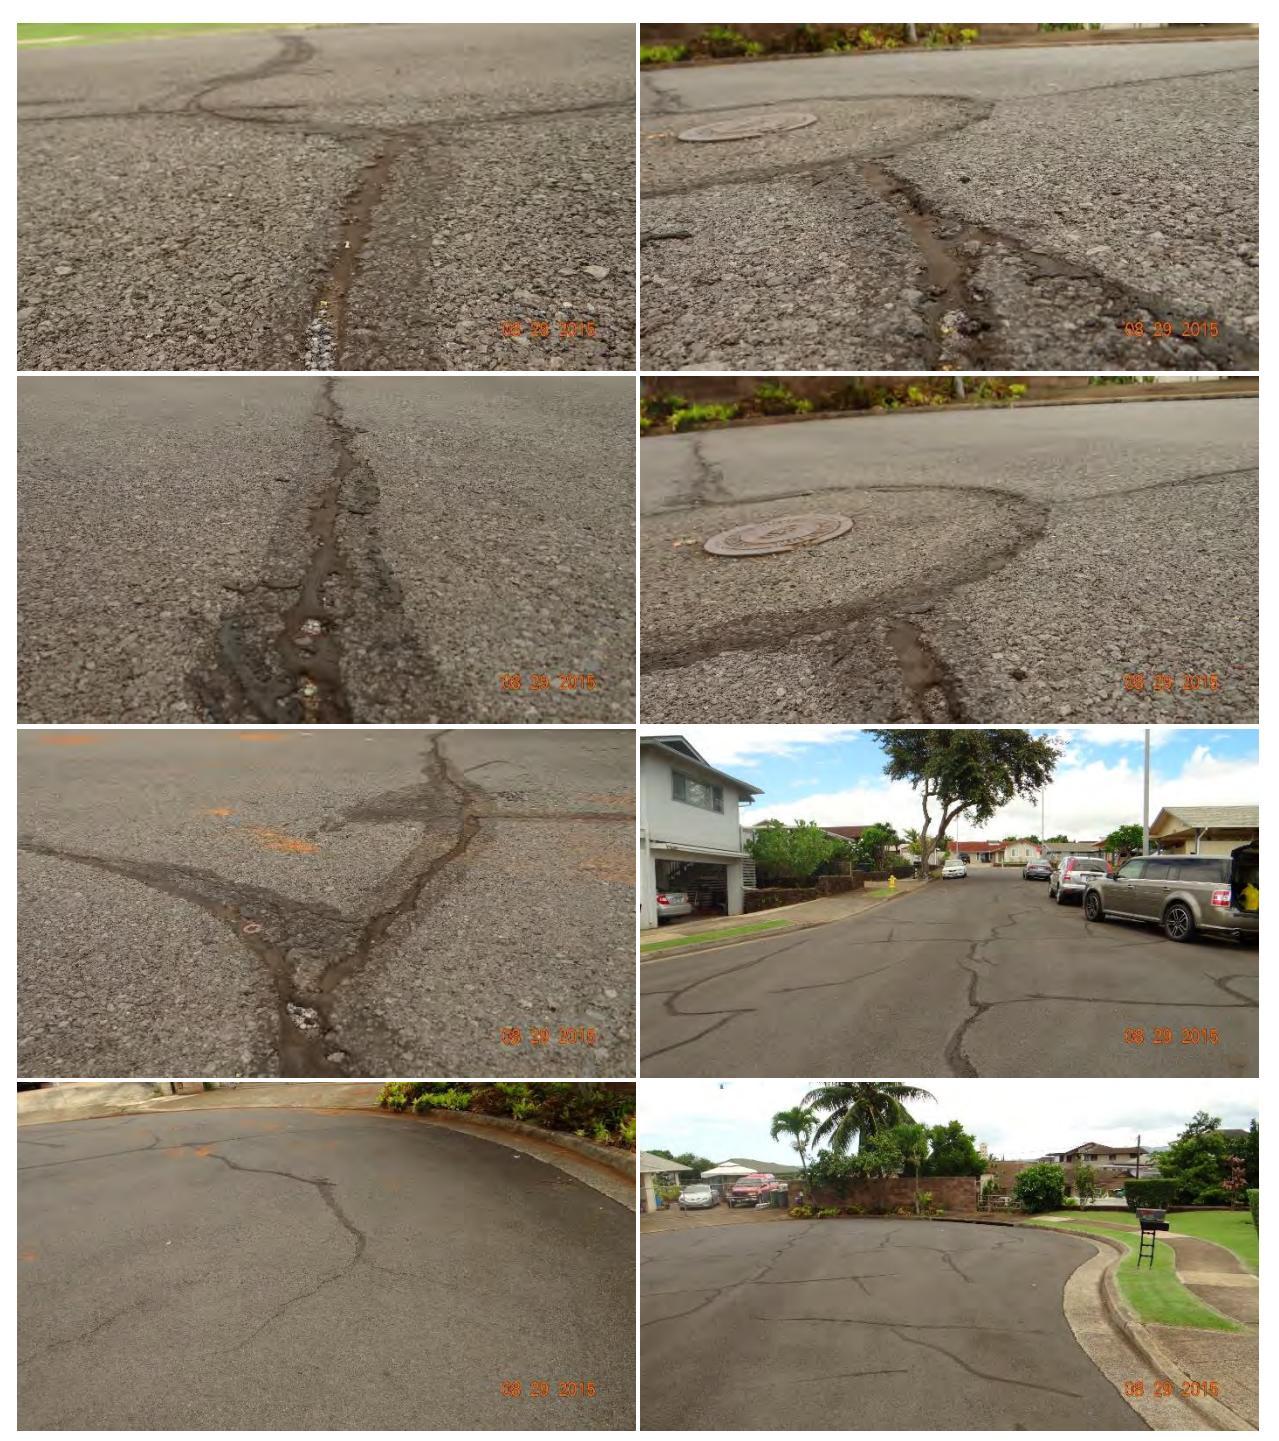
Figure C-38 shows the condition of the crack sealing on 08/29/2015. It is clear from the four top photos that the overband material had been largely removed by traffic (although the overbands were still visible, the aggregate surfaces were already exposed). It is also seen that loose aggregates had accumulated and had been pushed into the crack sealer in some areas. In some other cases, a portion of the sealer in wide cracks had been removed either because the crack was not properly cleaned before sealing, or because the larger crack width made it easier for the sealer to be pulled out of the crack when tracked, or because of a combination of these factors. Despite these issues, most of the sealed cracks continued to be properly sealed and performing as expected. The rest of the photos in Figure C-38 show that little change in the cracking pattern could be observed nine and a half months after the treatment application.

Figure C-38 Condition of the Paaaina Place section on 08/29/2015.

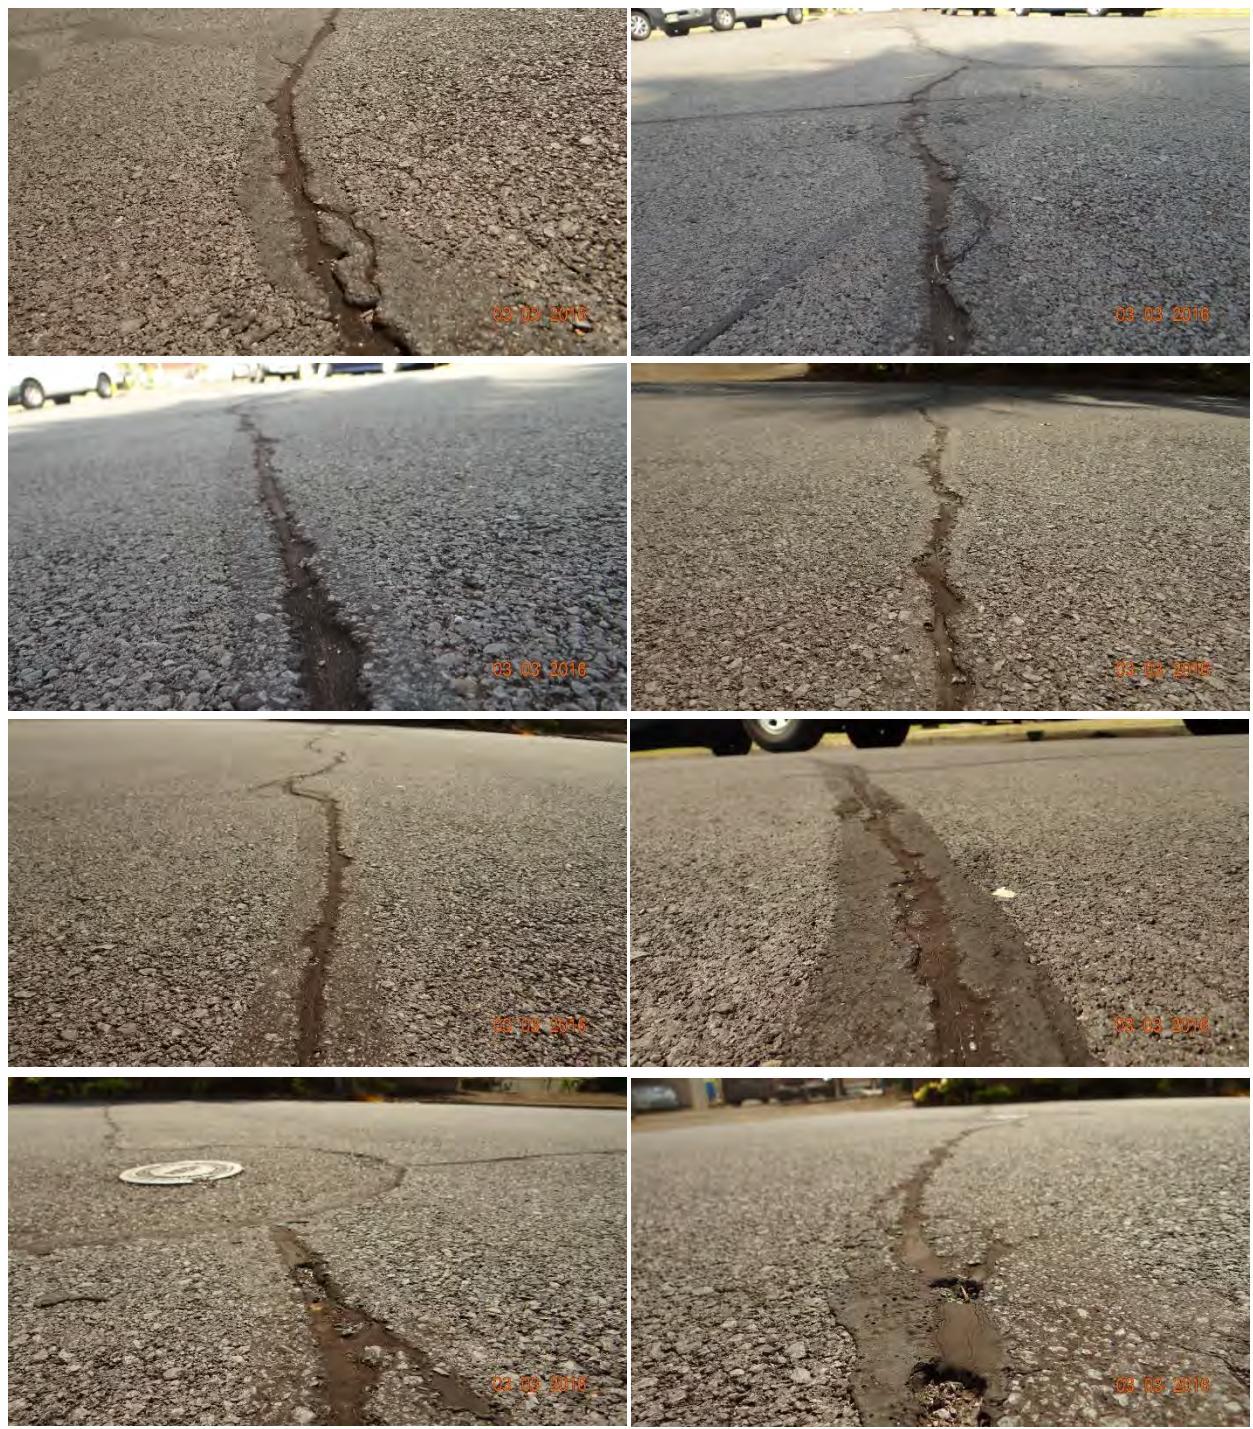
The top six photos in Figure C-39 illustrate that the crack sealer continued performing well in most of the section (with some occasional loose aggregate accumulation) as of 03/03/2016, fourteen months after the treatment application. The two bottom photos show two locations where the sealer had been removed in part of the crack and loose aggregate had accumulated. As indicated by the trend shown in Figure 4-9, the total cracking length increased slightly. Consequently, the cracking pattern, illustrated in Figure C-40 is virtually unchanged.

Figure C-39 Condition of the Paaaina Place section on 03/03/2016.

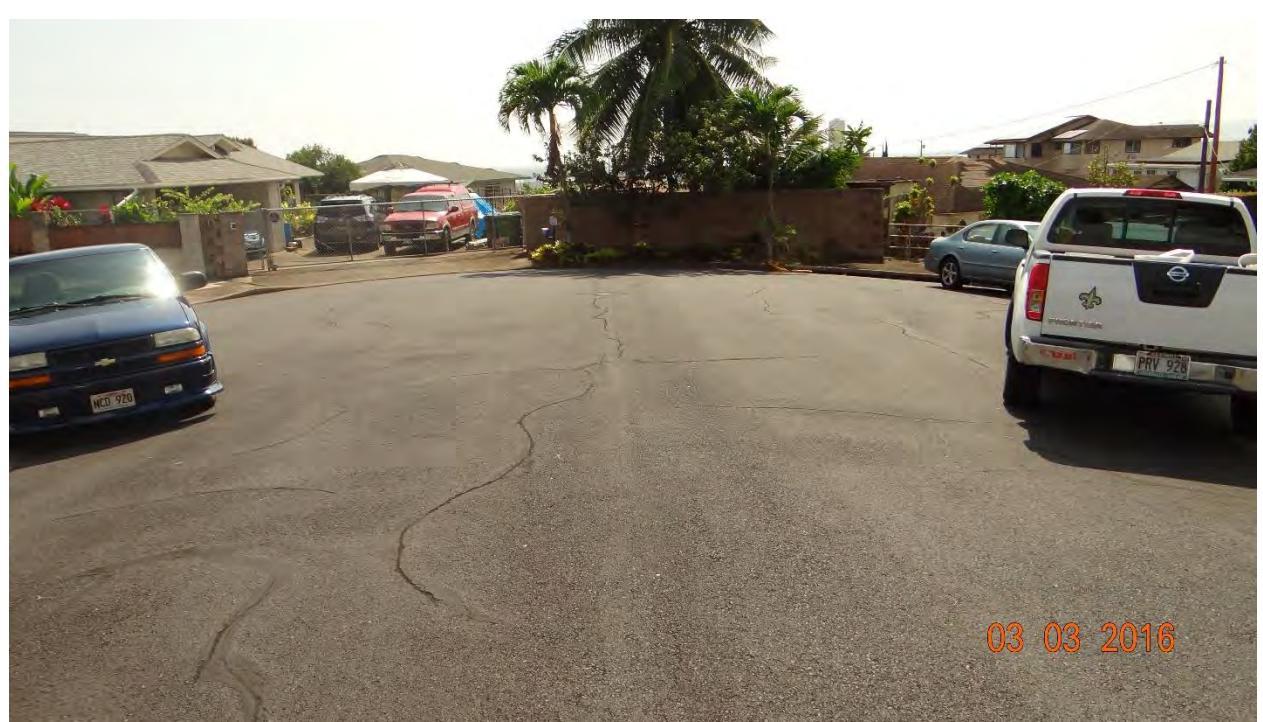
Figure C-40 Condition of the Paaaina Place section on 03/03/2016.
