PERFORMANCE MONITORING OF PRESERVATION TREATMENTS IN HONOLULU

FINAL PROJECT REPORT

Adrián Ricardo Archilla University of Hawaii at Manoa

May 2019

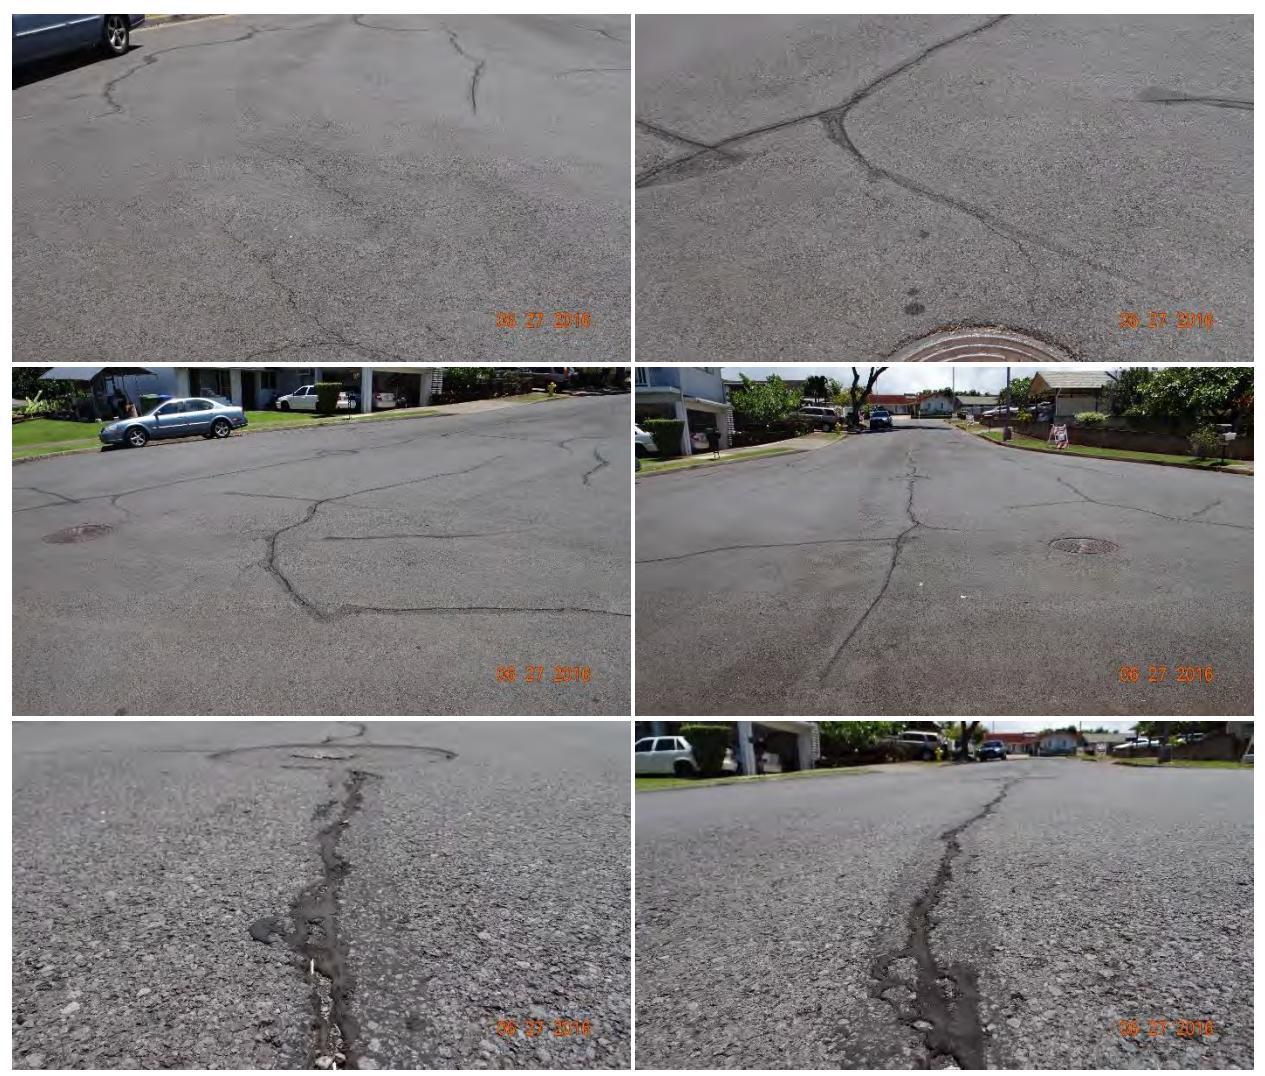
Figure C-41 through Figure C-45 document the slow progression of cracking observed on 06/27/2016, 12/14/2016, and 12/14/2016. Figure C-41 shows the progression of new cracks, some sealed cracks with the overband barely visible, and some cracks with a portion of the sealer removed. However, as illustrated in the photos in Figure C-42, the crack sealer for most of the section is still performing its function well since it fully fills the crack and it is in full contact with the crack walls. In addition, the sealer was still soft to the touch. Figure C-43 shows the conditions on 12/14/2016, two years and one month after the treatment application. The observations are basically the same as before.

Figure C-41 Condition of the Paaaina Place section on 06/27/2016.

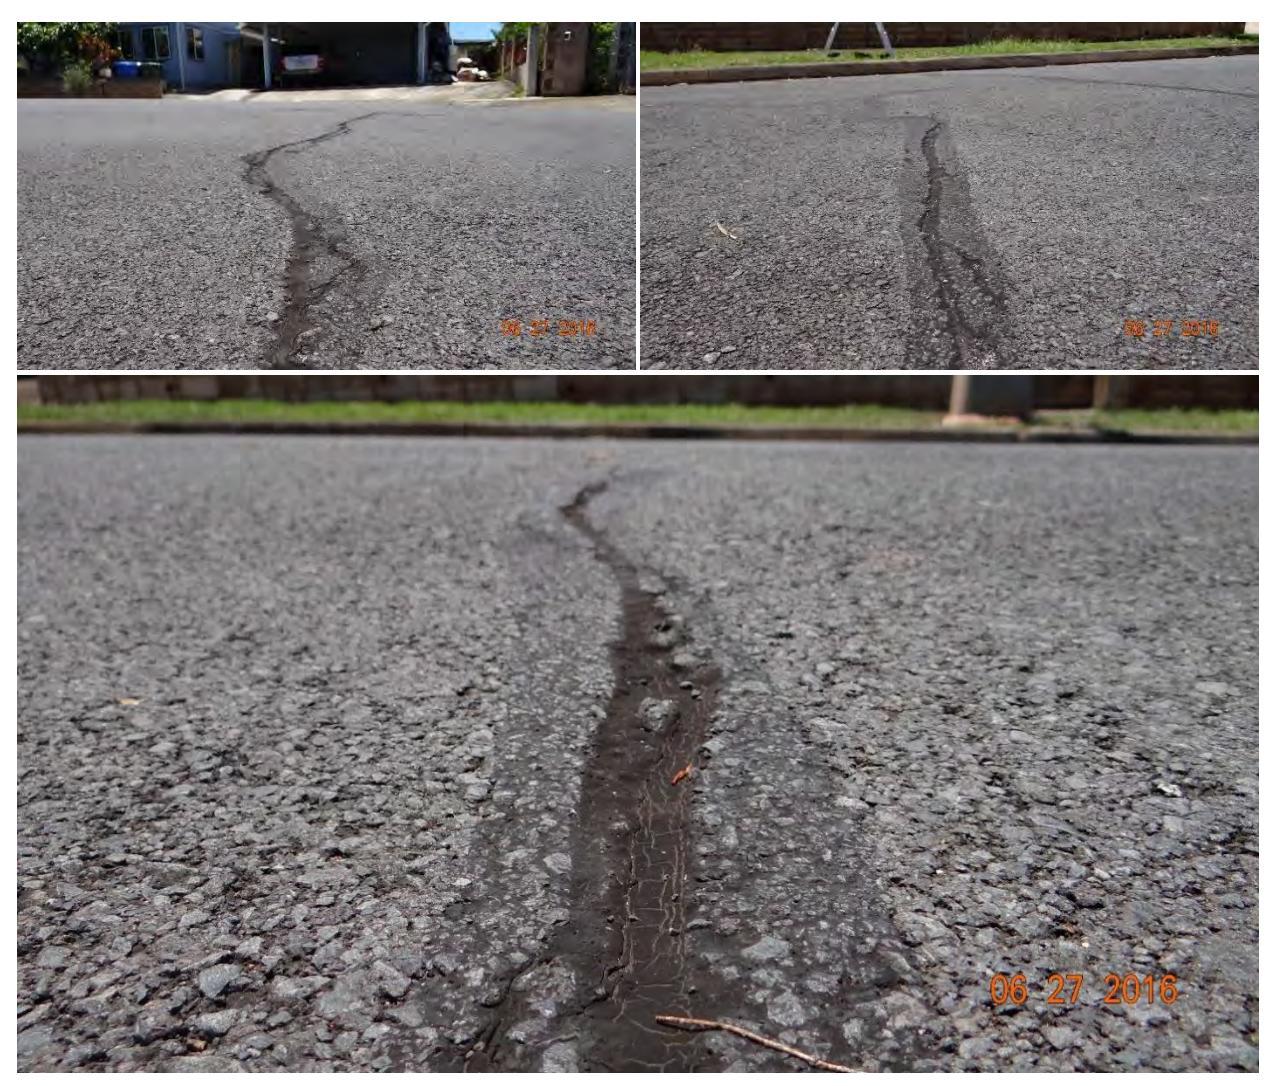
Figure C-42 Condition of the Paaaina Place section on 06/27/2016.

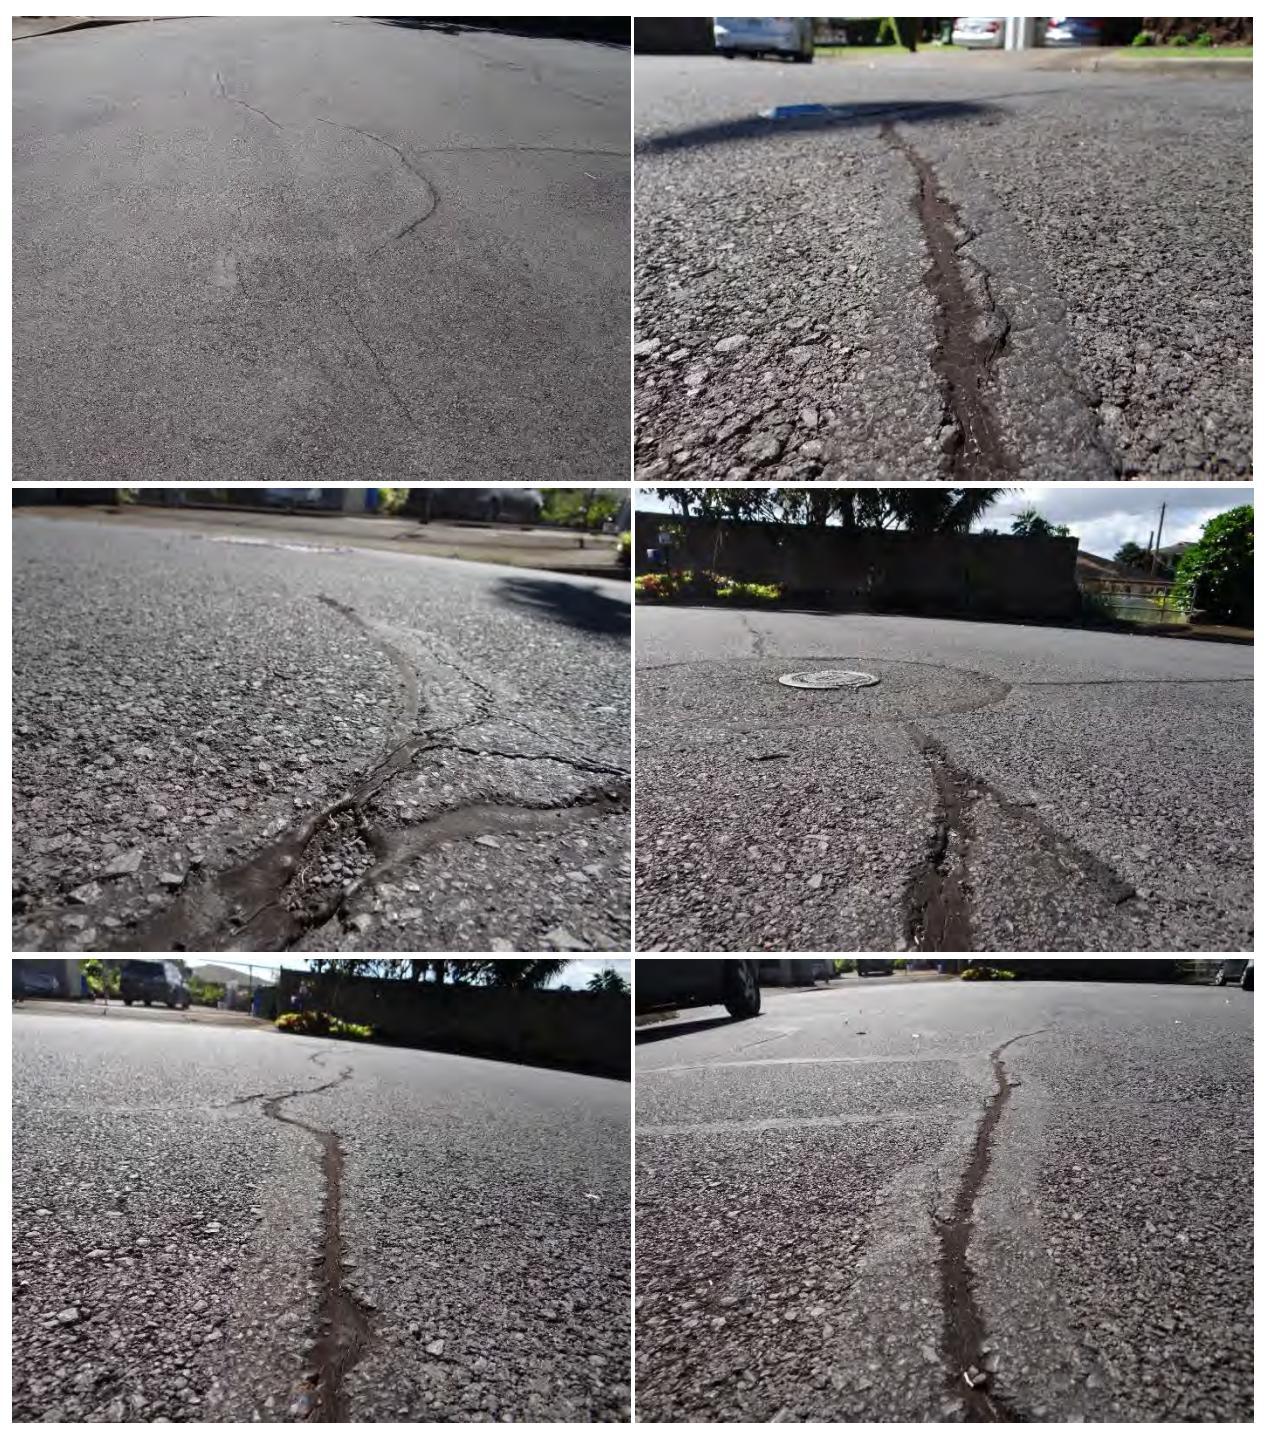
Figure C-43 Condition of the Paaaina Place section on 12/14/2016.

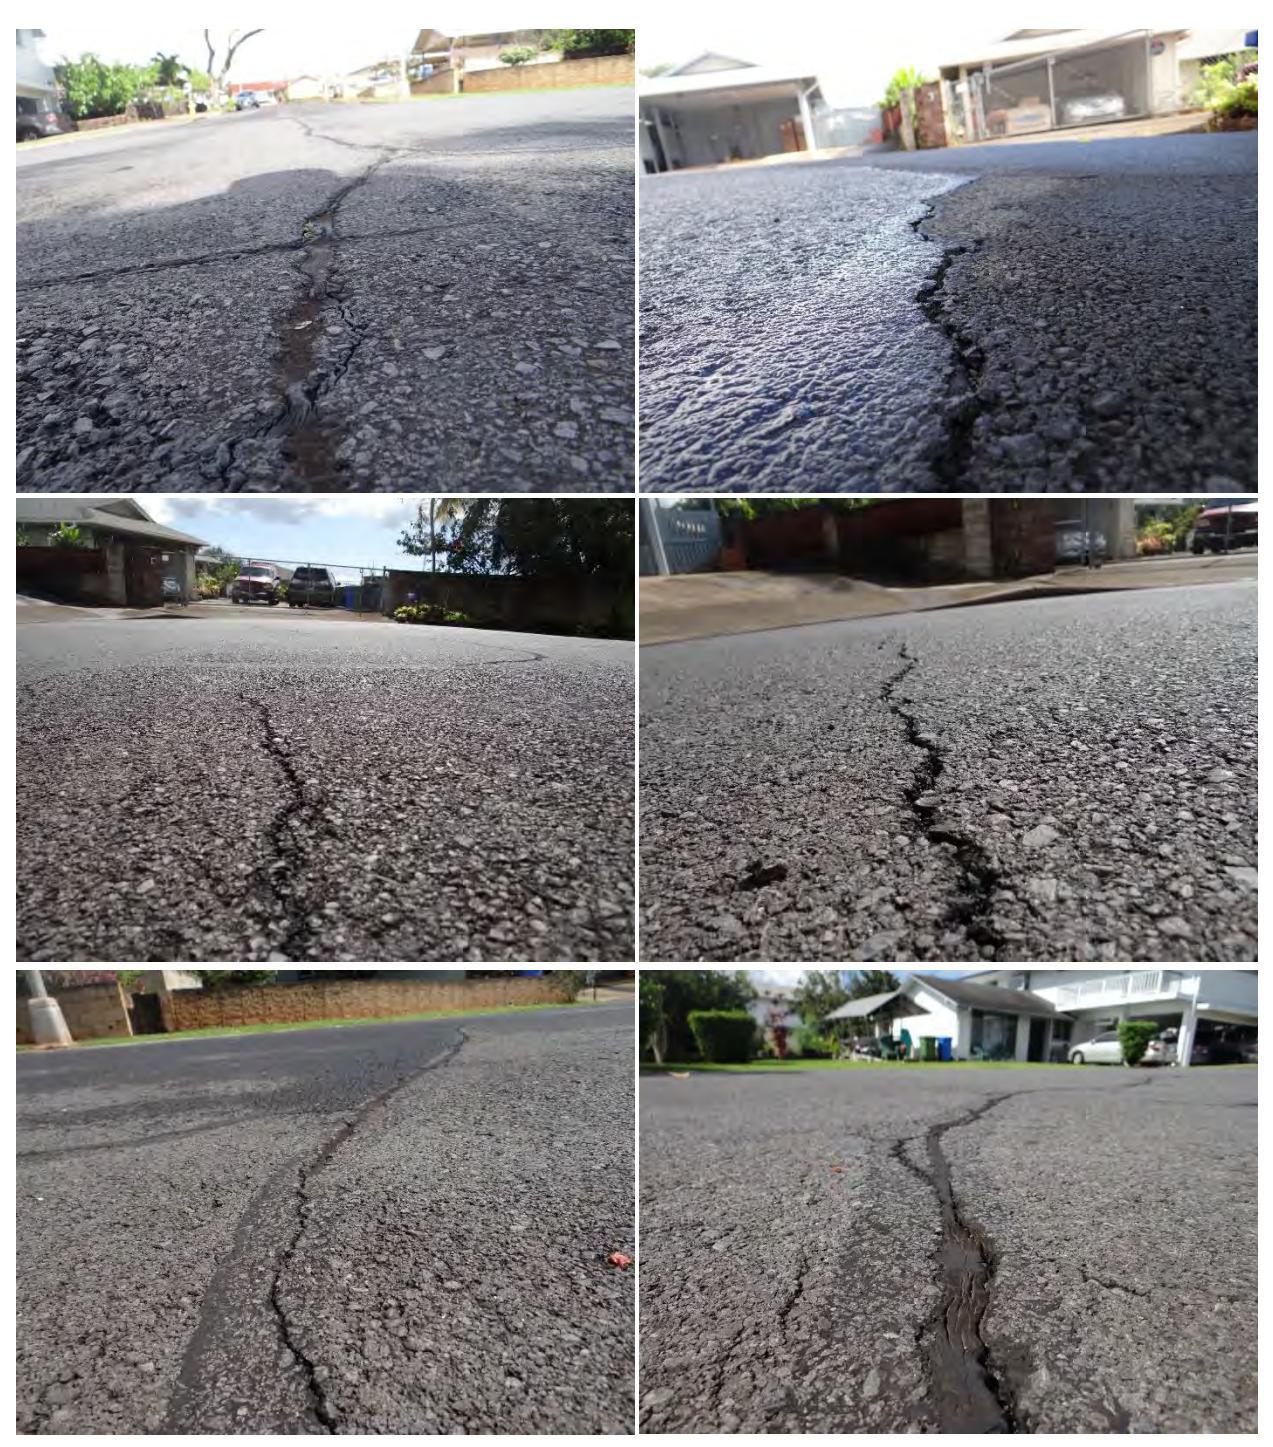
Figure C-44 Condition of the Paaaina Place section on 02/07/2018.

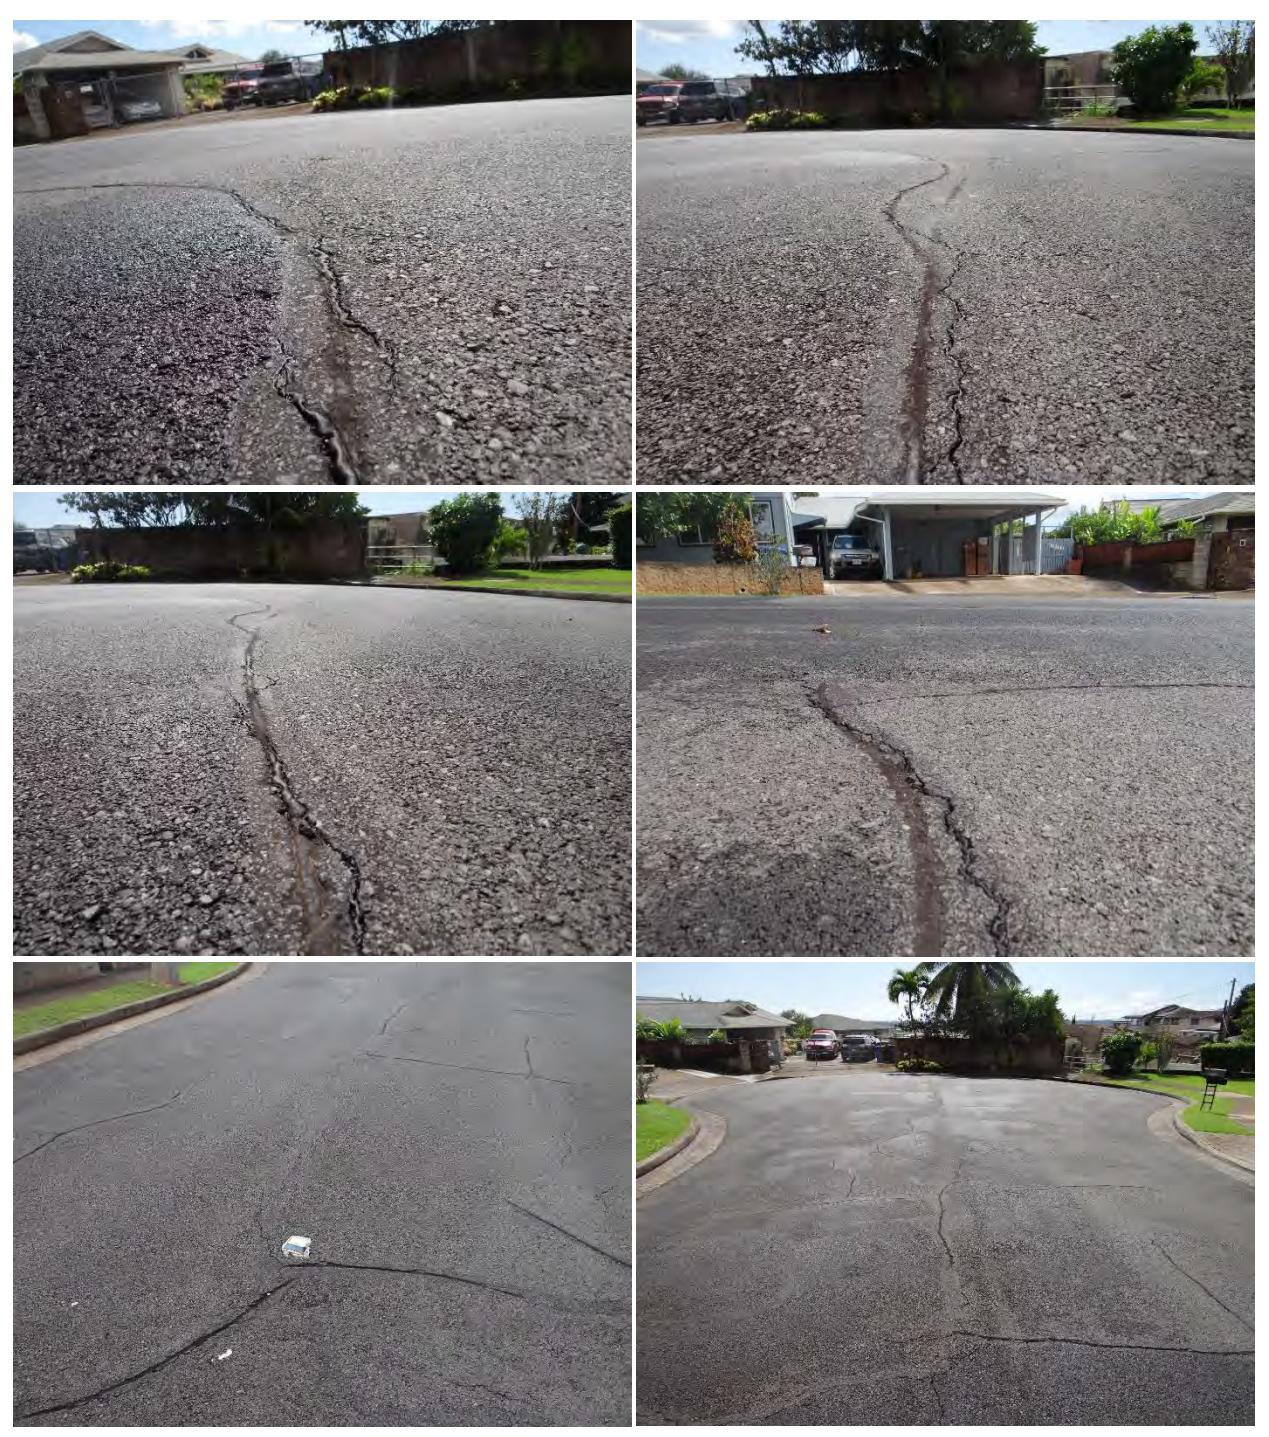
The top four photos in Figure C-45 clearly illustrate the different performance of the sealer in thin, unrouted cracks versus cracks with an adequate reservoir (either routed as shown in this figure or wide enough so that crack movements induce small strains in the sealer). In the thin, unrouted cracks, the sealer often appears to have been squeezed as the crack closes at higher temperatures and to have lost contact with the crack walls as the crack opens at lower temperatures. In very thin cracks, sometimes practically no sealer was seen inside the crack. On the other hand, on wider cracks, the exposed top surface of the sealer was mostly flat, and no spaces were noted between the sealer and crack walls. It is expected that performance of the crack sealer, in terms of minimizing water infiltration into the pavement structure, is quite different in each case, particularly for heavy rain conditions such as those illustrated in the top two photos in Figure C-46. The two middle photos in that figure show a more dull appearance of the surface around an unsealed crack indicating that water was infiltrating the pavement through the crack (in this particular case, the crack was also near the top of the pavement crown, which may have also contributed to that appearance; however, notice that no water was visible on the crack itself). On the other hand, the lower photos in Figure C-46 illustrate how the sealer was not allowing water to infiltrate into the pavement structure through the crack.

Figure C-45 Condition of the Paaaina Place section on 02/07/2018.

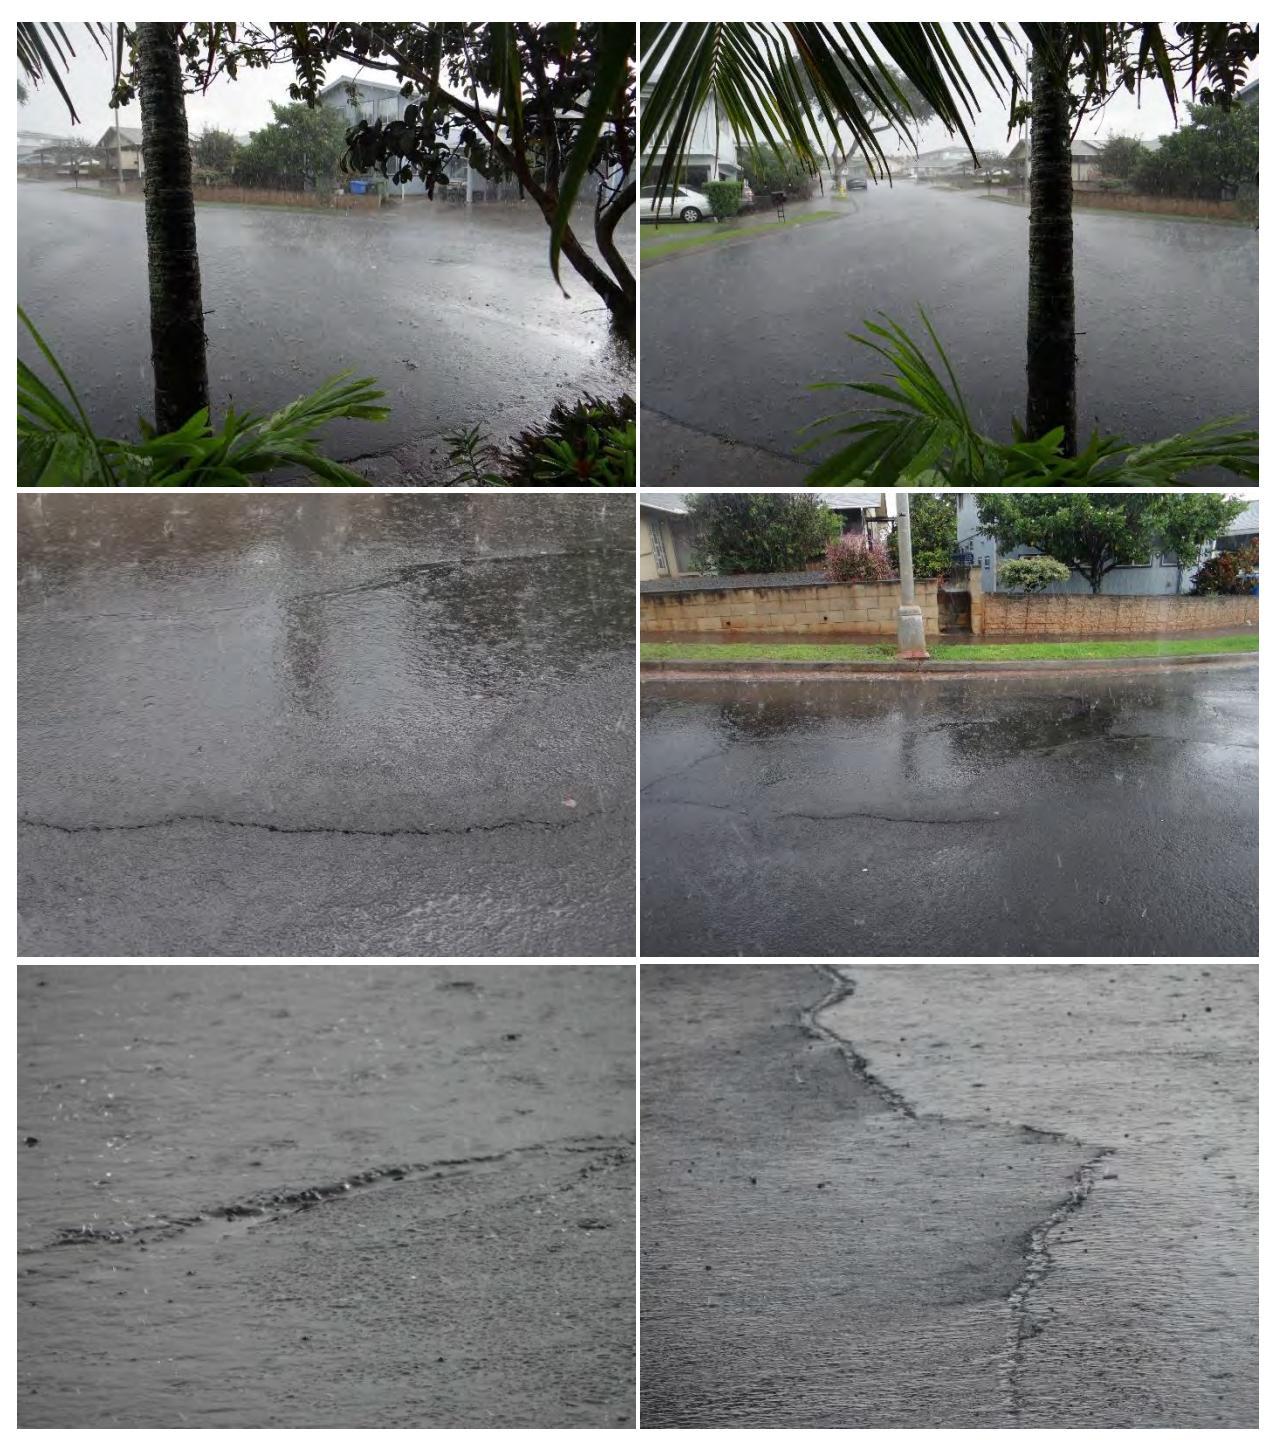
Figure C-46 Condition of the Paaaina Place section on 02/07/2018.

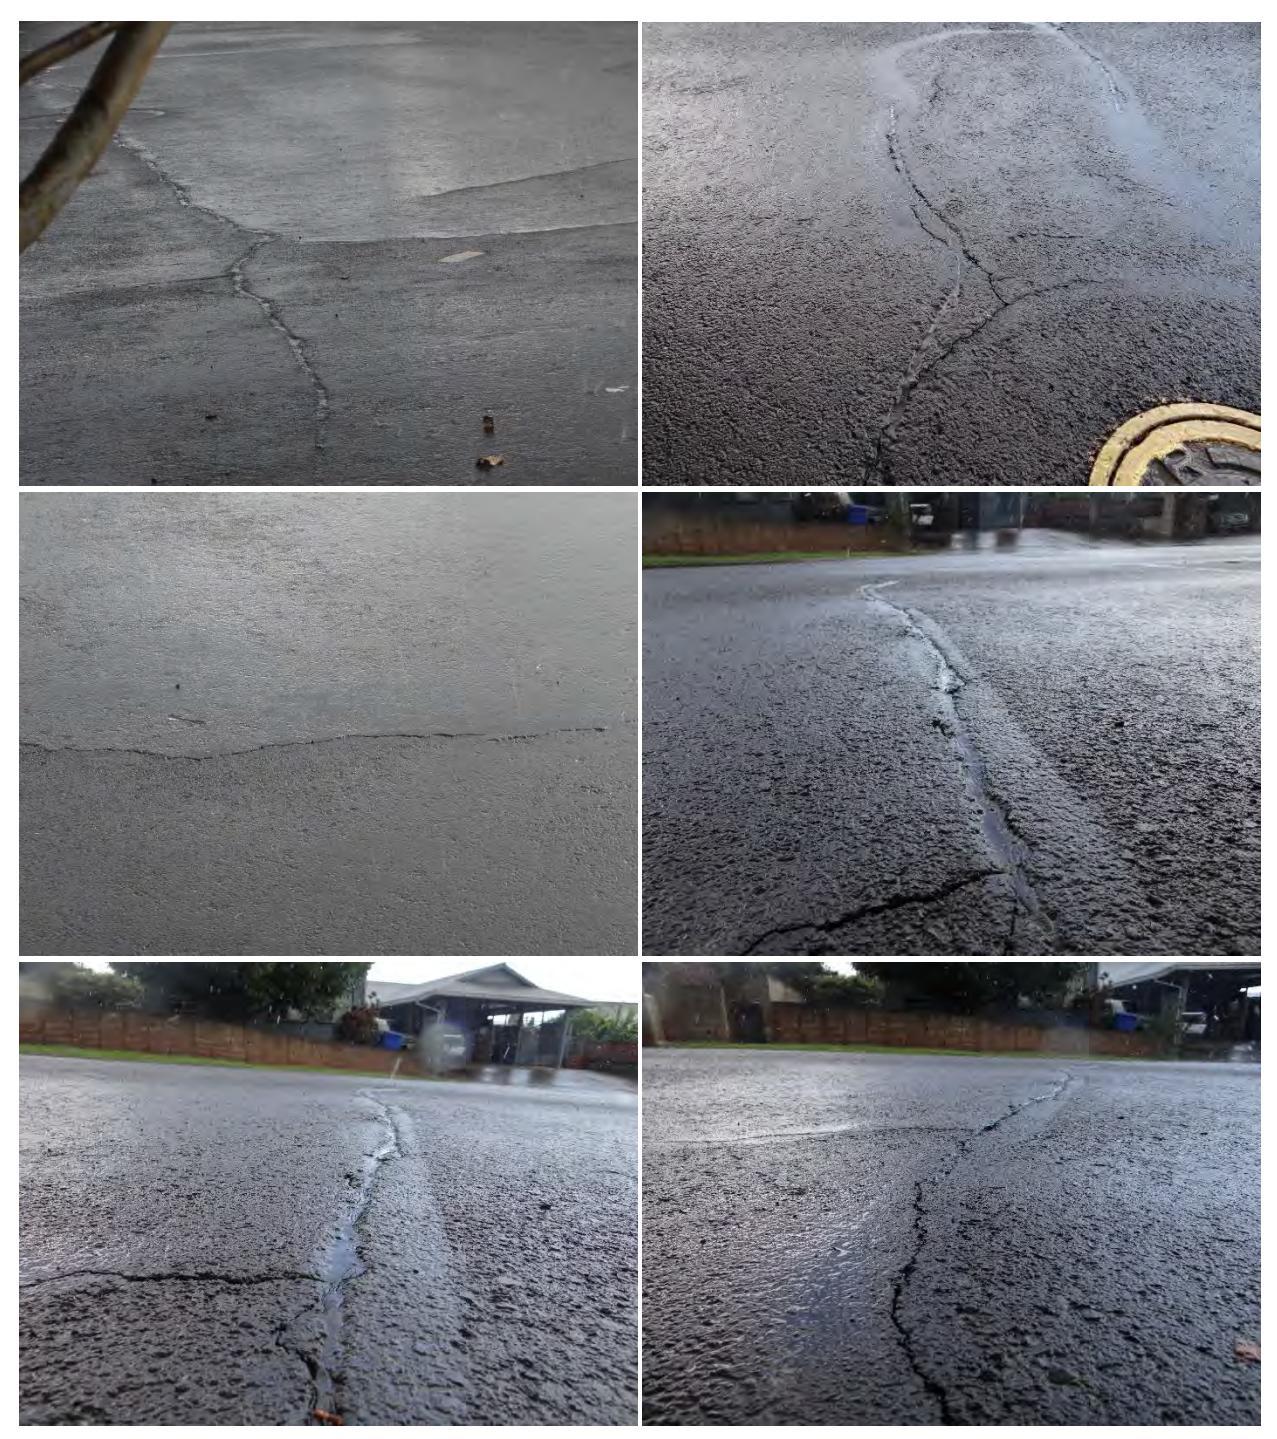
Figure C-47 and Figure C-48 show several photos illustrating the differences in surface appearance after the precipitation slowed significantly or shortly after the rain stopped. In all cases, the surfaces of the sealed cracks were still wet, as indicated by their shiny appearance, while at the same time no water was observed in the unsealed cracks and a dull surface appearance was noted on the surface around them. While these observations are expected and probably obvious, it is still considered useful to provide this photographic evidence of the benefits of properly sealing cracks, particularly on a state with so much precipitation as Hawaii.

Figure C-47 Condition of the Paaaina Place section on 02/07/2018.

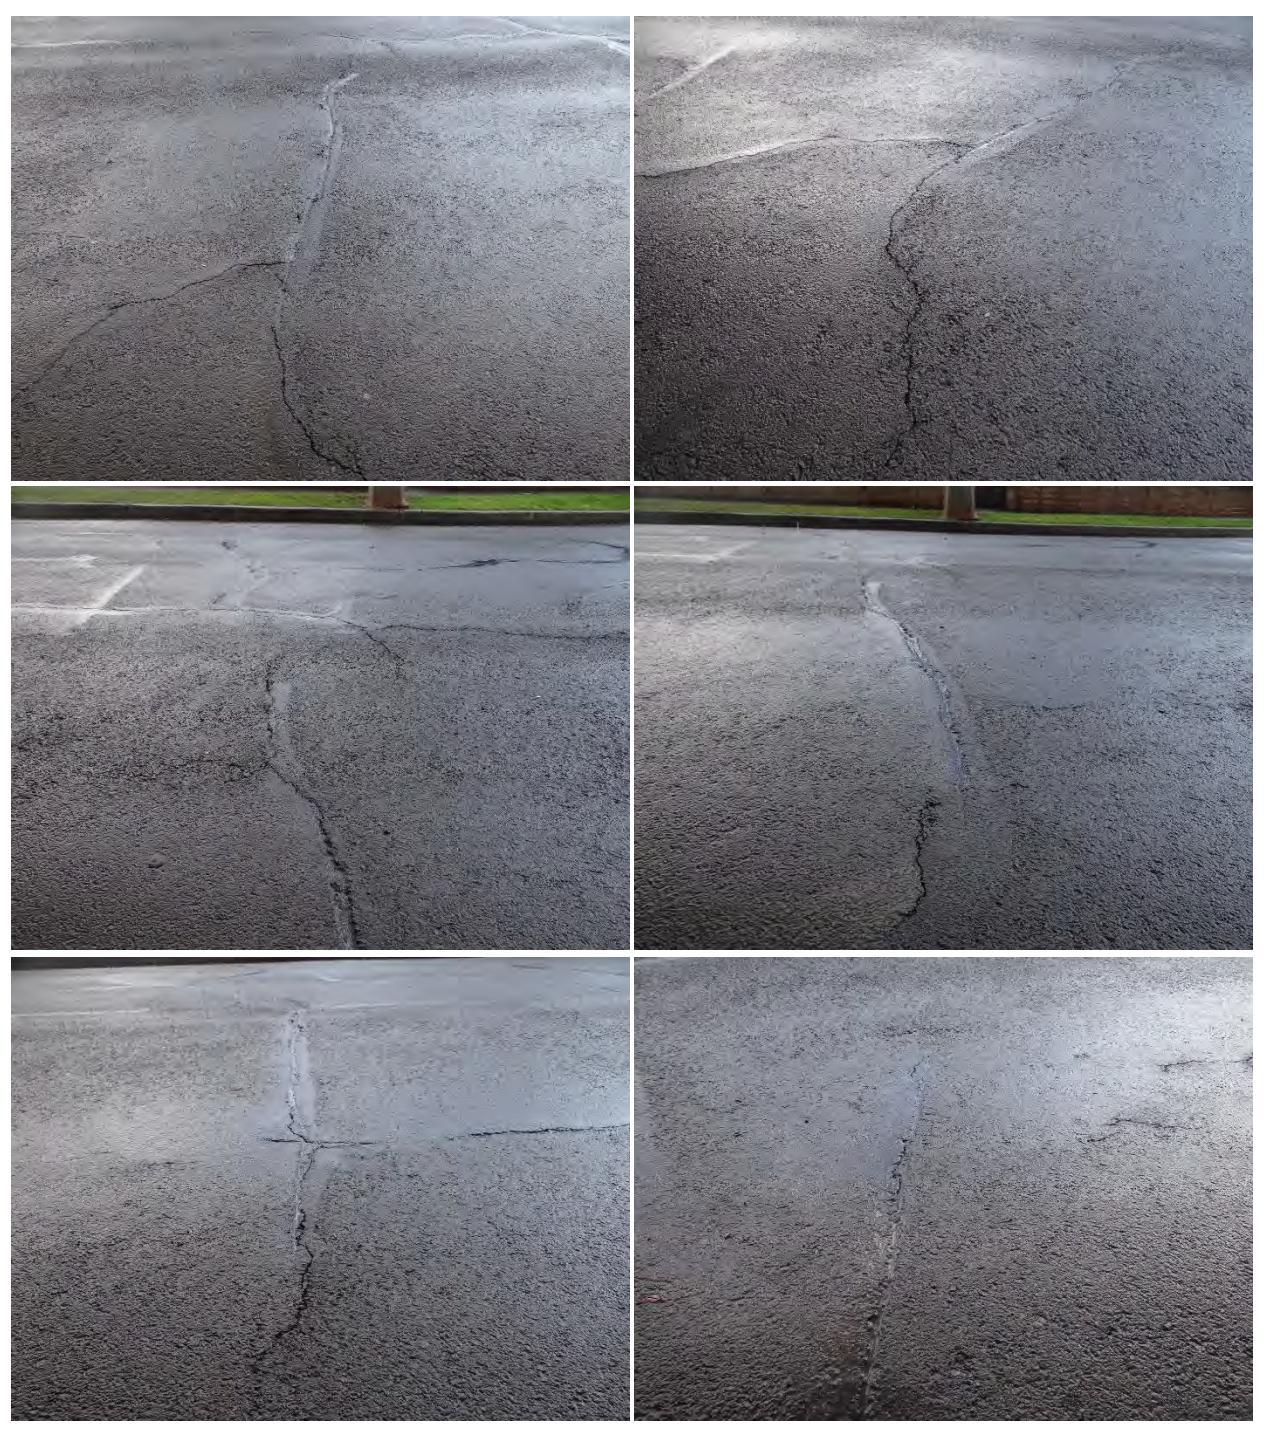
Figure C-48 Condition of the Paaaina Place section on 02/07/2018.

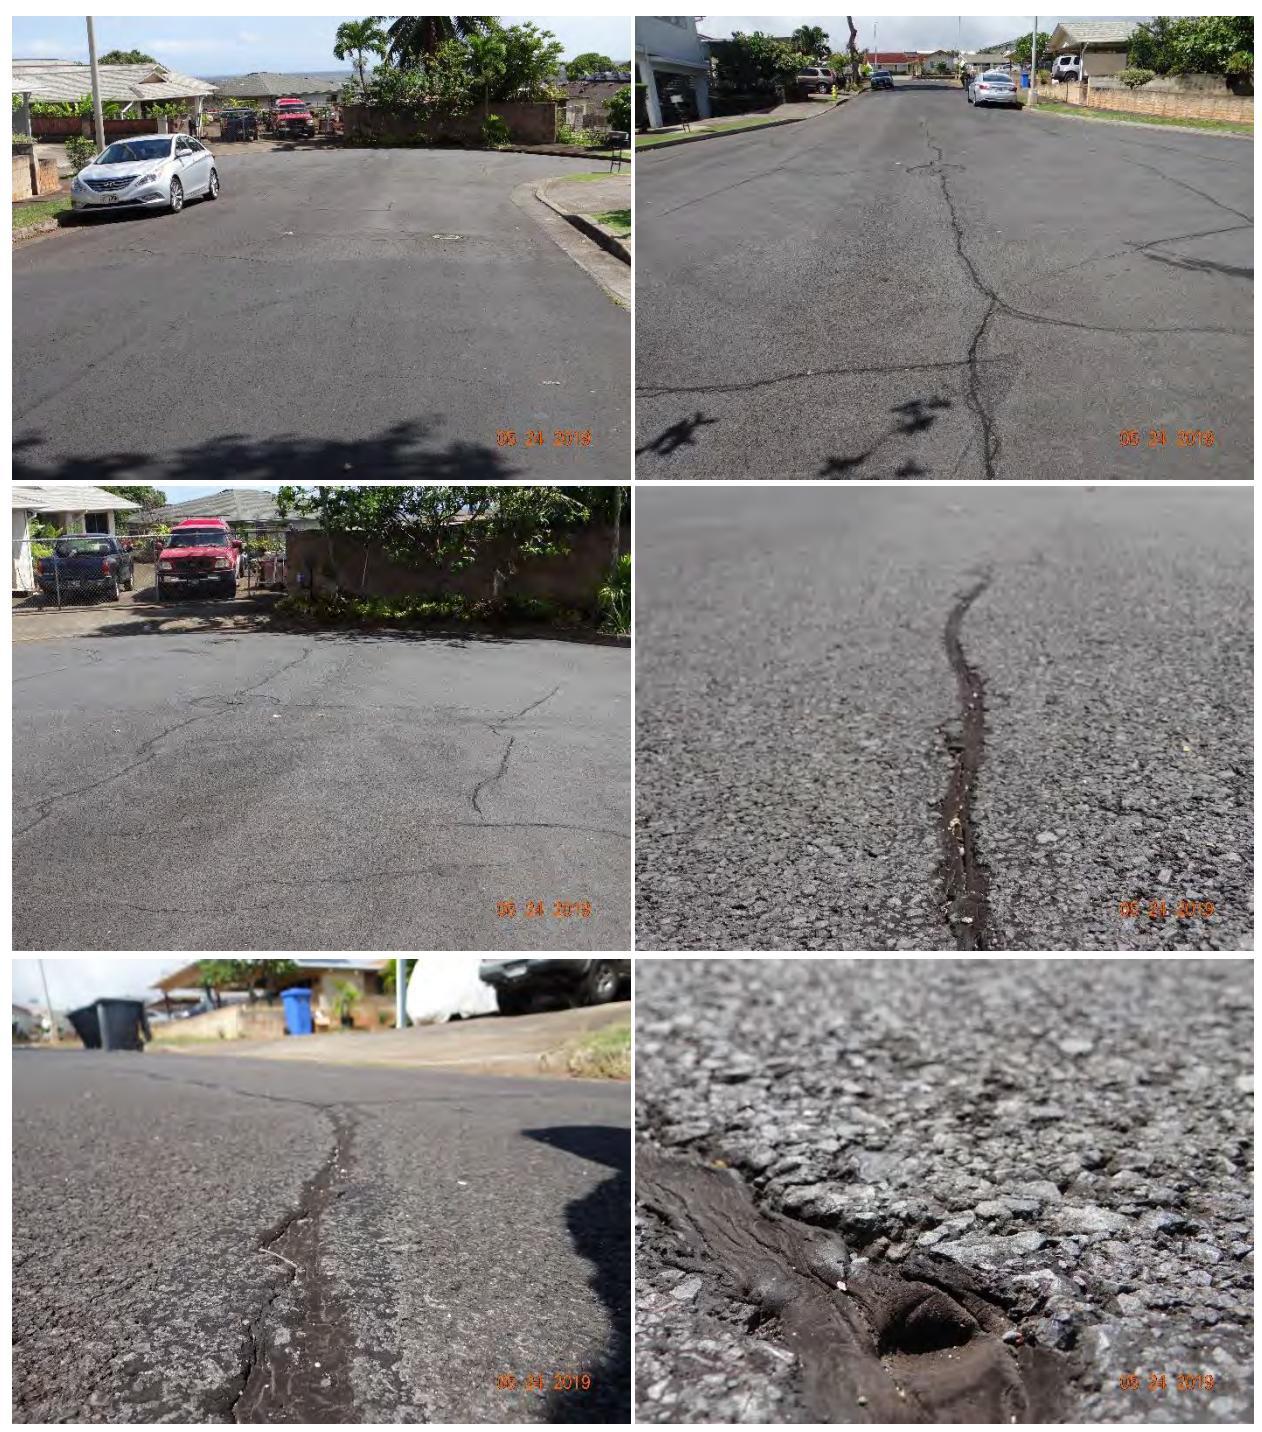
Figure C-49 shows the condition of the crack sealer on 5/24/2019. After 4.5 years, the crack sealer was still performing its function adequately. Notice that it was still soft enough to be indented. Most existing cracks were still adequately sealed.

Figure C-49 Condition of the Paaaina Place section on 5/24/2019.

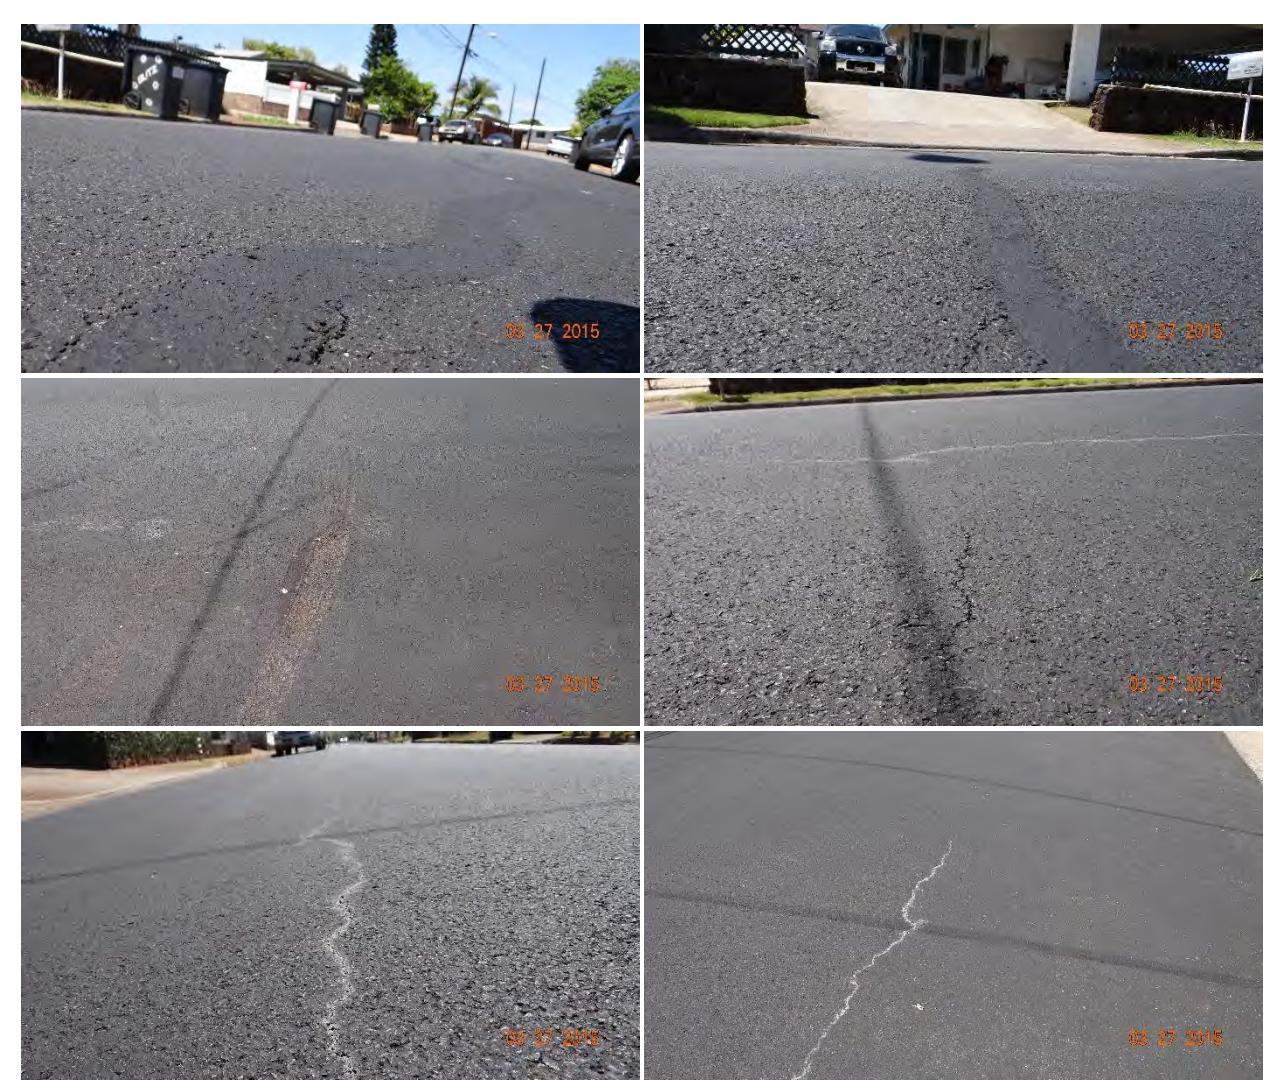
Figure C-51 shows the condition of the section on 03/27/2015, about four and a half months after the treatment application in November 2014. The two photos on the top show that, as expected, the sealed cracks were still in good condition. The left middle photo shows some scaring of the surface caused by traffic probably shortly after treatment application. Some new cracking was also observed, as illustrated in the right middle photo. This and the two photos on the bottom of the figure also show the appearance of some new longitudinal cracks with pumping of fines.

Figure C-51 Condition of Kaweloka Street section 1, treated with Plasti-Pave, on 03/27/2015.

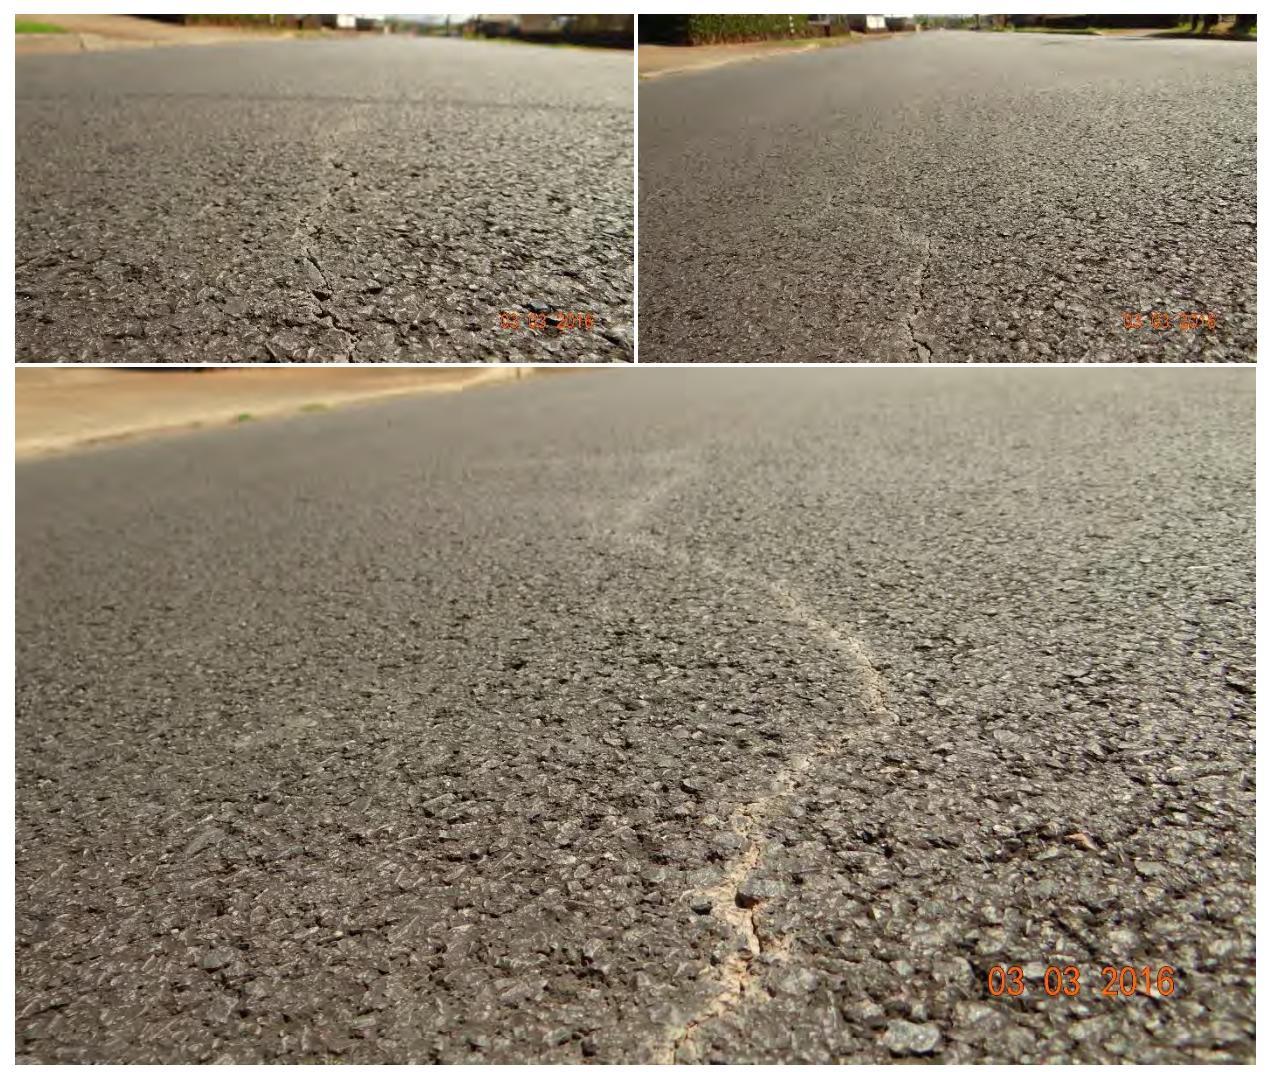
As shown in Figure C-53, about 15 months after the treatment application (03/3/2016), the cracks with pumping problems got slightly wider and continued pumping fines. The texture of the pavement looked similar, but with some of the aggregate faces showing some exposure.

Figure C-53 Condition of Kaweloka Street section 1, treated with Plasti-Pave, on 03/3/2016.

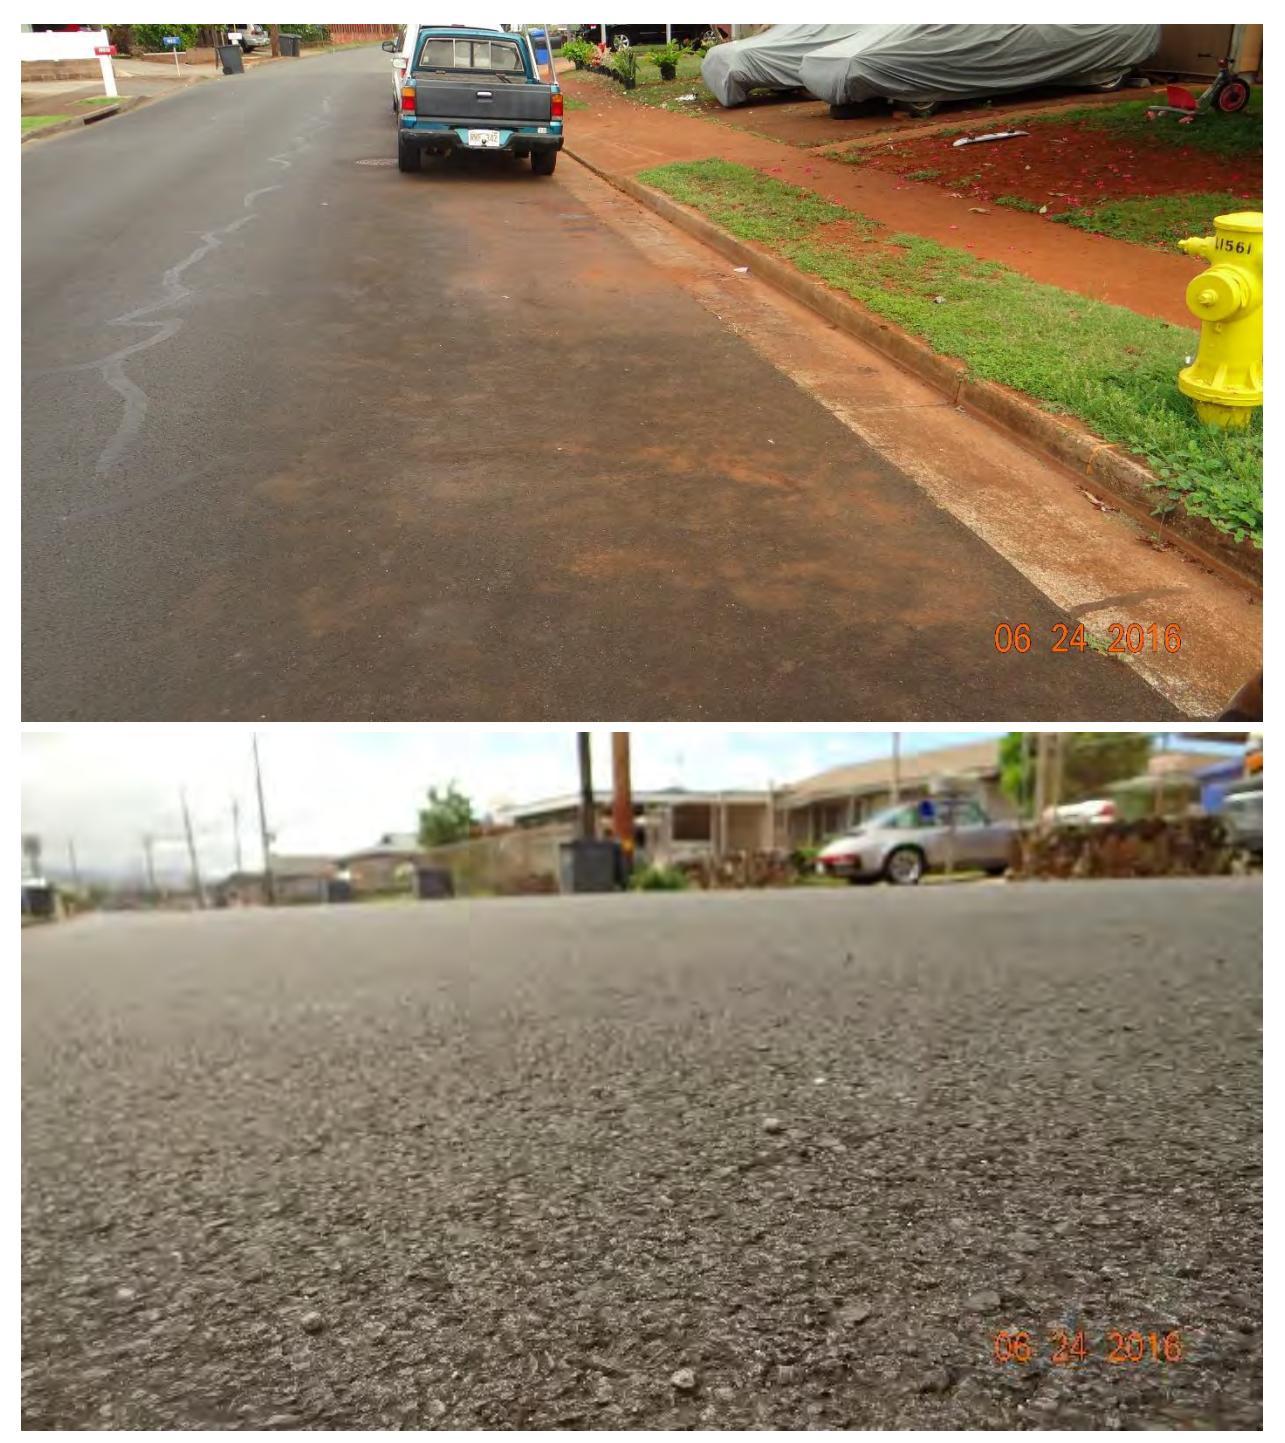
The top photo in Figure C-54 shows that a high contrast with the untreated pavement still existed on 06/24/2016, 19 months after the treatment application. The photo on the bottom illustrates the presence of some loose aggregates indicating the possibility of some incipient raveling. However, these were more likely to have come from the adjacent section that exhibited some raveling. The sealer was still filling the depressions, but the aggregate protrusions were a bit more exposed.

Figure C-54 Condition of Kaweloka Street section 1, treated with Plasti-Pave, on 06/24/2016.
