PERFORMANCE MONITORING OF PRESERVATION TREATMENTS IN HONOLULU

FINAL PROJECT REPORT

Adrián Ricardo Archilla University of Hawaii at Manoa

May 2019

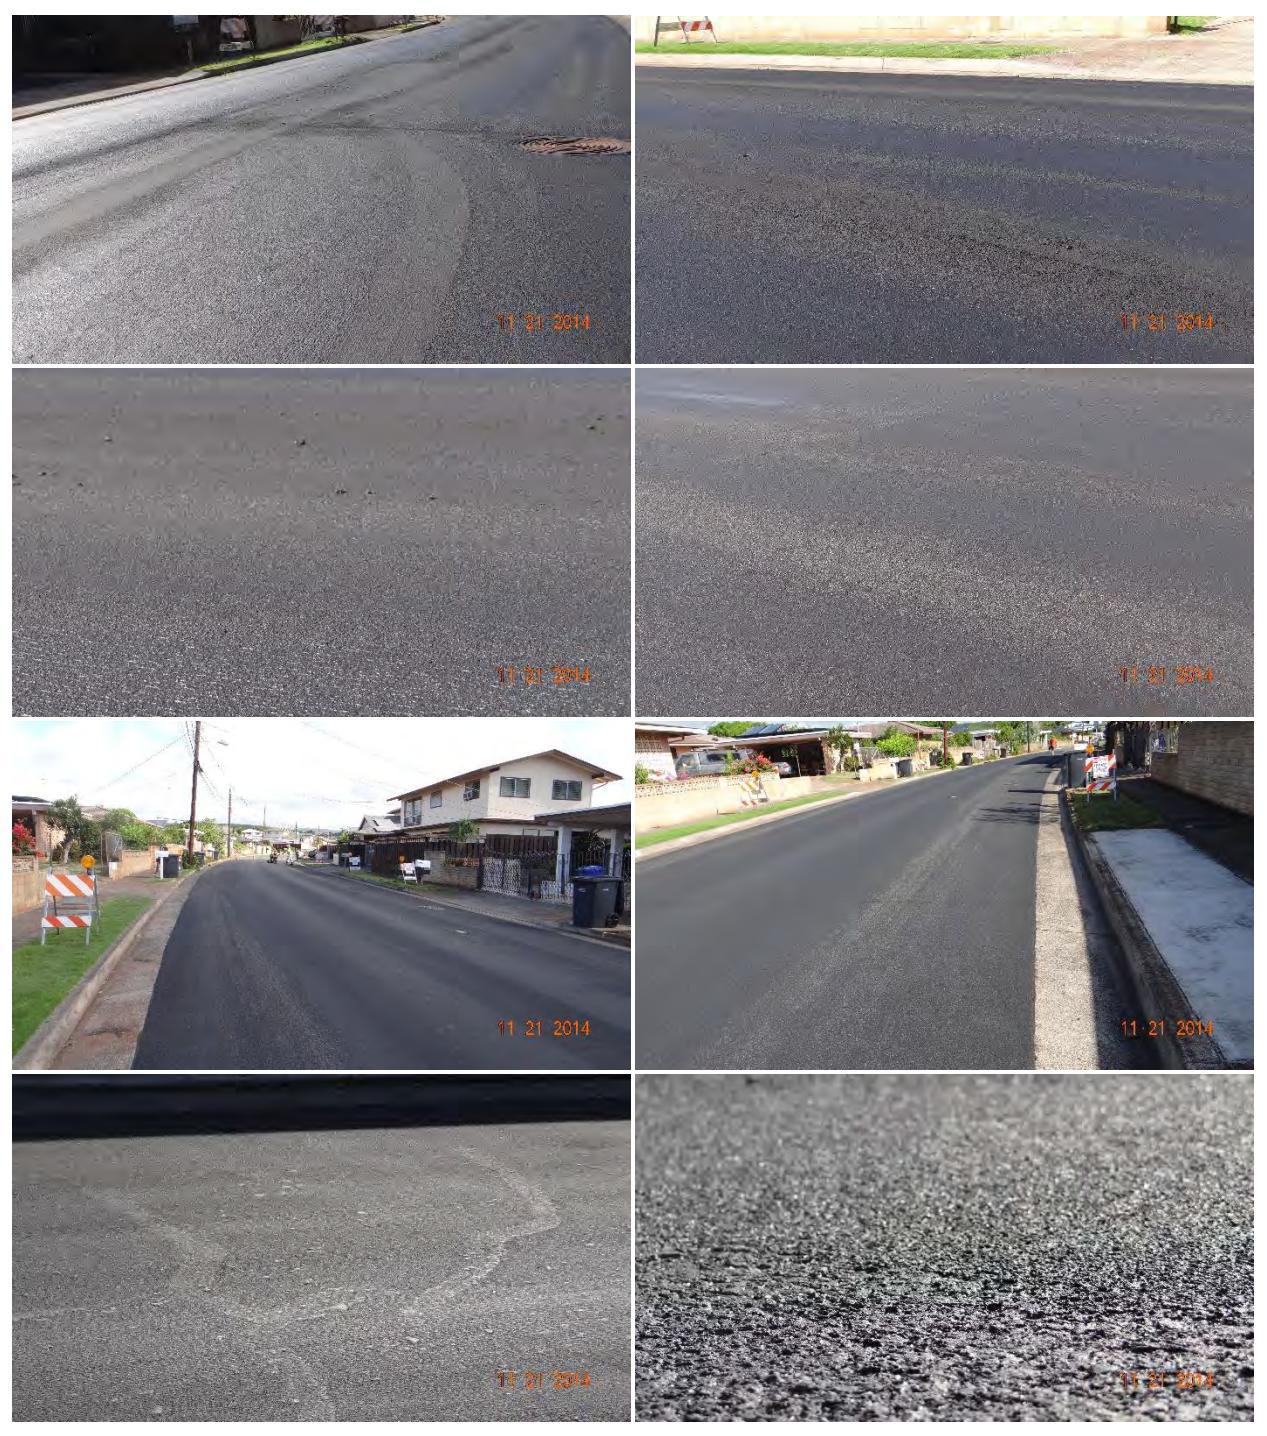
Figure C-58 shows the appearance of the treatment immediately after its application on 11/21/2014. Since the material in the first coat was spread with a spreader box and contained a relatively large amount of sand, this treatment typically had an uneven appearance immediately after its application. However, as shown later, once the material dried, the marks became less noticeable. The photo on the bottom left shows that sealed cracks were still identifiable, despite this treatment being thicker than the other seal coats used in this study. The photo on the bottom right shows that Liquid Road has a texture coarser than the other seal coats (this becomes clearer when compared with similar photos for the other treatments).

Figure C-58 Surface appearance on Kaweloka Street section 2, treated with Liquid Road, immediately after the second coat application on 11/21/2014.

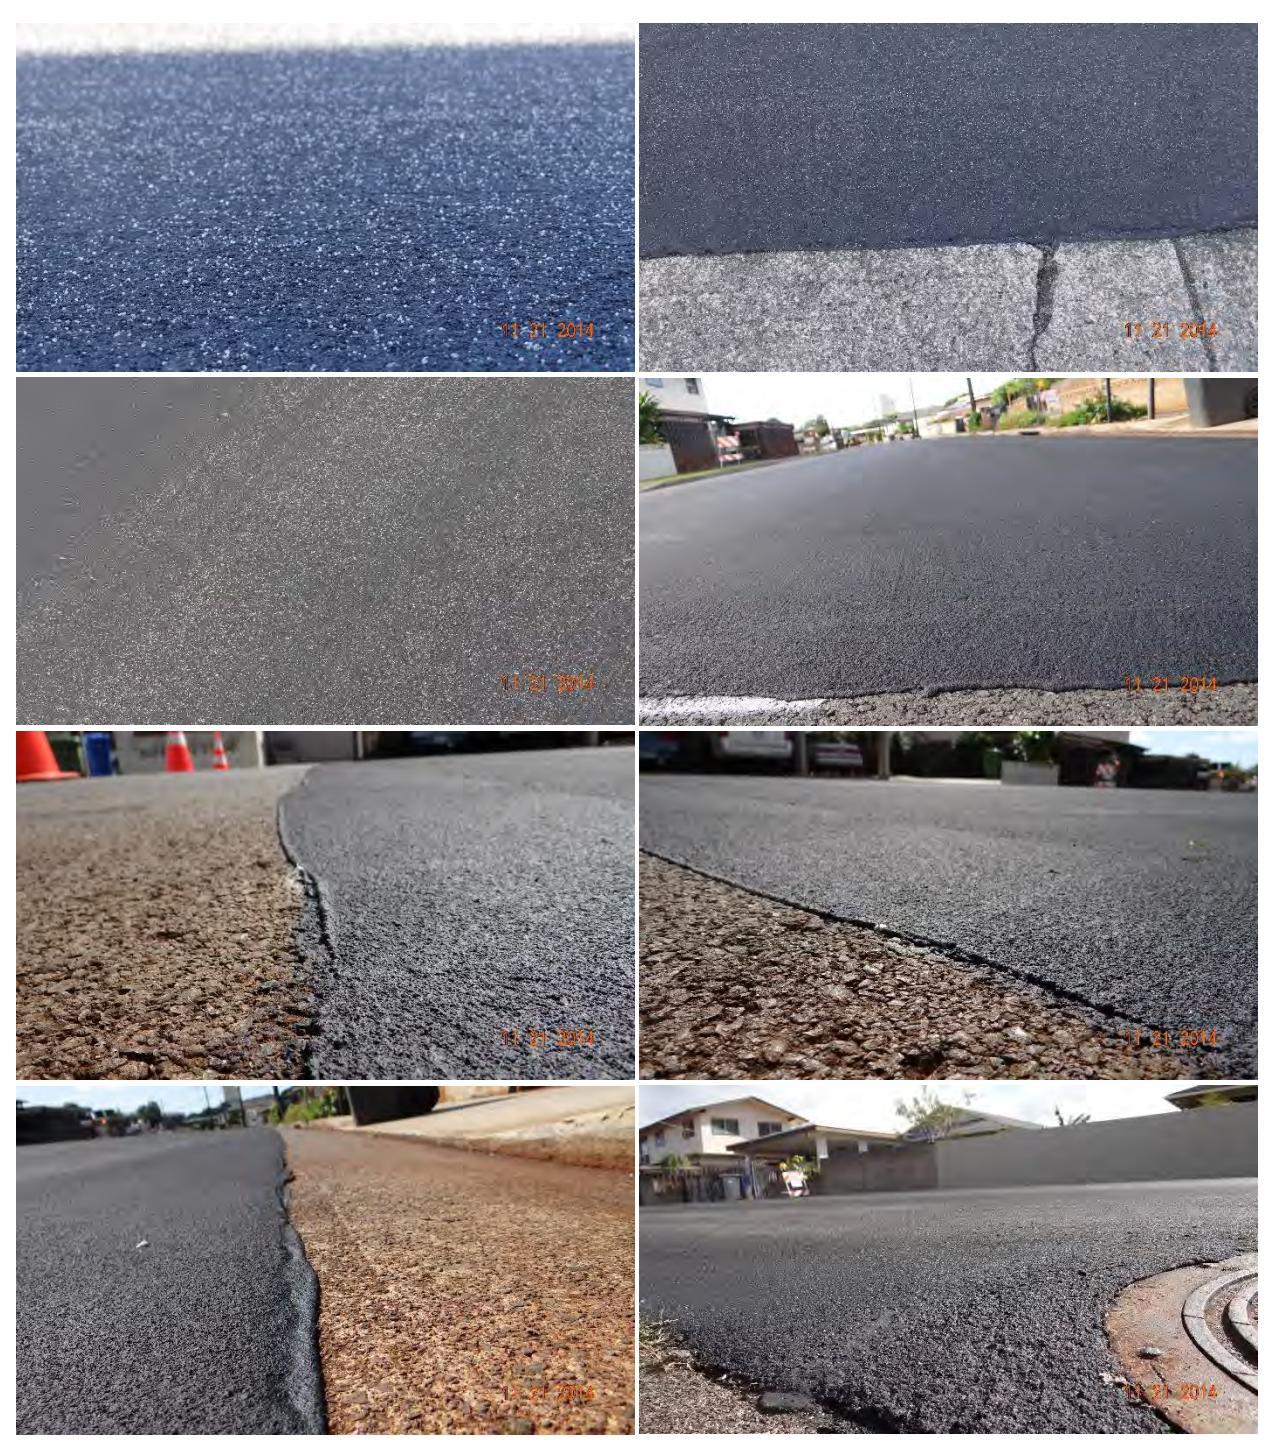
Figure C-59 Surface appearance on Kaweloka Street section 2, treated with Liquid Road, after further drying on the date of the second coat application, 11/21/2014.

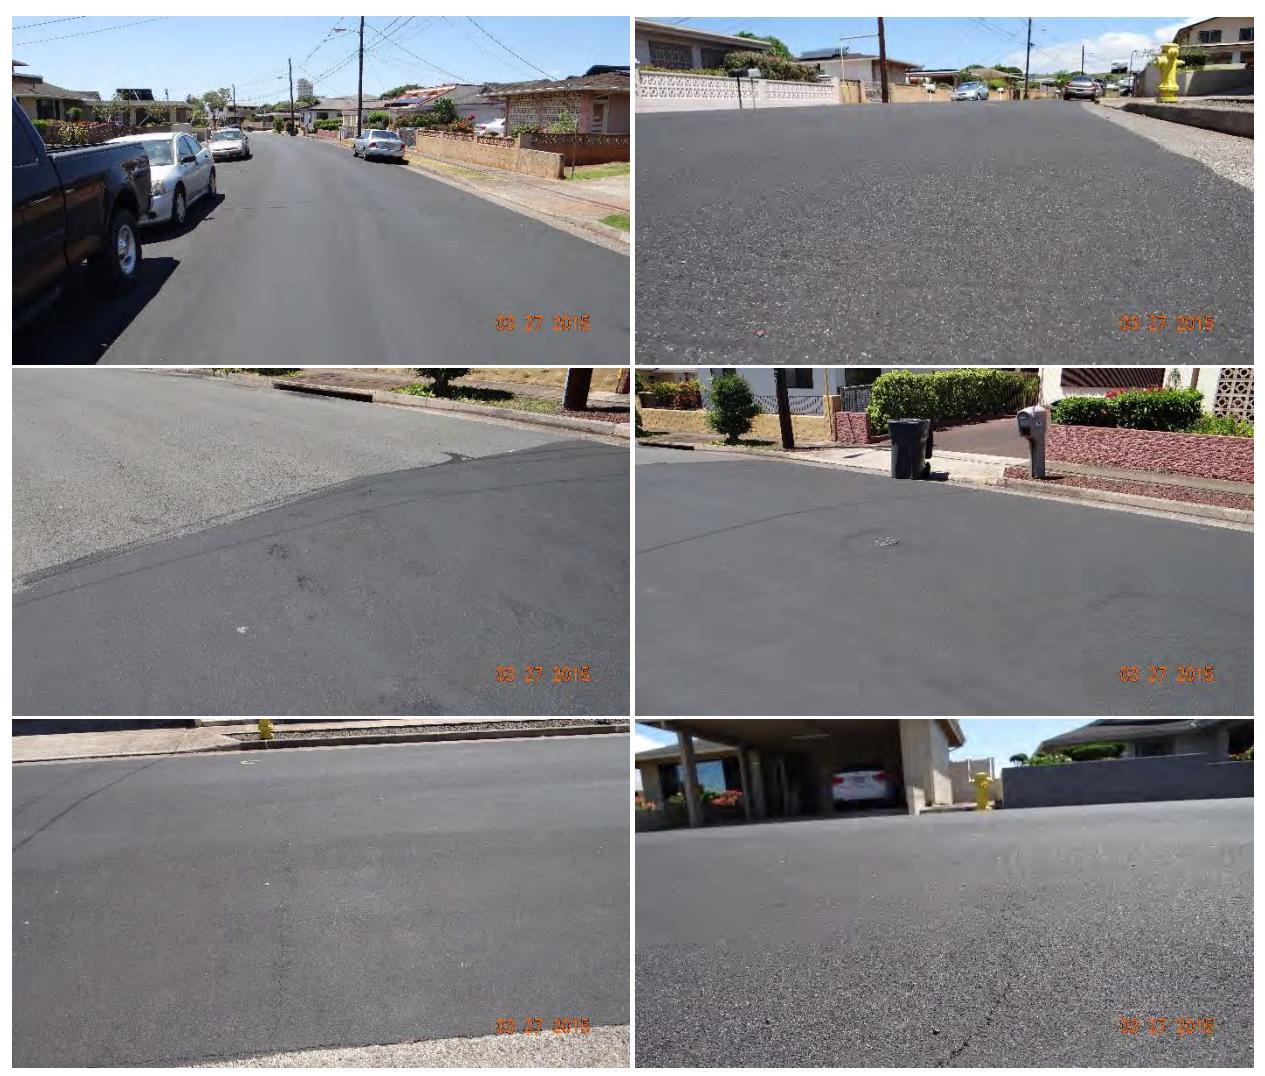
Figure C-60 shows the conditions on 3/27/2015, about four months after the treatment application. The top two photos show the general condition of the section. As illustrated by the photo on the left, the original spreading marks were now more inconspicuous. The photo on the right shows a considerable amount of sand still available on the surface. The two middle photos show that the treatment still provided a high contrast with the existing pavement while the two photos on the bottom show that some cracks had already started to develop. As discussed earlier, this is to be expected since the larger amount of sand is likely resulting in the binder being subjected to much higher strains within the seal coat.

Figure C-60 Condition of Kaweloka Street section 2, treated with Liquid Road, on 3/27/2015.

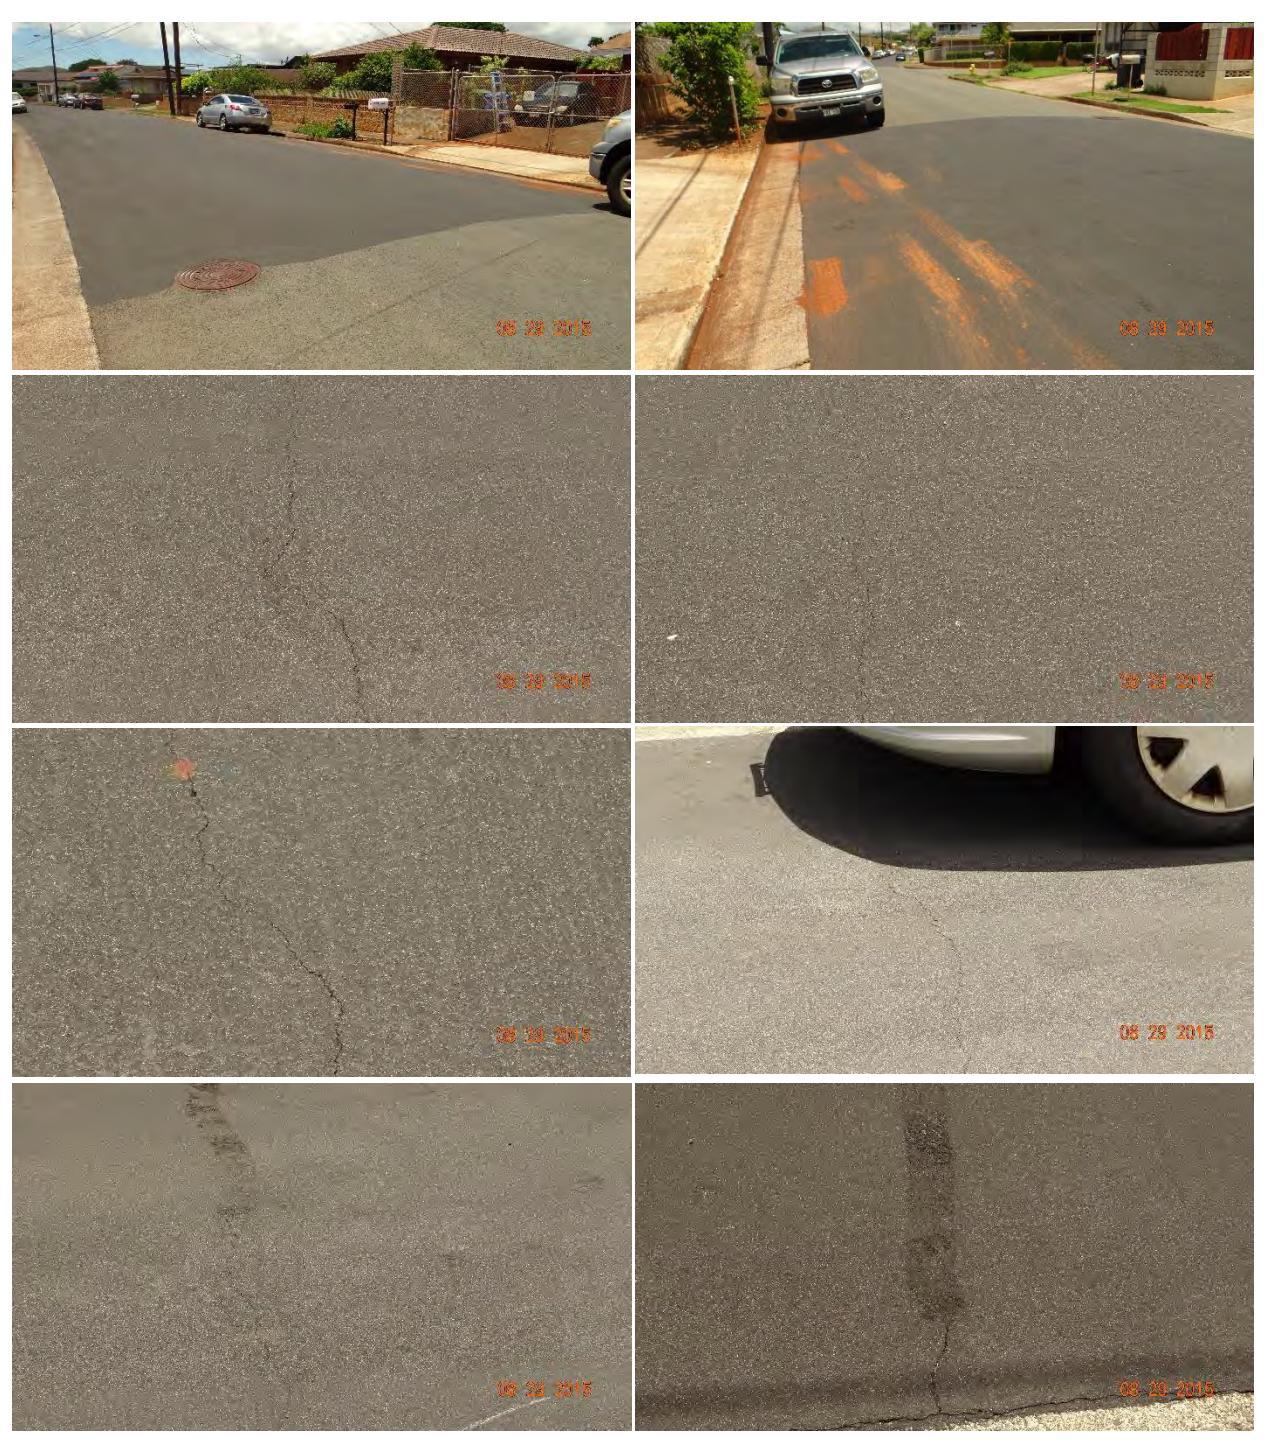
The top two photos in Figure C-61 show that on 8/29/2015, nine months after its application, Liquid Road still provided the appearance of a new road. The top middle photos show the appearance of many new very thin cracks. On the other hand, the two photos on the bottom show existing cracks that continue propagating.

Figure C-61 Condition of Kaweloka Street section 2, treated with Liquid Road, on 8/29/2015.

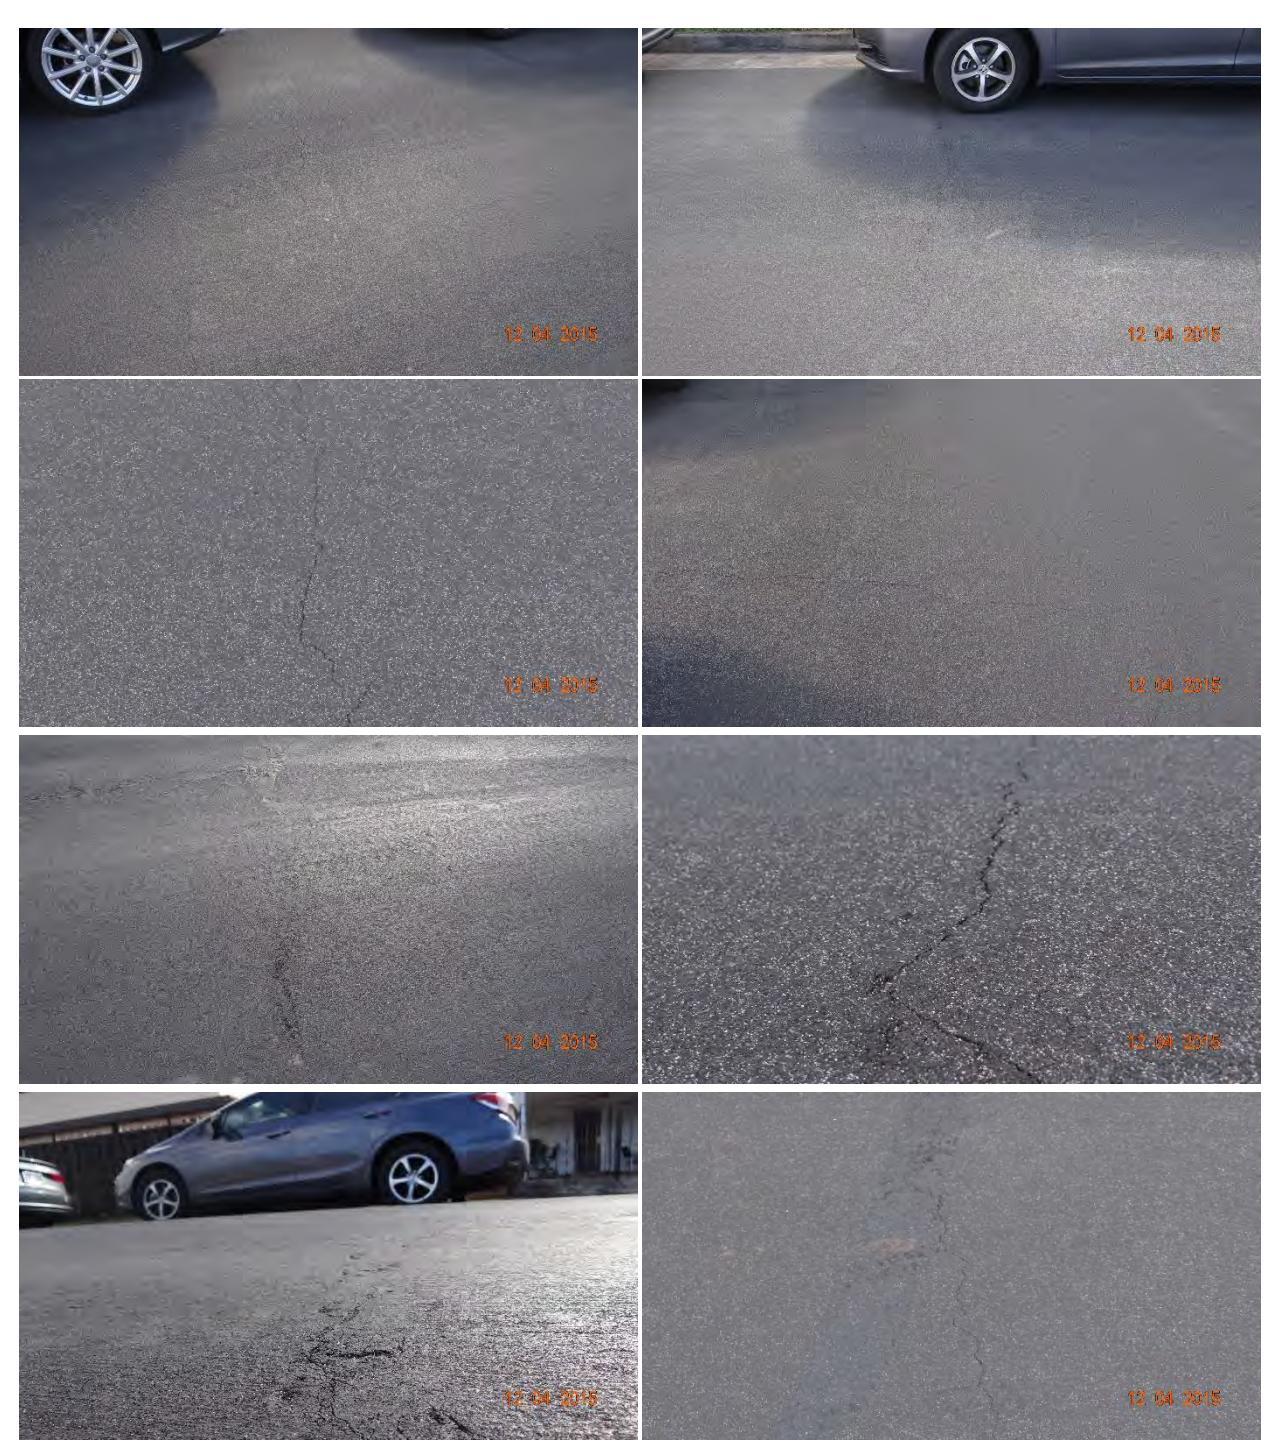
The conditions in Figure C-62 illustrate that on 12/4/2015, almost a year after its application, this treatment still provided a general new surface like appearance. However, additional thin new cracks continued appearing and some other cracks started to get wider. The two photos at the bottom illustrate that the seal coat often cracked on top of a sealed crack and in other cases the cracks diverged from a sealed crack. At this early stage, it was believed no water could infiltrate through these cracks. However, it is difficult to ascertain when that occurs.

Figure C-62 Condition of Kaweloka Street section 2, treated with Liquid Road, on 12/4/2015.

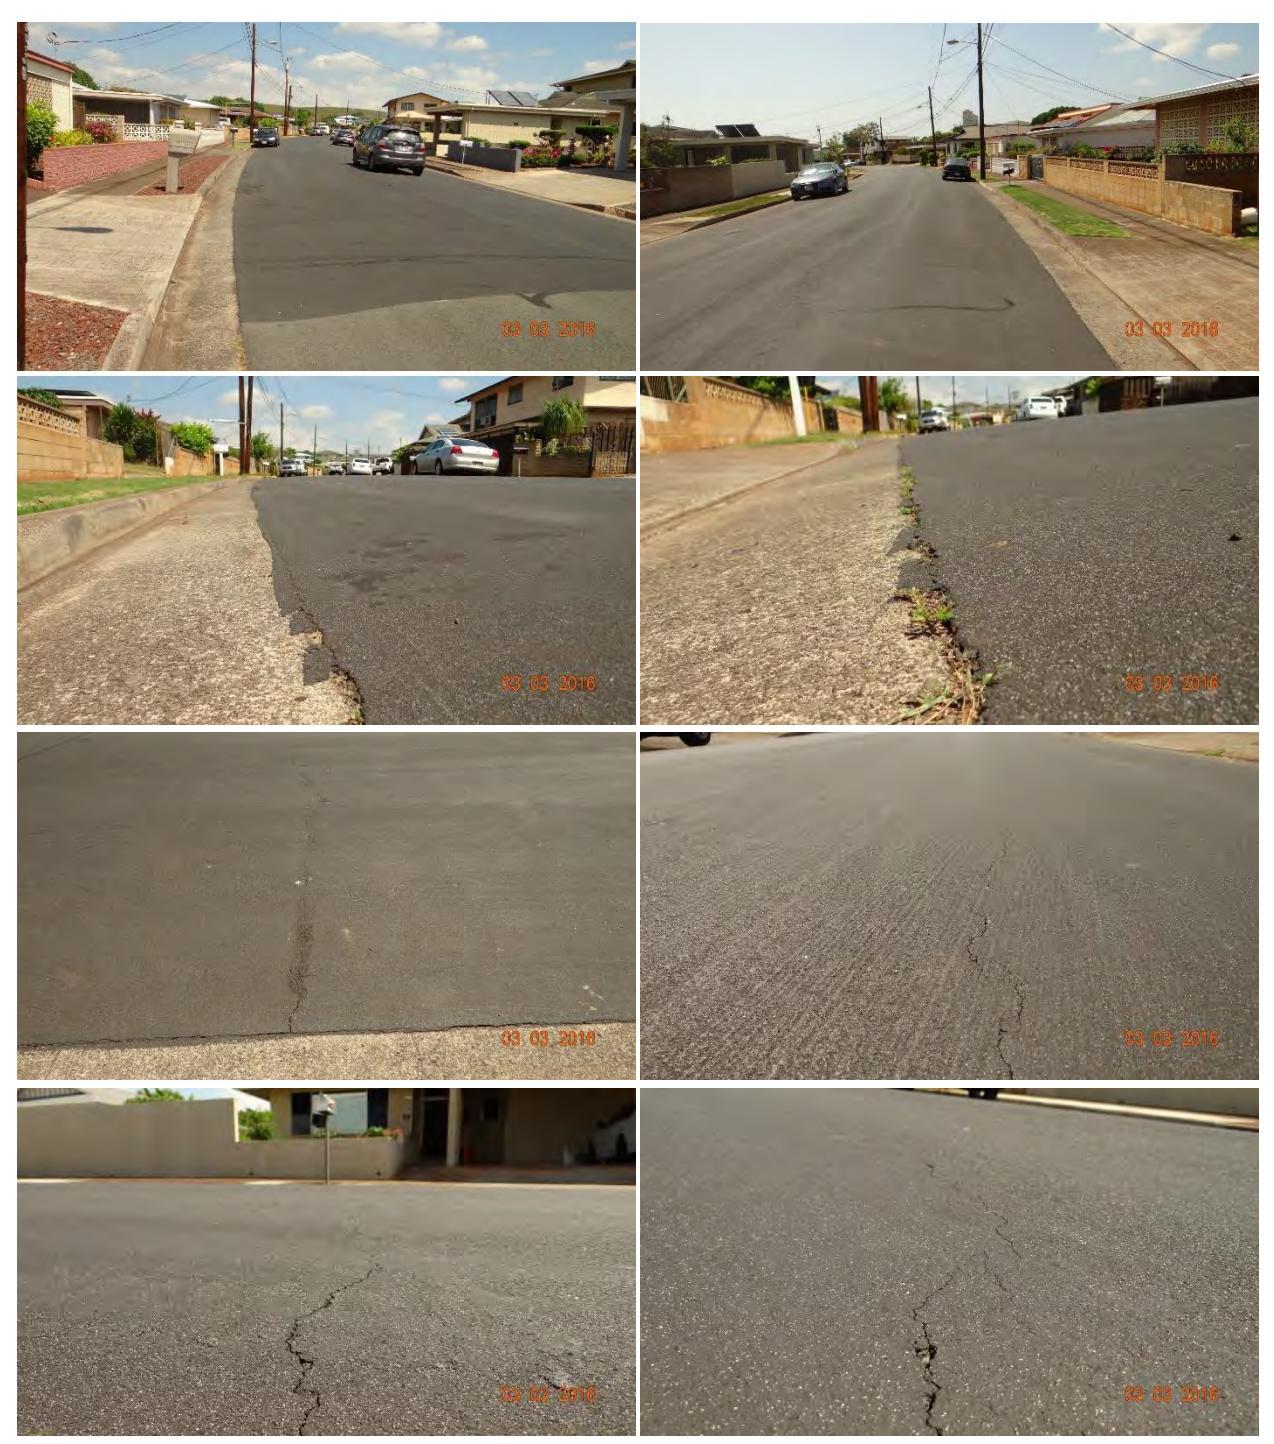
Figure C-63 shows the Liqui Road condition on 3/3/2016, 15 months after its application. The two photos at the top still show a high contrast with the untreated section and an overall good appearance. The two photos on the second row show the condition of the treatment at the joint with the gutter. It is seen that if the joint is not sealed with a crack sealer, any excess seal coat material left on top of the joint will be broken off eventually, exposing the joint to moisture, as indicated by the vegetation growth. The photo on the left on the third row illustrate how the seal had cracked on top of sealed cracks and how those cracks continued propagating beyond the sealed crack portion. This is common to all seal coats in this study, which indicates that none of them would prevent the additional cracking that would eventually occur with or without seal coat. The photo on the right shows the appearance of new longitudinal load related cracks. Finally, the last two photos in Figure C-63 show some of the cracks getting wider and developing some spalling.

Figure C-63 Condition of Kaweloka Street section 2, treated with Liquid Road, on 3/3/2016.

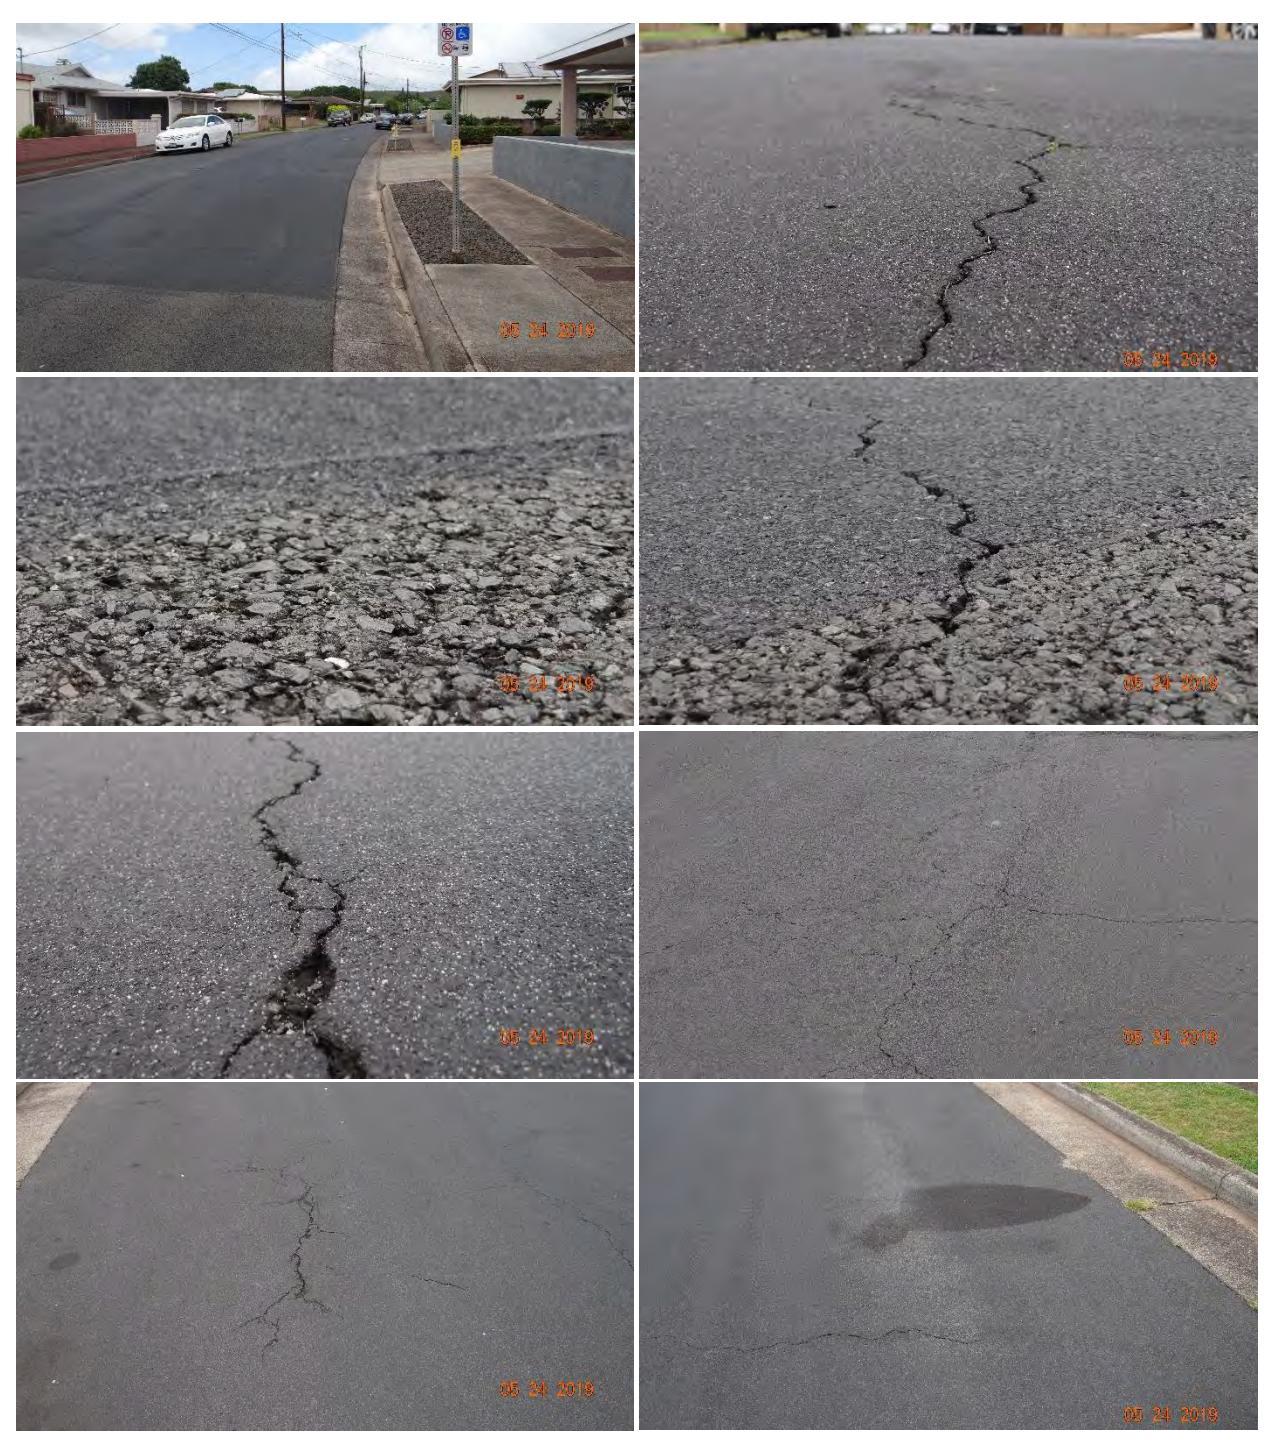
Finally, Figure C-68 shows the conditions of the treatment on 5/24/2019, 4.5 years after the treatment application. Although not measured, it is apparent that cracking had continued growing slowly in length and severity. Some of the cracking was now changing into a fatigue cracking pattern. There were also areas where the material was starting to show signs of wearing. Nevertheless, as seen in some of the photos in this figure, the pavement texture was still substantially better than the texture of the untreated section. Clearly, the material was still helping to arrest aggregate losses.

Figure C-68 Condition of Kaweloka Street section 2, treated with Liquid Road, on 5/24/2019.

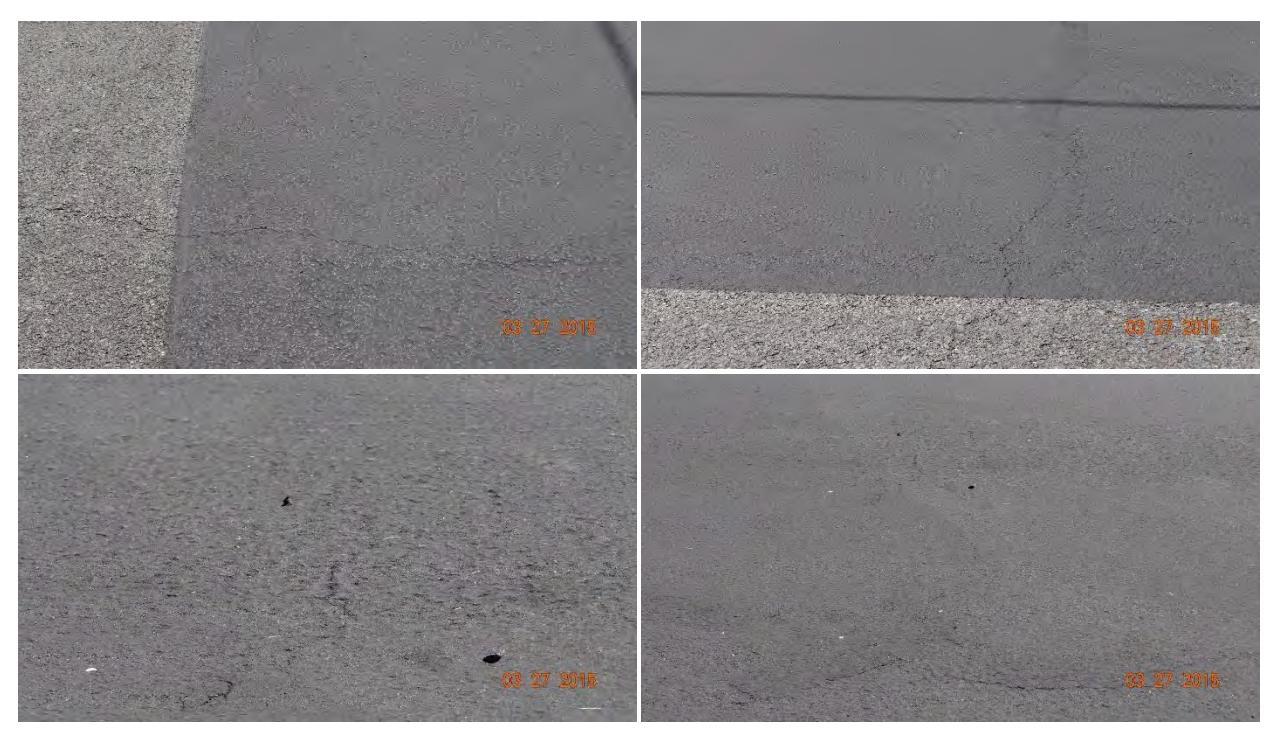
Figure C-69 shows the appearance of the treatment on 3/27/2015, fourth months after its application. This treatment exhibited a uniform appearance. The two top photos show the high contrast and different textures of the treated and untreated surfaces (later photographs provide a better illustration of the differences in texture). The two photos on the bottom illustrate that this treatment does not hide existing defects on the pavement. This is also better illustrated in later photographs. Note that this is common to the other seal coats monitored in this study ("seal coats" as used in Hawaii, which does not include treatments such as Chip Seals), except for Liquid Road that to a certain extent has a better ability to hide defects because of its thicker application.

Figure C-69 Condition of Kaweloka Street section 3, treated with MasterSealTM RTU, on 3/27/2015.

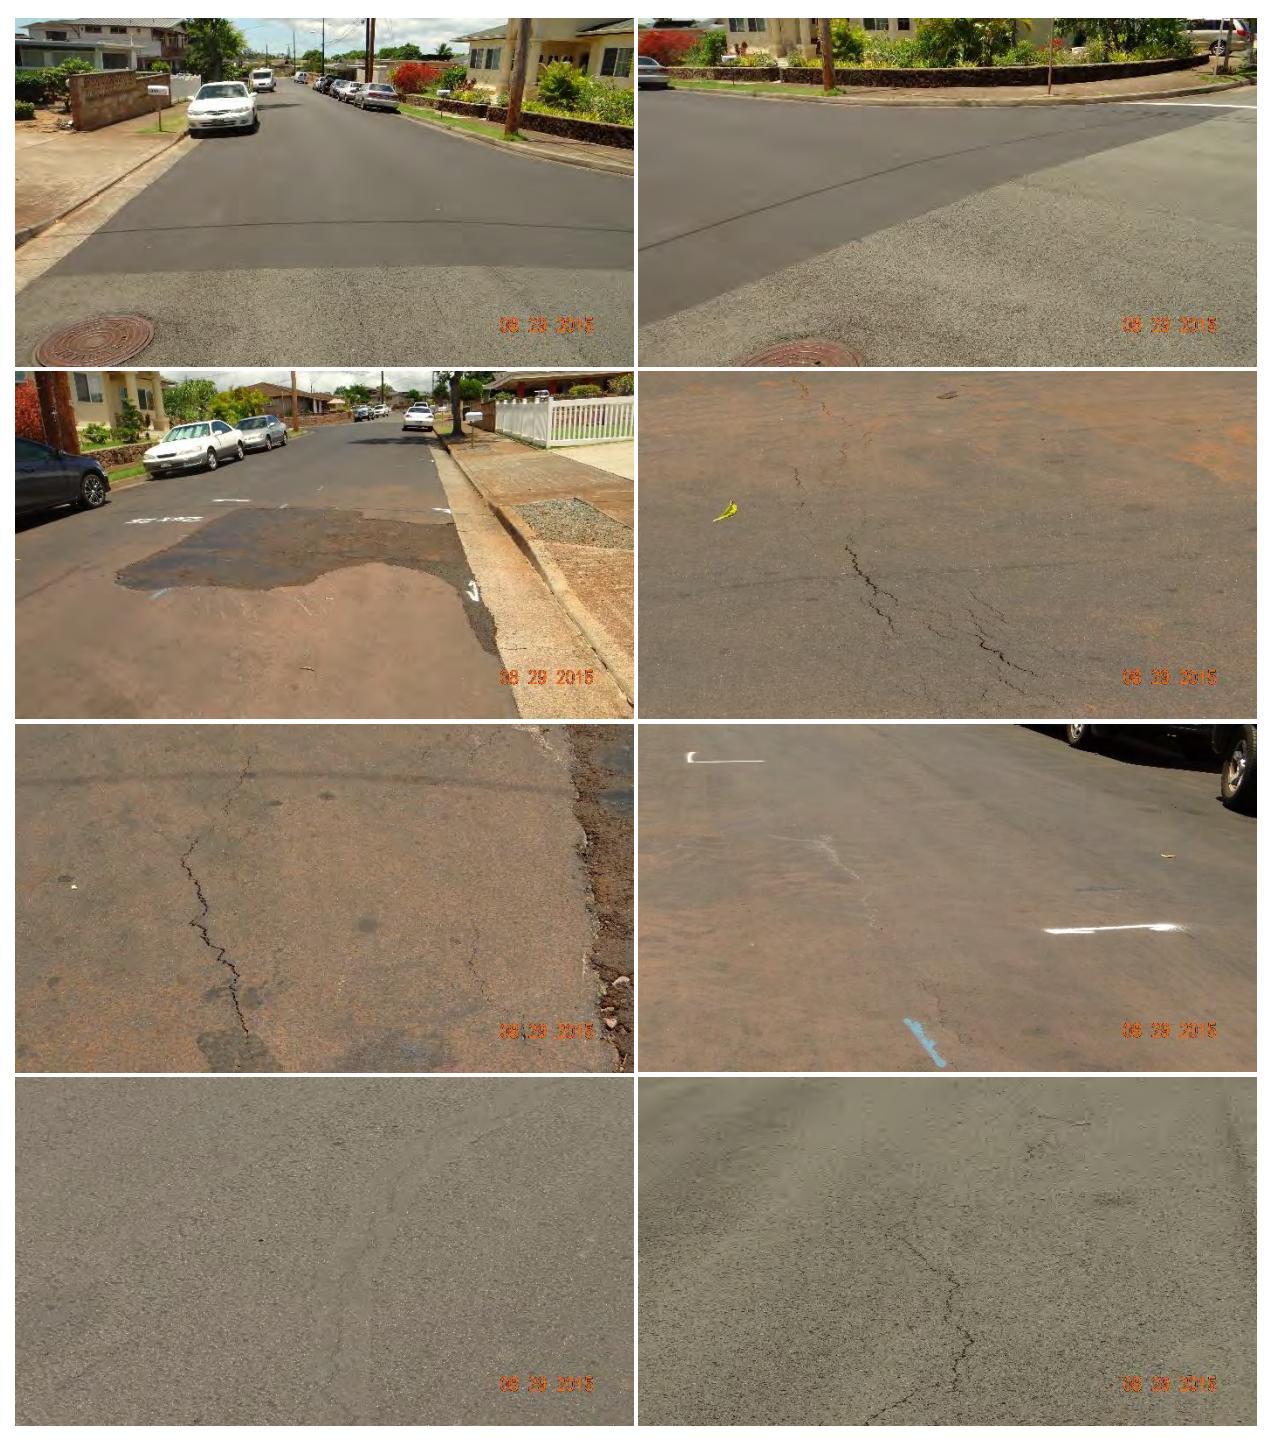
Figure C-70 shows the section condition on 8/29/2015, about 10 months after the treatment application. Again, the top two photos show the high contrast between the treated and untreated surfaces, with the treated surface having a much closer appearance to a new pavement. Unfortunately, as illustrated in the middle four photos, the Board of Water Supply apparently had to patch an area affected by a water main break. As shown in some of these photographs, significant cracking was developing around that area. Therefore, as explained earlier, the portion around this area believed to be affected by the water main break was excluded from the measurements in the section and compensated with measurement on a portion on one of its ends that had been treated with a single coat only. The two photos at the bottom illustrate sealed cracks that were still sealed and some new cracks (outside the area affected by the patching).

Figure C-70 Condition of Kaweloka Street section 3, treated with MasterSealTM RTU, on 8/29/2015.

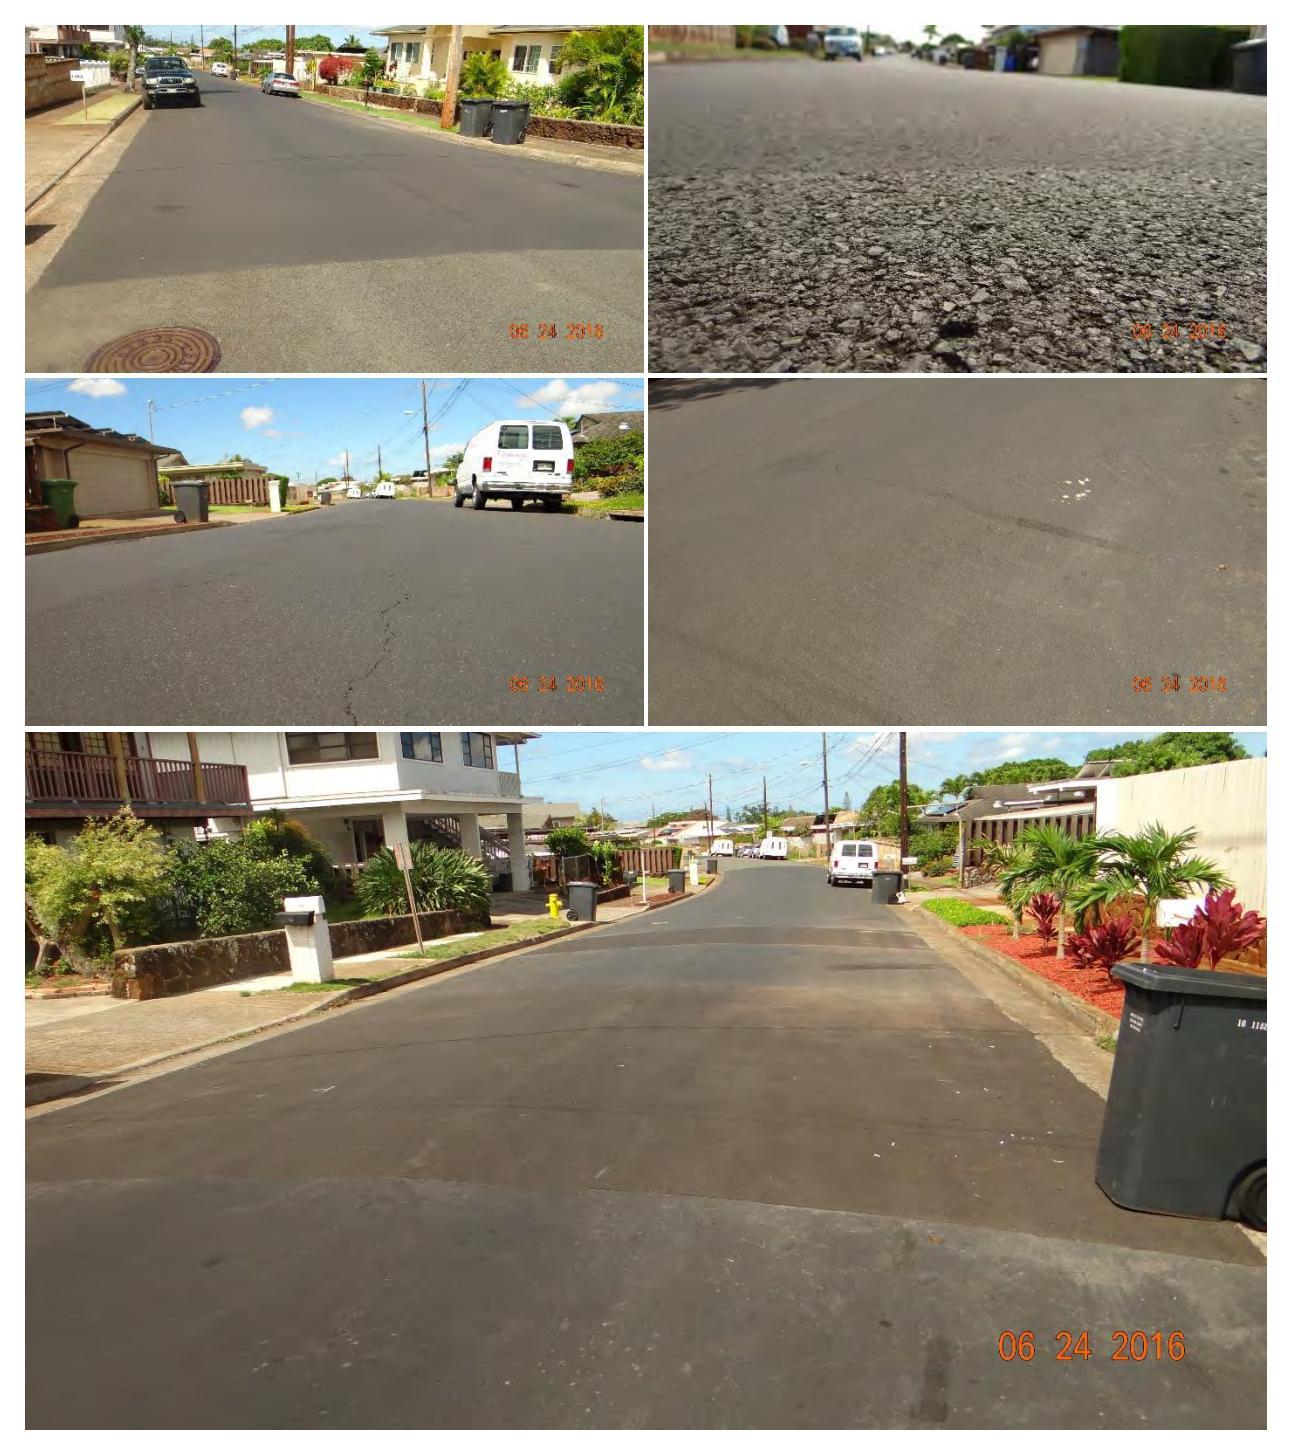
The photo on the top left of Figure C-71 shows that substantial differences in texture and appearance between the treated and untreated surfaces was maintained as of 6/24/2016, 18 months after the treatment application. This is highlighted in the closeup photo on the top right of the figure. The photo on the left of the second row shows the development of a new load related longitudinal crack upstream of the patched area, whereas the photograph on the right

illustrates that this type of treatment cannot hide existing pavement defects. Finally, the bottom photograph shows that a more permanent set of patches had been performed around the water main break area.

Figure C-71 Condition of Kaweloka Street section 3, treated with MasterSealTM RTU, on 6/24/2016.

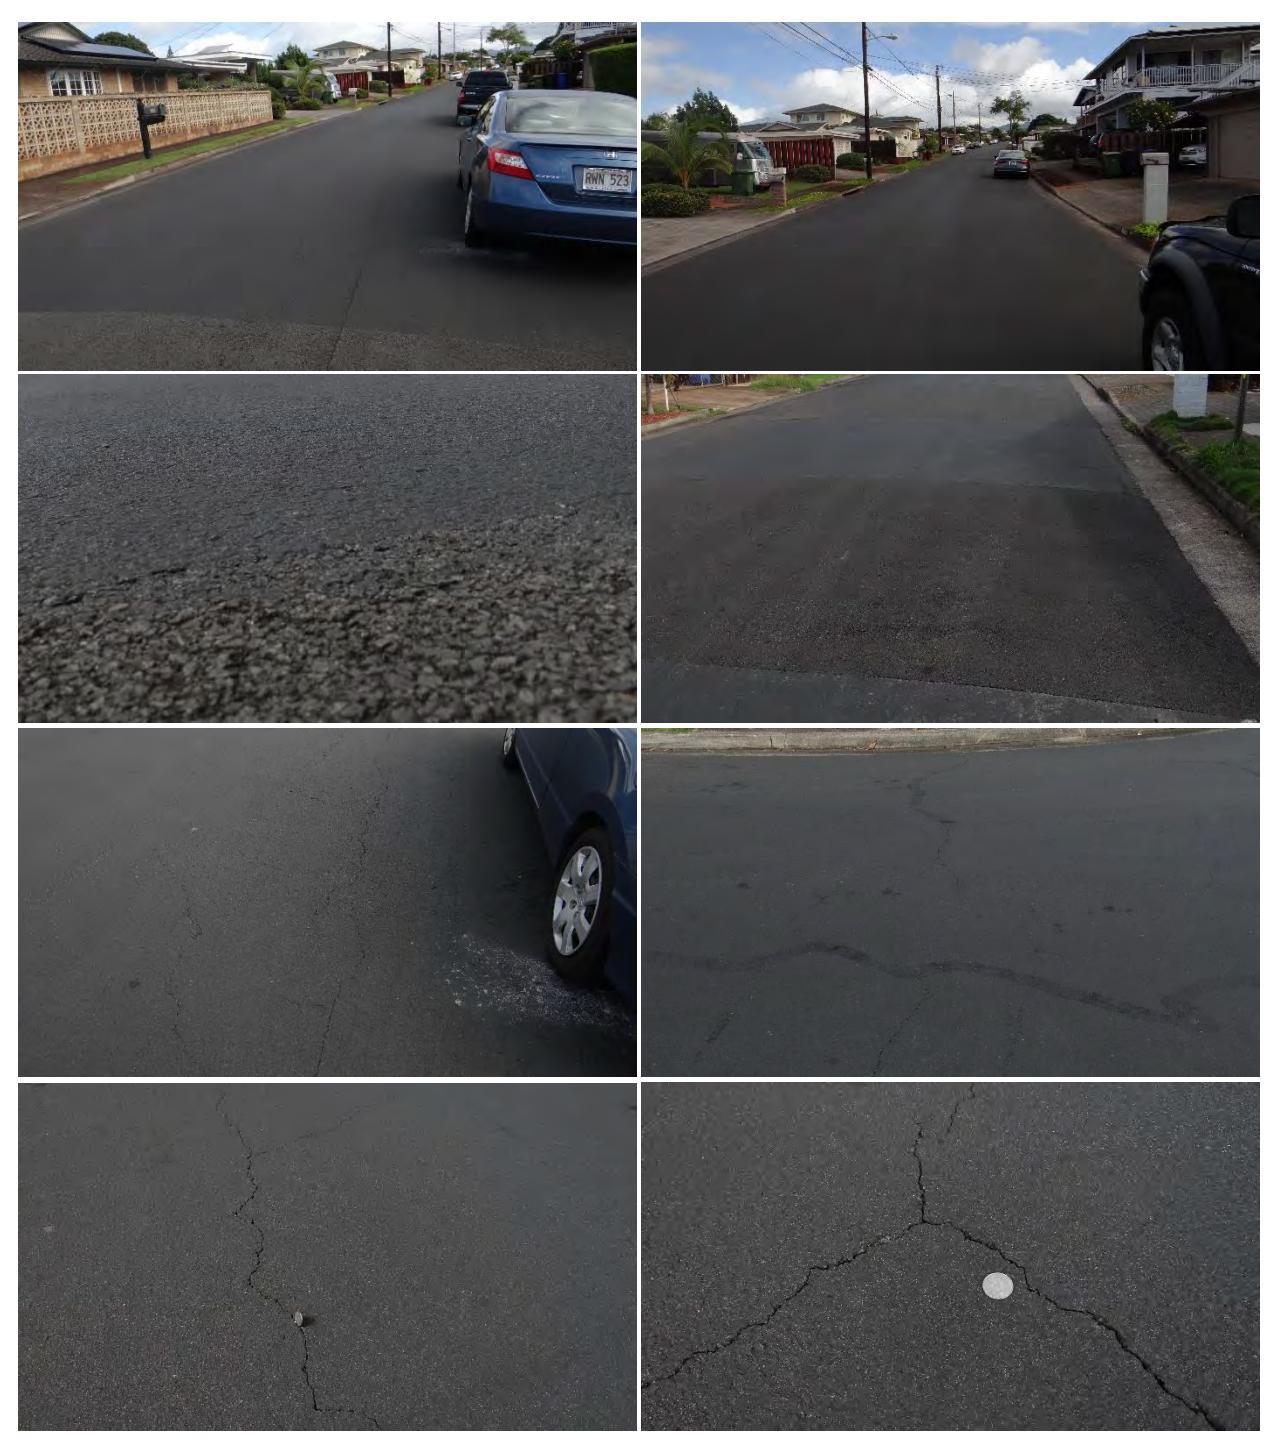
Figure C-72 shows that similar conditions were observed on 12/13/2016, slightly more than two years after the treatment application. As illustrated by the four top photos, except for the patched area, the section still had a new appearance without the pitting and raveling of the untreated surfaces. Nevertheless, as shown in the four bottom photos, cracking was still progressing relatively quickly. However, at this stage, most of the cracks were very thin.

Figure C-72 Condition of Kaweloka Street section 3, treated with MasterSealTM RTU, on 12/13/2016.
Figure C-73 and Figure C-74 show the conditions on 1/26/2018, 38 months after the treatment application. The top left photo of Figure C-73 clearly shows that there was still a sharp contrast between the treated and untreated surfaces. This is not the case on the photo on the top right, where some fading of the treatment is observed. It is important to note that, at the request of neighbors, this was the portion that was extended from the original plan but was treated with a single coat. The closeups in the photos of the second row show more clearly how the treatment was being washed out in some places, most likely by large amounts of water running down the gutter and the adjacent pavement at high speed. This was an unplanned experiment, but it clearly highlights the benefit of the application of two coats. However, as shown on the left photo on the third row of Figure C-73, some fading of the seal coat was also noted upstream of the patched area. While the patched area itself showed no cracking (right photo on the third row), the last two photos show that the treated area around it show some incipient fatigue cracking. However, this may not be attributable solely to the patch, since as shown in Figure C-74, fatigue cracking was starting to develop throughout the treated section. Recall from Figure 4-14 that the cracking length on this section was large, but as seen in these photographs they were still generally thin. Nevertheless, some signs of pumping were noted, which again brings into question the appropriateness of the design HMA thickness.
