PERFORMANCE MONITORING OF PRESERVATION TREATMENTS IN HONOLULU

FINAL PROJECT REPORT

Adrián Ricardo Archilla University of Hawaii at Manoa

May 2019

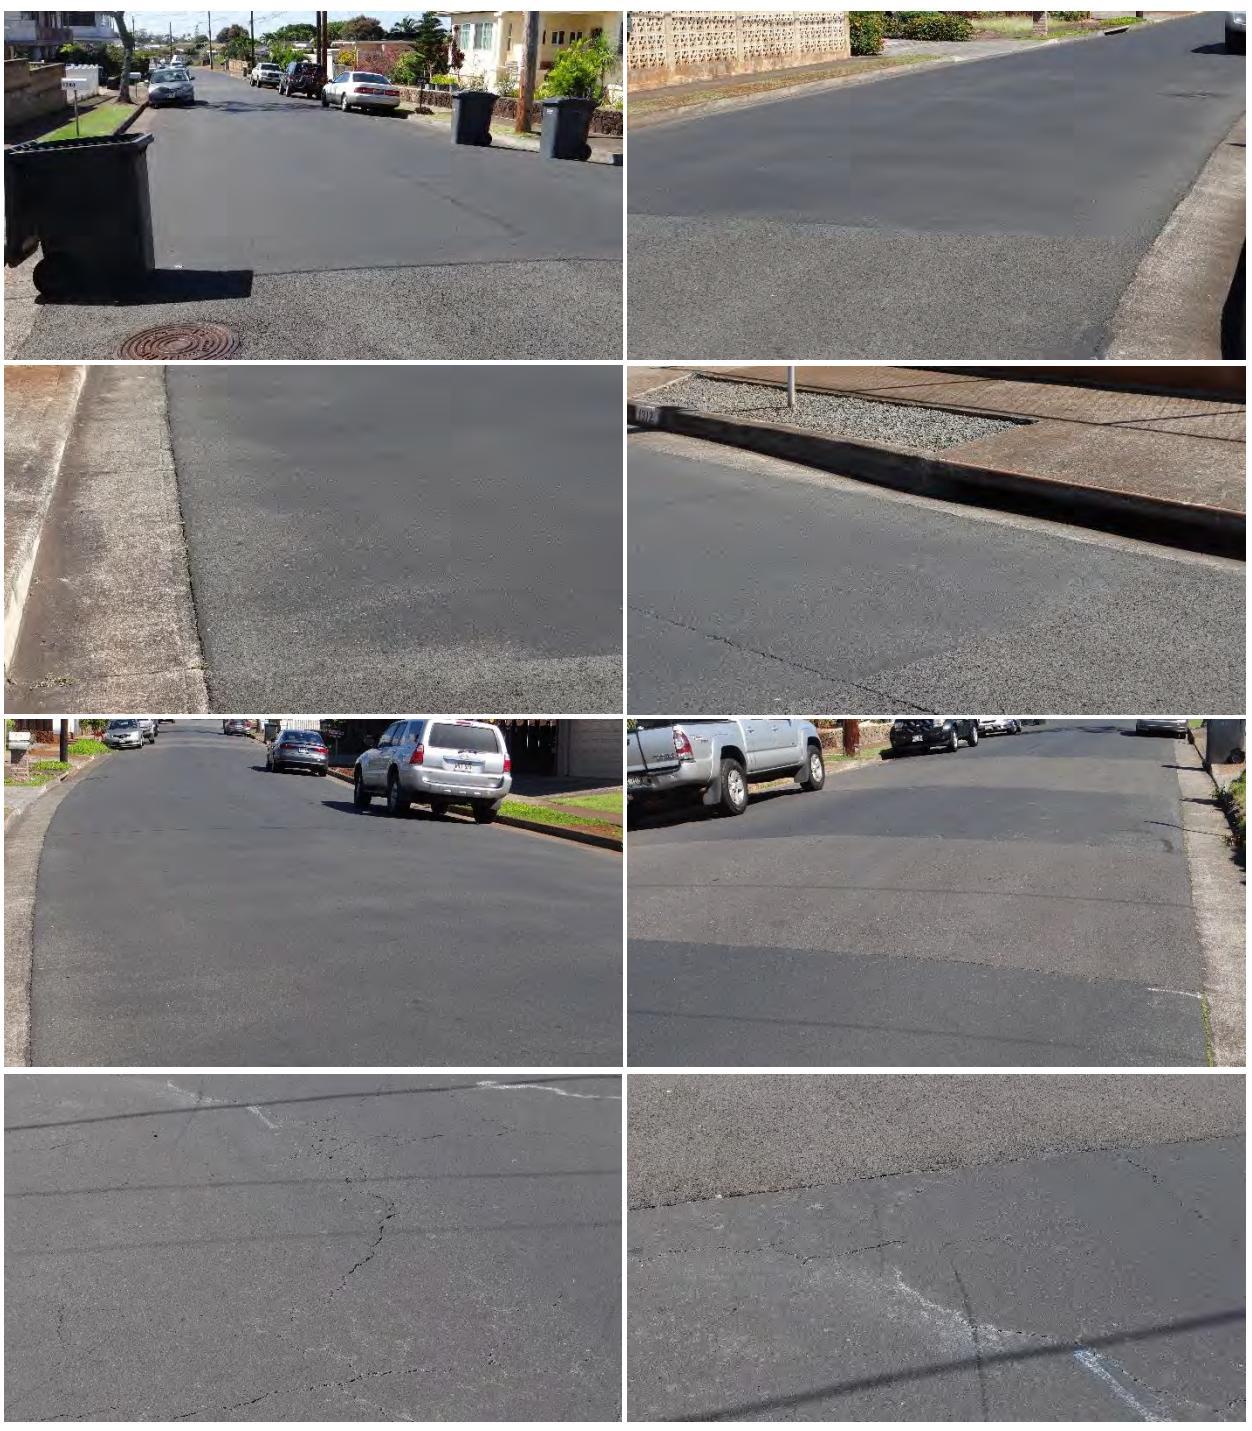
Figure C-72 Condition of Kaweloka Street section 3, treated with MasterSealTM RTU, on 12/13/2016.
Figure C-73 and Figure C-74 show the conditions on 1/26/2018, 38 months after the treatment application. The top left photo of Figure C-73 clearly shows that there was still a sharp contrast between the treated and untreated surfaces. This is not the case on the photo on the top right, where some fading of the treatment is observed. It is important to note that, at the request of neighbors, this was the portion that was extended from the original plan but was treated with a single coat. The closeups in the photos of the second row show more clearly how the treatment was being washed out in some places, most likely by large amounts of water running down the gutter and the adjacent pavement at high speed. This was an unplanned experiment, but it clearly highlights the benefit of the application of two coats. However, as shown on the left photo on the third row of Figure C-73, some fading of the seal coat was also noted upstream of the patched area. While the patched area itself showed no cracking (right photo on the third row), the last two photos show that the treated area around it show some incipient fatigue cracking. However, this may not be attributable solely to the patch, since as shown in Figure C-74, fatigue cracking was starting to develop throughout the treated section. Recall from Figure 4-14 that the cracking length on this section was large, but as seen in these photographs they were still generally thin. Nevertheless, some signs of pumping were noted, which again brings into question the appropriateness of the design HMA thickness.

Figure C-73 Condition of Kaweloka Street section 3, treated with MasterSealTM RTU, on 1/26/2018.

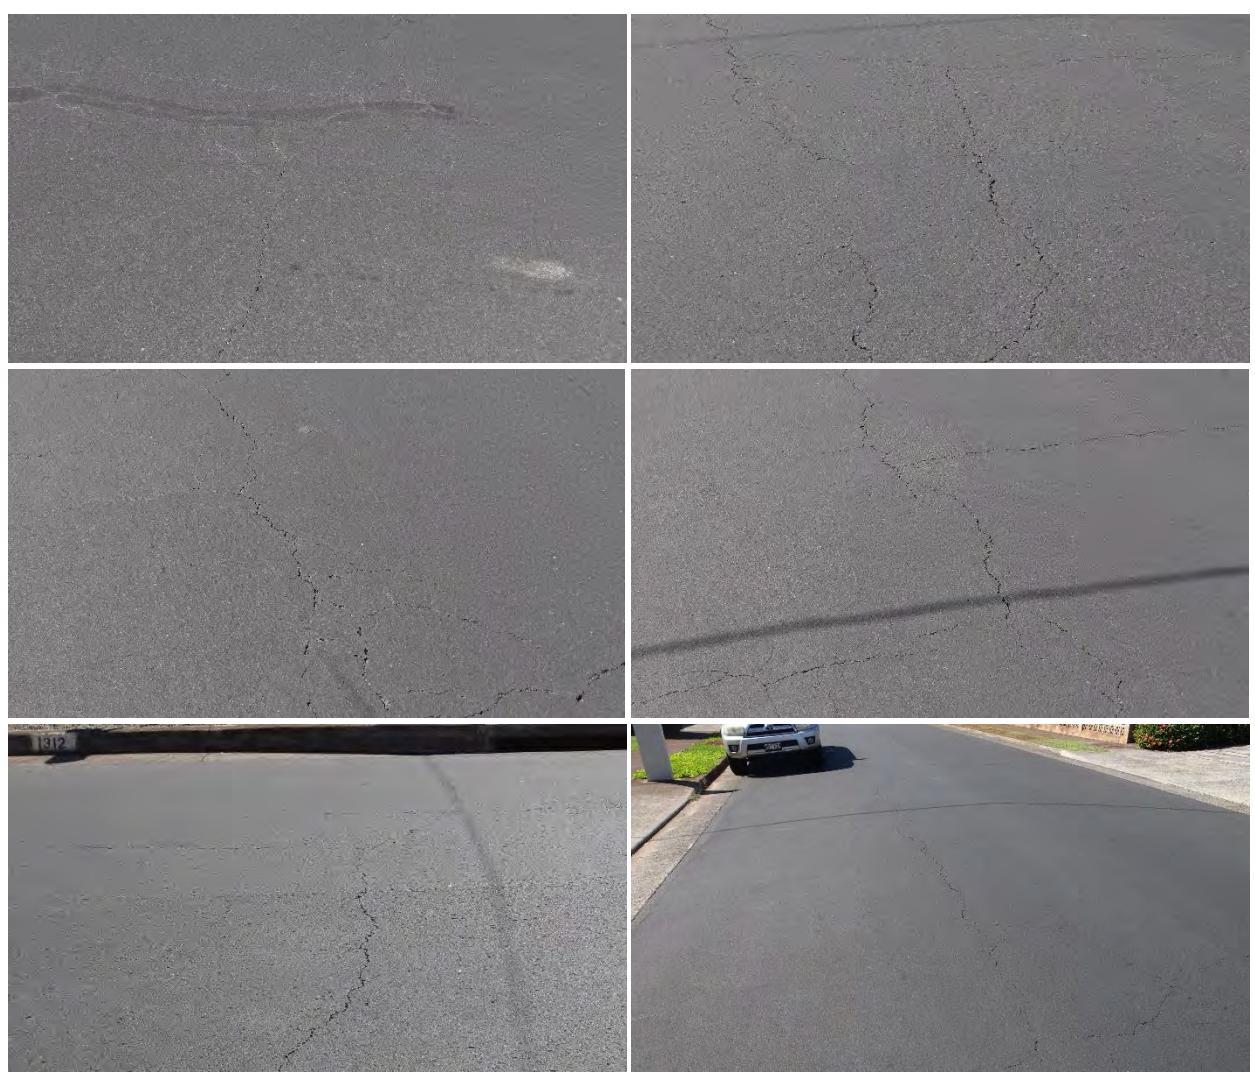
Figure C-74 Condition of Kaweloka Street section 3, treated with MasterSealTM RTU, on 1/26/2018.

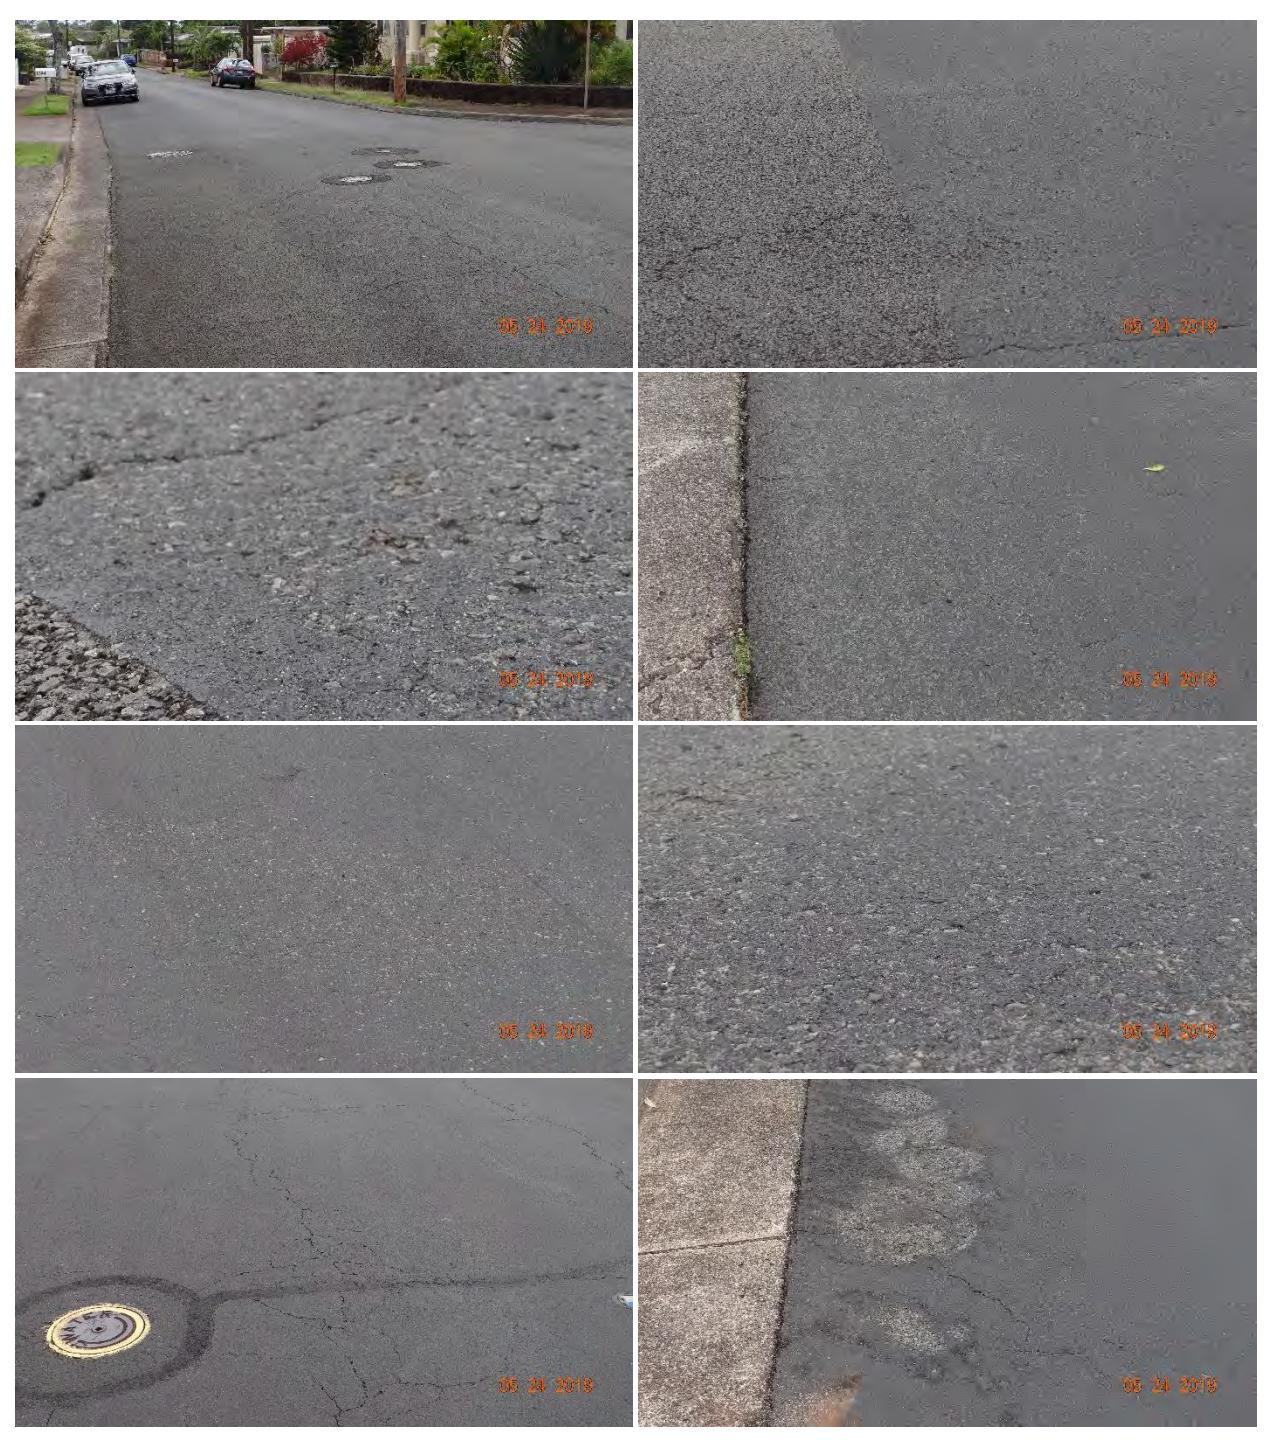
Figure C-75 shows the conditions on 5/24/2019, 4.5 years after the treatment application. There was still contrast between the untreated and treated surfaces. There were further signs of wearing off the treatment in the areas with two coats, but the texture still showed much less loss of aggregate and/or mastic. As noted earlier, fatigue cracking had continued its development. Only one photo is shown but it was now much more widespread (again, on this survey, cracking was not quantified). The figure also shows an example of the consequences of some type of solvent leaked into the surface. In the small area shown, the treatment was all but gone (of course, the problem was not the seal coat but whatever was pour on top of it).

Figure C-75 Condition of Kaweloka Street section 3, treated with MasterSealTM RTU, on 5/24/2019.

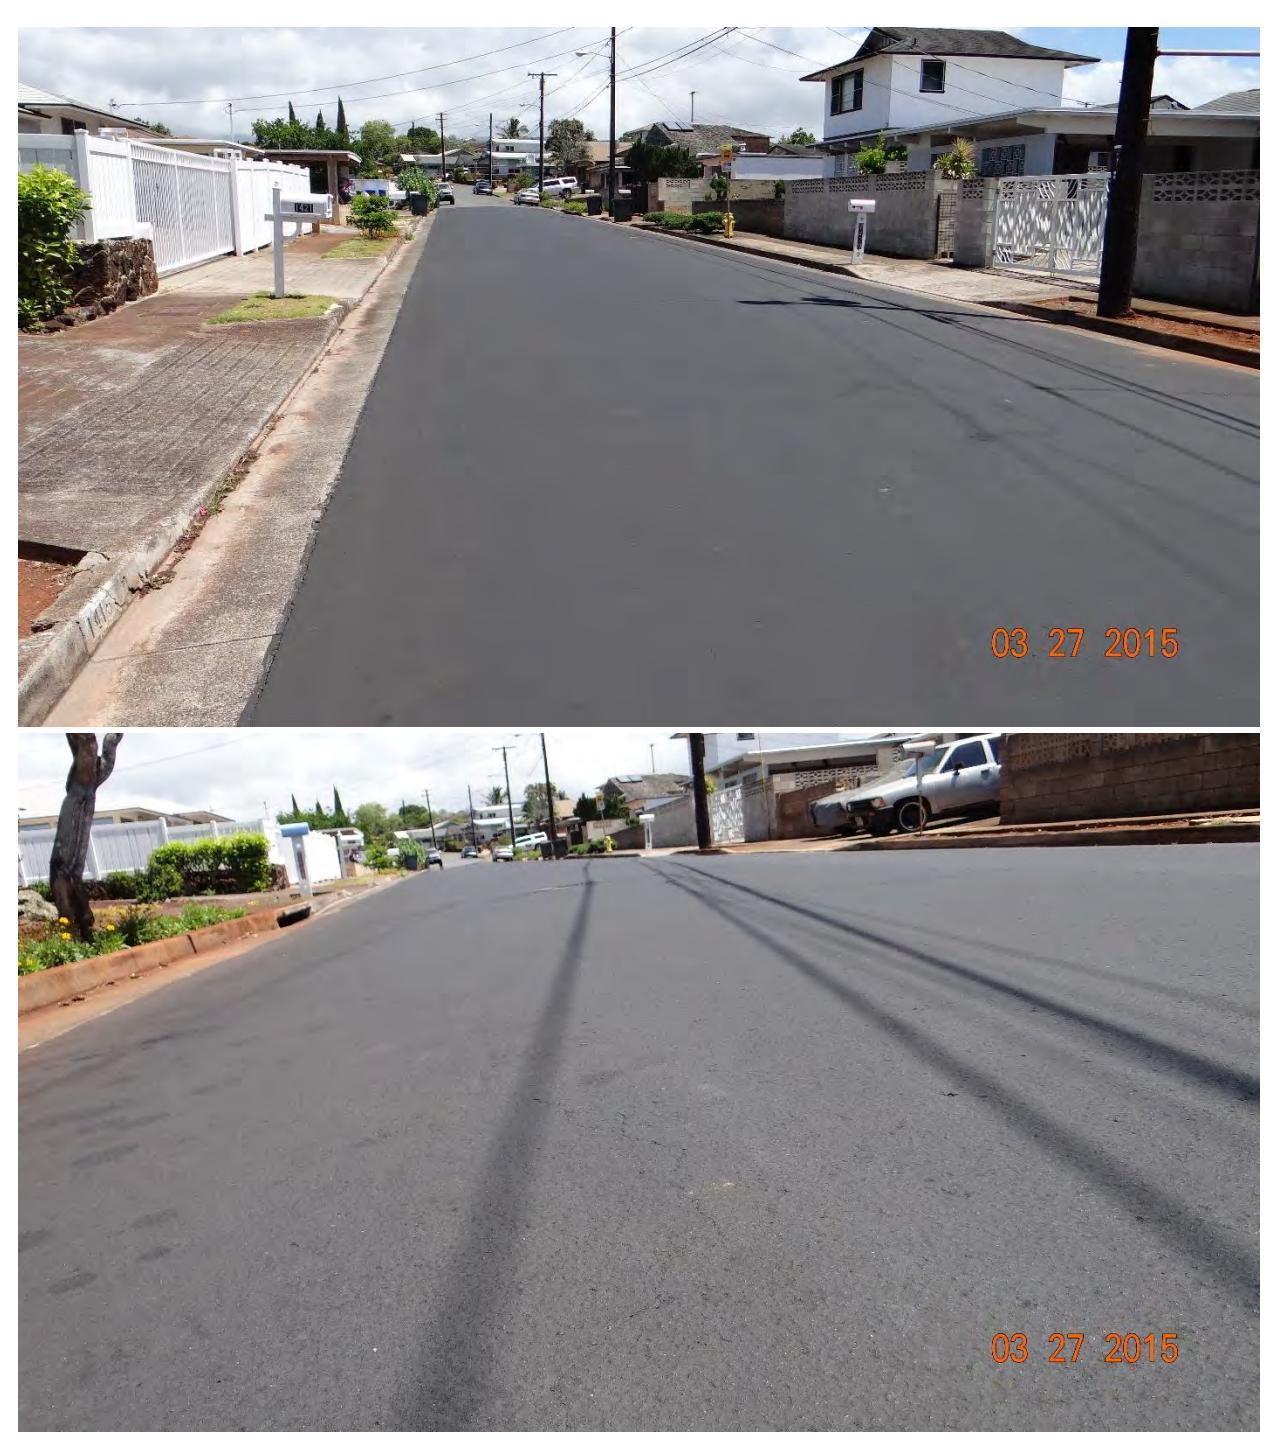
Figure C-76 shows the appearance of the treatment on 3/27/2015, fourth months after its application. The top photo shows a nice and uniform appearance of the treatment shortly after its application. As with other treatments, this makes the pavement look more like a new road. However, the photo on the bottom shows that new cracking was already happening. Recall that this section exhibited the largest increase of cracking over the study period. Figure C-76 also illustrates that the grade of the untreated pavement upstream of the section was even higher than the one on the section. Thus, if water running under the pavement was indeed an issue, this may have created the potential for water to be running under pressure on this section.

Figure C-76 Condition of Kaweloka Street section 4, treated with OptiPave PlusTM RTU, on 3/27/2015.

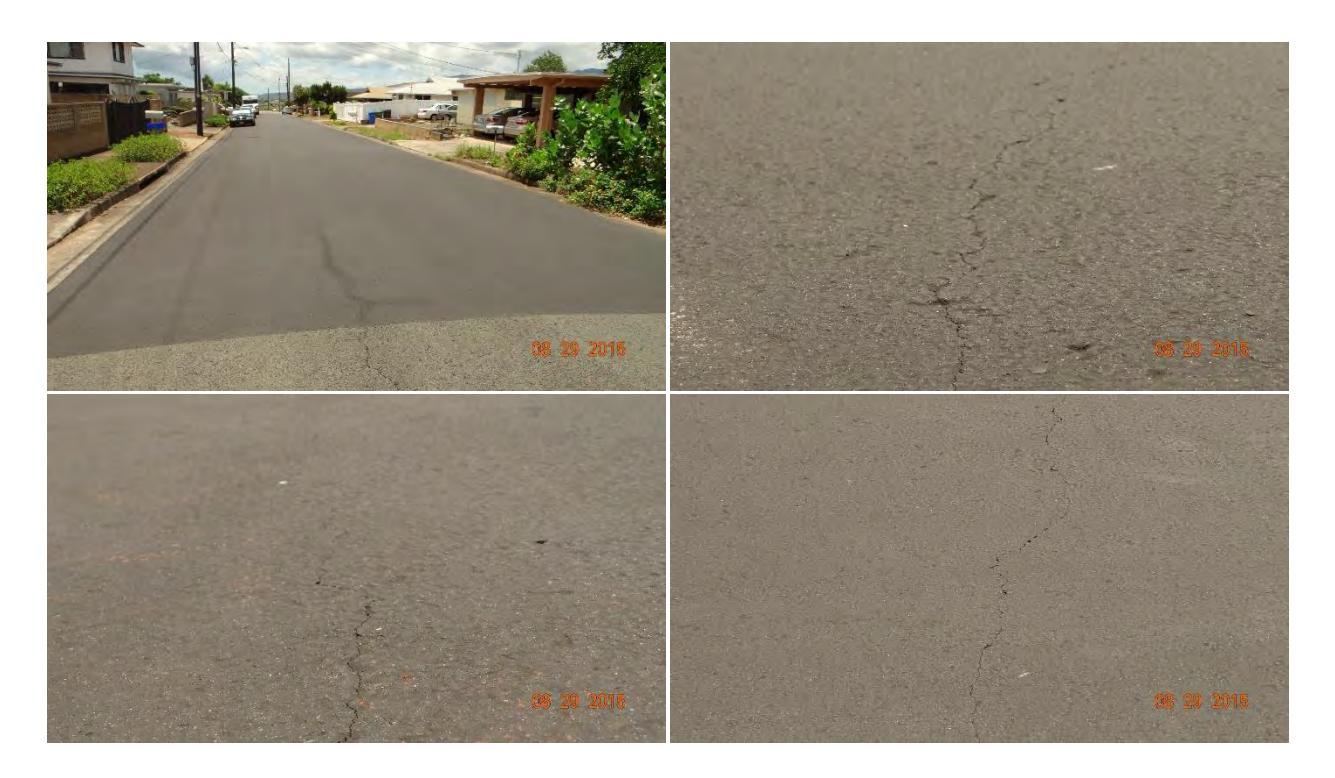
Figure C-77 shows that although the overall appearance of the treatment was maintained on 8/29/2015, 9 months after its application, several new cracks were occurring in several places. The cracking continued to get worse with time, as illustrated in Figure C-78, which shows the conditions on 3/3/2016, 15 months after the treatment application. Some of the photographs in this figure show the cracks getting wider, exhibiting some spalling, and developing a typical fatigue cracking pattern.

Figure C-77 Condition of Kaweloka Street section 4, treated with OptiPave PlusTM RTU, on 8/29/2015.

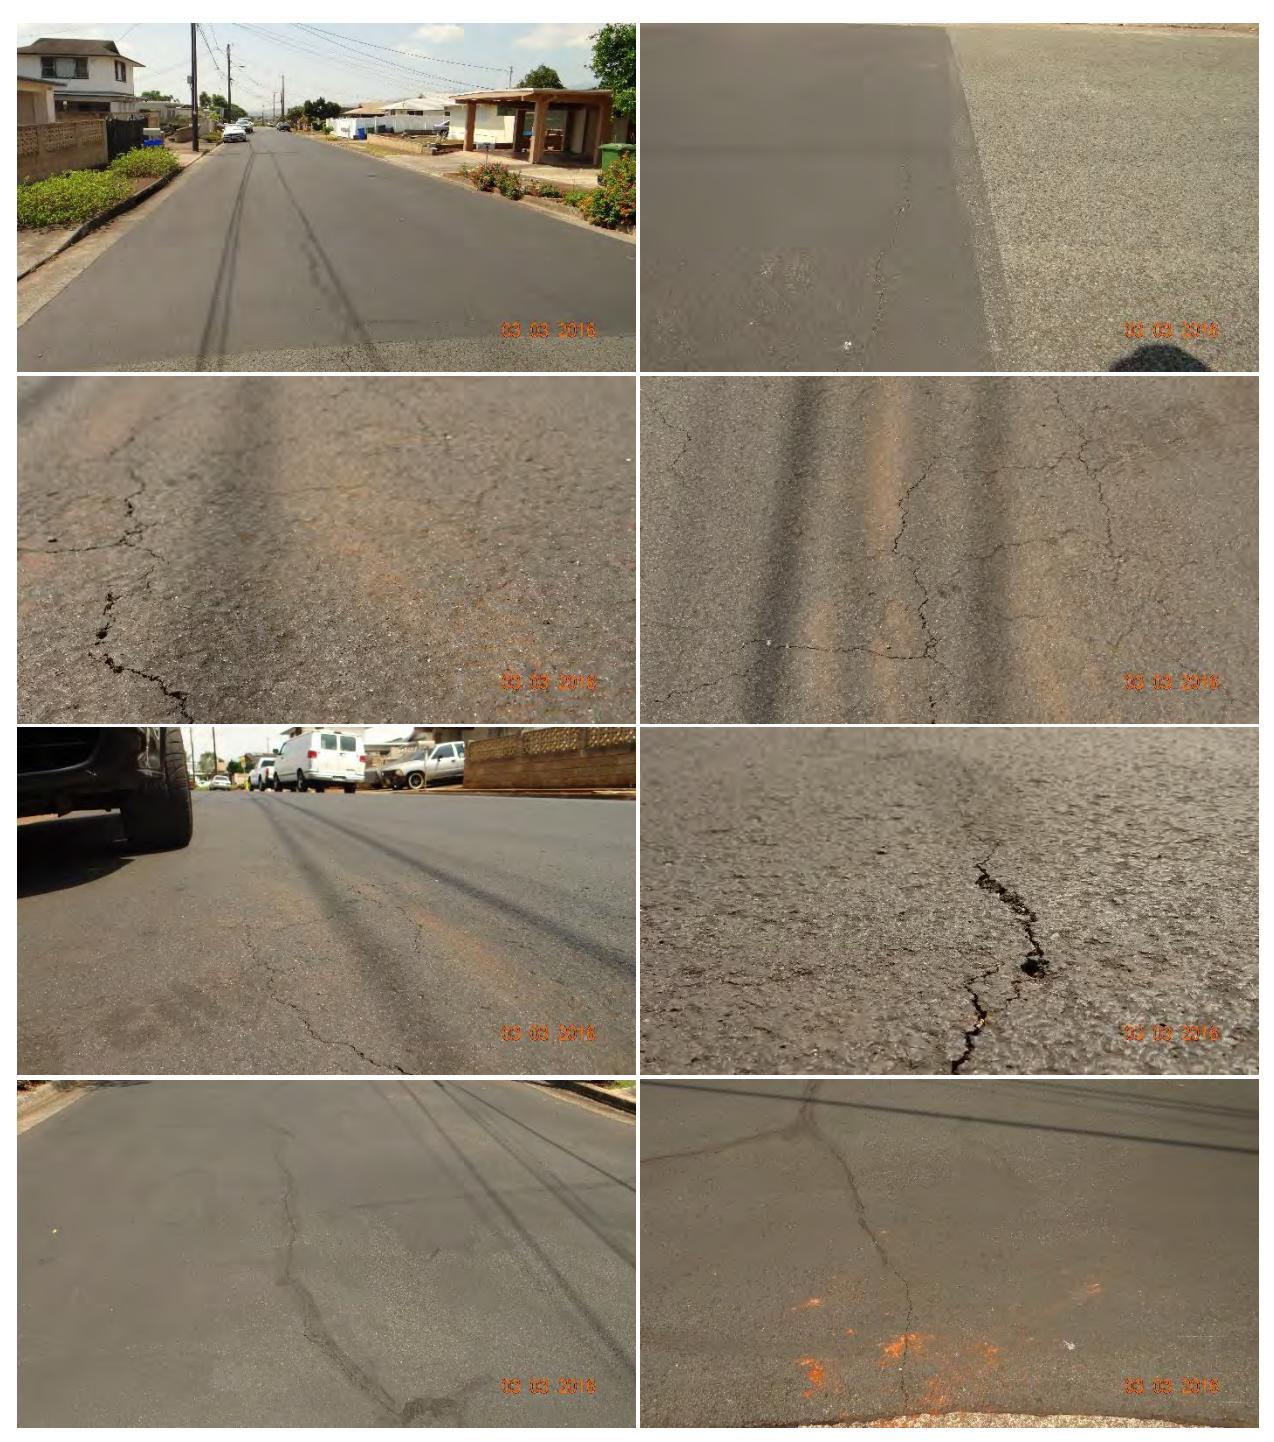
Figure C-78 Condition of Kaweloka Street section 4, treated with OptiPave PlusTM RTU, on 3/3/2016.

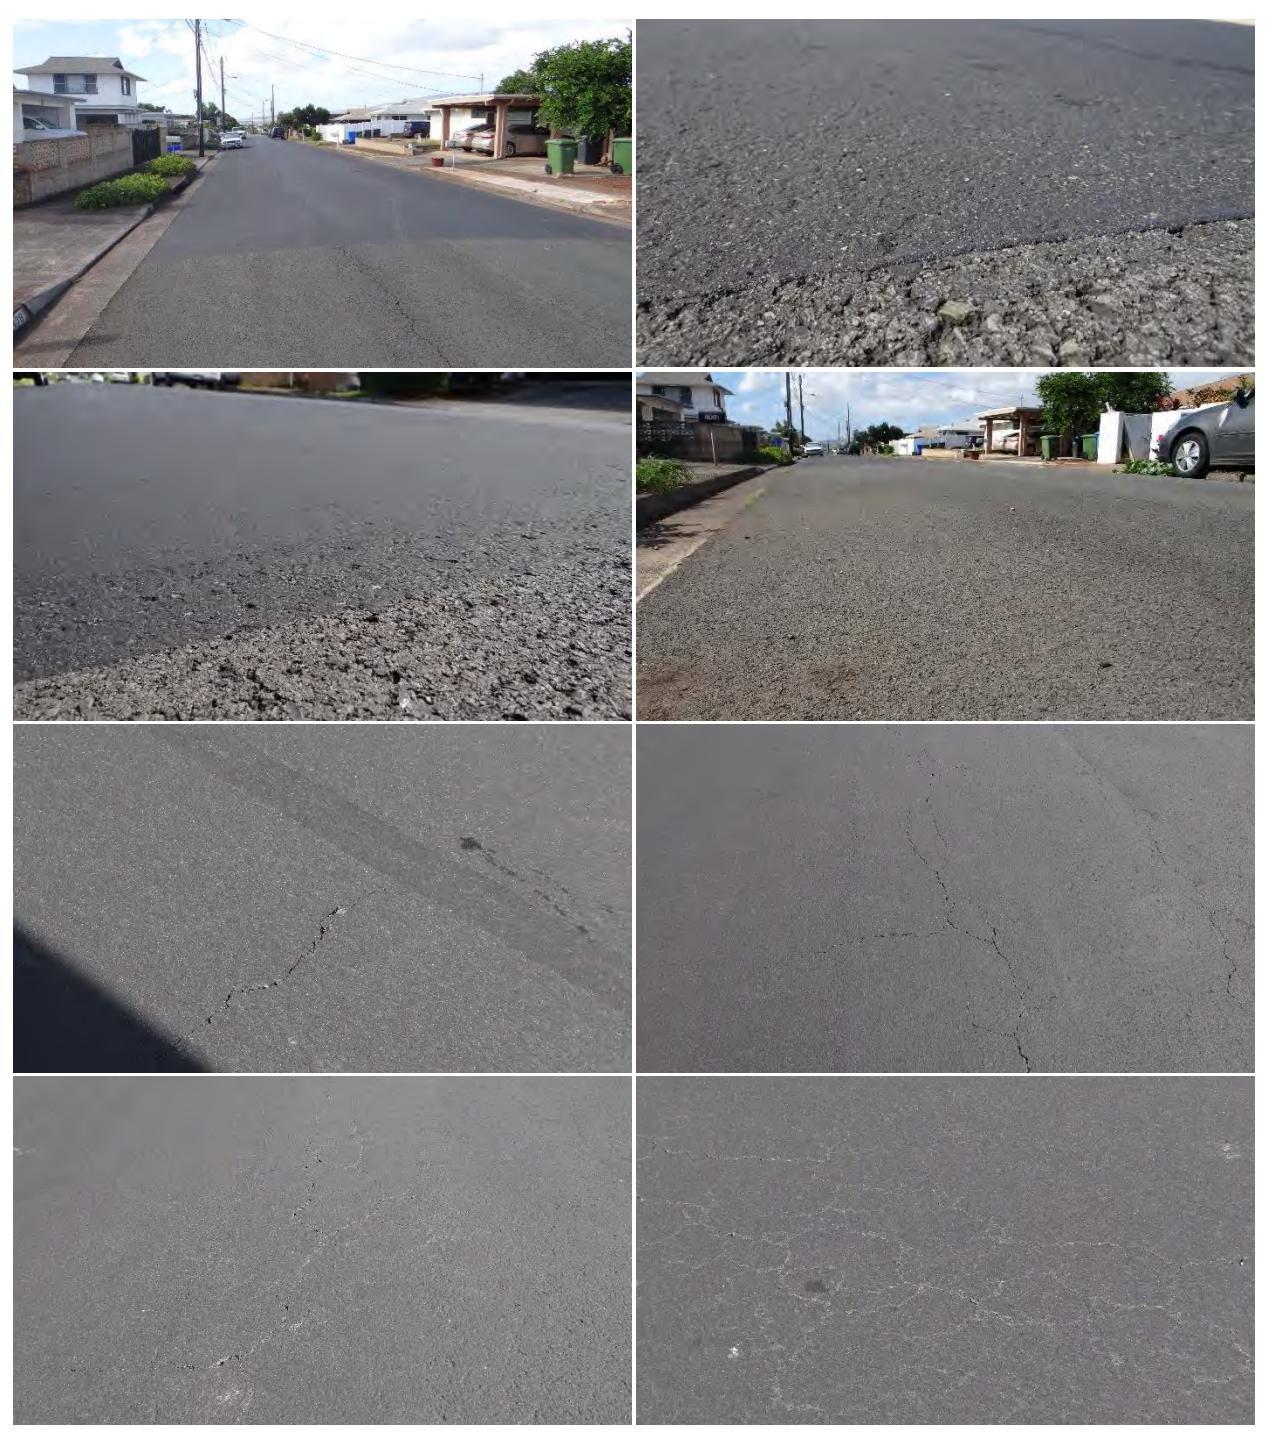
Note that the surface of the treatment itself was still in good condition even after 25 months from its application (12/13/2016). These is illustrated by the top four photos in Figure C-79, which shows the untreated pavement exhibiting pitting, raveling, and binder stripping while none of these problems were seen on the treated section. The right photo on the second row also shows significant loose aggregate on the surface of the untreated section, indicating that substantial raveling was occurring there while none of this was observed in the treated section. The last four photos in Figure C-79 are examples of the cracking observed on this date, which is basically similar to what was discussed before.

Figure C-79 Condition of Kaweloka Street section 4, treated with OptiPave PlusTM RTU, on 12/13/2016.

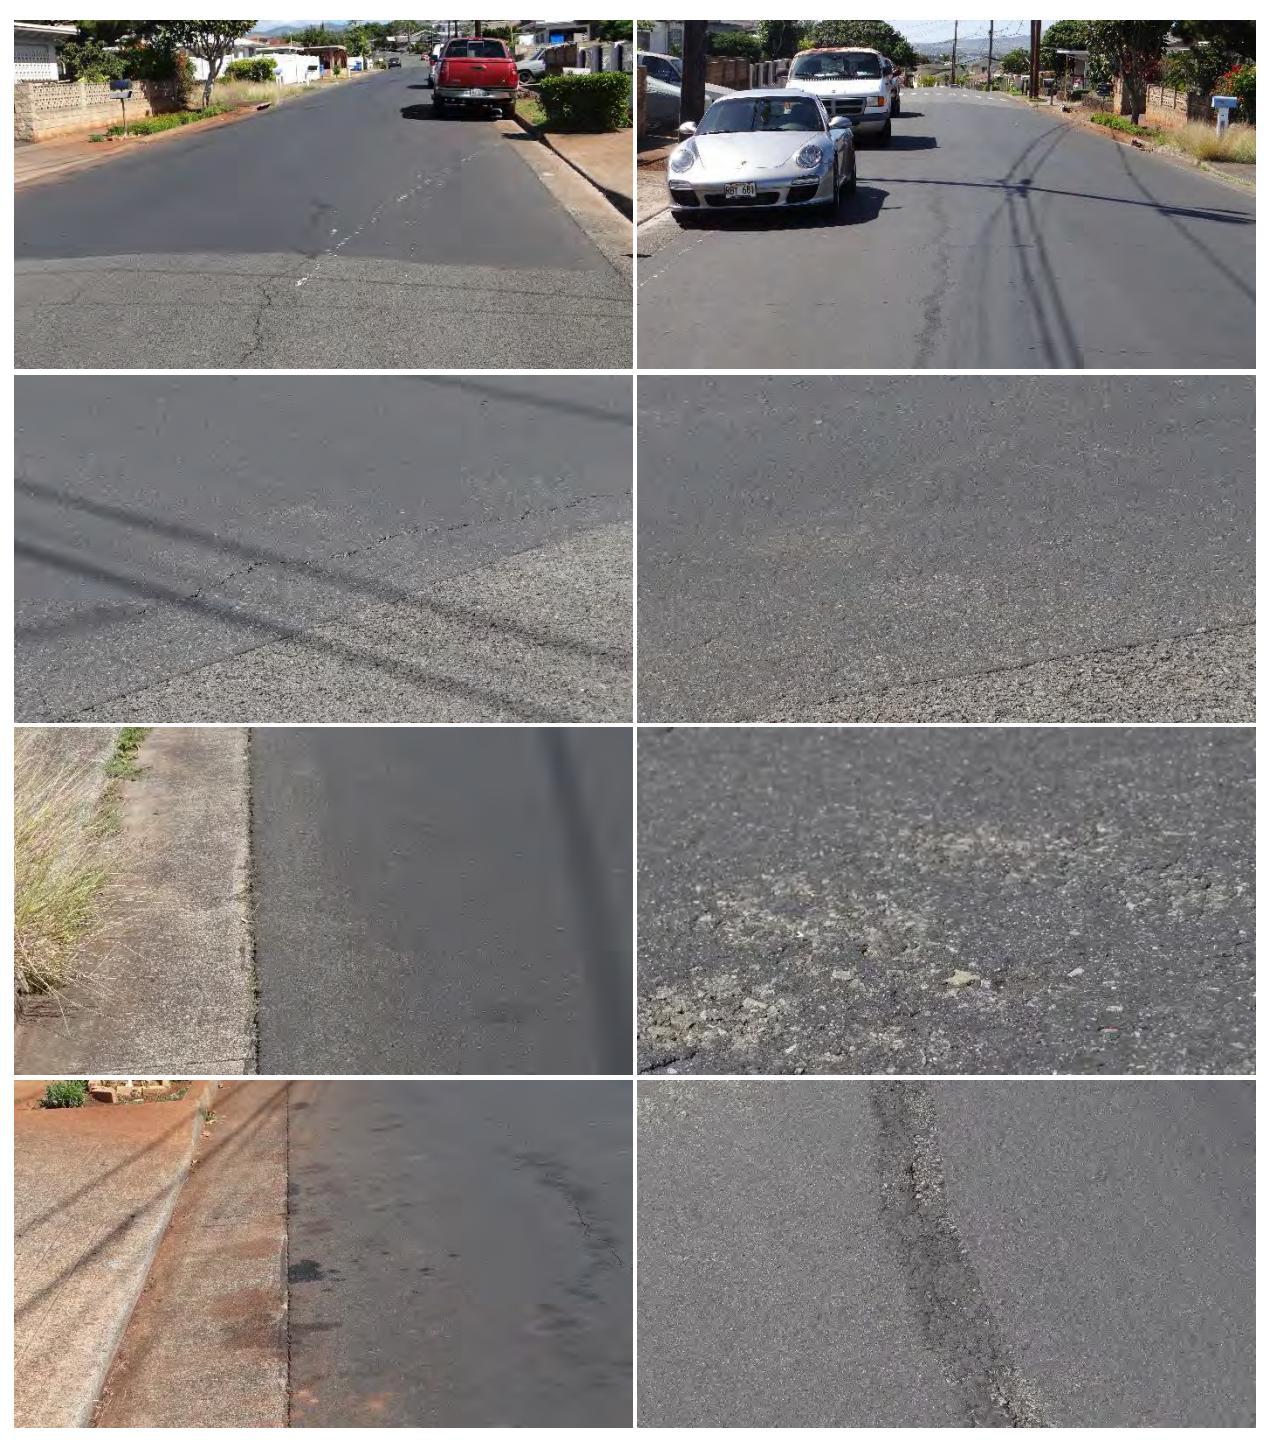
Figure C-80 and Figure C-81 show the conditions of the treatment on 1/26/2018, 38 months after its application. The photos in Figure C-80 were selected to illustrate the condition of the treatment itself. The two photos on the top show that the overall appearance of the section was better than that of the untreated pavement. However, as shown in the following four photos, some fading was starting to occur at the section ends and near the gutters. Another common problem near the gutters were the oil leaks as illustrated in the bottom left photo. Finally, the bottom right photo shows some aggregate being exposed because of the loss of part of the overband of a sealed crack.

Figure C-80 Condition of seal on Kaweloka Street section 4, treated with OptiPave PlusTM RTU, on 1/26/2018.

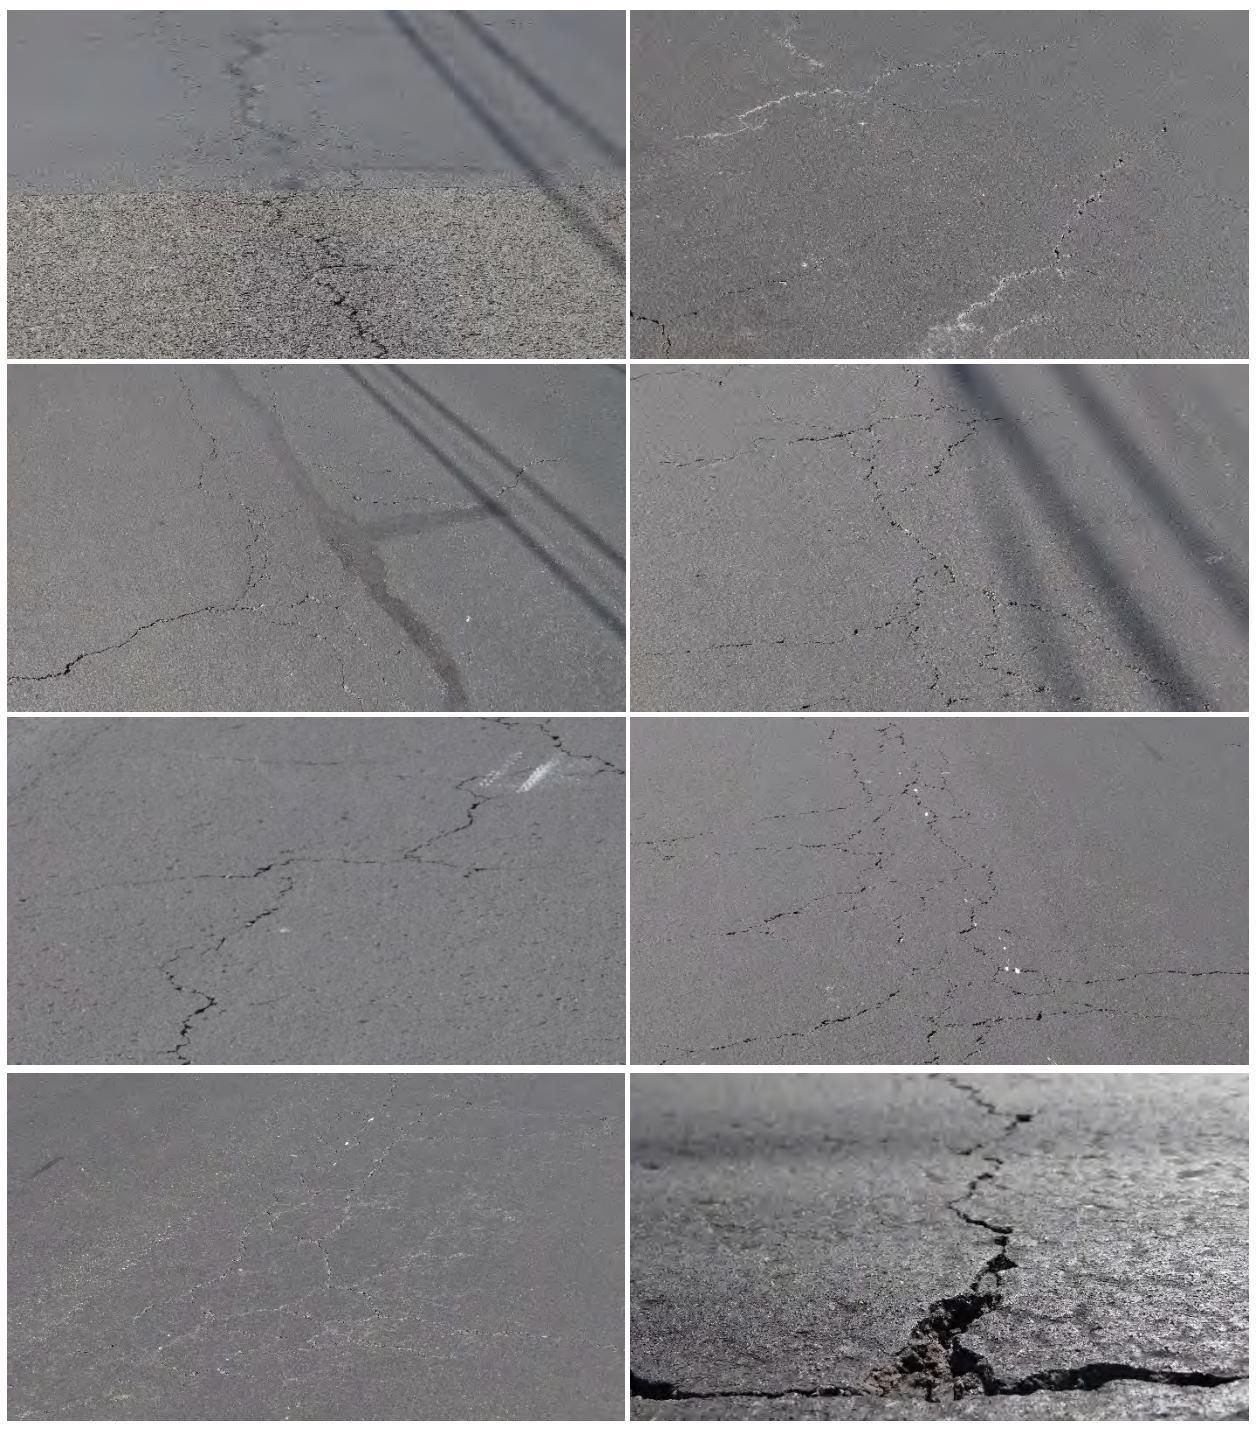
The photos in Figure C-81 were selected to illustrate the cracking on the section at the end of the monitoring period. These photos show that some of the cracks were basically a continuation of the cracks occurring on the untreated section, but they also show many locations with fatigue cracking. In fact, this section showed the clearest manifestation of fatigue cracking in all the treated sections.

Figure C-81 Cracking on Kaweloka Street section 4, treated with OptiPave PlusTM RTU, on 1/26/2018.

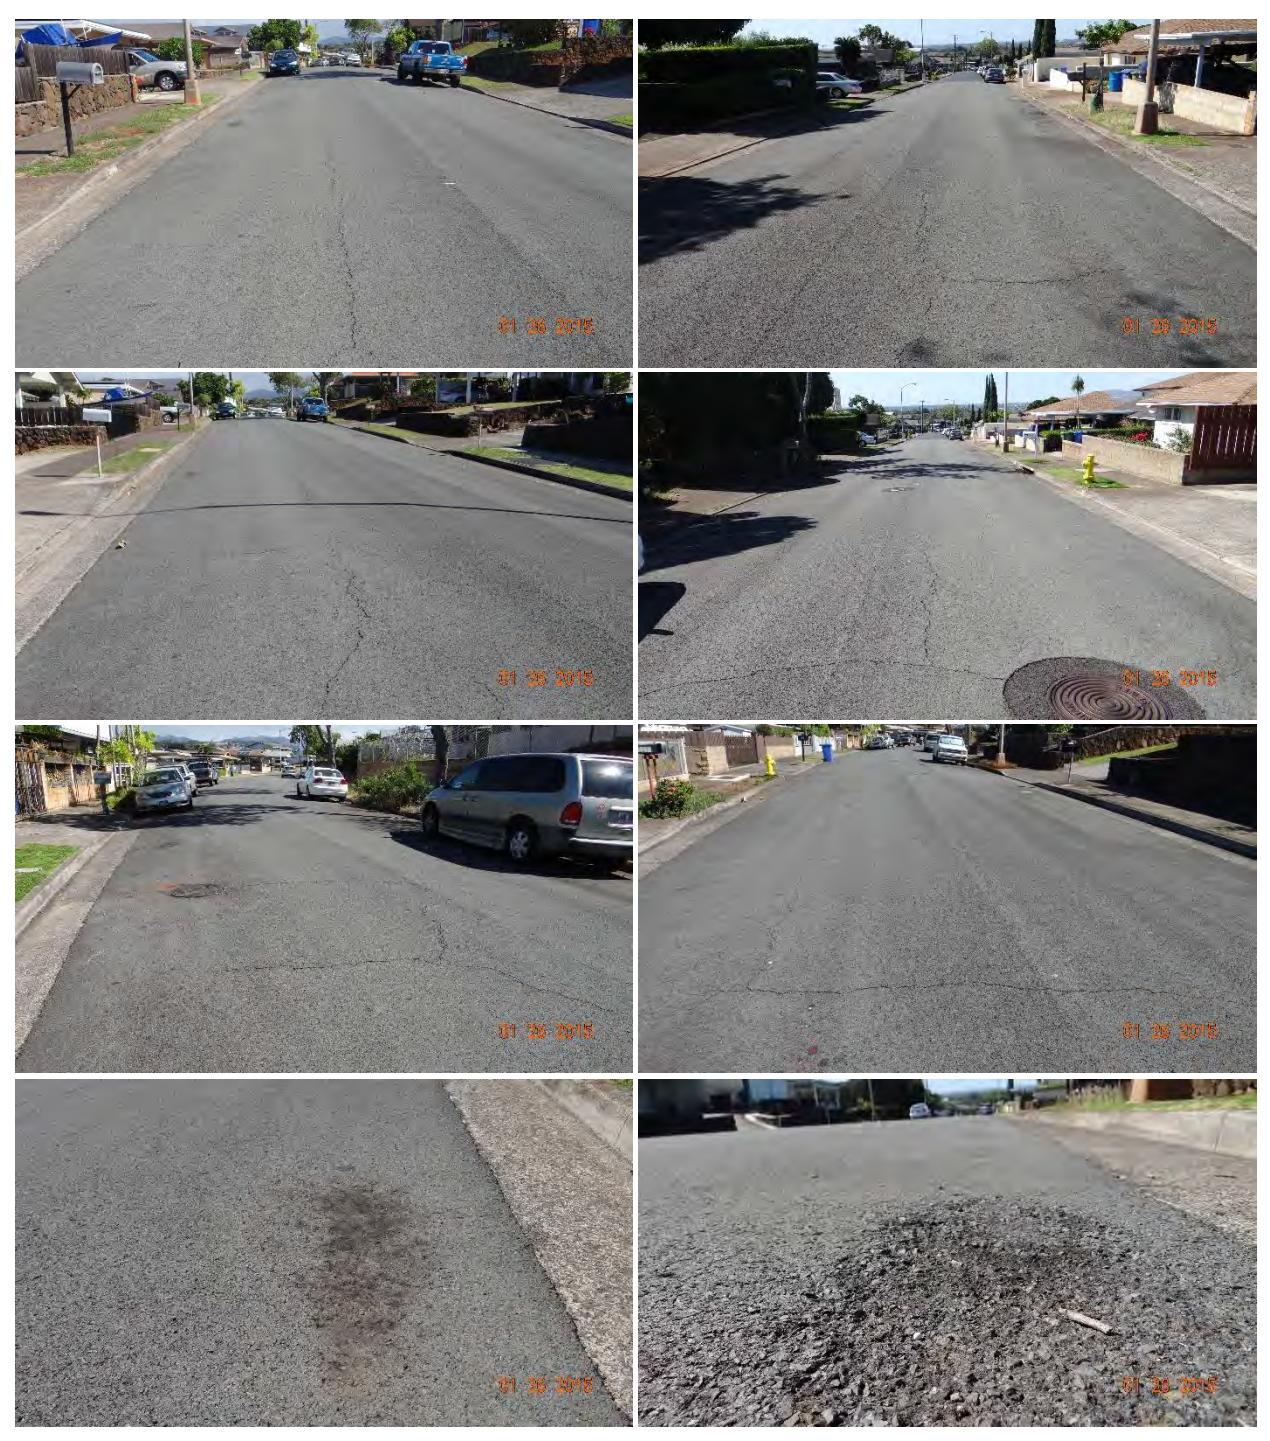
Figure C-83, Figure C-84, Figure C-85, and Figure C-86 are presented to illustrate the conditions of these control sections at four points in time. Specifically, the photos correspond to site visits on 1/26/2015, 6/24/2016, 12/13/2016, and 5/24/2019, respectively. In general, the cracking in the three figures indicate that most of it was environmentally related. The bottom photos in Figure C-83 illustrate a spot with oil leaks (left) and an area with severe raveling/disintegration. This is particularly severe, and it may be a consequence of recurrent oil leaks (with the same vehicle parked on the same spot every day).

Figure C-83 Condition of control sections 6, 7, 8 for straight sections without bus traffic on Kaweloka Street, on 1/26/2015.

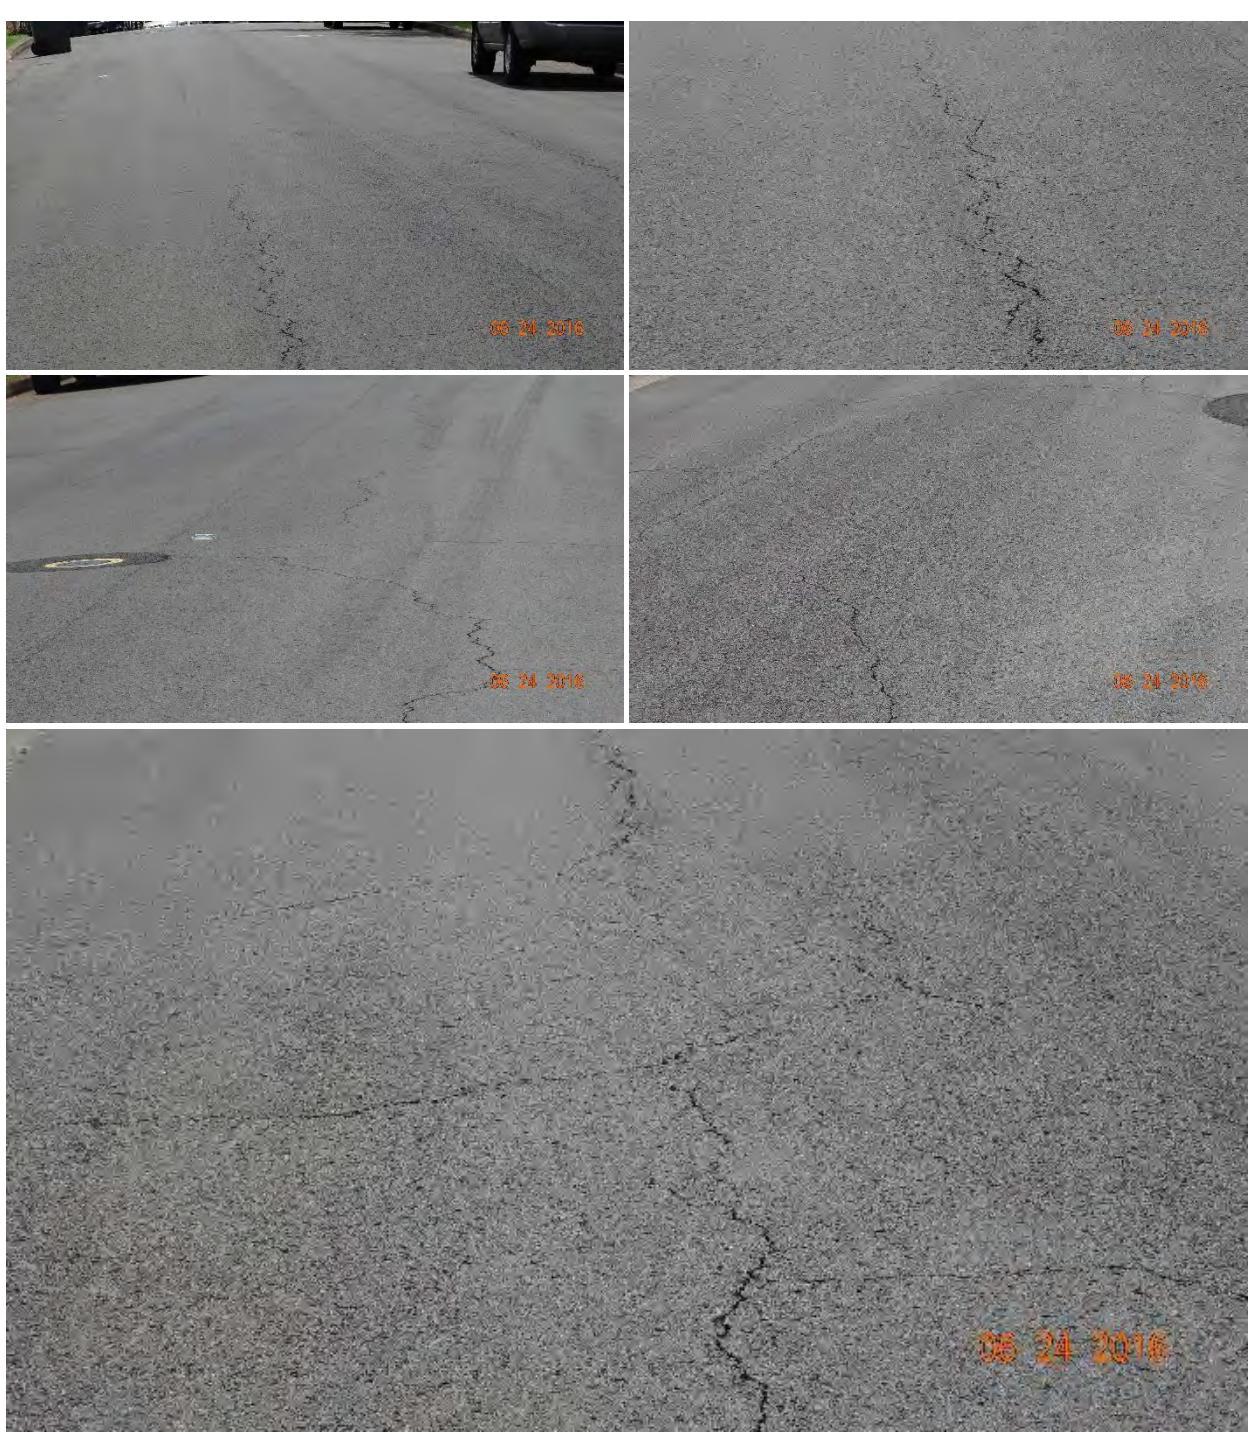
Figure C-84 Condition of control sections 6, 7, 8 for straight sections without bus traffic on Kaweloka Street, on 6/24/2016.

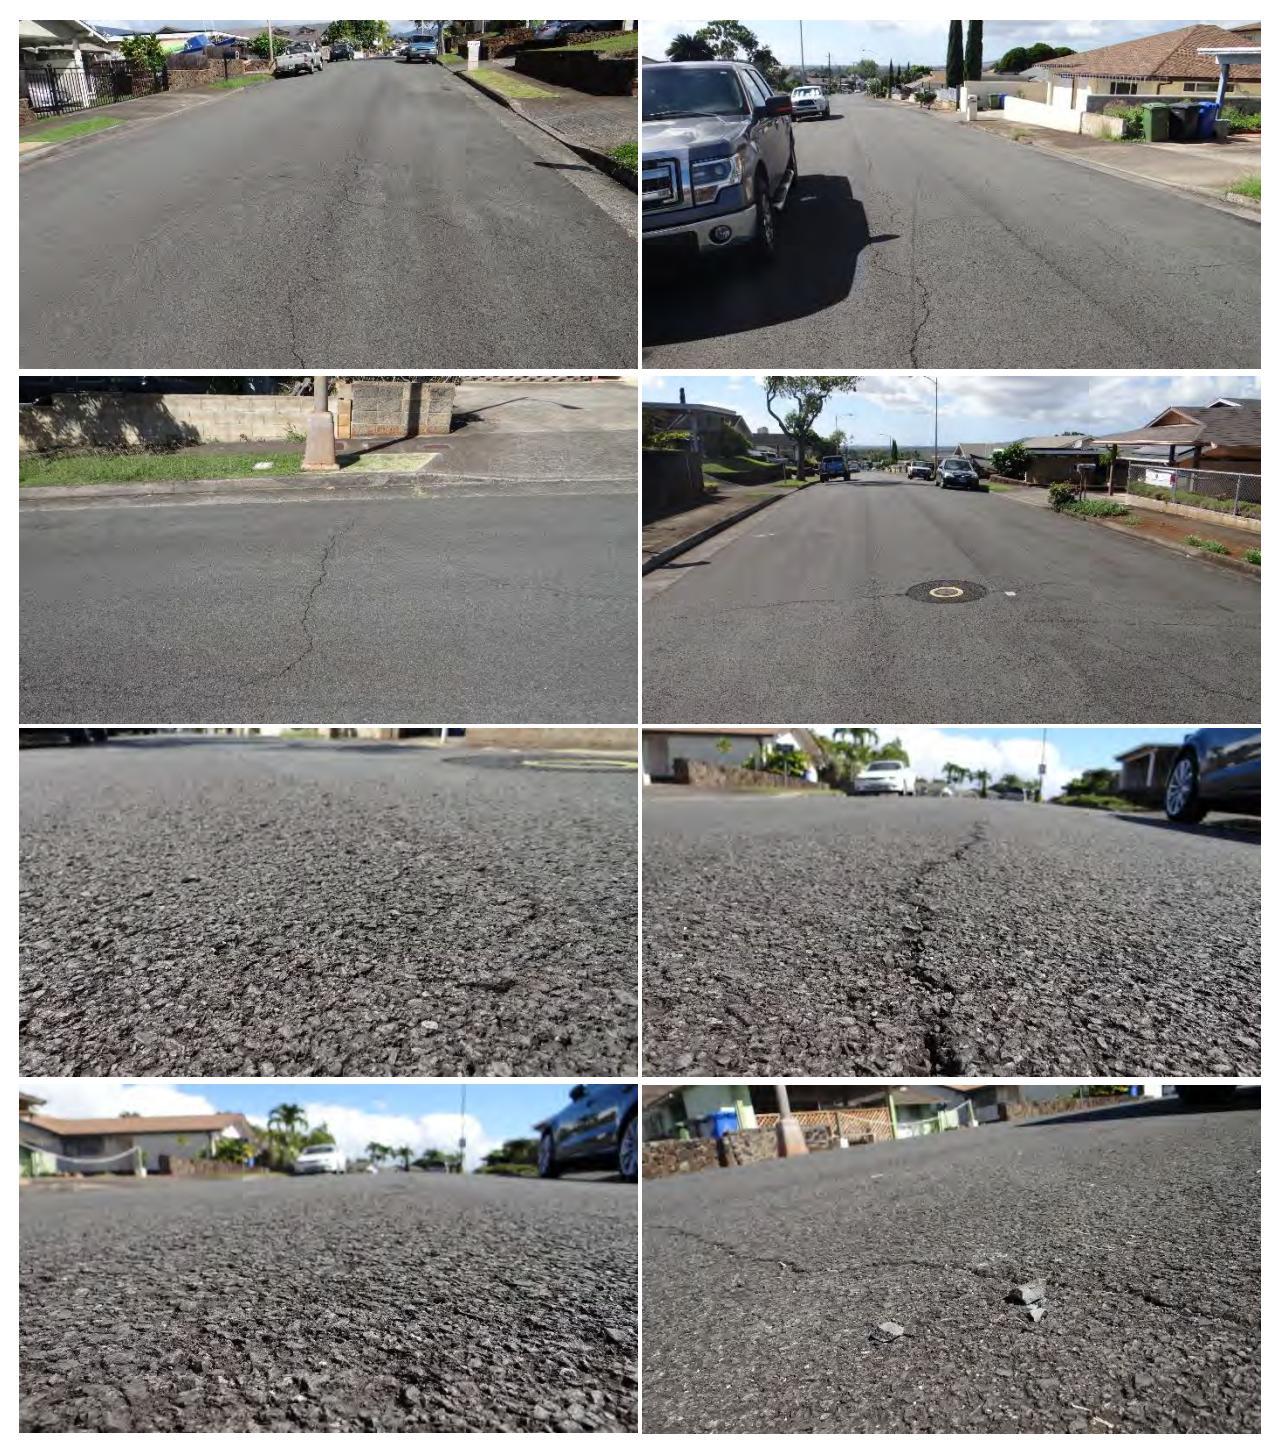
On the other hand, the bottom four photos in Figure C-85 show some significant raveling related mostly to environmental effects such as binder oxidation and binder stripping by moisture. These are indicative of what can be expected when sections are left untreated.

Figure C-85 Condition of control sections 6, 7, 8 for straight sections without bus traffic on Kaweloka Street, on 12/13/2016.
