PERFORMANCE MONITORING OF PRESERVATION TREATMENTS IN HONOLULU

FINAL PROJECT REPORT

Adrián Ricardo Archilla University of Hawaii at Manoa

May 2019

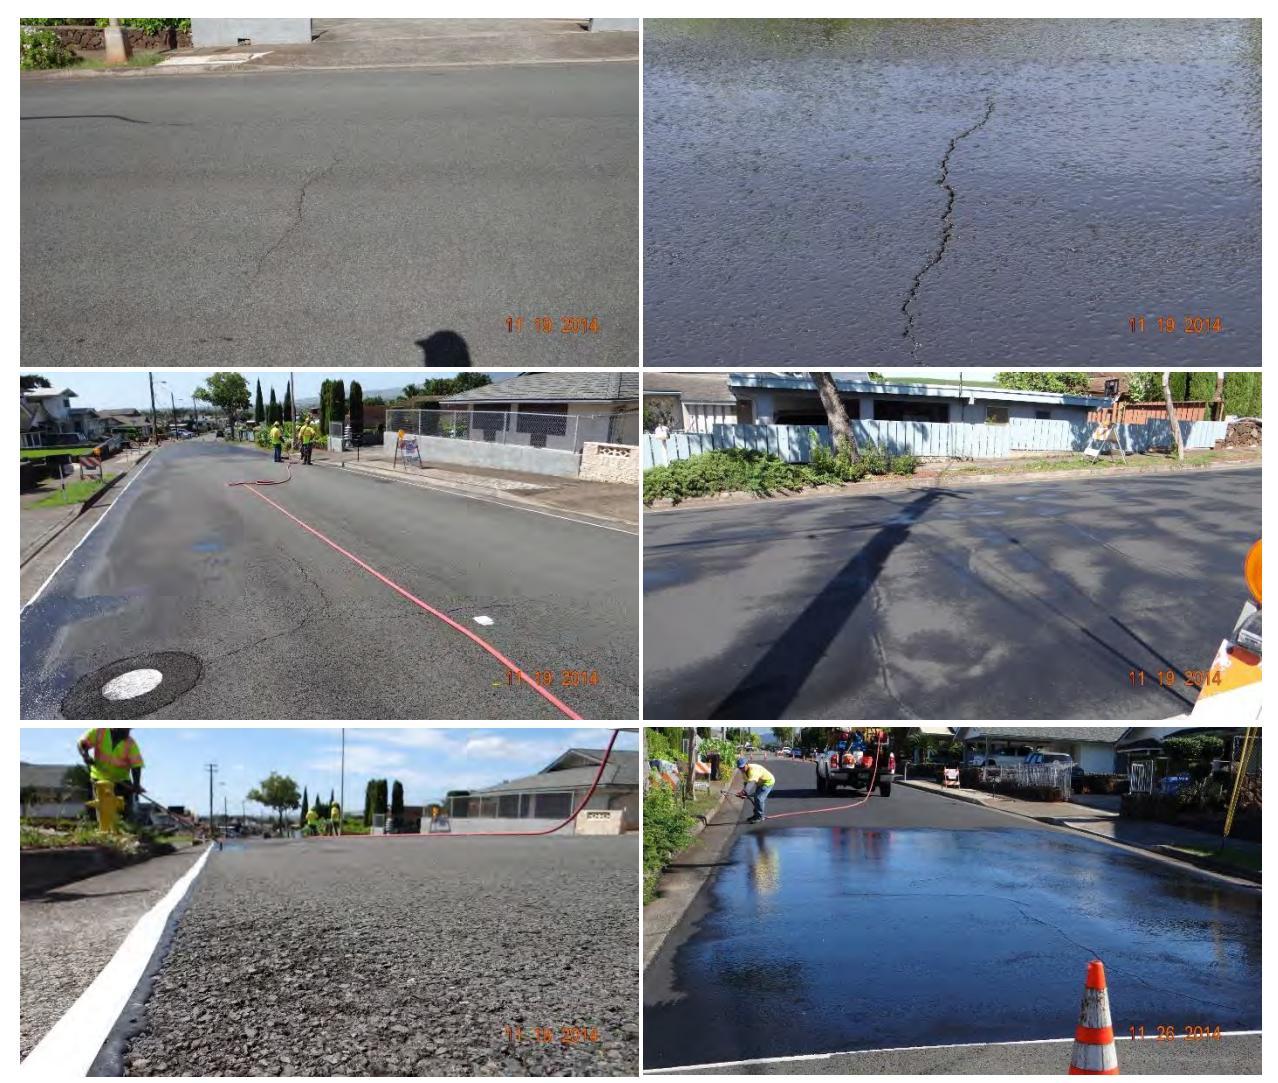
Figure C-87 Condition of section 5 on Kaweloka Street, treated with CarbonSeal-HF, on 11/19/2014 and 11/26/2014.

Figure C-87 shows the conditions on the day of the application of the first coat (11/19/2014) to illustrate that the cracks on about half of the section were not sealed for some unknown reason. The cracks on the other half were mostly routed and sealed (mid right photo). The bottom left photo also illustrates a small area with some severe raveling whose progression was stopped with the application of the treatment.

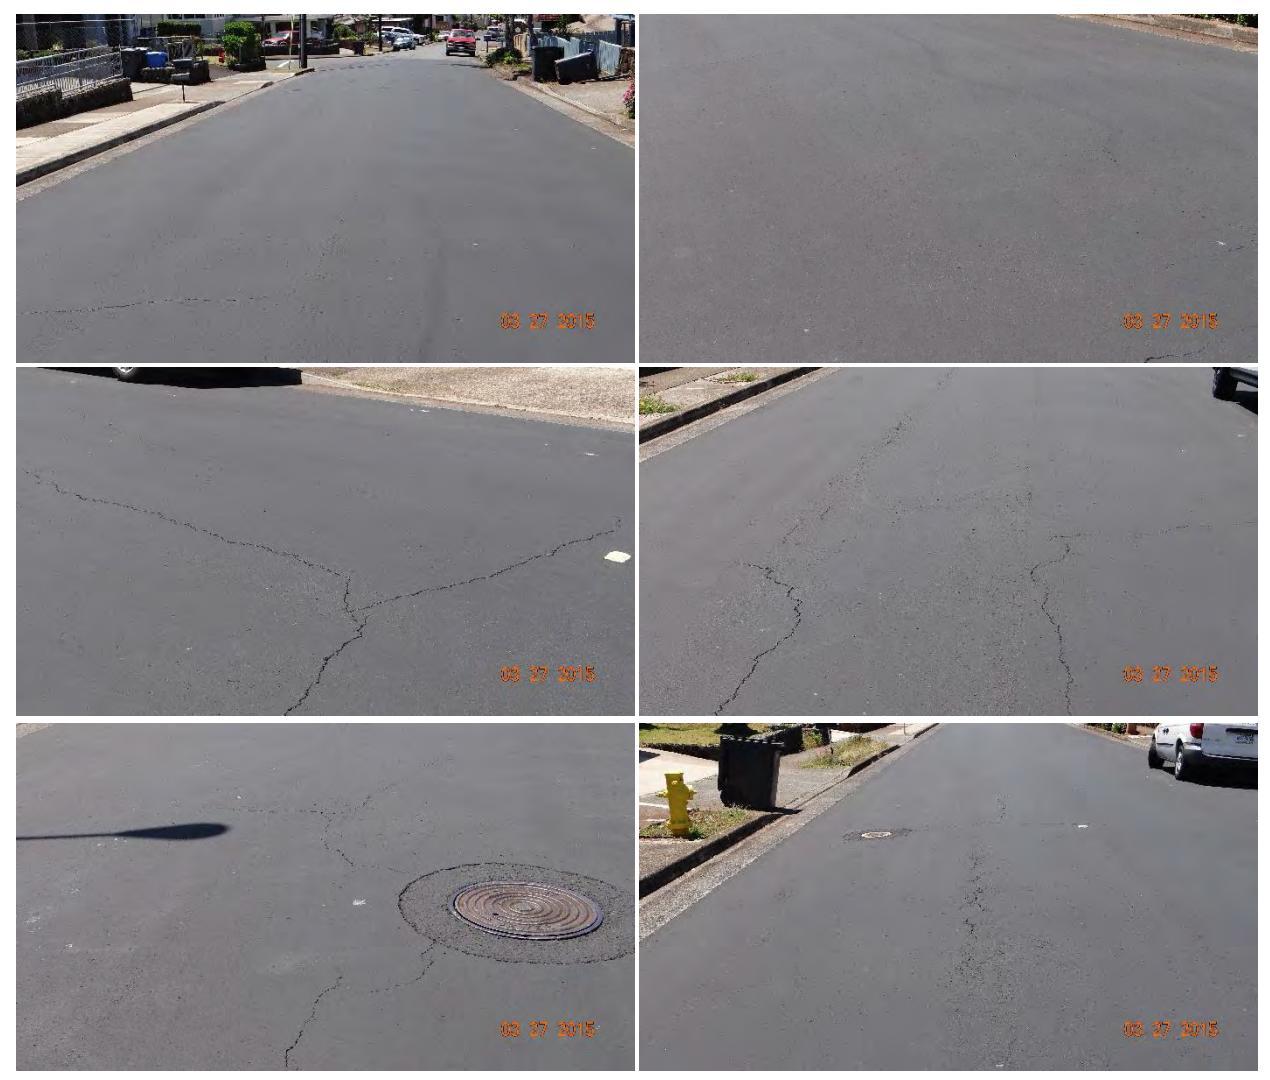
Figure C-88 Condition of section 5 on Kaweloka Street, treated with CarbonSeal-HF, on 3/27/2015.

Figure C-88 shows the conditions of the treatment on 3/27/2015, almost four months after its application. The treatment had a very uniform appearance. Most of the cracks observed in these photos existed before the treatment application, but the presence of those that were not sealed was essentially highlighted by the application of the seal coat. Although it is difficult to appreciate in these photos, the color of this treatment is dark grey as opposed to the black color of all the other treatments evaluated in this study.

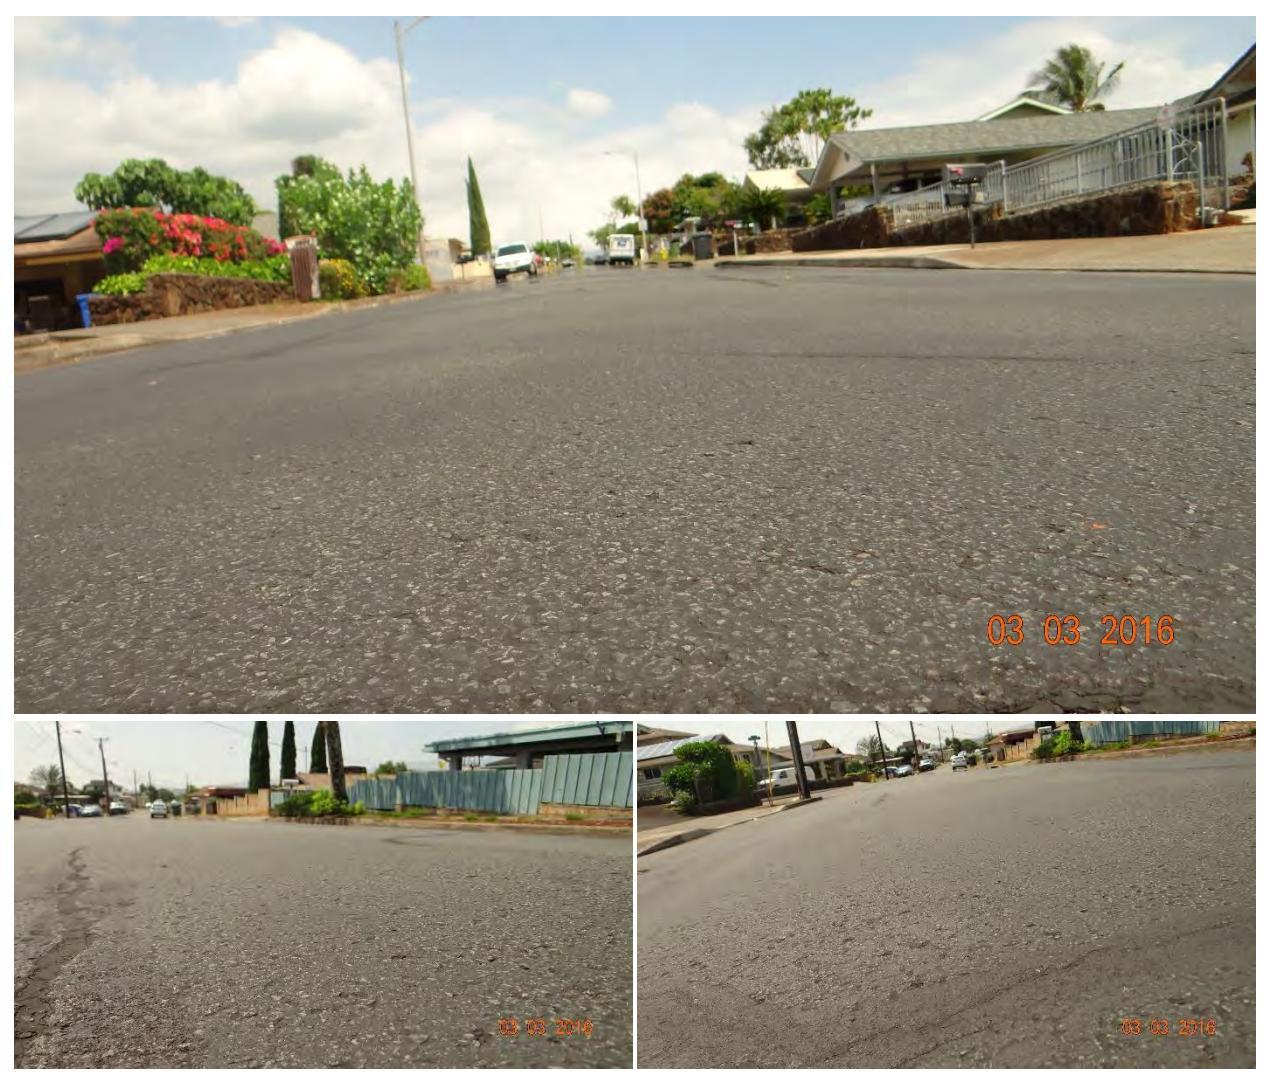
Figure C-89 Condition of section 5 on Kaweloka Street, treated with CarbonSeal-HF, on 3/3/2016.

Figure C-89 shows the condition of the seal coat on 3/3/2016. Even though this was only 16 months after the treatment application, there were already some signs that seal coat was fading away. This is illustrated in the top photo in Figure C-89, where an uneven distribution of the color can be seen. It can also be seen that the surface of the top of many aggregates were exposed. The other two photos in the figure illustrate that the crack sealing was performing as expected.

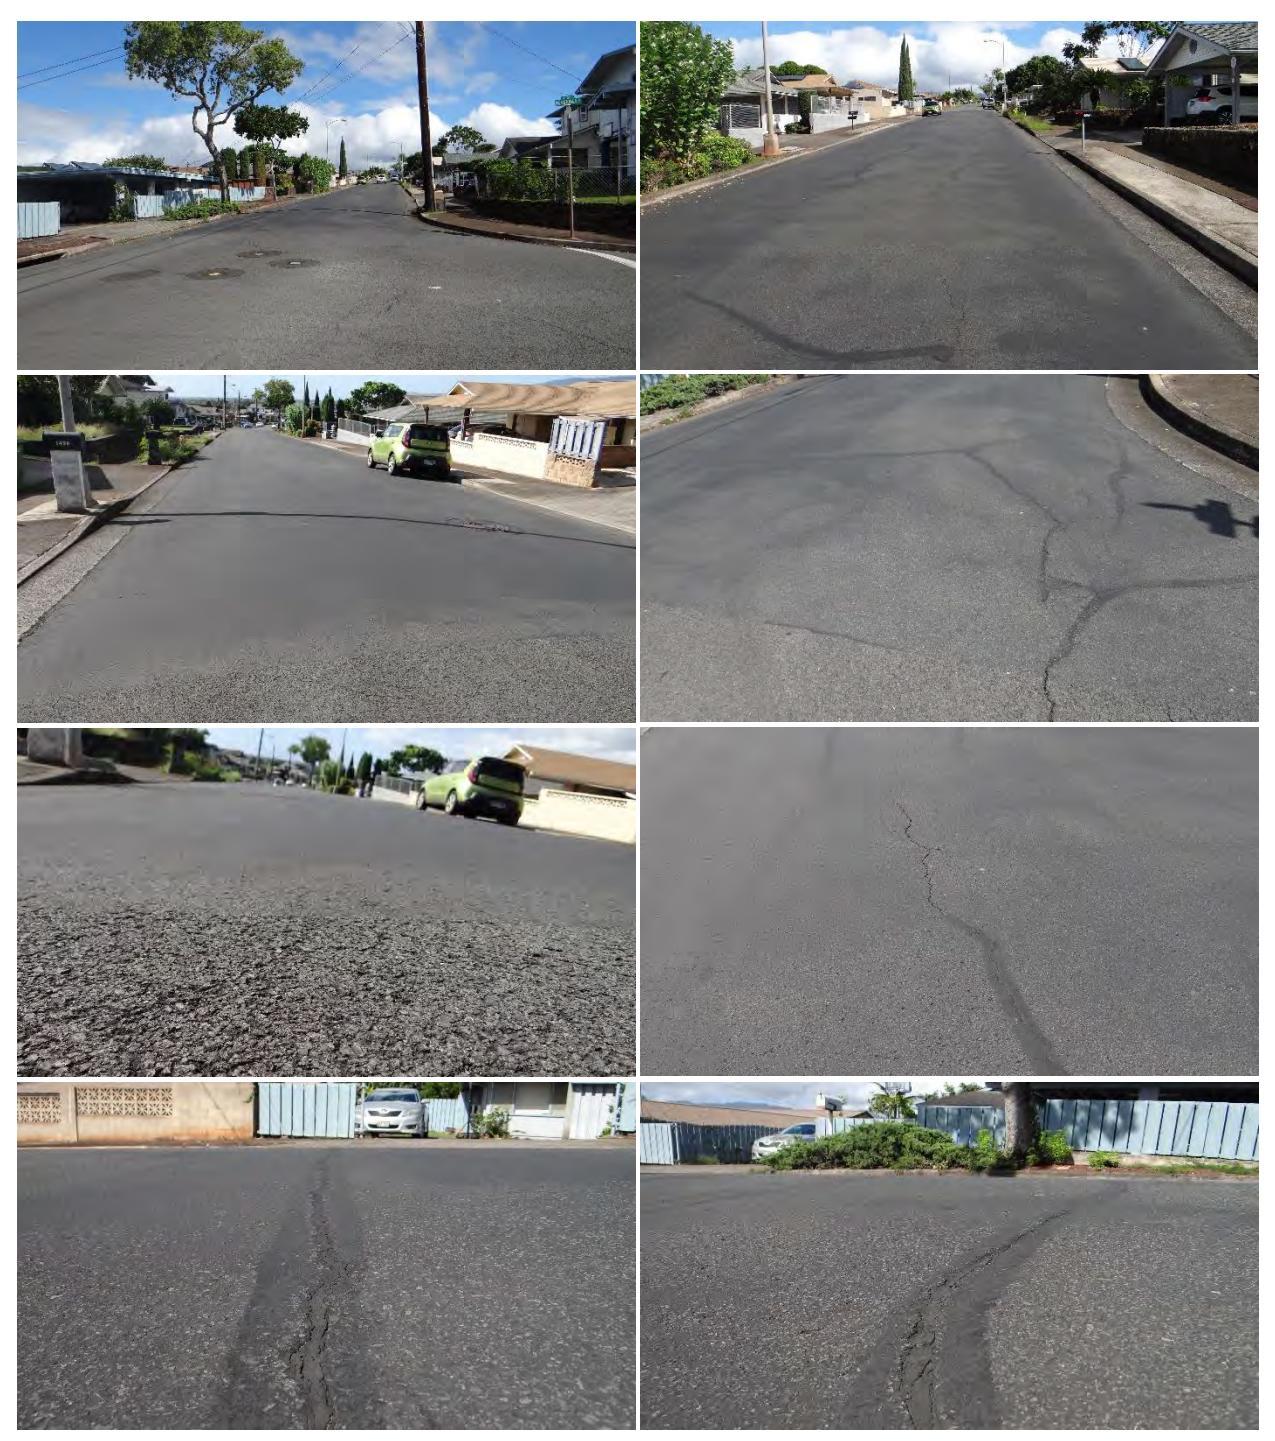
Figure C-90 Condition of section 5 on Kaweloka Street, treated with CarbonSeal-HF, on 6/24/2016.

The top four photos in Figure C-90 show that merely three and half months later, on 6/24/2016, the fading of the seal coat was much more evident and widespread. Nevertheless, as seen by the photo on the left of the third row, the surface with the seal coat did not show the raveling seen on the untreated surface. The other photos illustrate the propagation of some cracks that were sealed as well as the good performance of the crack sealer up to this point.

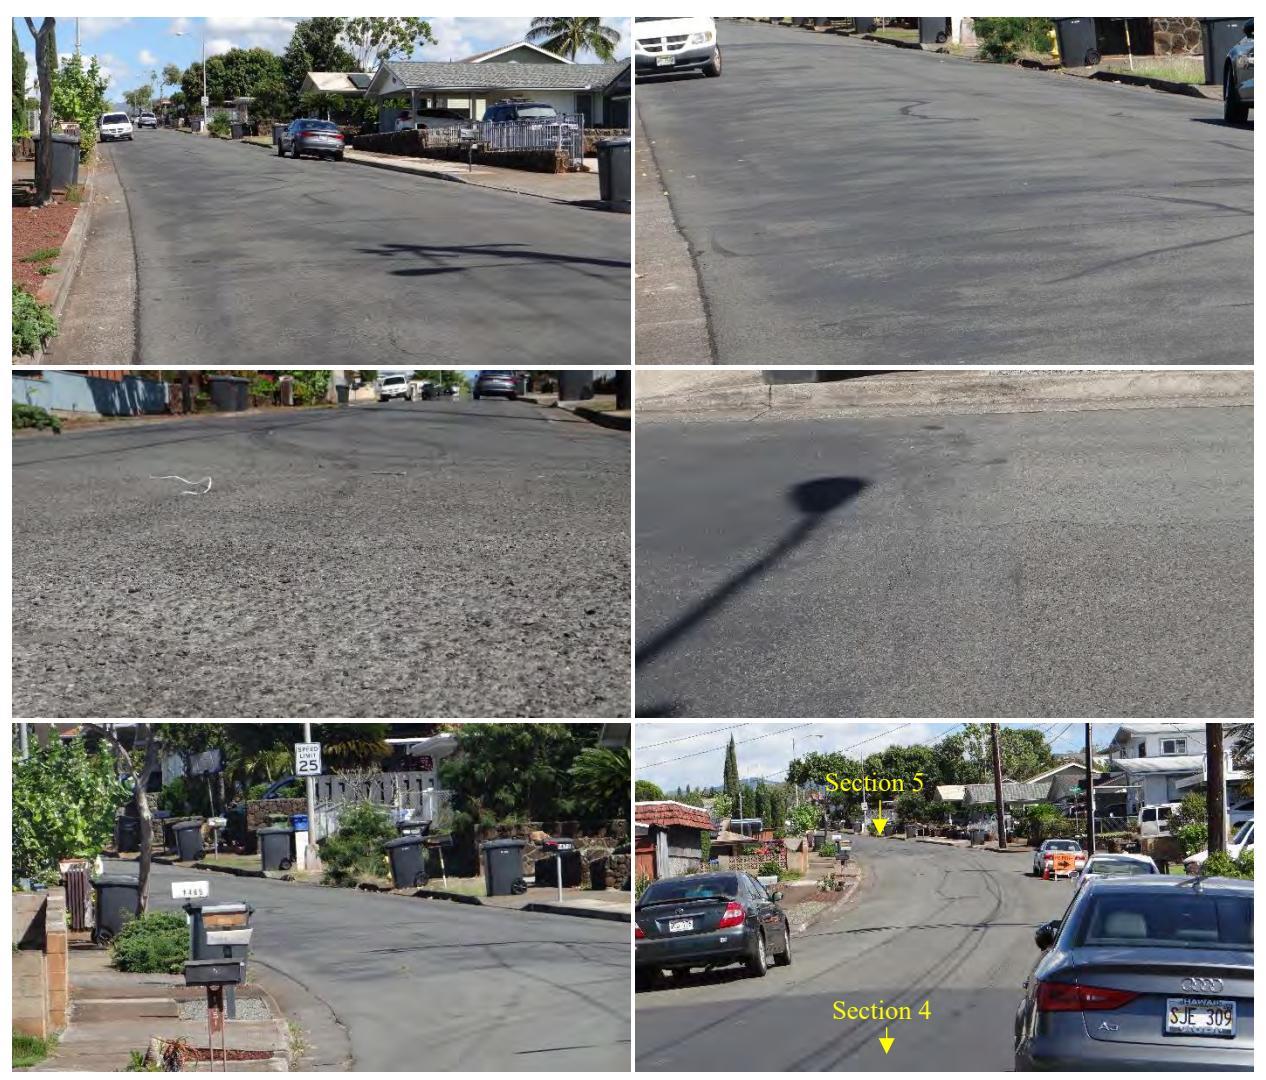
Figure C-91 Condition of section 5 on Kaweloka Street, treated with CarbonSeal-HF, on 1/26/2018.

Figure C-91, Figure C-92, and Figure C-93 show the treatment condition on 1/26/2018, 37 months after its application. The top photos in Figure C-91 show that in several areas the seal coat was practically gone. Still, as illustrated in the two middle photos, during the time of the study, the seal coat was successful at arresting the raveling seen in the untreated surfaces. The last two photos emphasize how much the seal coat had faded. The photo on the left shows a view from further away where the treatment is barely noticeable whereas the photo on the right provides a view from section 4. The difference between the two sections (sections 4 and 5) is substantial.

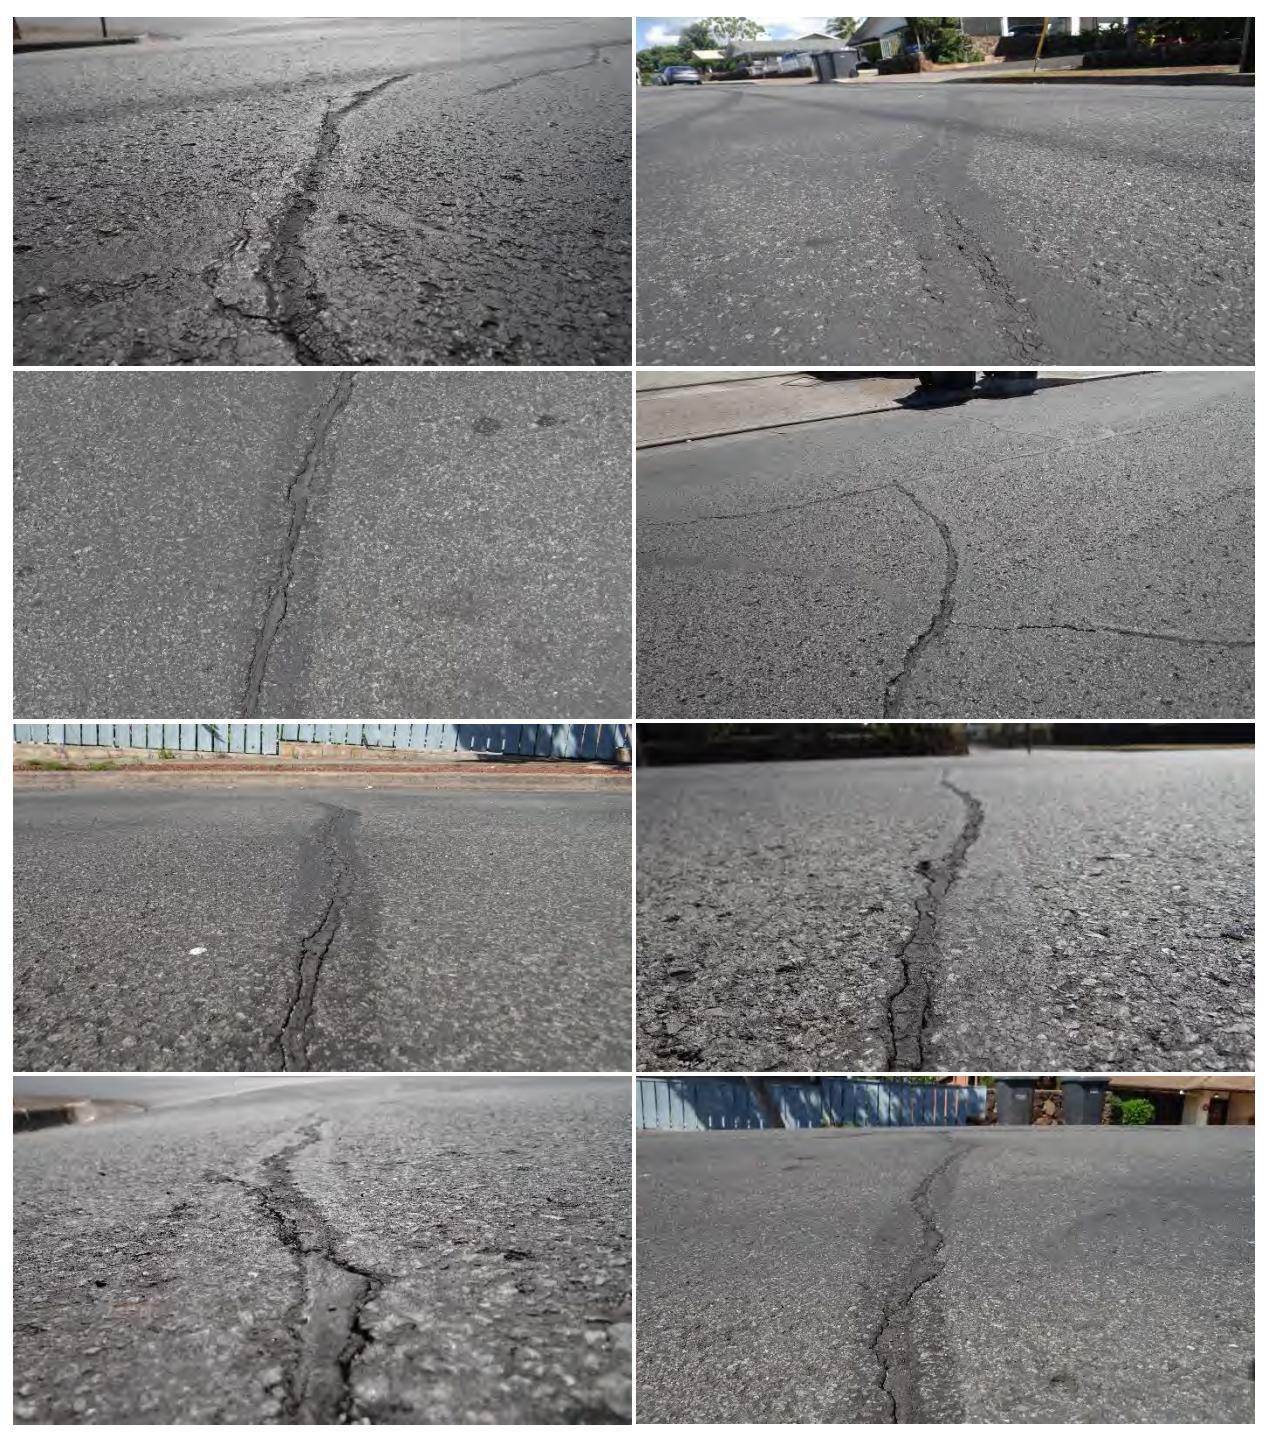
Figure C-92 Condition of section 5 on Kaweloka Street, treated with CarbonSeal-HF, on 1/26/2018.

The photos in Figure C-92 show the performance of the crack sealing in the section. In general, the crack sealing performed as expected with some cracks being almost perfectly sealed after three years and with other showing some possible separation with the crack walls. Since most of these cracks were routed, this good performance was expected.

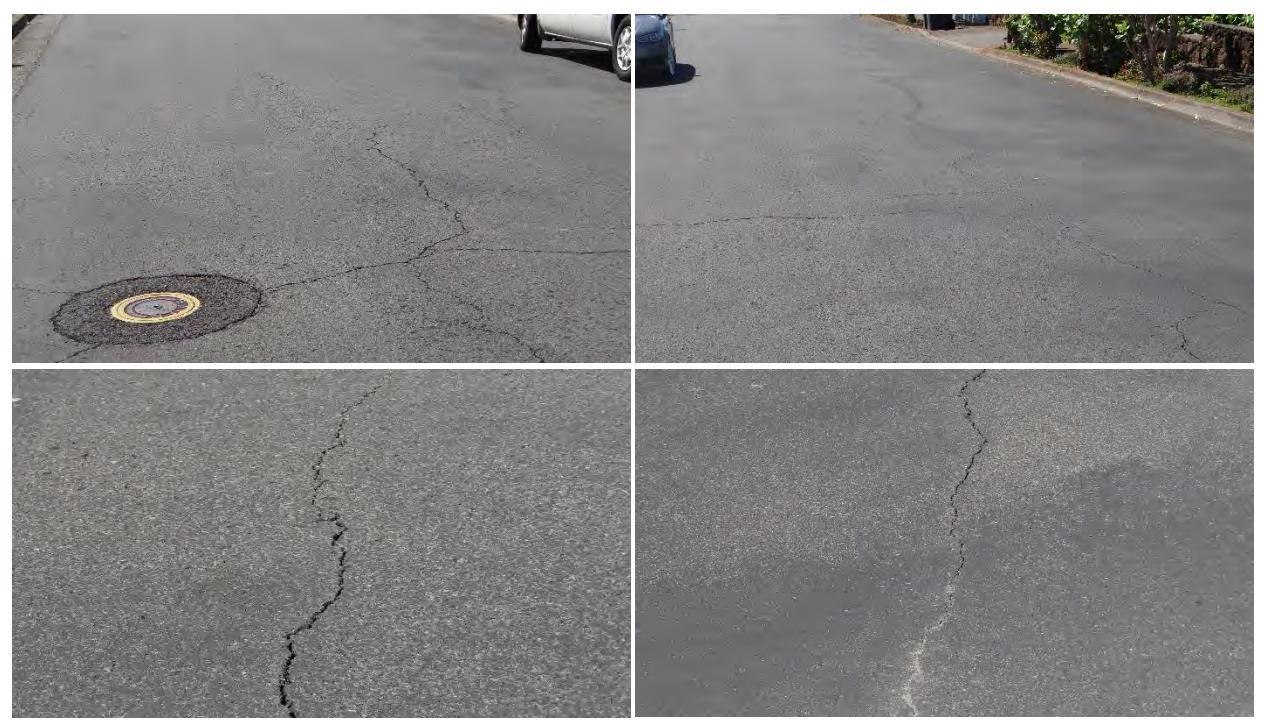
Figure C-93 Condition of section 5 on Kaweloka Street, treated with CarbonSeal-HF, on 1/26/2018.

Figure C-93 shows some of the unsealed cracks. These were mostly environmentally induced cracks but even without bus loading some of these showed signs of pumping.

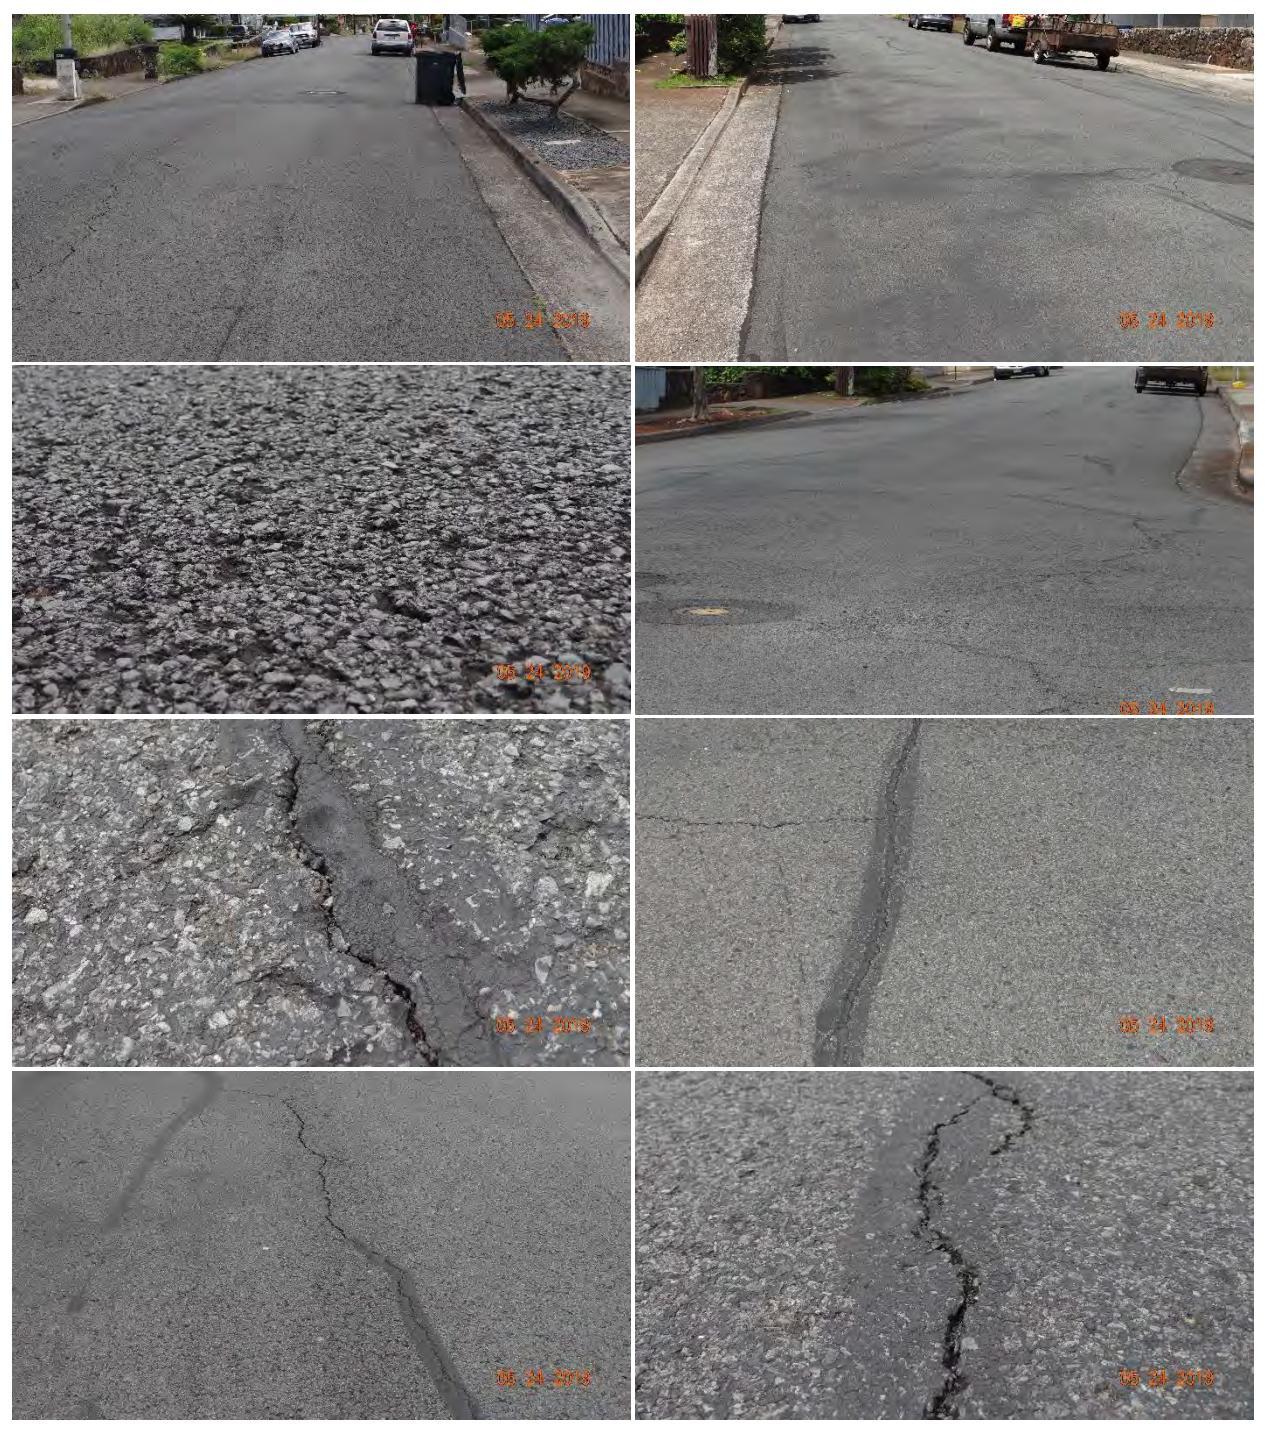
Figure C-94 Condition of section 5 on Kaweloka Street, treated with CarbonSeal-HF, on 5/24/2019.

Finally, Figure C-94 shows the conditions on 5/24/2019, about 4.5 years after its application. Further fading of the seal coat was noted with the surface showing some early signs of loss of material. As shown in one of the photos, the crack sealer was soft enough that could still be indented with the finger but at that particular location it appears was not in contact with the crack wall anymore. Once again, in general, the sealer on cracks that were routed or were thick when sealed were still performing well, but those that were thin when sealed were exposed as shown by the last photo in the figure.

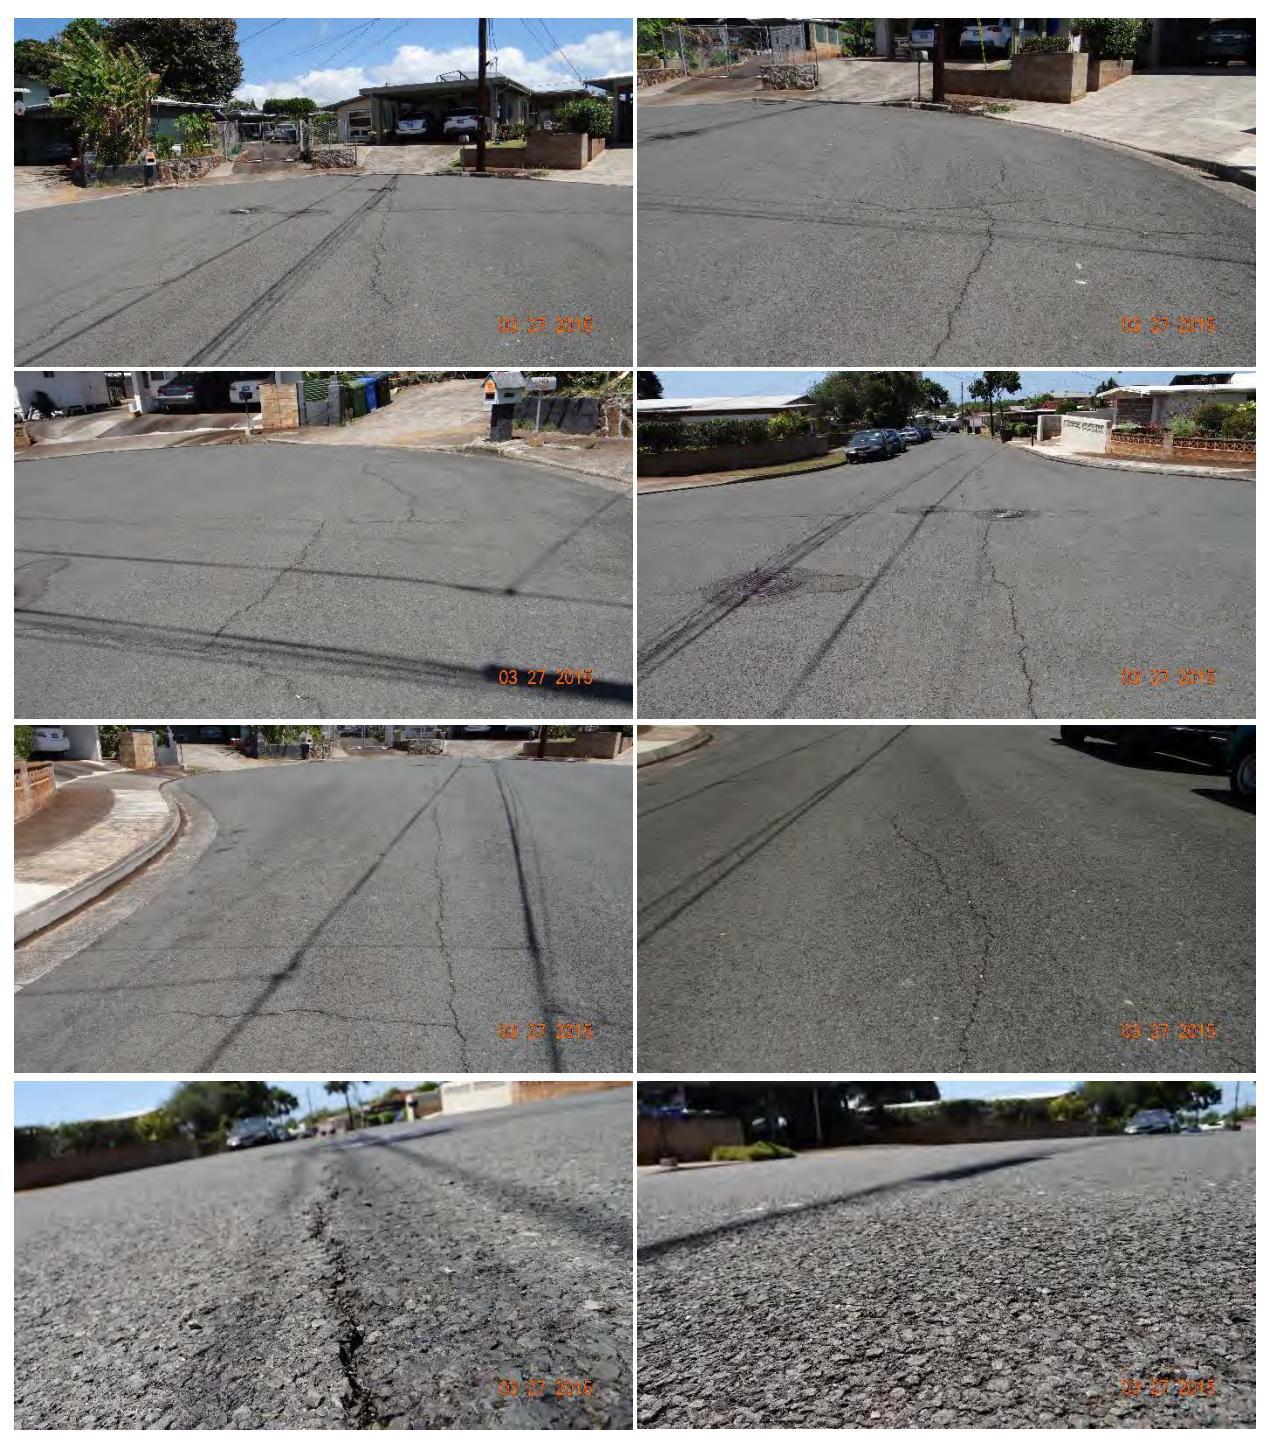
Figure C-95 Condition of the control section in cul-de-sacs on Kaumoli Street on 3/27/2015.

Figure C-95 shows the conditions of the control section for cul-de-sacs on Kaumoli street on 3/27/2015. The first six photos show a the typical pattern in cul-de-sacs, with a large longitudidal crack near the centerline and a block cracking pattern with one side of the block accompaning the curvature of the cul-de-sac. The last two photos illustrate that the severity of many cracks could be considered moderate and that the section was already exhibiting some raveling.

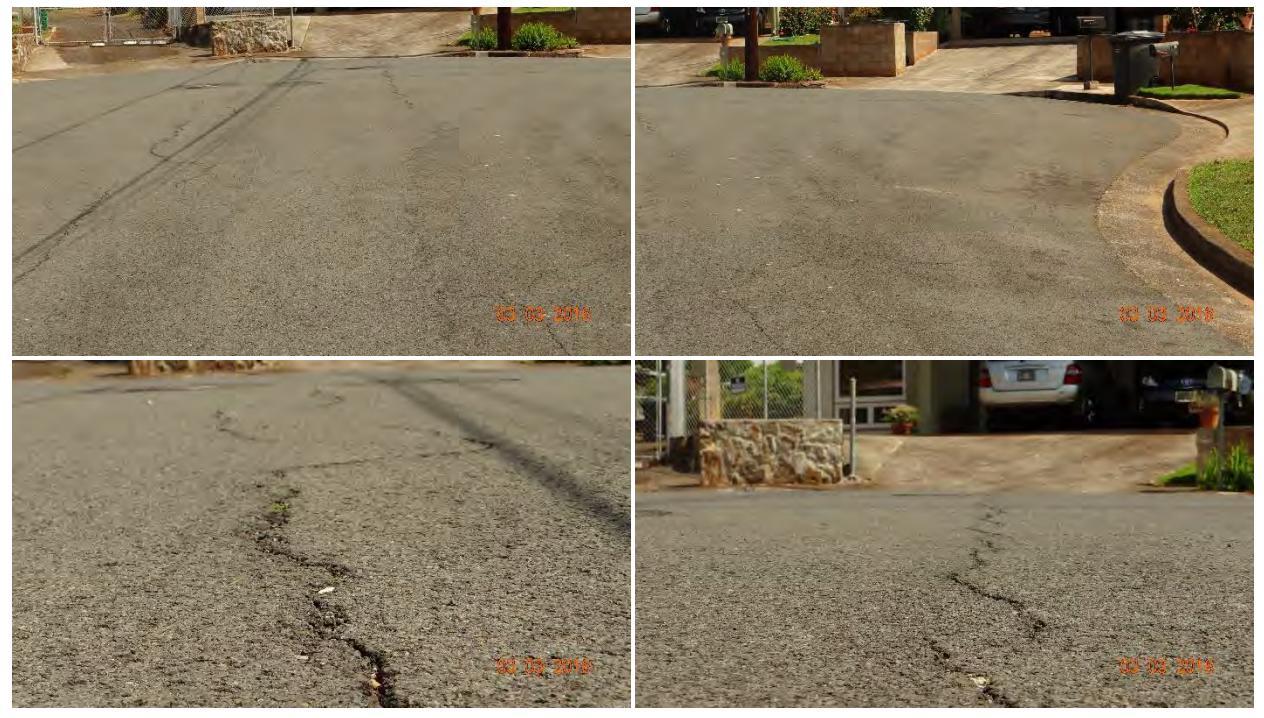
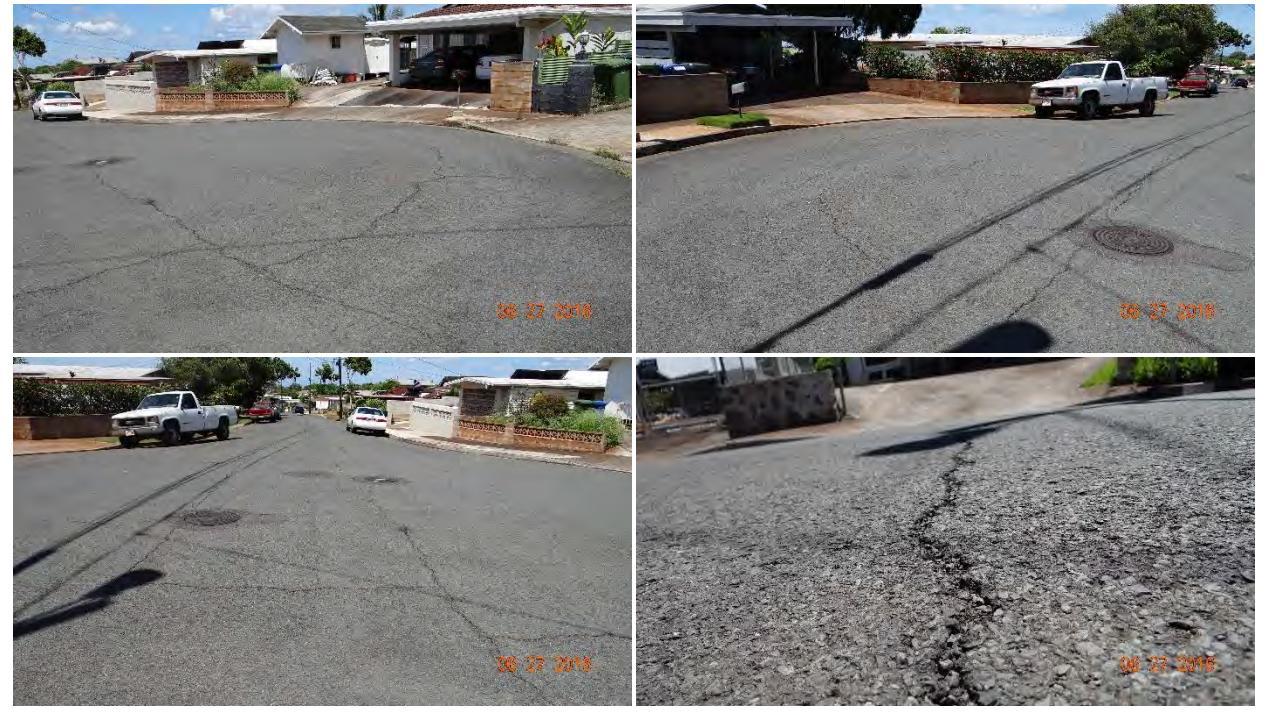
Figure C-96 and Figure C-97 illustrate the condition seen on 3/3/2016 and 6/24/2016, respectively. Visually, not much change was noted except that the cracks appeared to be getting wider and the surface a bit more ravelled.

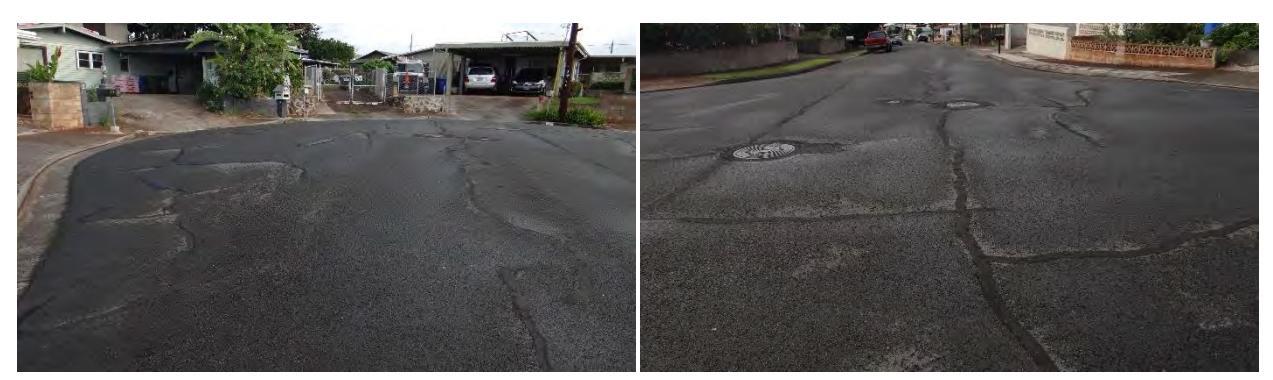
Figure C-98 Condition of the control section on Kaumoli Street on 12/13/2016.

Figure C-98 shows that by 12/13/2016, the section had already been crack sealed. Subsequently, it was also covered with a seal coat. Note that the length of cracking, as seen by the length of the crack sealing overbands on the surface, were measured on that date and included in the trend in Figure 4-21. As noted earlier, the length with sealer usually overestimates the actual length of cracking because of the extension of the overbands at the ends of each crack, which implies that the cracking trend of 0.576 ft/day/10⁴ft² in Figure 4-21 may be slightly off. Unfortunately, that last observation is very influential and the cracking trend without it drops to 0.260 ft/day/10⁴ft². Thus, the actual cracking rate should be expected to fall somewhere between these values. As discussed before, this is consistent with the Palamoi Street section used as a control section for crack sealing on cul-de-sacs, for which the rate of 0.416 ft/day/10⁴ft² was estimated.

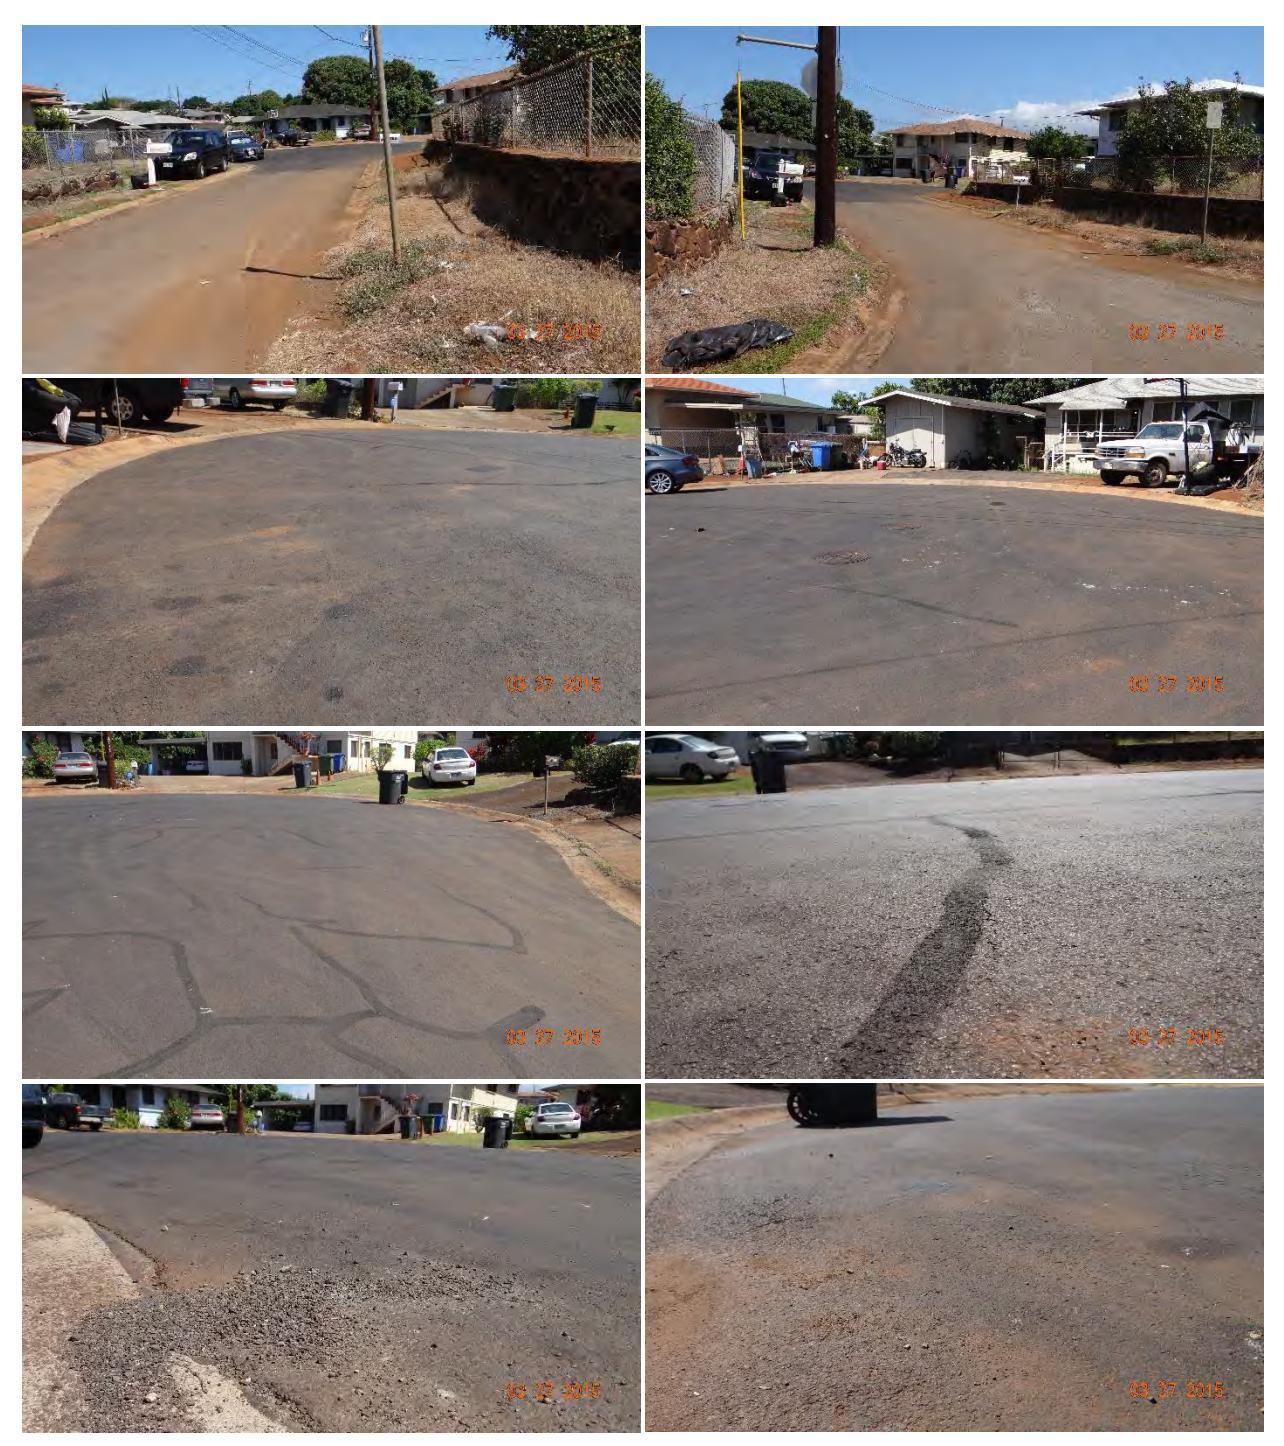
Figure C-99 Condition of the section on Hoolawa Place, treated with Plasti-Pave, on 3/27/2015.

Figure C-99 show the condition on 3/27/2015, four months after the treatment application. This section was extremely dirty because of some accumulation of clay material near its entrance due to some apparent drainage problem. The photos on the second row illustrate the overall seal condition and those on the third row show some of the locations where crack sealing had been done prior to the fog seal application. The photos in the last row provide further illustration of the dirty conditions of this section.

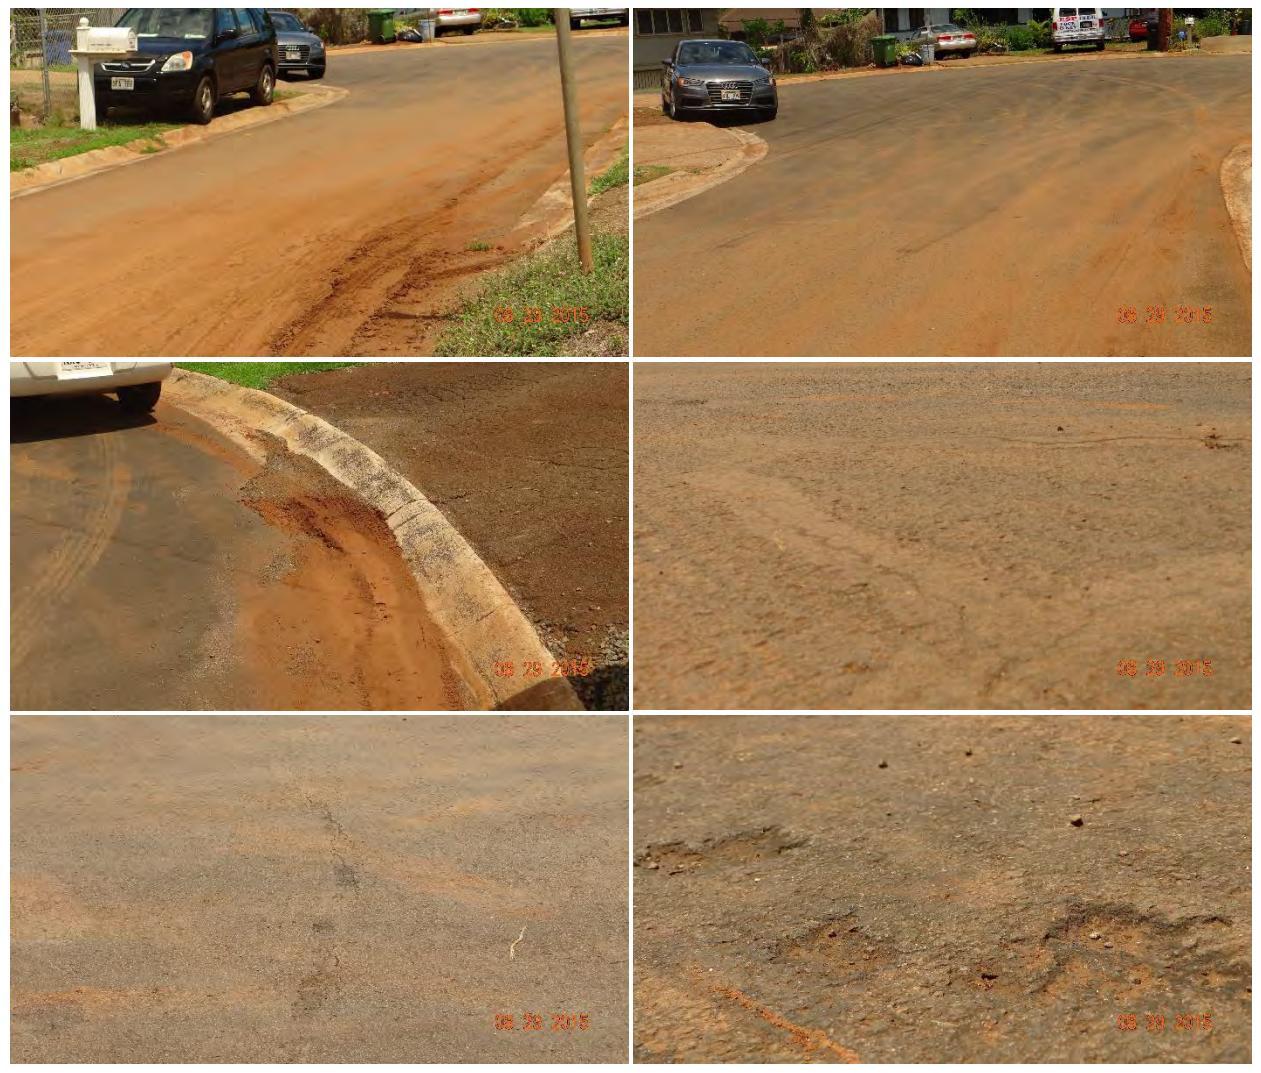
Figure C-100 Condition of the section on Hoolawa Place, treated with Plasti-Pave, on 8/29/2015.

Figure C-100 shows the conditions on 8/29/2015. The photos in this figure illustrate that the dirty conditions at times got much worse, depending on the precipitation in the days prior to each survey. Such conditions often made it very difficult to assess the condition of the fog seal itself.
