PERFORMANCE MONITORING OF PRESERVATION TREATMENTS IN HONOLULU

FINAL PROJECT REPORT

Adrián Ricardo Archilla University of Hawaii at Manoa

May 2019

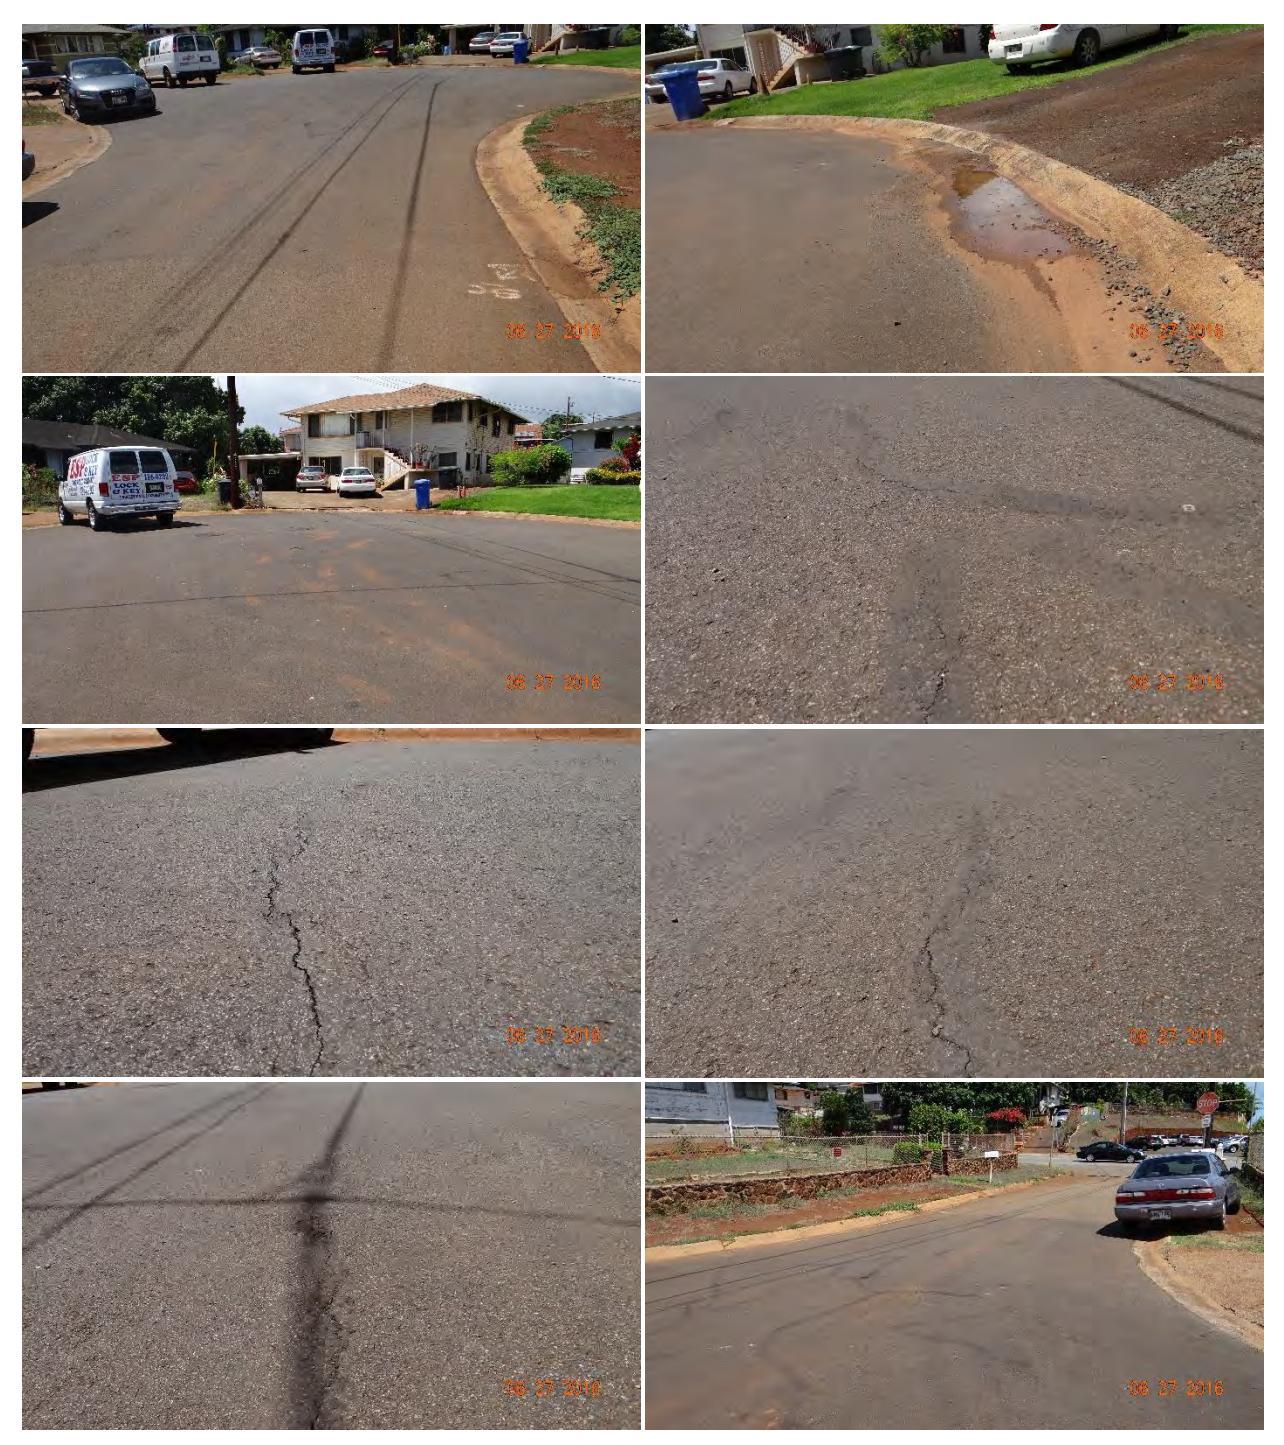
Figure C-101 Condition of the section on Hoolawa Place, treated with Plasti-Pave, on 6/27/2016.

Figure C-101 shows that the surface was cleaner on 6/27/2016, but still quite dirty. Some of the photos show that on several existing thin cracks, the sealer was either gone or not effectively sealing the crack. As discussed before, this was a common observation about the performance of the crack sealing on thin cracks for all sections.

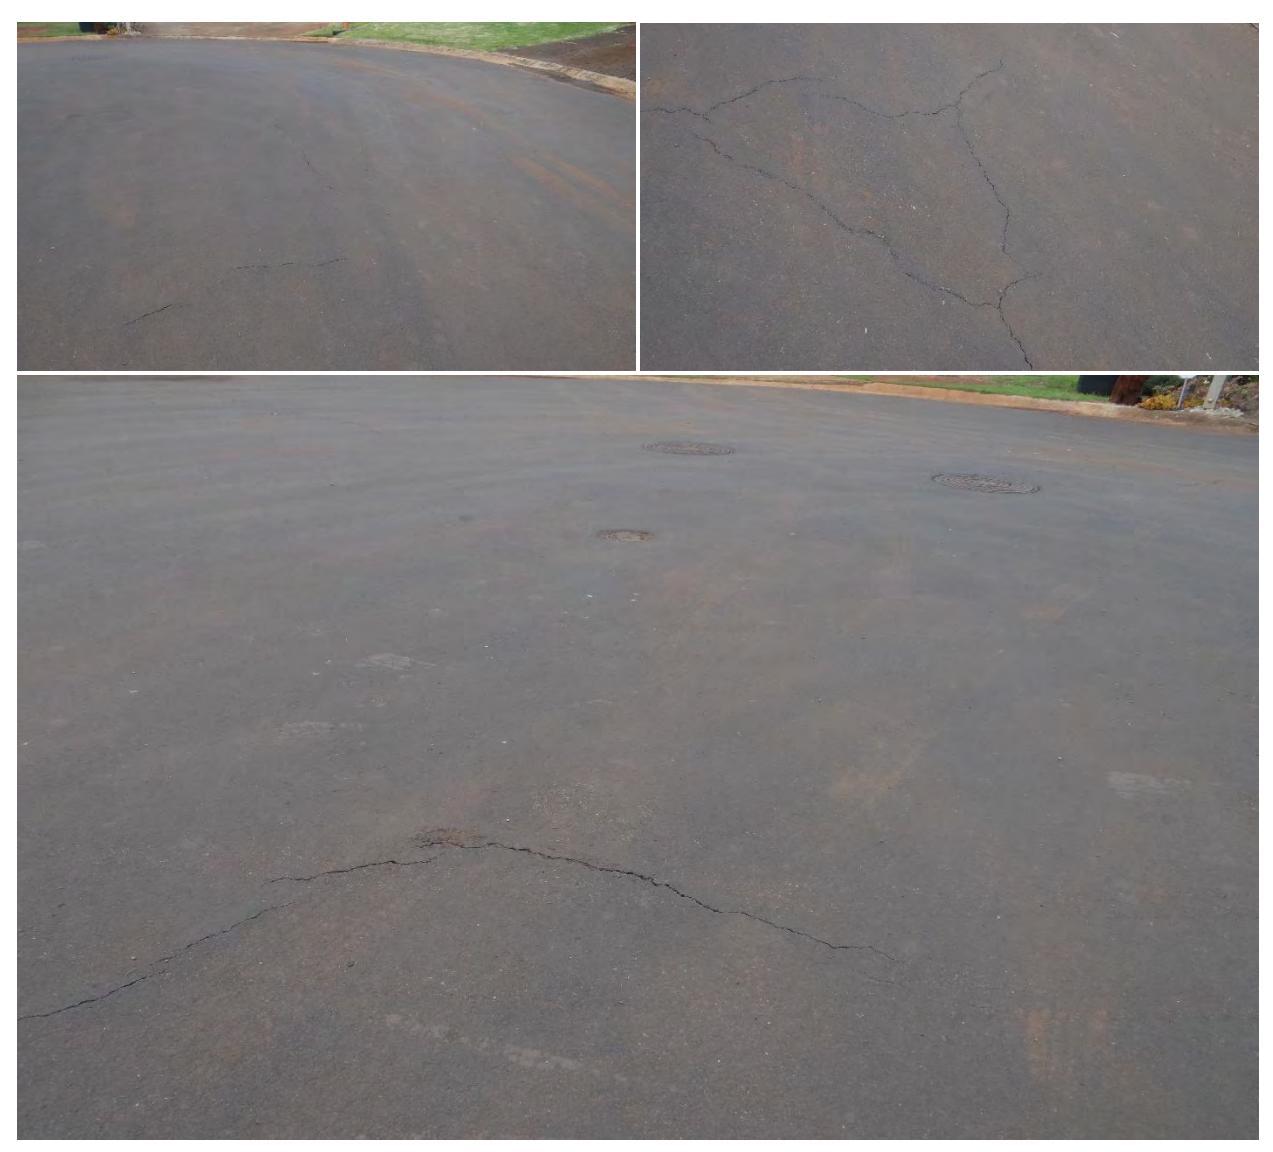
Figure C-102 Condition of the section on Hoolawa Place, treated with Plasti-Pave, on 2/7/2018.

Figure C-102 shows the overall condition of the section on 2/7/2018, 38 months after the treatment application. Despite the dirty conditions, the fog seal still appeared to be performing well.

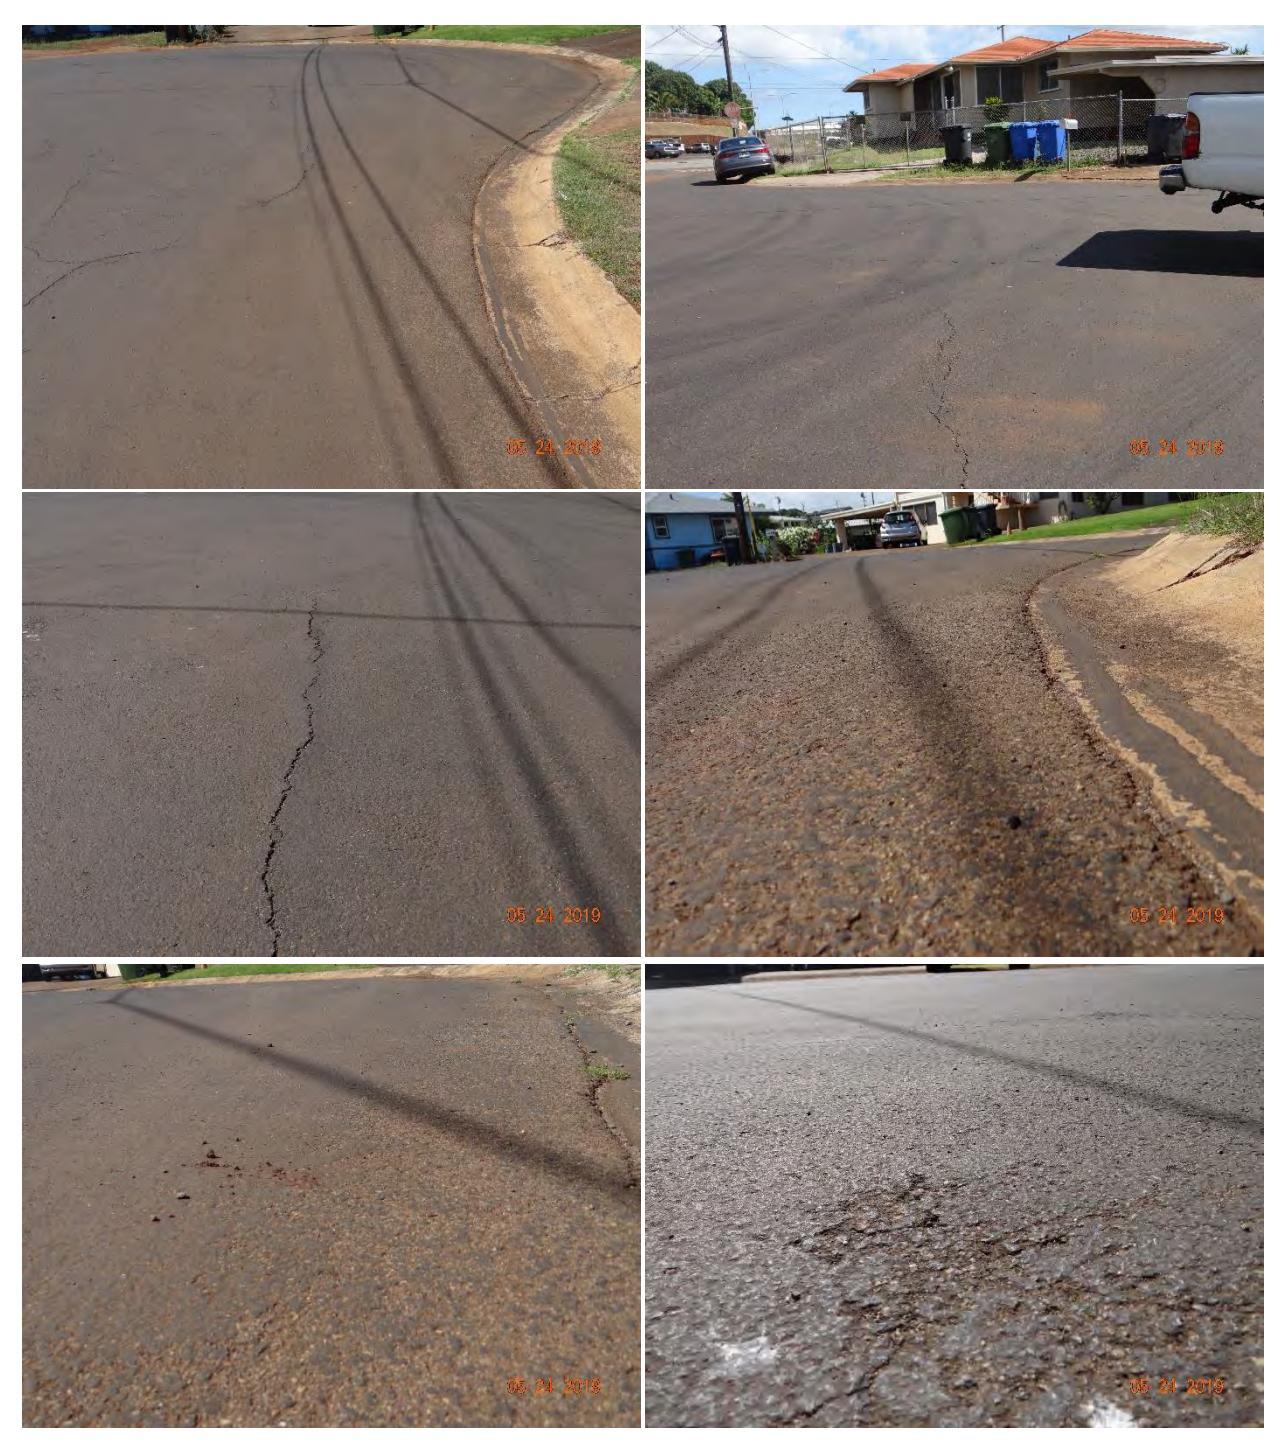
Figure C-103 Condition of the section on Hoolawa Place, treated with Plasti-Pave, on 5/24/2019.

Figure C-103 show the conditions on 5/24/2019. The sealer was still performing relatively well in most of the cul-de-sac, but it had started to wear off near the gutters, where some raveling was noted.

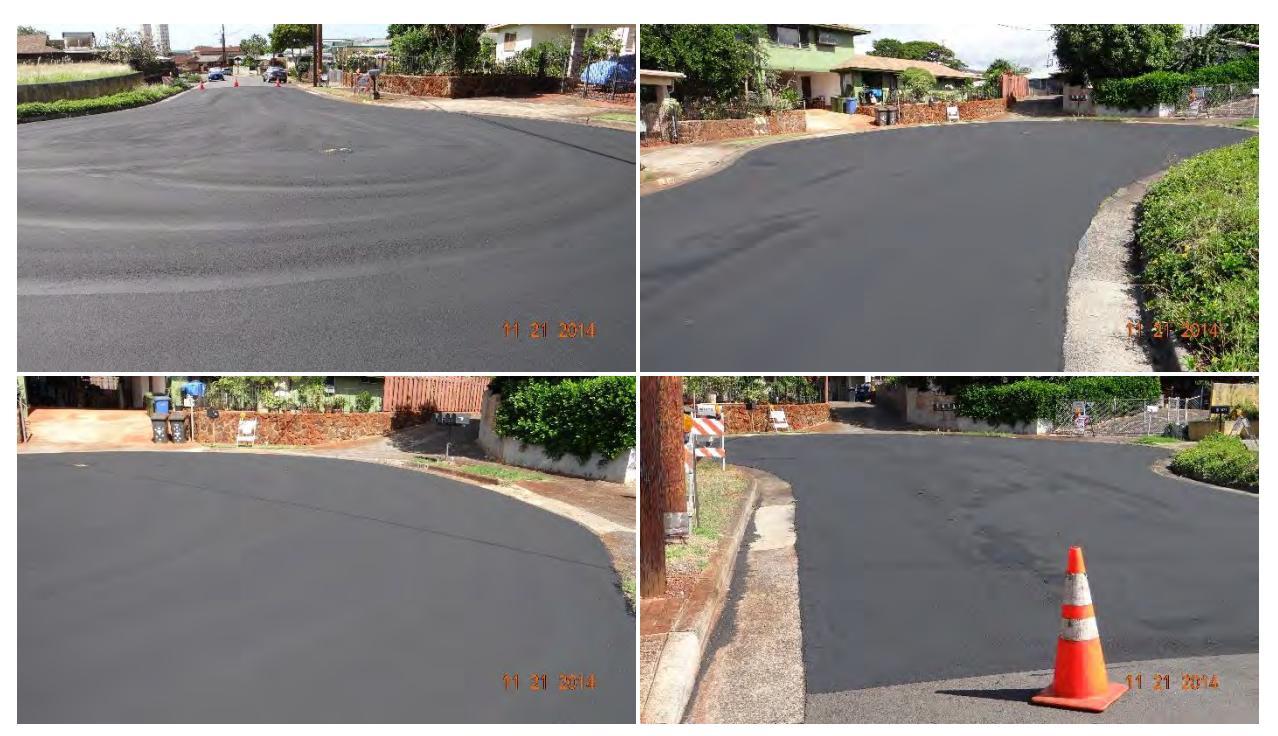
Figure C-104 Condition of the section on Kanihi Street, treated with Liquid Road, on 11/21/2014.

Figure C-104 through Figure C-109 show the condition of this section over time. Figure C-104 illustrates the treatment appearance on 11/21/2014, immediately after its application. Similarly to the observation made for the straight section treated with Liquid Road, this treatment can show some uneven appearance shortly after its application. Although the uneven appearance does not completely disapear, it gets substantially less conspicous as the emulsion sets.

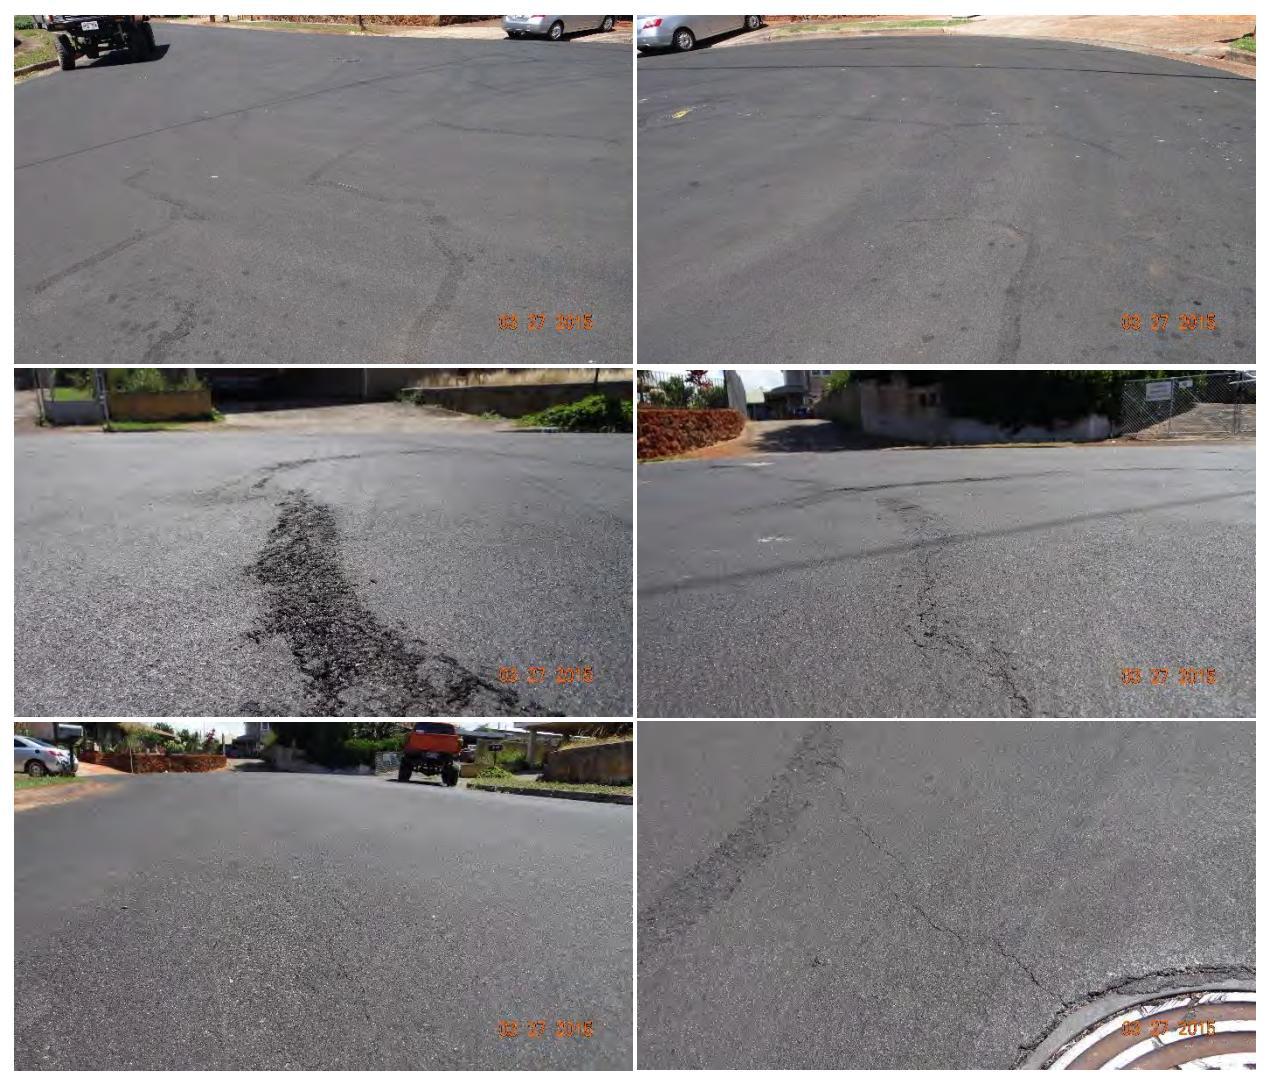
Figure C-105 Condition of the section on Kanihi Street, treated with Liquid Road, on 3/27/2015.

The photos in Figure C-105 illustrate the condition of the section on 3/27/2015, after four months of service. As discussed before, this treatment is thicker and provides some more texture than the other seal coats evaluated in the study. Nevertheless, the sealed cracks were still visible. In situations where the crack sealer had been tracked, the cracks appeared a bit unseemly. This was a common problem in sections in residential areas, where traffic could not always be kept out until the sealer cured, despite signage and even policy presence. These photos also show some new hairline cracks and some cracking of the sealer on top of sealed cracks.

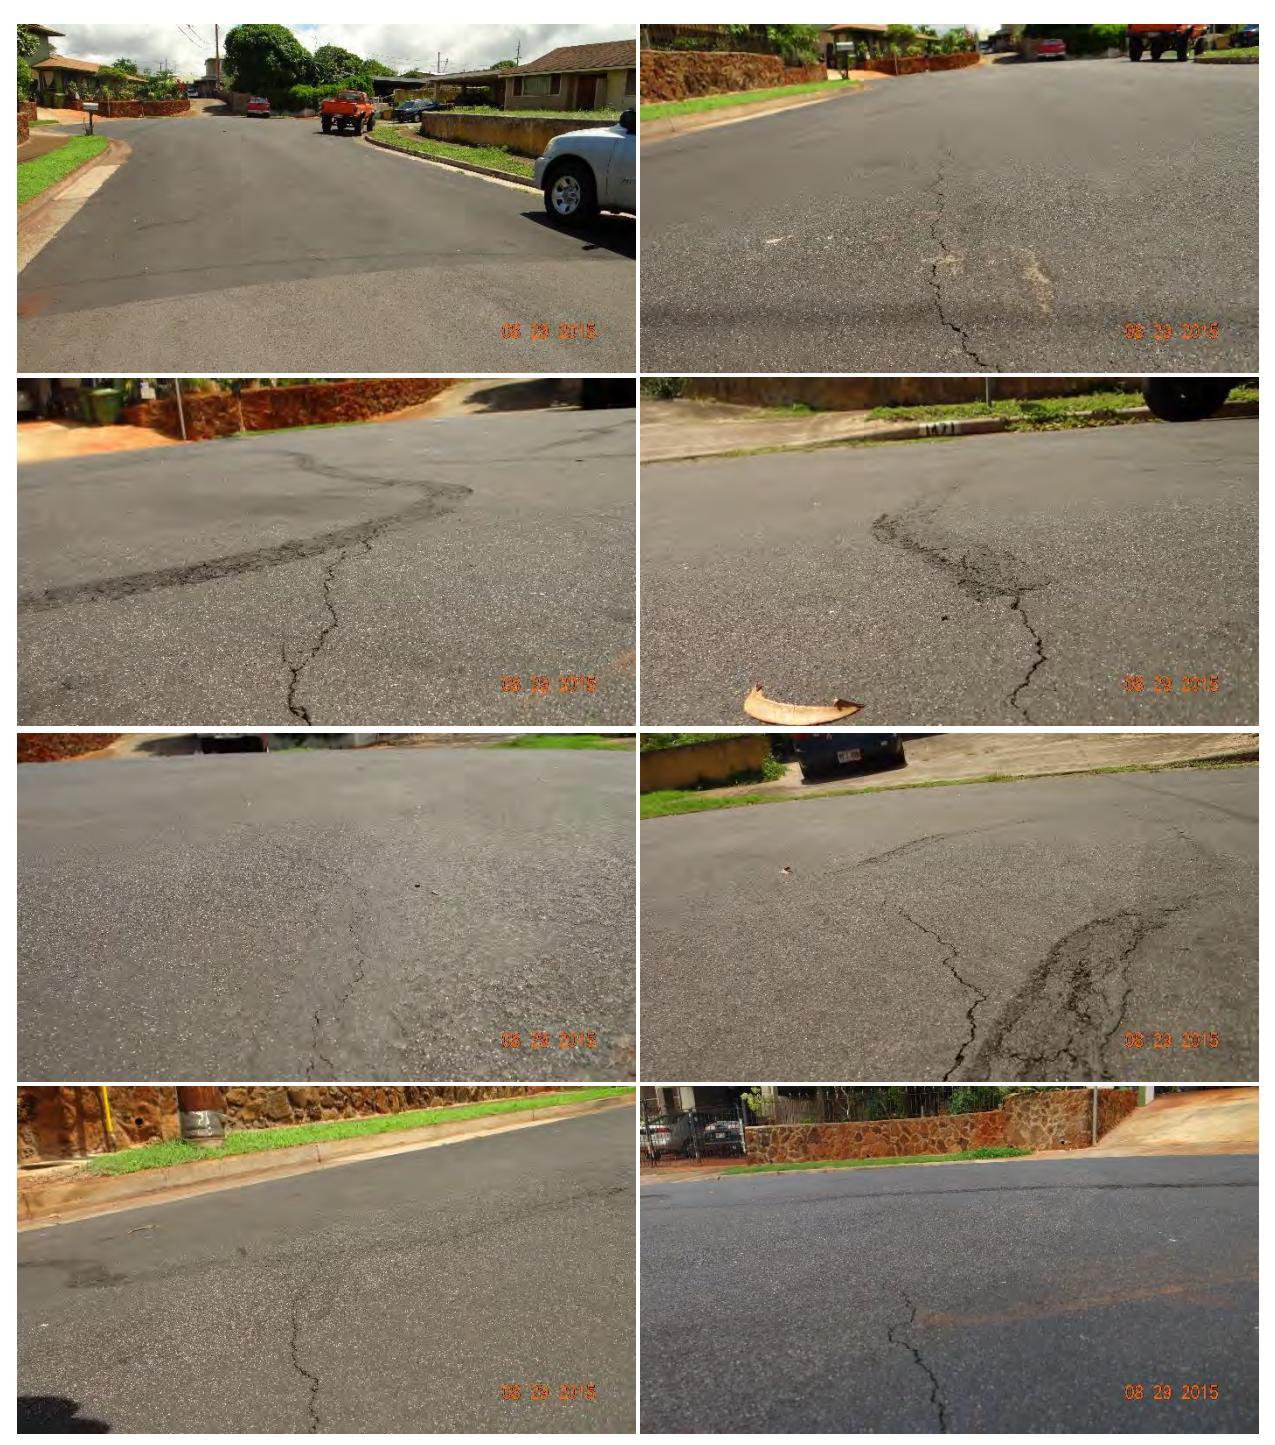
Figure C-106 Condition of the section on Kanihi Street, treated with Liquid Road, on 8/29/2015.

The top left photo in Figure C-106 shows that as of 8/29/15, 9 months after the treatment application, there was still a very marked contrast between the treated and untreated surfaces. The other photos in the figure also illustrate that there was still a large amount of sand on the surface of the treatment and that most of the hairline crack had grown in width and they were therefore much more noticeable. However, most of those cracks would be classified as low severity.

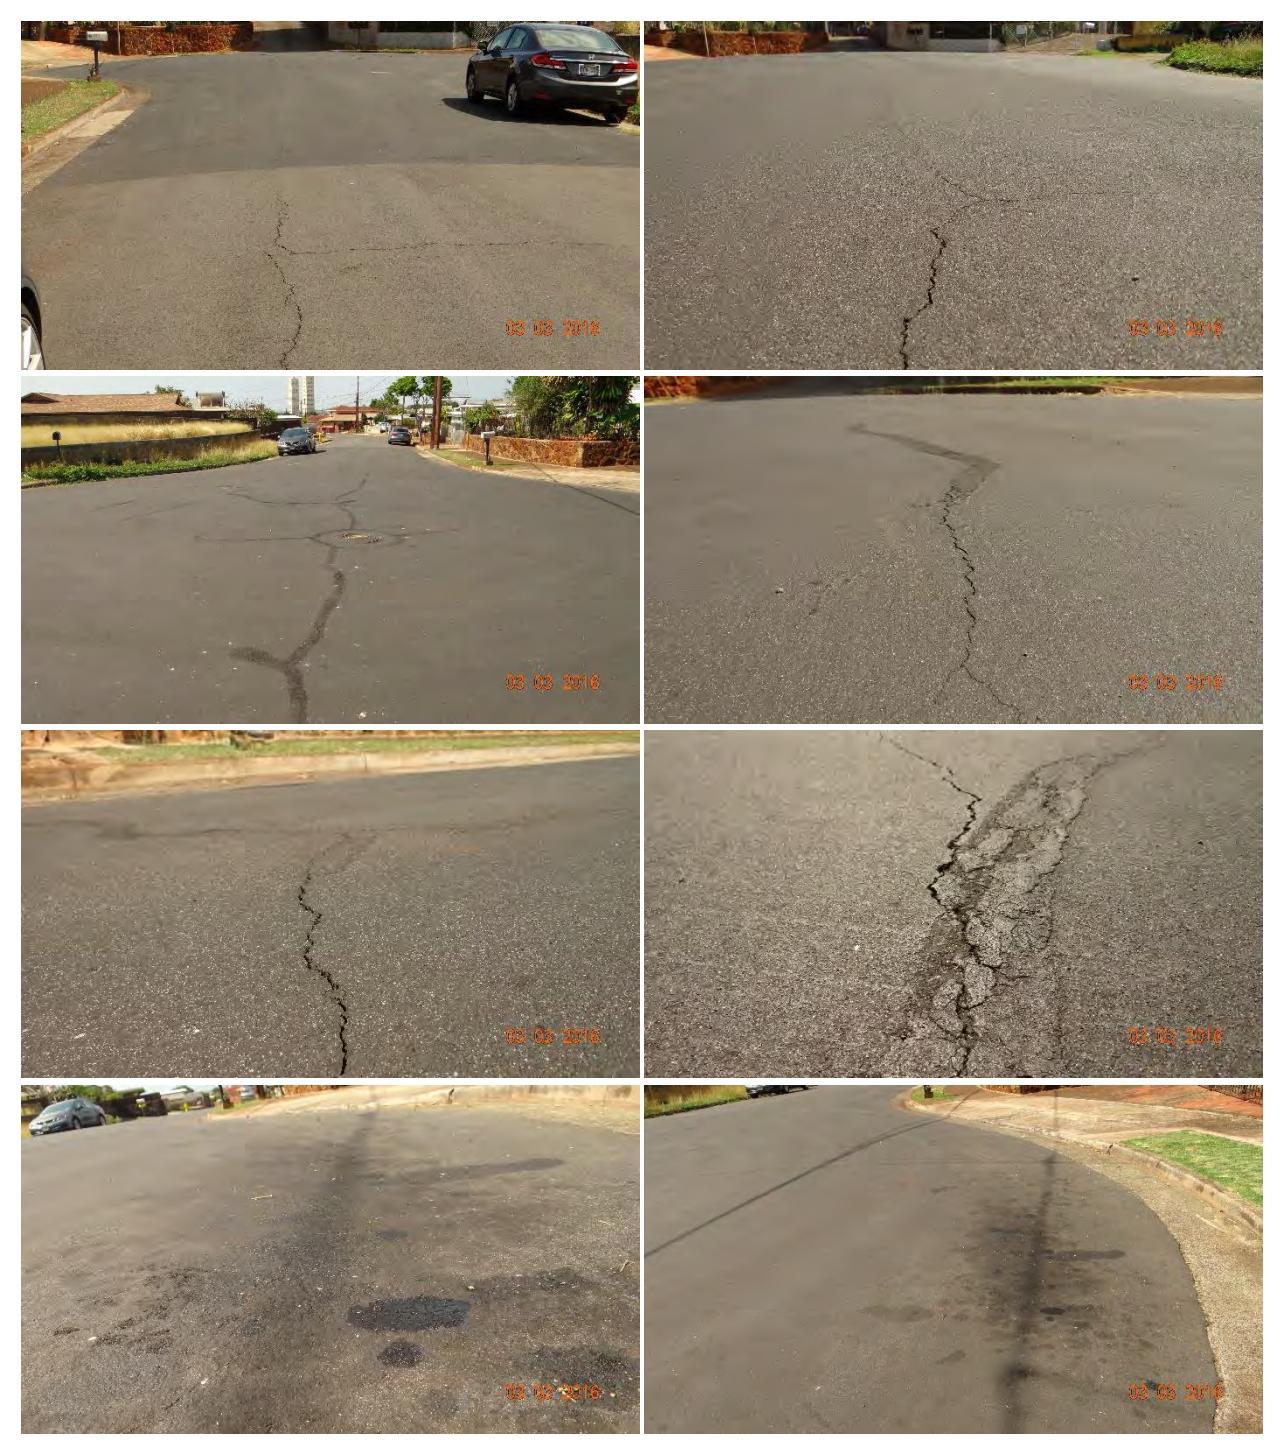
Figure C-107 Condition of the section on Kanihi Street, treated with Liquid Road, on 3/3/2016.

Figure C-107 shows that the conditions were similar on 3/3/2016, about 15 months after treatment application, except perhaps that now some cracks were reaching the limit between low and moderate severity. The last two photos in this figure also illustrate the common problem observed in other sections with oil spots created by leaking from parked vehicles.

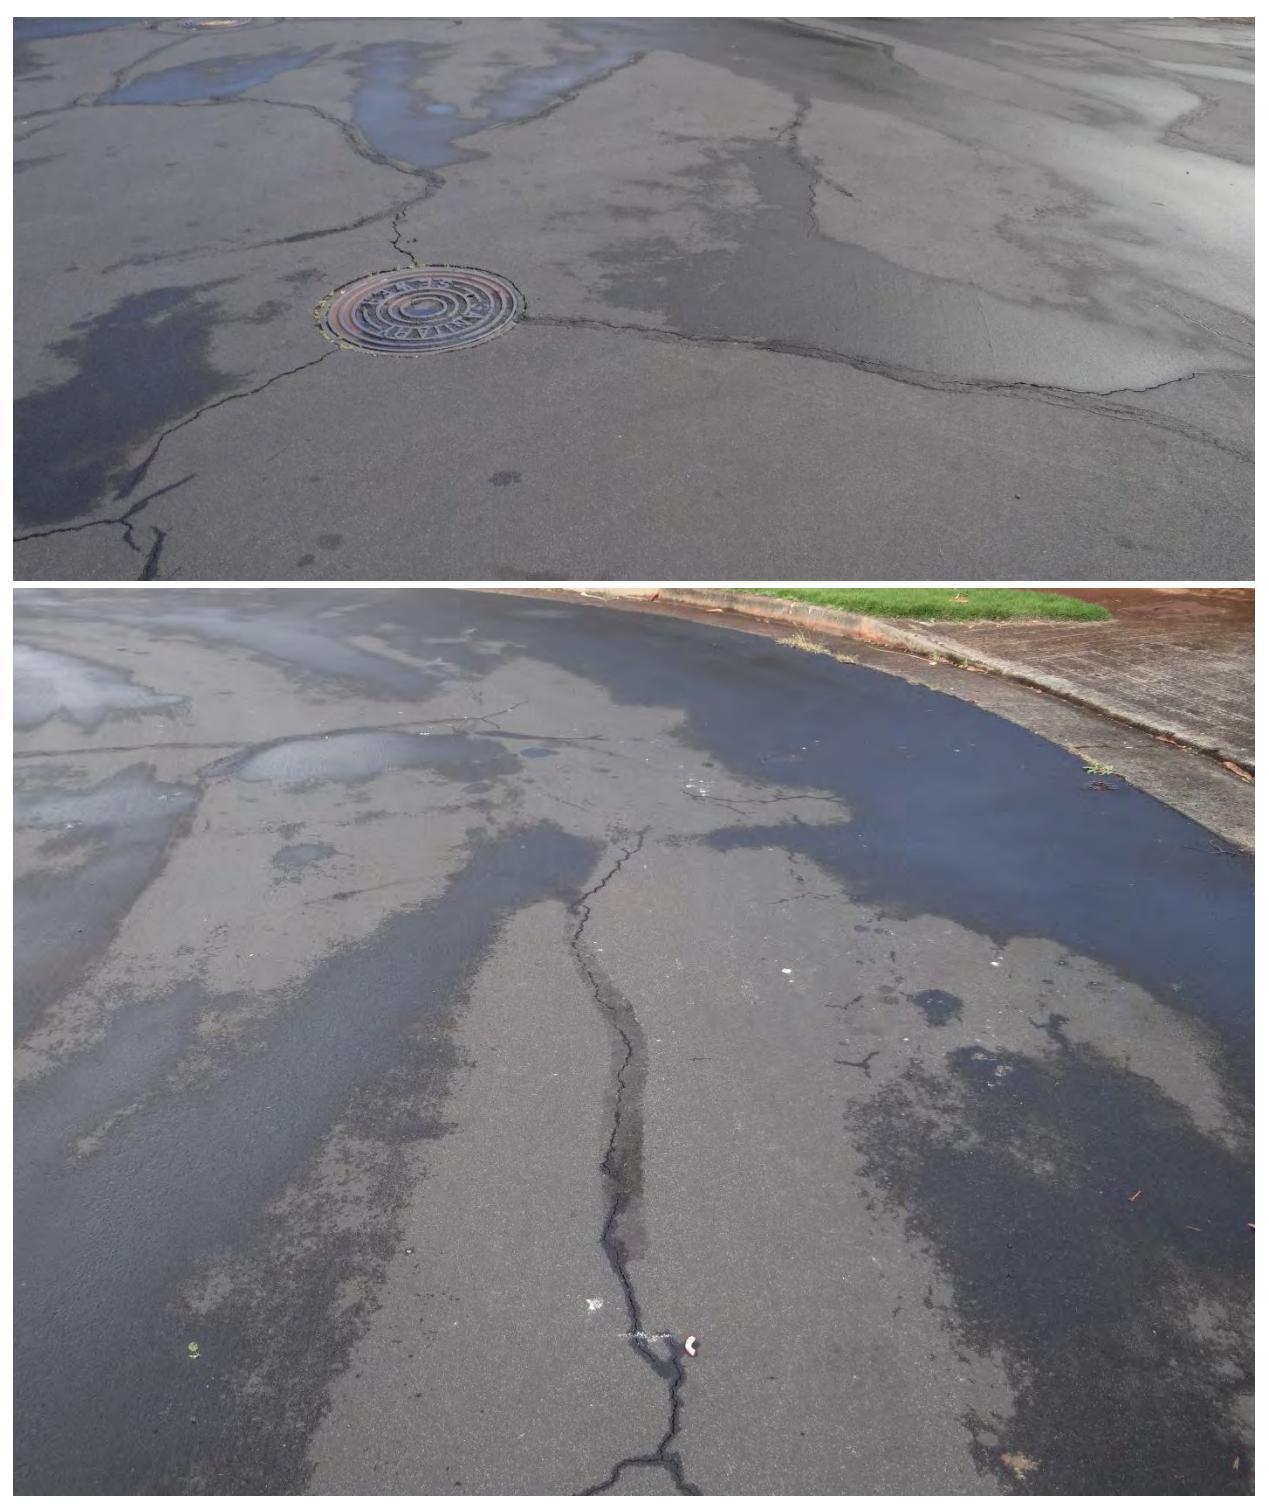
Figure C-108 Condition of the section on Kanihi Street, treated with Liquid Road, on 12/13/2016.

Figure C-108 illustrates the conditions on 12/13/2016, about 25 months after the treatment application. Clearly, these photos were taken after a rain event, but they are helpful in highlighting the good condition of the surface of the treatment. Of course, the additional cracking developing in the underlying pavement had continued reflecting on the surface. The photo at the bottom of the figure shows a crack that had originally been sealed but that had grown on both ends. It is interesting to see the apparent different moisture levels around most of the sealed crack and its new extensions. The extensions appeared to have more moisture, which may be an indication that even if the crack sealer is not sealing the pavement perfectly it may still be preventing some of the water to infiltrate the crack.

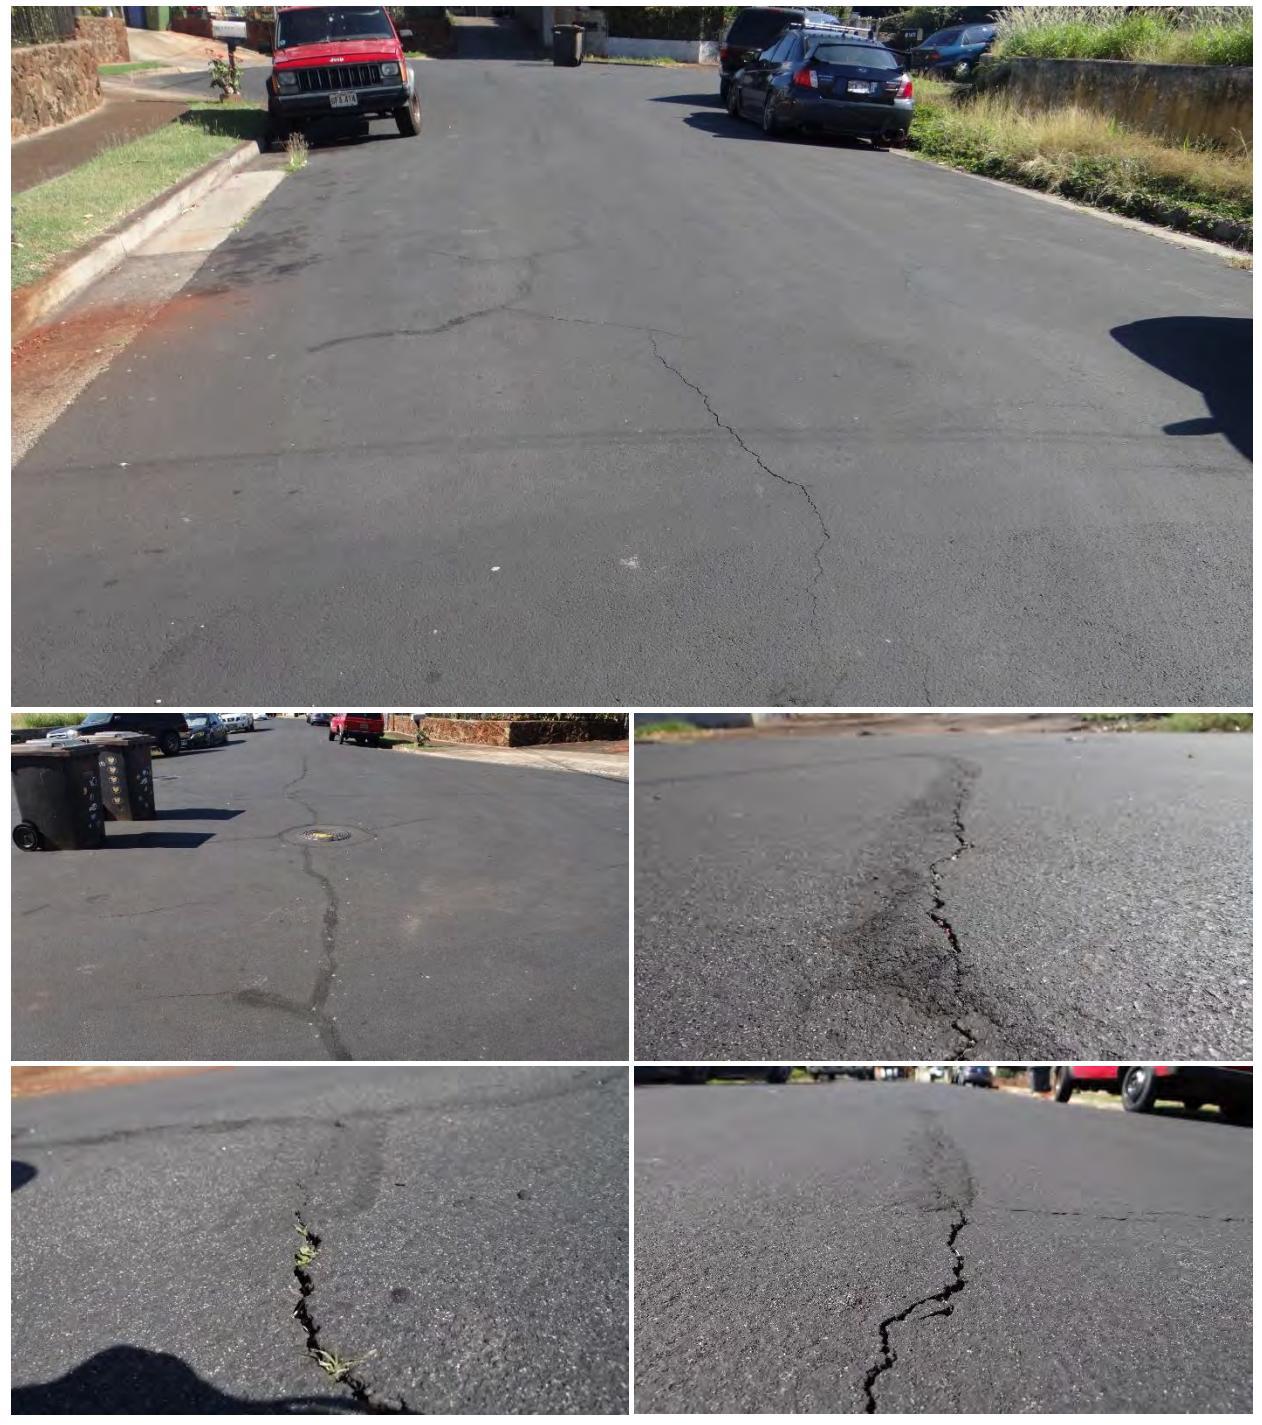
Figure C-109 Condition of the section on Kanihi Street, treated with Liquid Road, on 1/26/2018.

Figure C-109 shows the conditions on 1/26/2018, at the end of the observation period and 38 months after the treatment application. The top photo in the figure shows the overall appearance of the section, which was still good. Note that the photo shows practically no contrast with the "previously untreated pavement" because now that section had been treated as part of existing pavement preservation efforts of the City and County of Honolulu. The fact that it was not easy to detect the difference between the original treatment and the new one attests to the good performance of Liquid Road in this section.

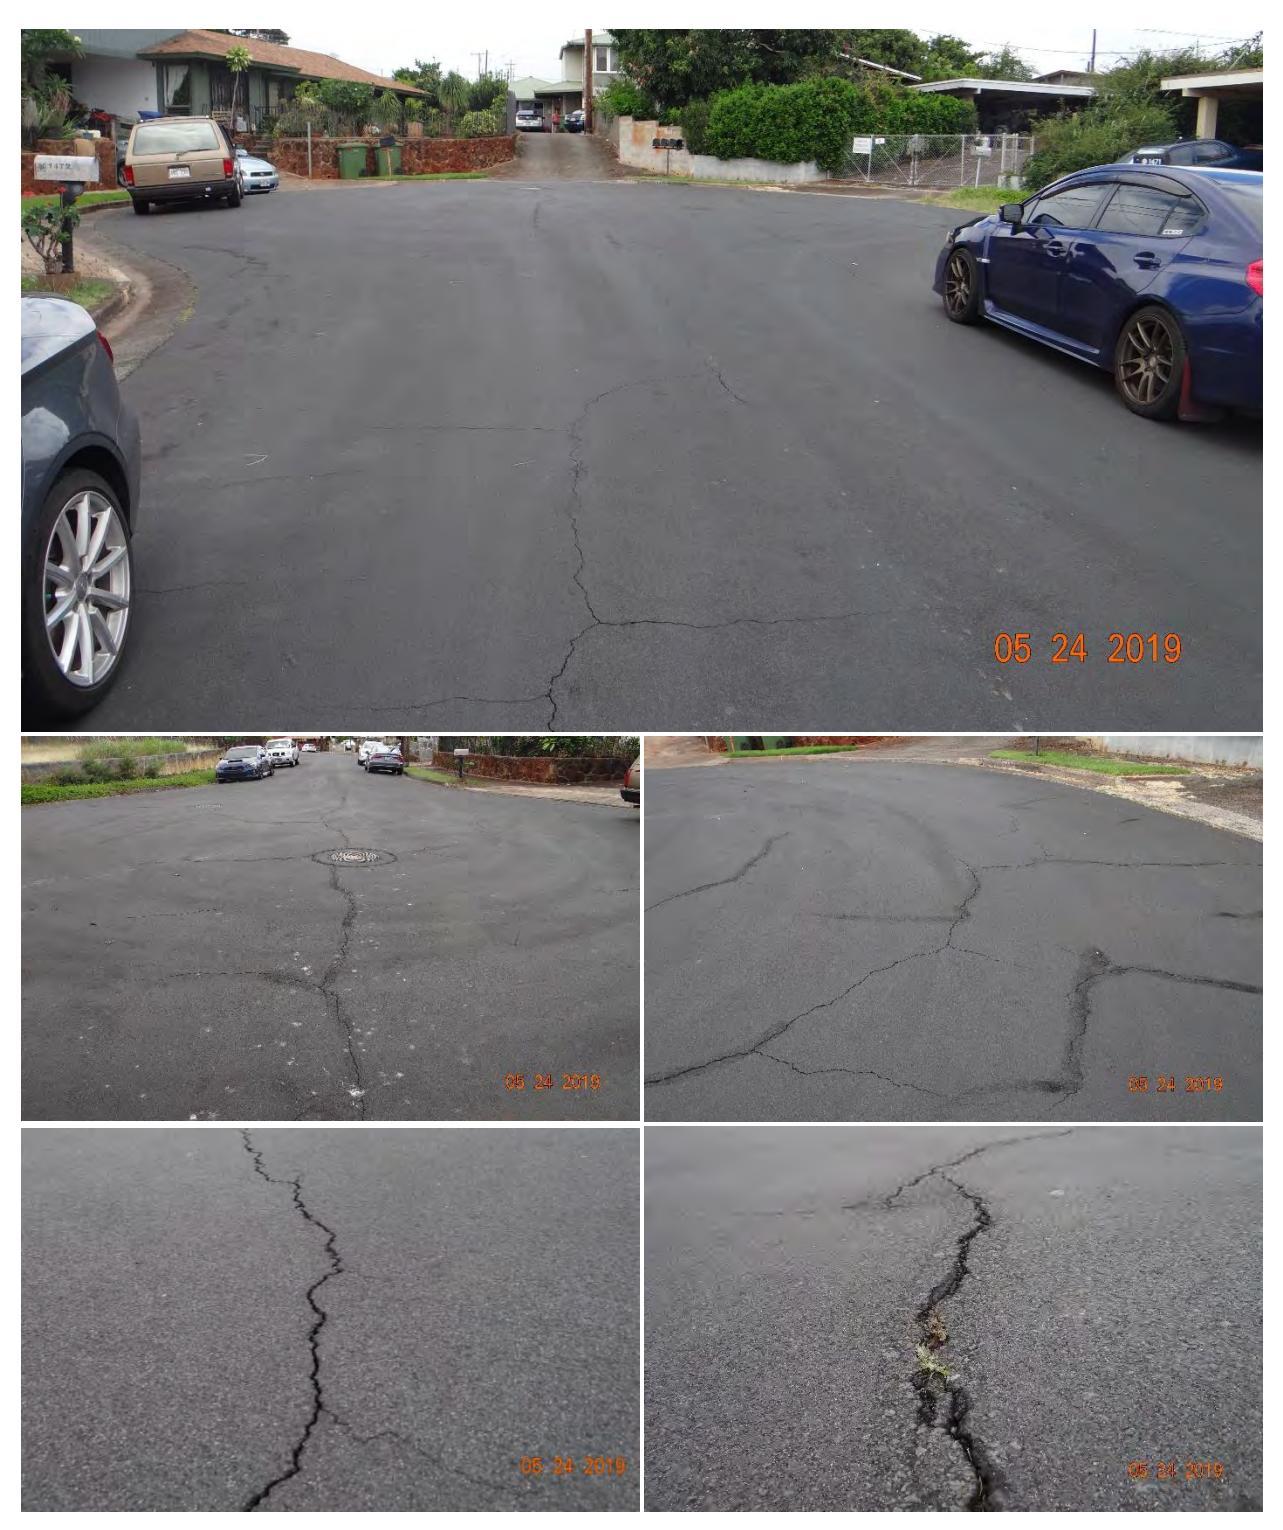
Figure C-110 Condition of the section on Kanihi Street, treated with Liquid Road, on 5/24/2019.

Figure C-110 shows the conditions on 5/24/2019, 16 months after the end of the observation period and 54 months (4.5 years) after the treatment application. The overall appearance of the section was still good, except that the length of cracking appeared to have increased (note that this is just an impression since no measurements were performed for this last survey). The treatment surface still exhibited a texture like the one observed after its application and appears to have significant residual life. Consequently, with a routine crack sealing program that seals these cracks, the surface could be maintained sealed for a while longer.

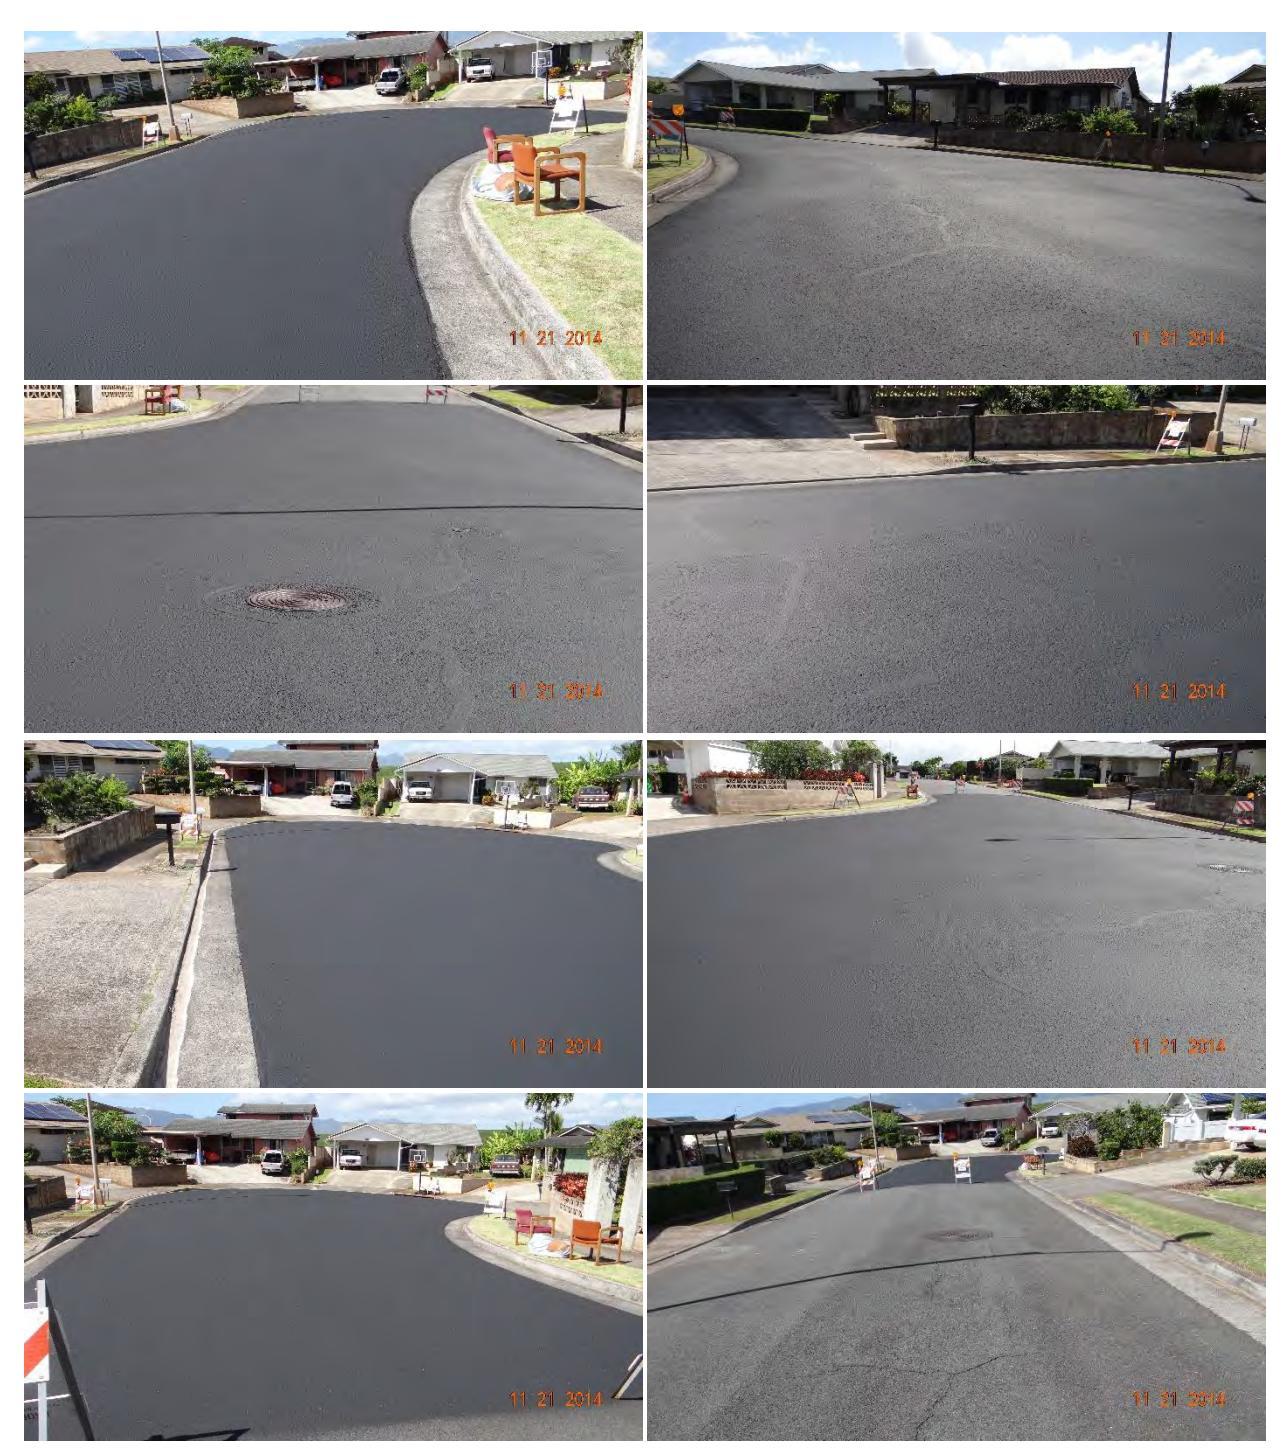
Figure C-111 Condition of the section on Kalauipo Place, treated with MasterSealTM Ready to Use, on 11/21/2014.

Figure C-111 through Figure C-116 show the condition of this section over time. Figure C-111 illustrates the very uniformly black appearance of this treatment immediately after its application on 11/21/2014. The figure also shows the high contrast with the untreated section. It can also be seen that the crack sealing underneath was still visible though not very conspicous.

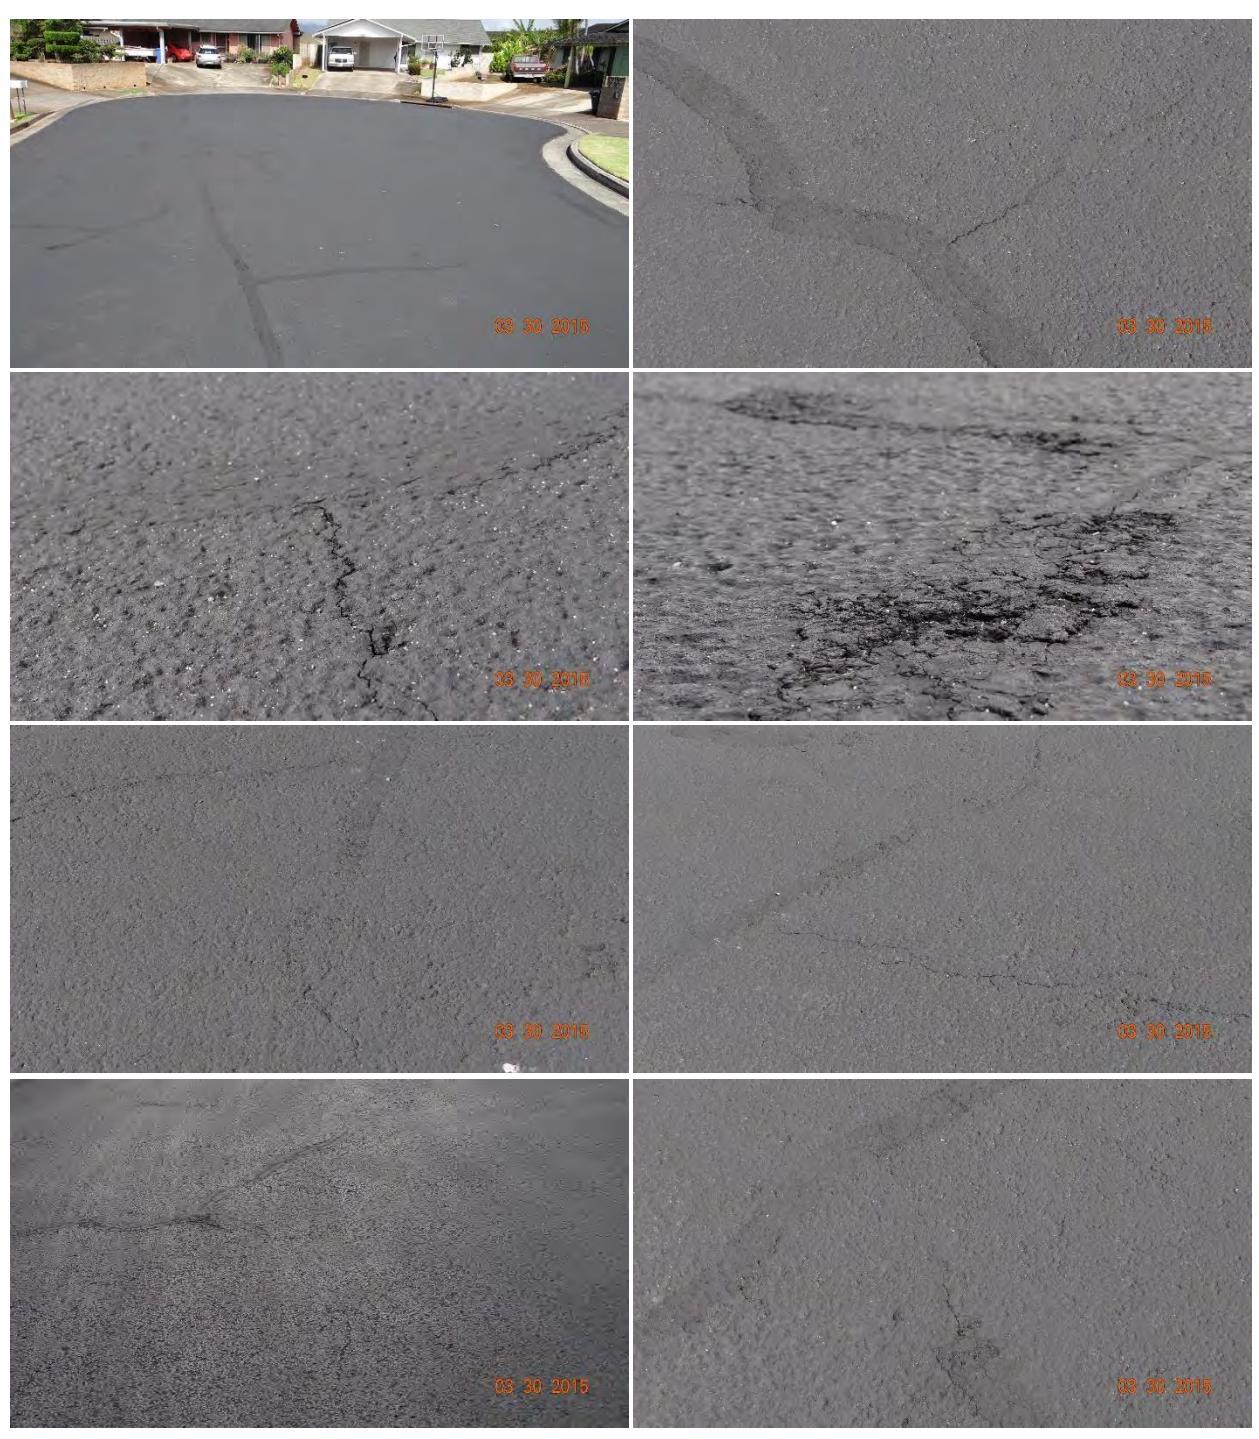
Figure C-112 Condition of the section on Kalauipo Place, treated with MasterSealTM Ready to Use, on 3/30/2015.

Practically no change was observed on 3/30/2015, four month after application of the treatment, with the exception of the appearance of a few harline cracks. The condition is shown in Figure C-112.
