PERFORMANCE MONITORING OF PRESERVATION TREATMENTS IN HONOLULU

FINAL PROJECT REPORT

Adrián Ricardo Archilla University of Hawaii at Manoa

May 2019

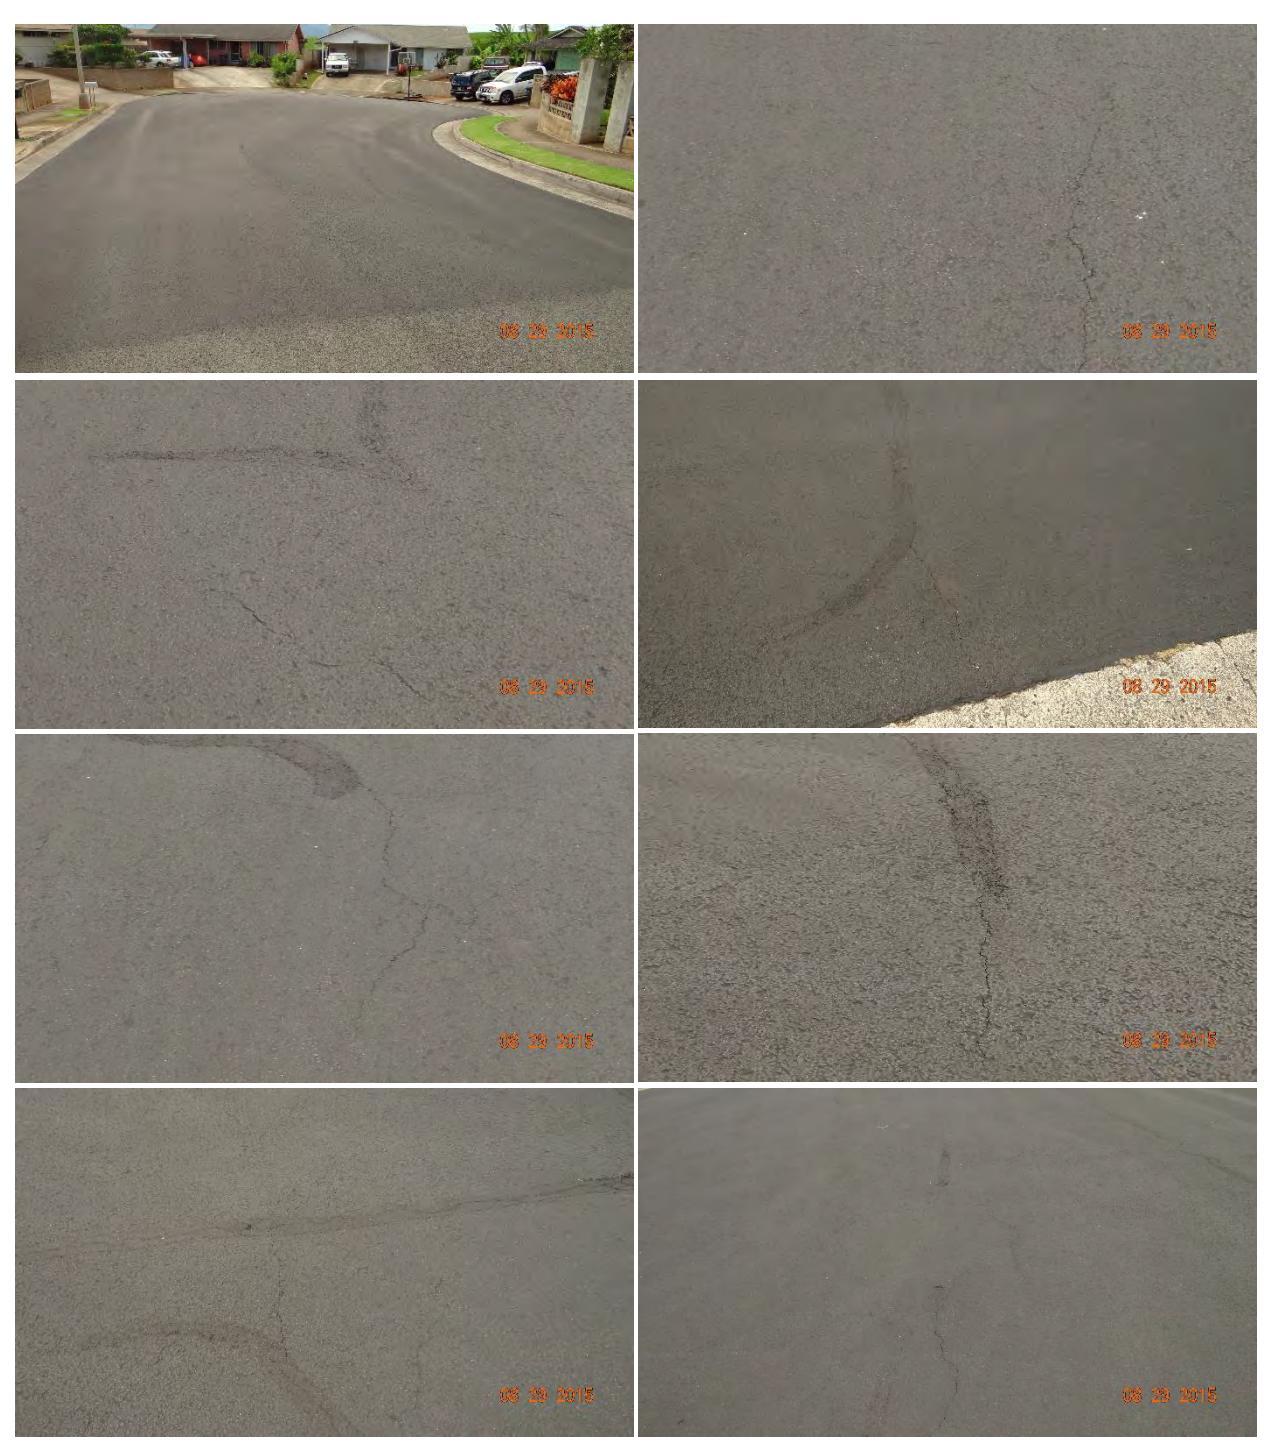
Figure C-113 Condition of the section on Kalauipo Place, treated with MasterSealTM Ready to Use, on 8/20/2015.

Again, as illustrated in Figure C-113, no noticeable changes were observed on 8/20/2015, nine months after application of the treatment.

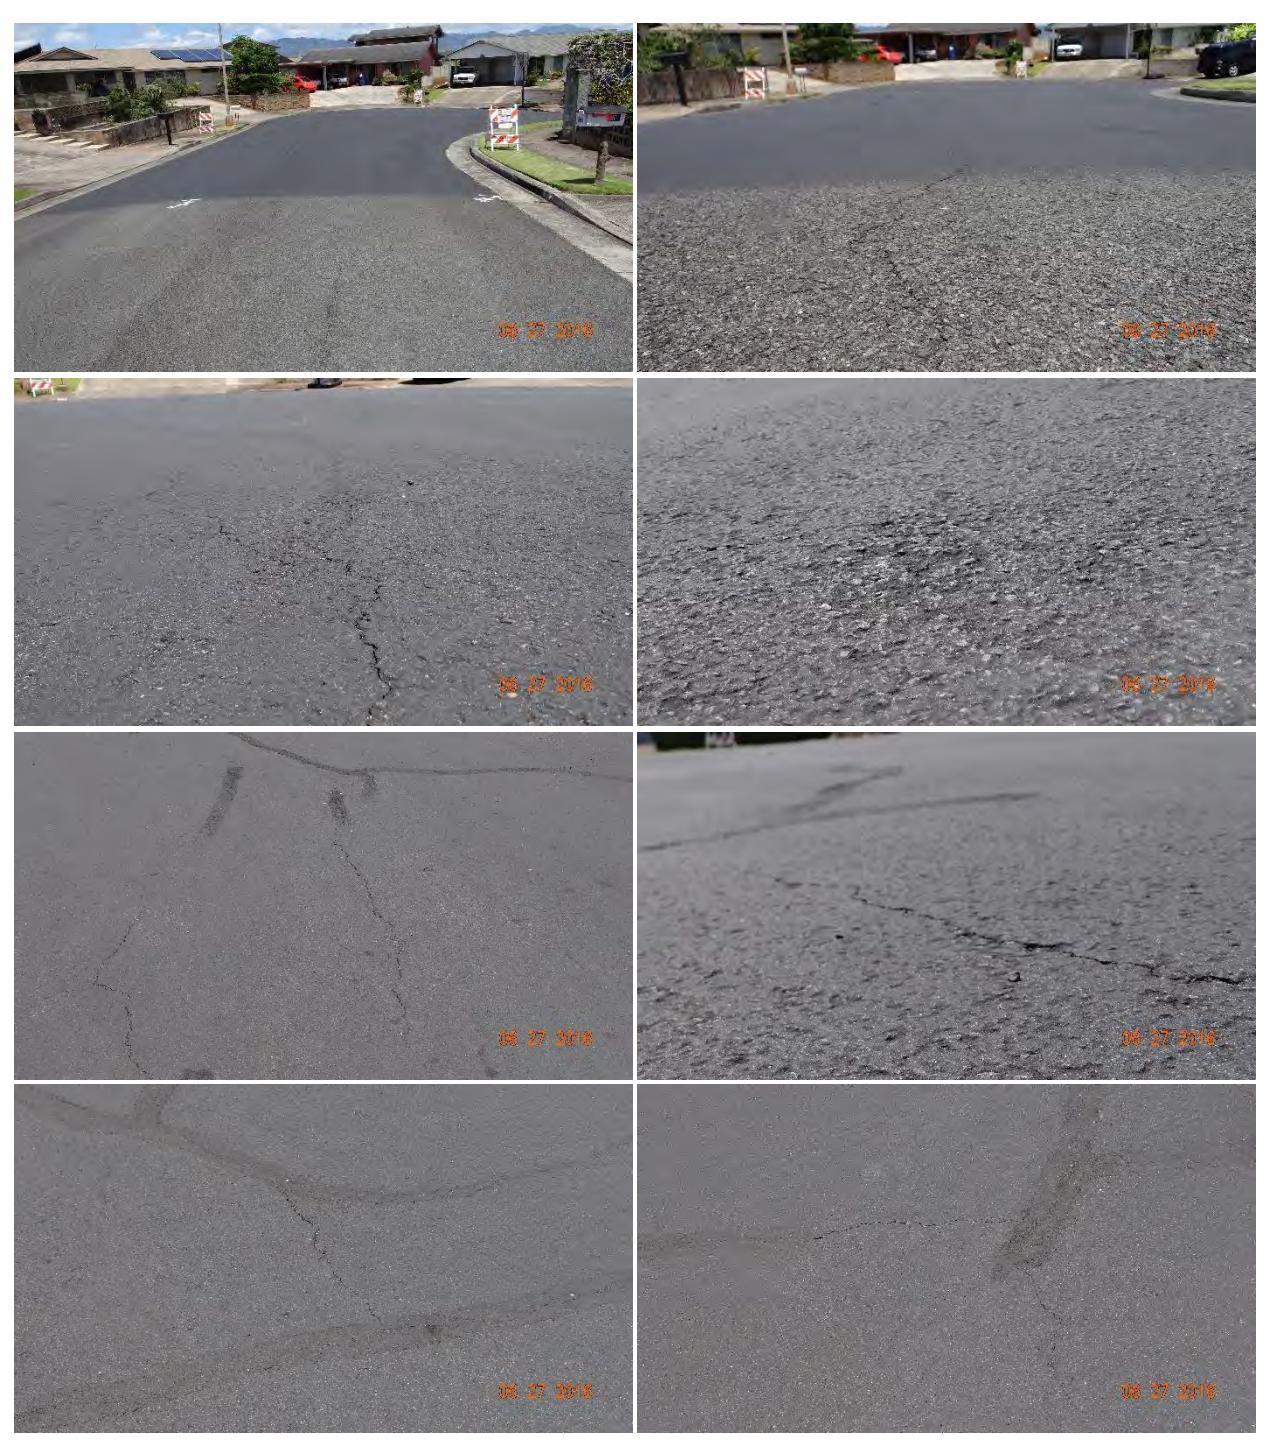
Figure C-114 Condition of the section on Kalauipo Place, treated with MasterSealTM Ready to Use, on 6/27/2016.

Figure C-114 shows the conditions on 6/27/2016, 19 months after the treatment application. The two photos on the top show the contrast with the untreated pavement. Note also that the sealer was holding the aggregates in place and avoiding the raveling observed in the untrated pavement. The other photos in the figure show some of the additional cracking and the prior defects that are not hidden well by this type of treatment.

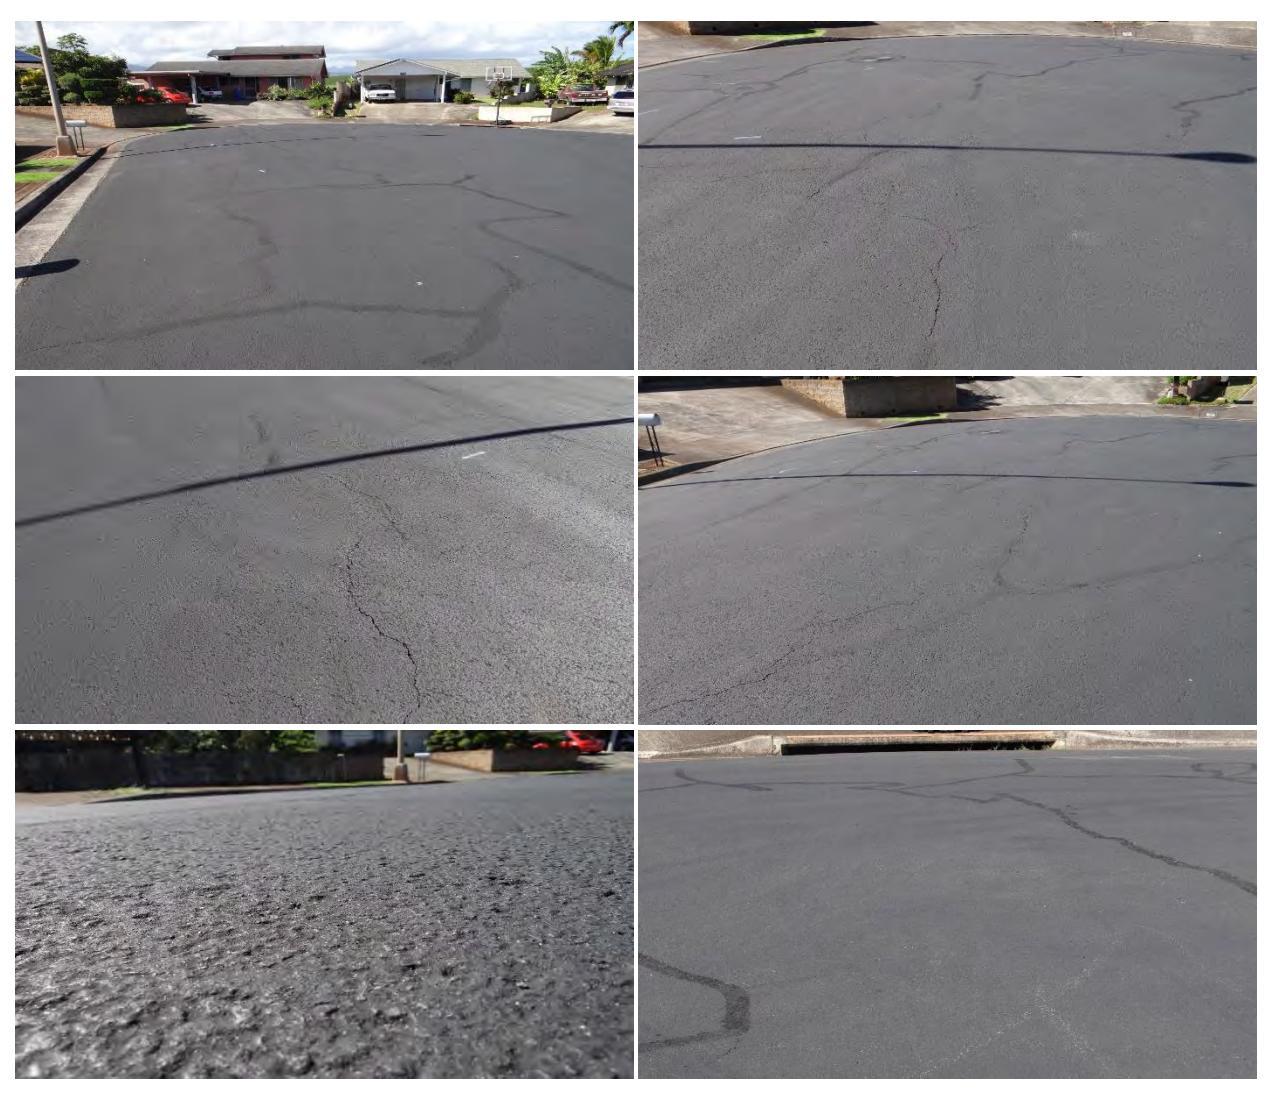
Figure C-115 Condition of the section on Kalauipo Place, treated with MasterSealTM Ready to Use, on 12/14/2016.

As of 12/14/2016, about 25 months after the application of MasterSeal RTU, the surface of the treatment was still is very good condition. This is illustrated in Figure C-115, which also shows that the length of additional cracking continue growing and that some crack were getting wider.

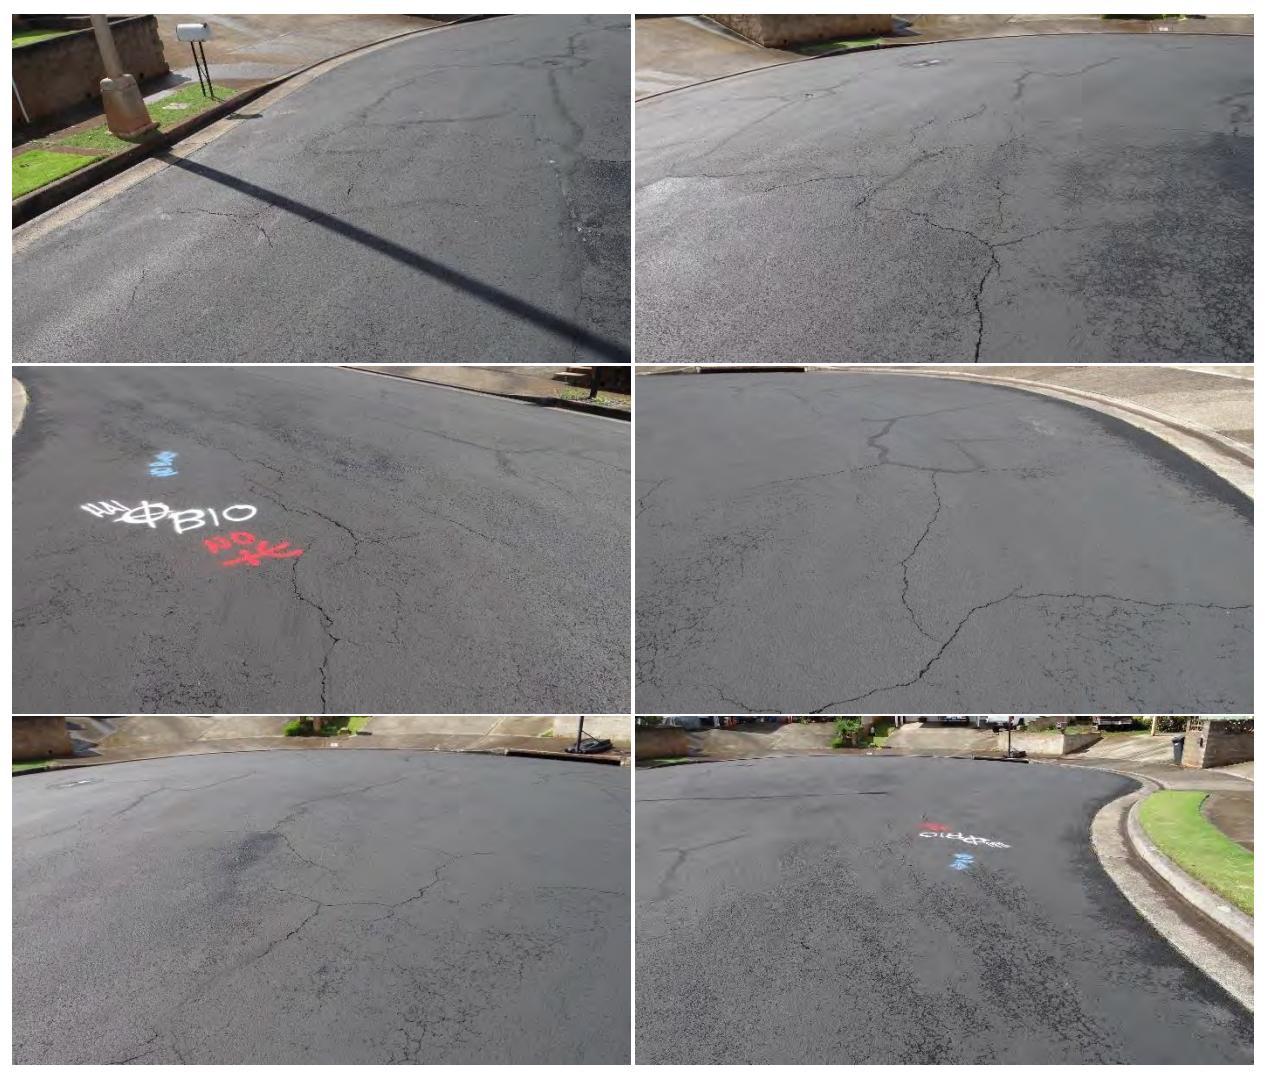
Figure C-116 Condition of the section on Kalauipo Place, treated with MasterSealTM Ready to Use, on 2/7/2018.

Figure C-116 shows the condition on 2/7/2018, about 38 months after the treatment application. These photos show that cracking continued getting more extensive and with slightly larger crack widths. Other than that, the seal coat was still protecting the pavement surface.

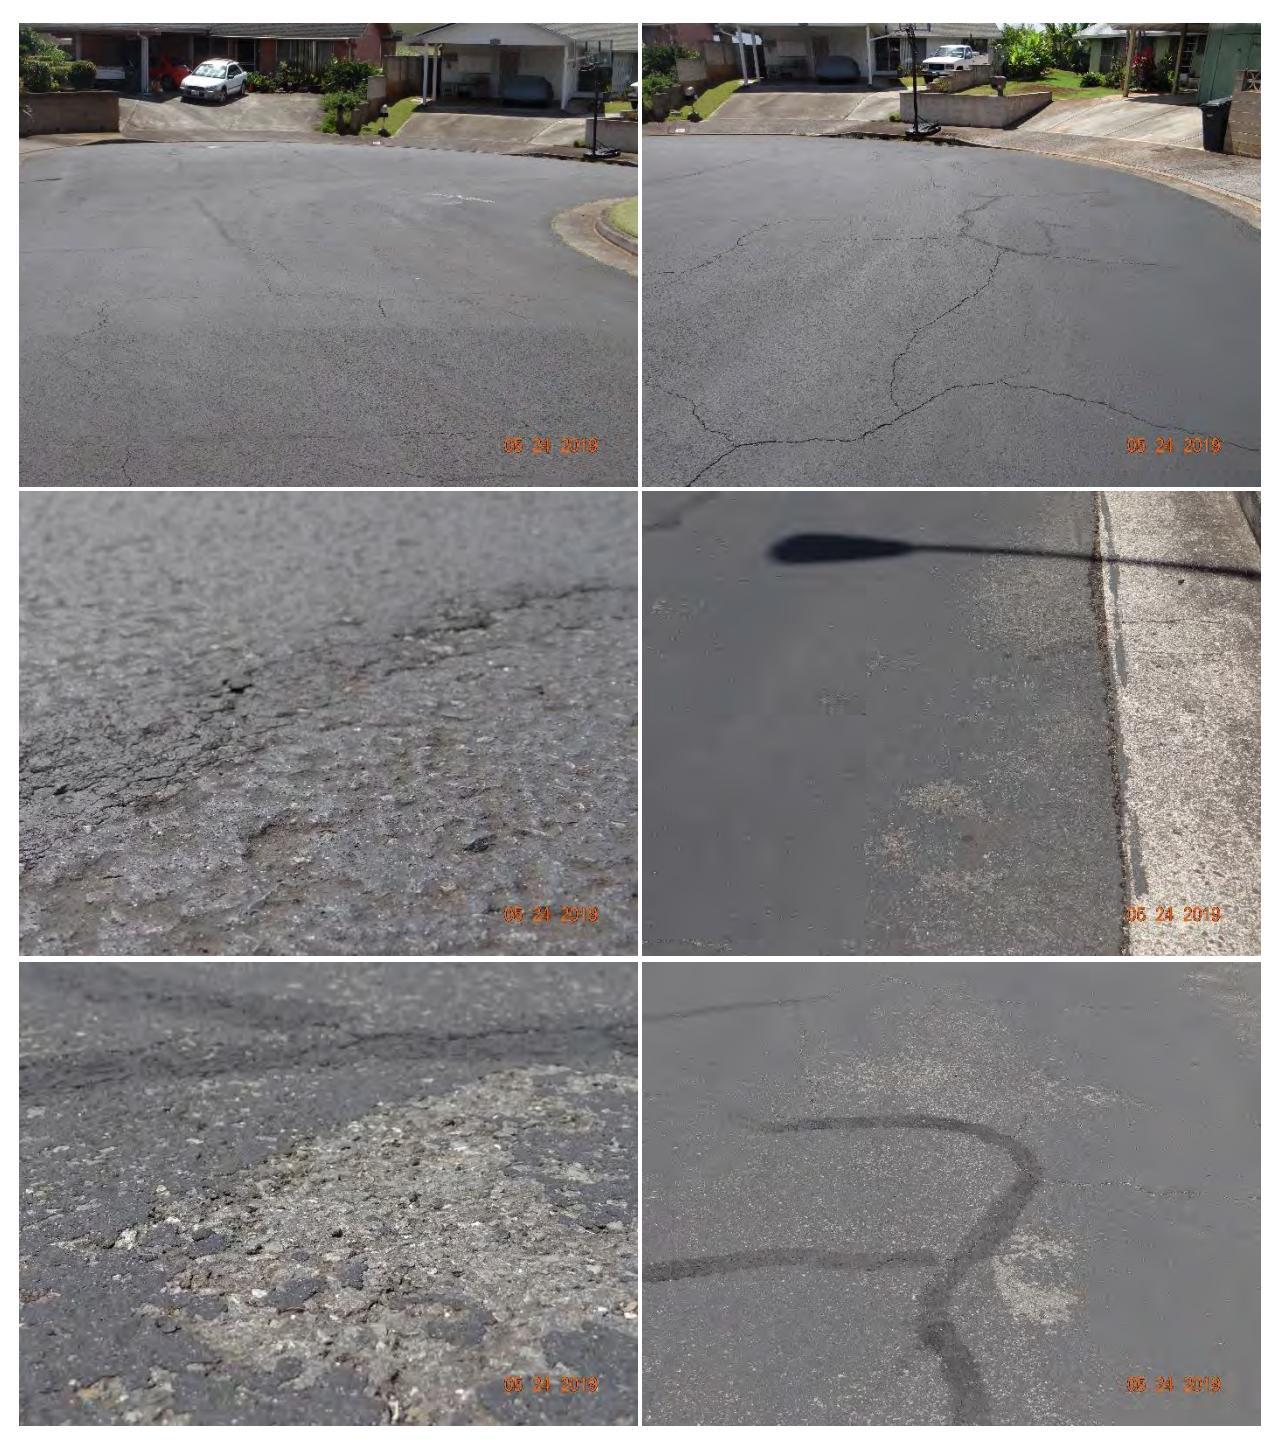
Figure C-117 Condition of the section on Kalauipo Place, treated with MasterSealTM Ready to Use, on 5/24/2019.

Finally, Figure C-117 shows the conditions on 5/24/2019. Although the overall condition of the section still looked good, the treatment had started to wear off in some areas near the gutter and in some turning spots. In the latter, there were some loose aggregates dislodge from the exposed surface.

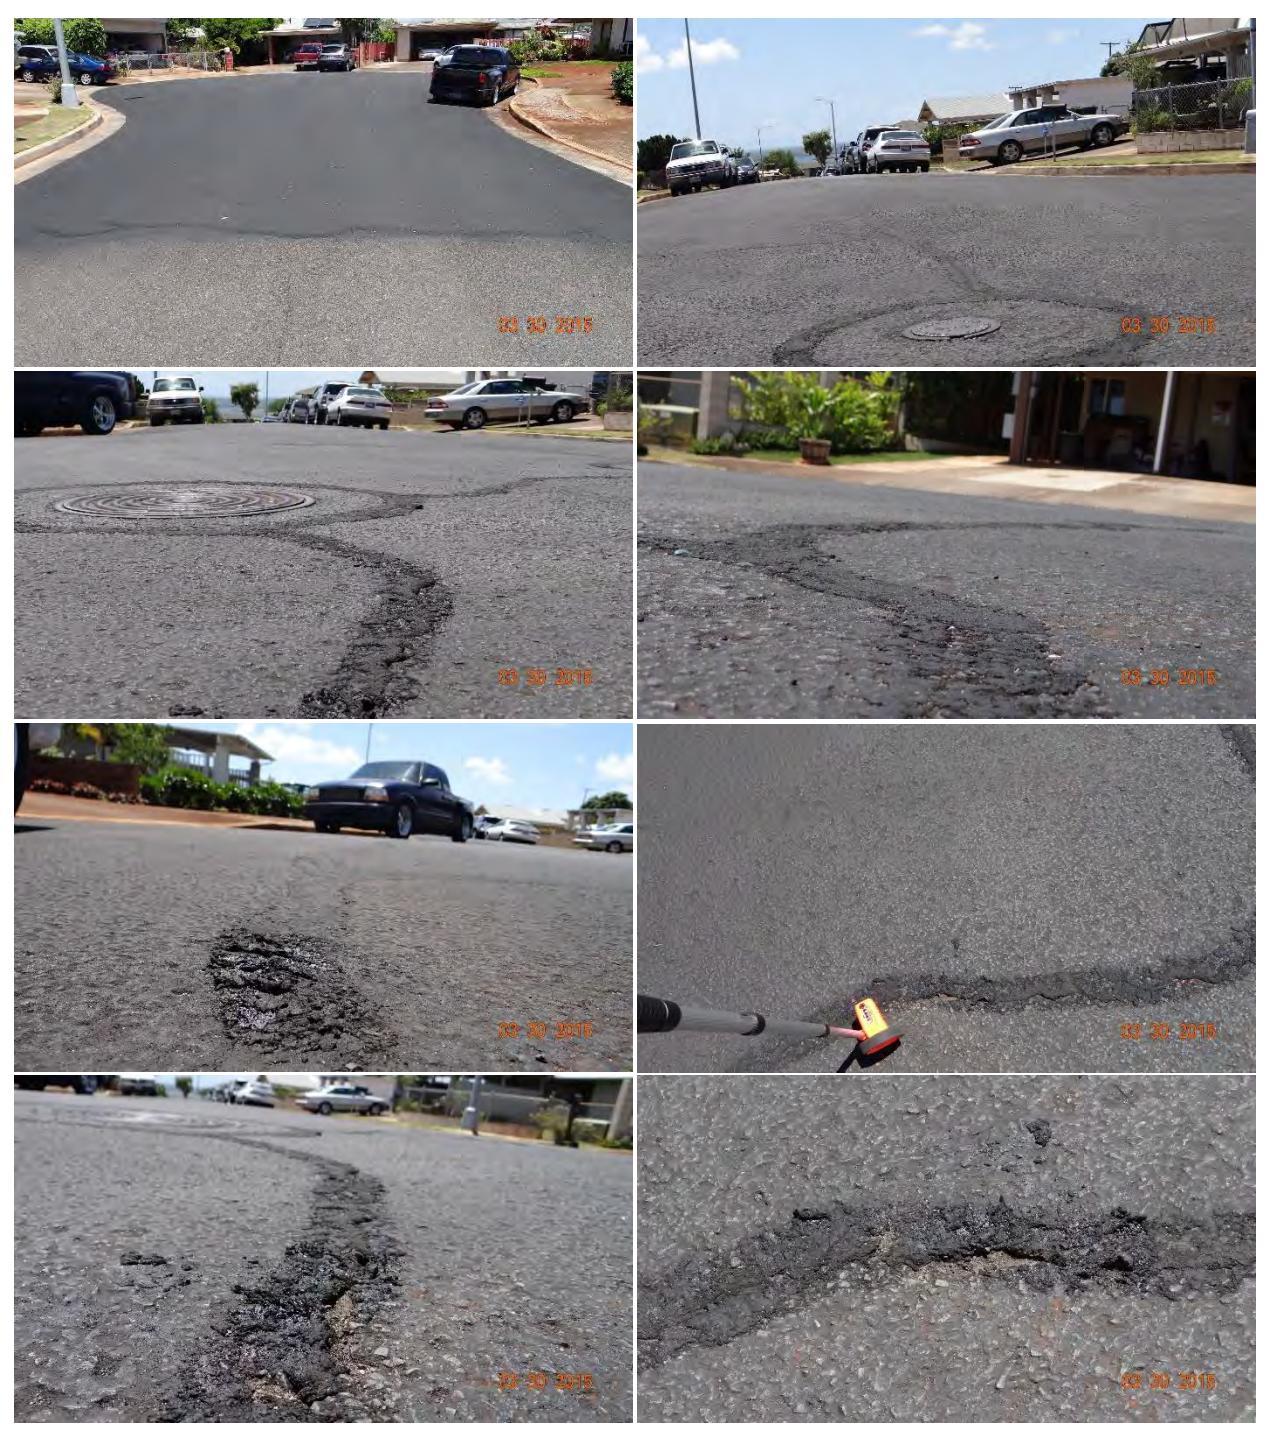
Figure C-118 Condition of the section on Hoolana Place, treated with OptiPave PlusTM Ready to Use by SealMasters®/Hawaii, on 3/30/2015.

Figure C-118 through Figure C-123 show the condition of this section over time. The top left photo in Figure C-118 shows the whole section and its contrast with the untreated pavement surface on 3/30/2015, after four month of service. The other photos show situations where the crack sealer had been tracked, creating an unpleasant display.

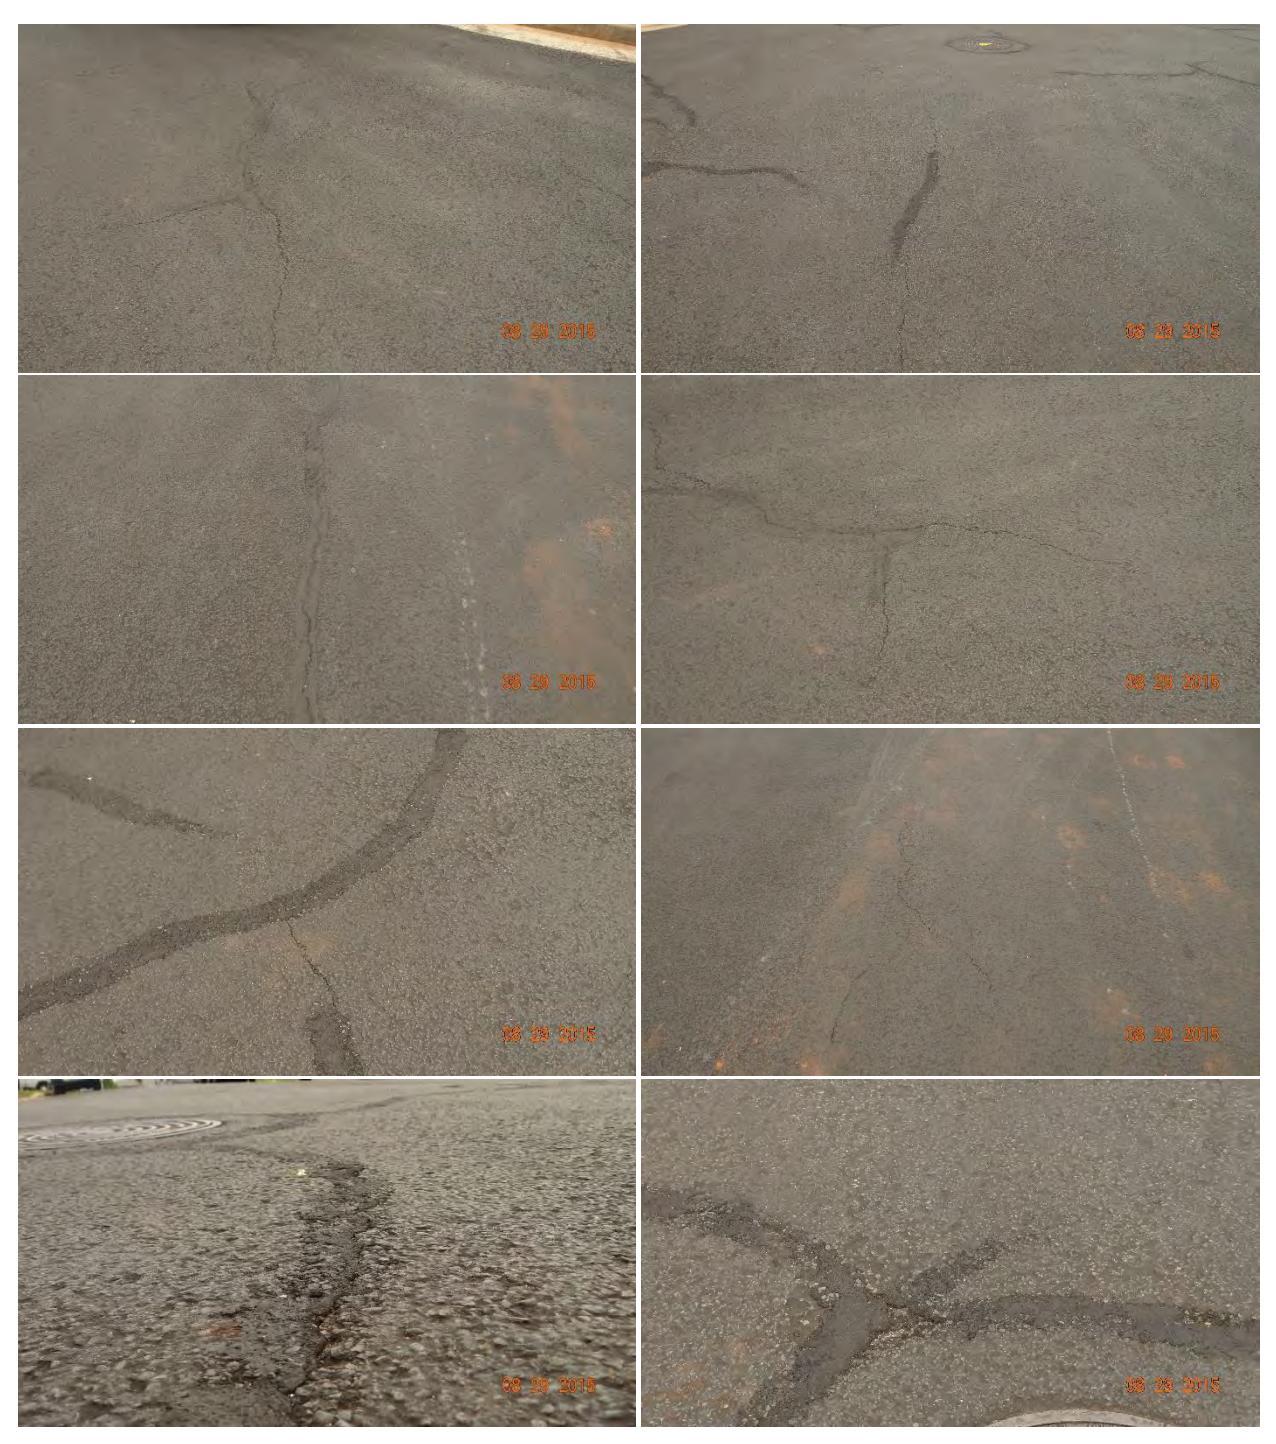
Figure C-119 Condition of the section on Hoolana Place, treated with OptiPave PlusTM Ready to Use by SealMasters®/Hawaii, on 8/29/2015.

As shown in Figure C-119, most of the changes on 8/29/2015, nine months after the treatment application, were new hairline cracks. The last two photos shown in the figure illustrate how the overband material was wearing off in some cracks.

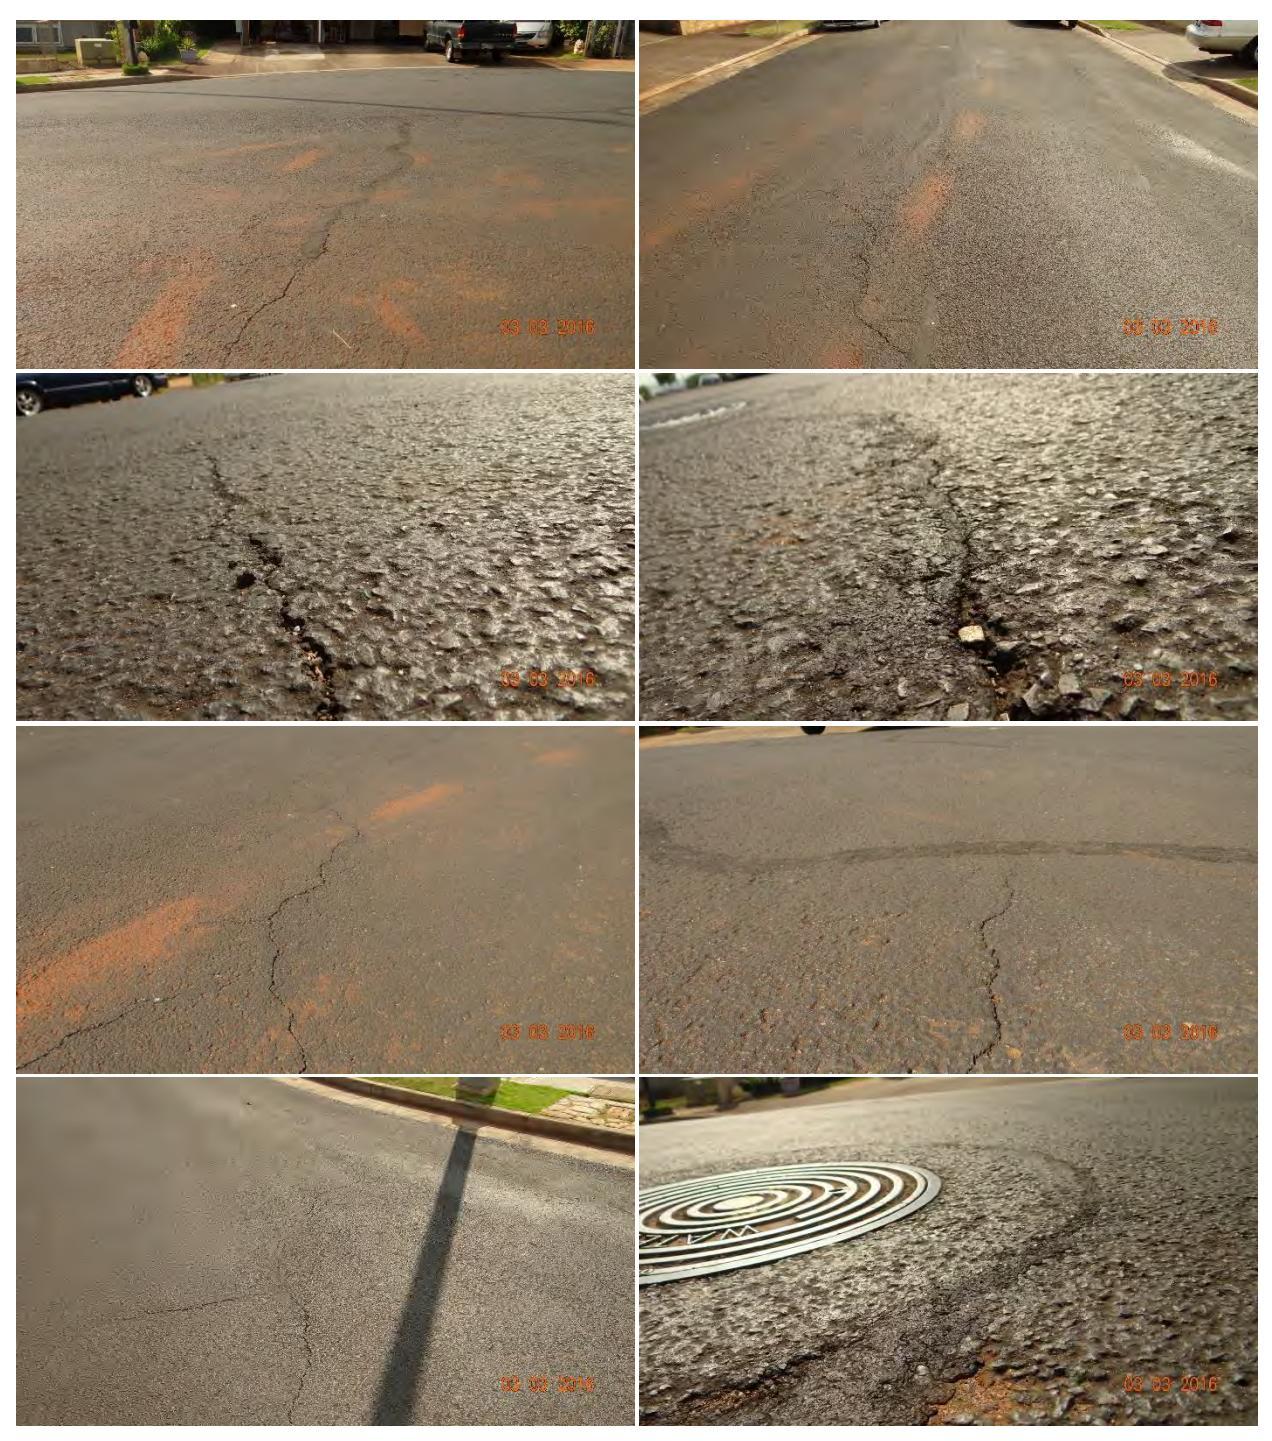
Figure C-120 Condition of the section on Hoolana Place, treated with OptiPave PlusTM Ready to Use by SealMasters®/Hawaii, on 3/3/2016.

Figure C-120 shows that on 3/3/2016 the cracking length continued its steady growth. In addition, as shown in the photos in the second row, some new cracks were getting wider and the crack sealer had been removed from some of the sealed cracks.

Figure C-120 also shows that there was a source of dirt in this section that made the pavement surface dirty and less attractive. This is seen more clearly on Figure C-121 showing the conditions on 6/27/2016, after 19 months in service. Some portions of the pavement looked reddish from so much dirt on its surface. Note that the treatment was still showing a high contrast with the untreated surface, which was showing signs of raveling (see the top photos). The photos in the third row show how the propagation of new cracks continued whereas the photos in the last row illustrate further loss of overband material as well as sealer material within sealed cracks.

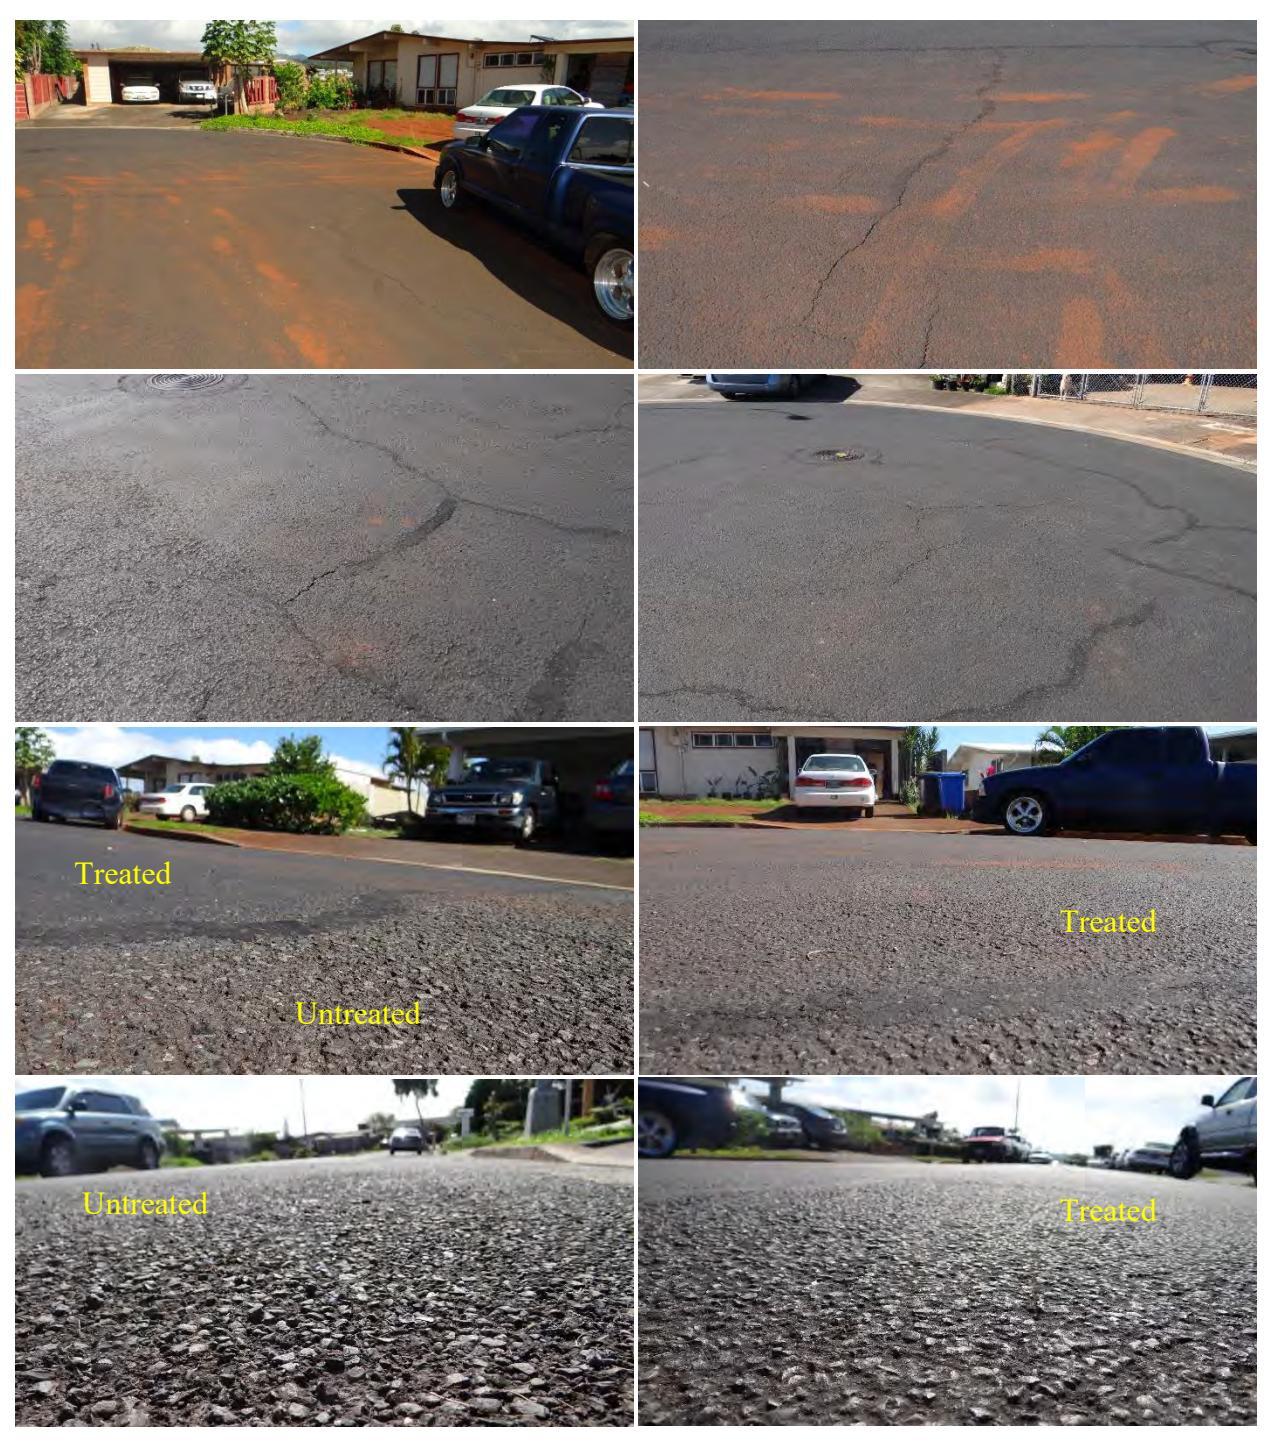
Figure C-122 Condition of the section on Hoolana Place, treated with OptiPave PlusTM Ready to Use by SealMasters®/Hawaii, on 12/14/2016.

Figure C-122 shows the conditions on 12/14/2016. Again, the photos on the top show how vehicles using one the driveways were spreading dirt over the pavement surface. The top two rows of photos also show how cracking had propagated with the appearance of new cracks. The last four photos show the sharp contrast in texture between the treated and untreated surfaces. The last two photos in particular show that while the untreated surface displayed significant raveling, with many loose particles, particles that can be dislodge with little effort, and aged binder in the valleys between particles; the treated surface had the valleys between particles still coated with the unaged seal coat material while only the top ridges of the aggregates were exposed. This emphasizes a major benefit of the regular application of this type of treatment.

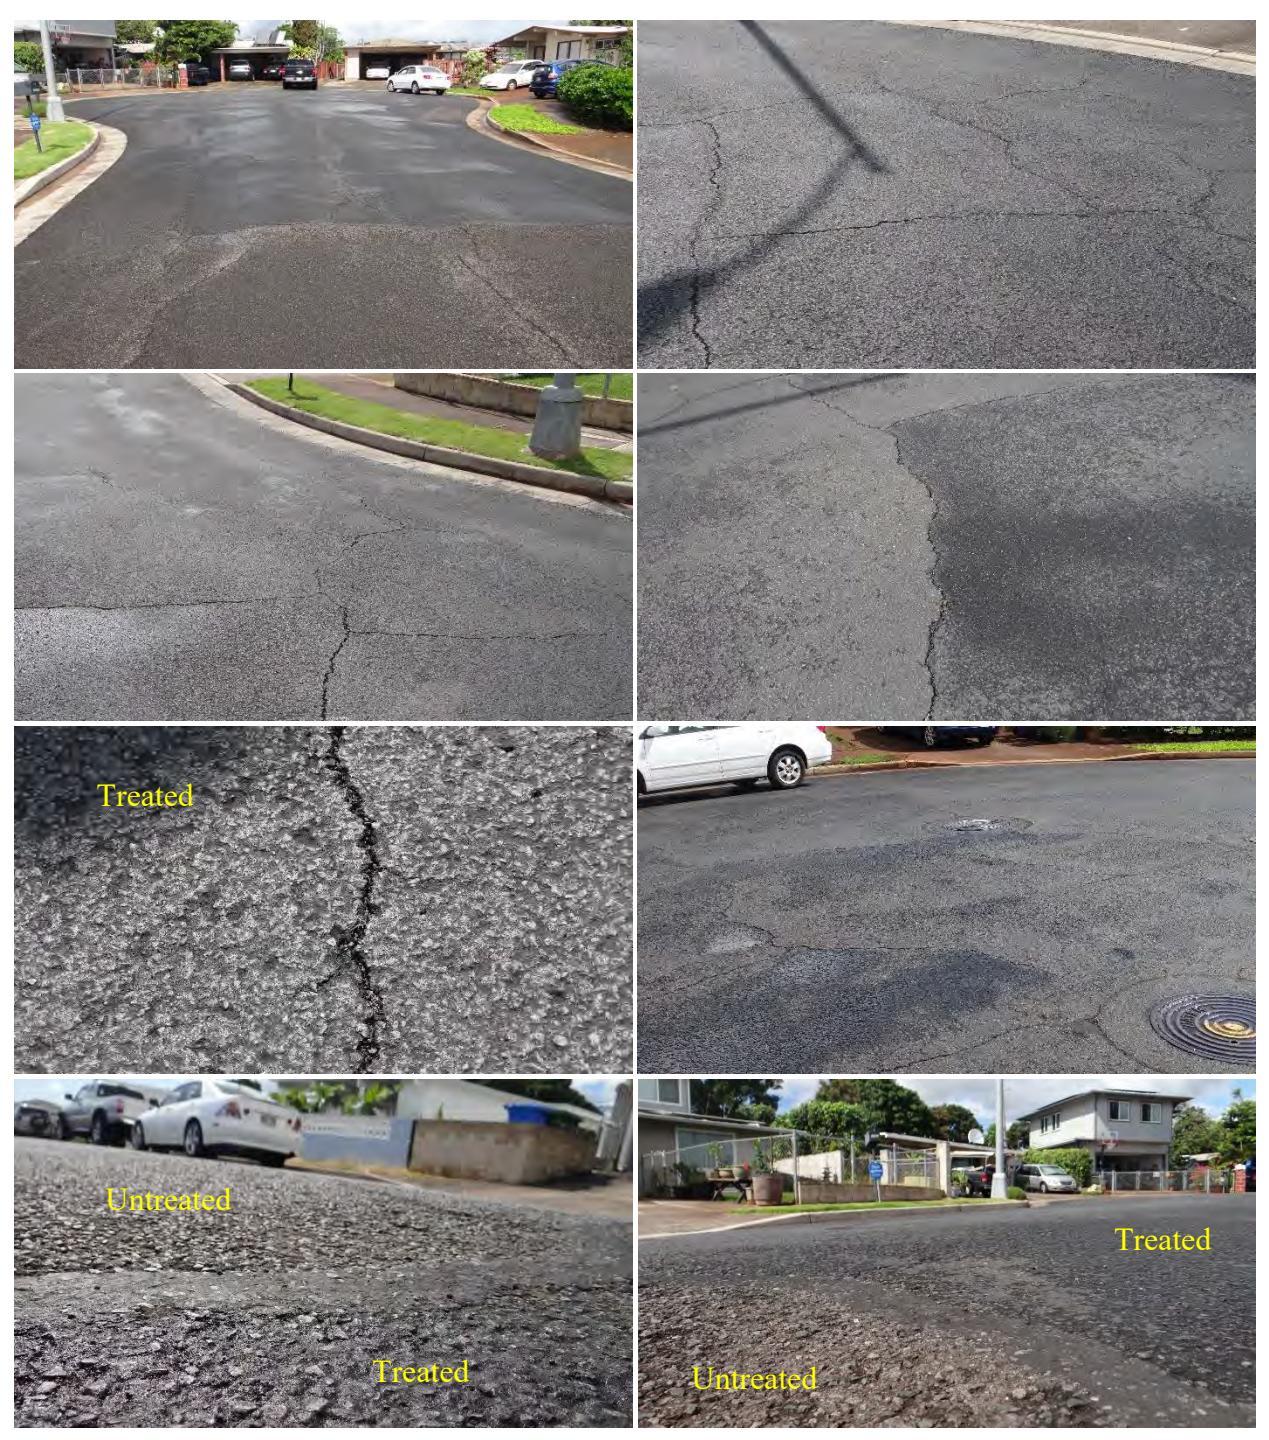
Figure C-123 Condition of the section on Hoolana Place, treated with OptiPave PlusTM Ready to Use by SealMasters®/Hawaii, on 2/7/2018.

Figure C-123 shows that by 2/7/2018, the surfaced exhibited a well-developed block cracking pattern with cracks of moderate severity. The contrast between the treated and untreated surfaces was still quite visible, even though the photographs were taken after a rain.

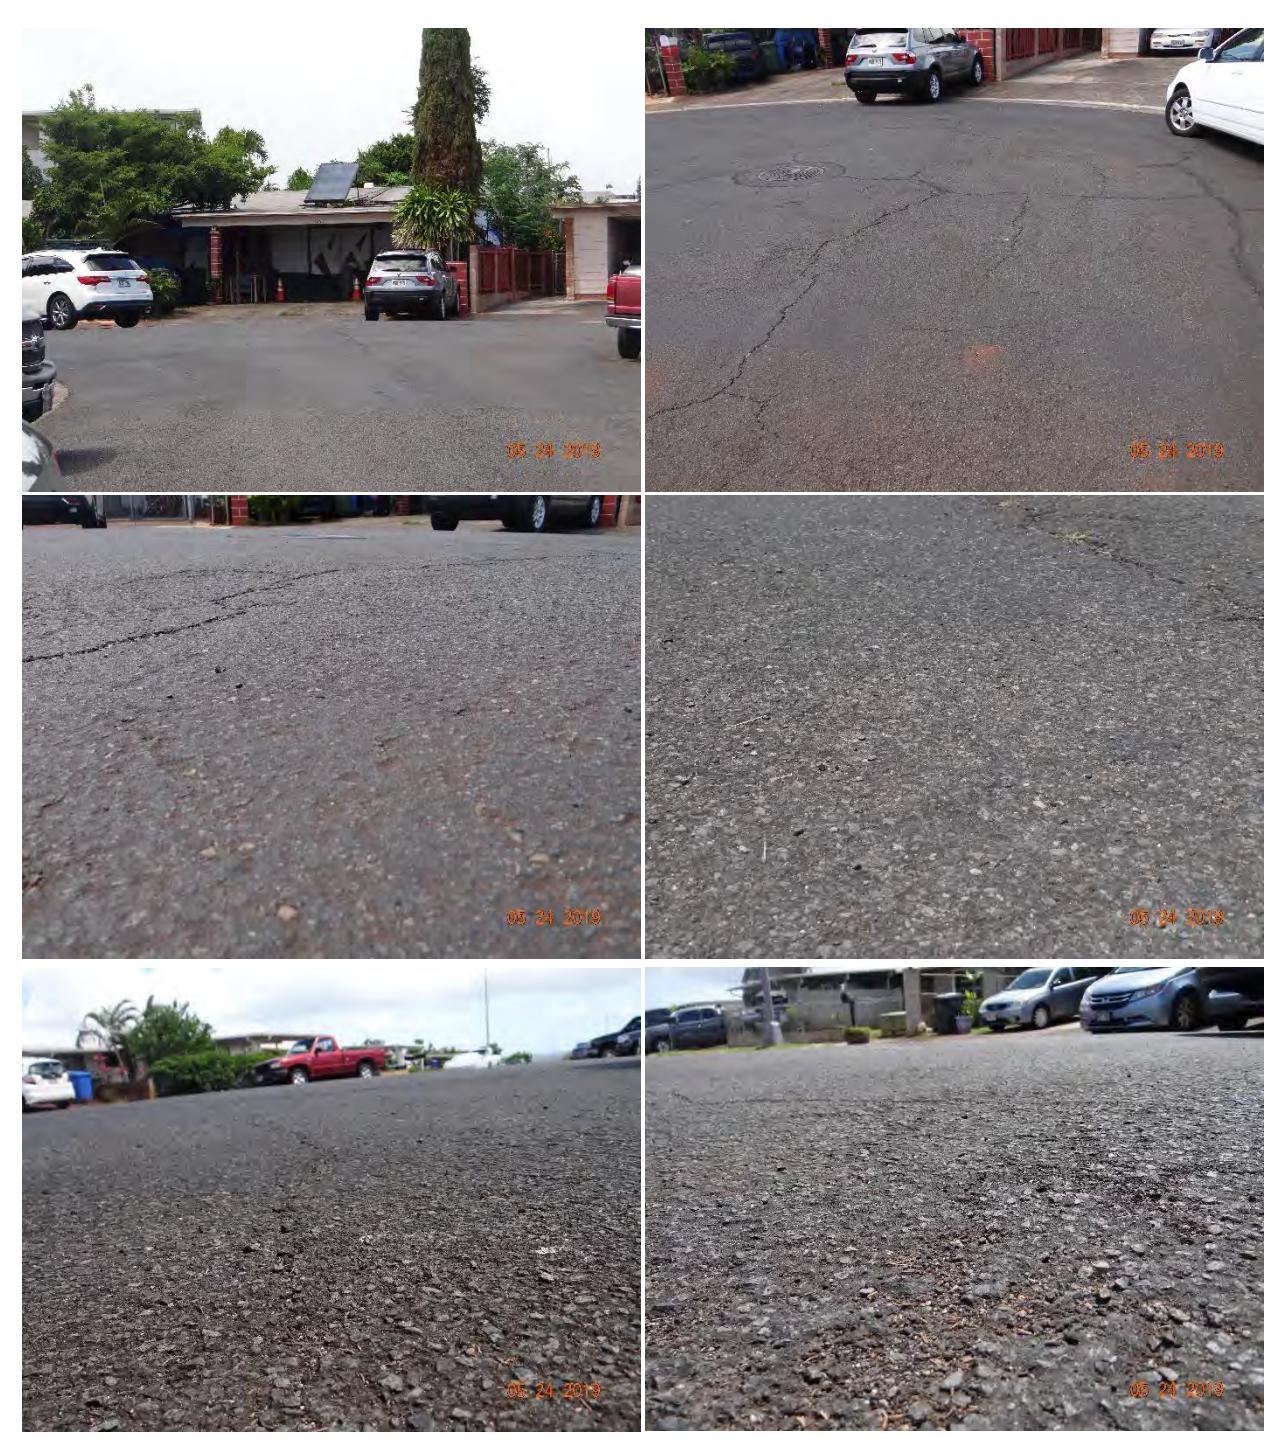
Figure C-124 Condition of the section on Hoolana Place, treated with OptiPave PlusTM Ready to Use by SealMasters®/Hawaii, on 5/24/2019.

Figure C-124 shows the conditions on 5/24/2019. At this point, it was observed that the treatment was losing its capability to resist raveling, which was now seen on some spots within the section.

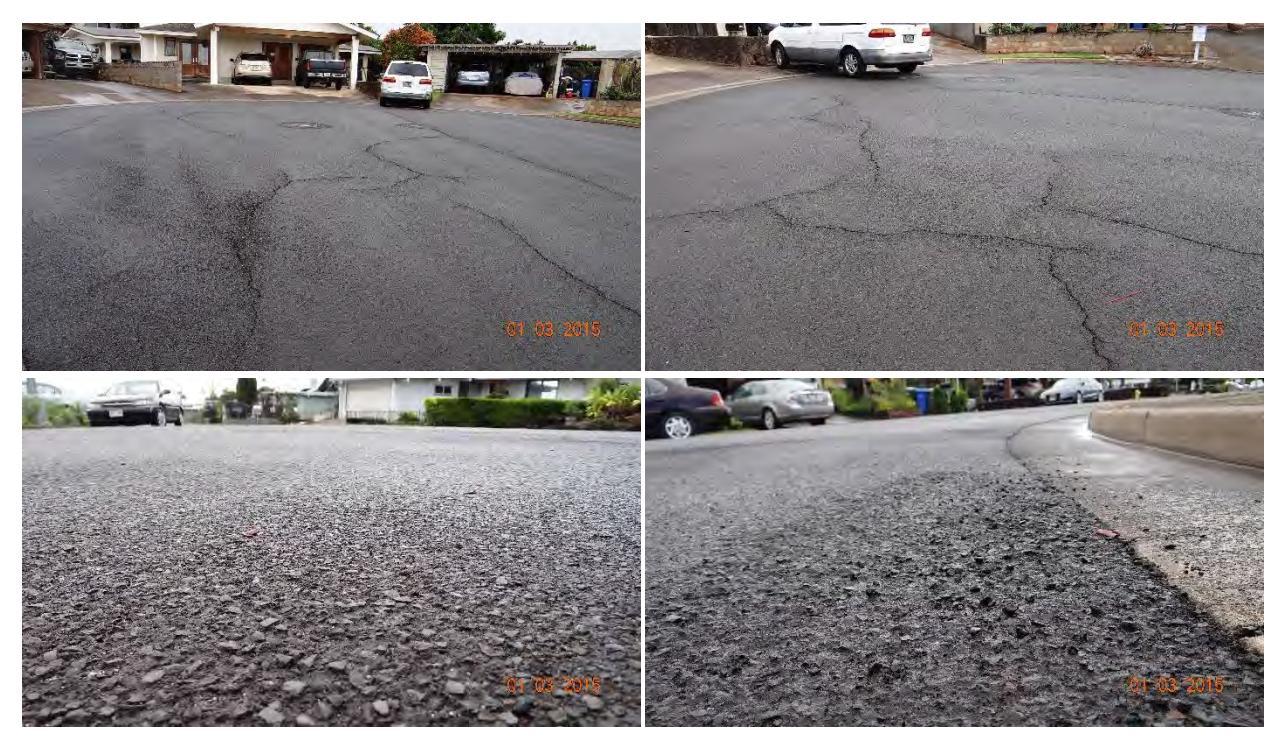
Figure C-125 Condition of the section on Hooheno Street, before treatment with Resurfacer by Brewer Cote (work performed by Oahu Seal Coating and Paving), on 1/3/2015.

Figure C-125 shows the general condition of the section before treatment. In addition to showing a well-developed moderate severity block cracking pattern, it shows that the surface was already at a point where some rejuvenation was needed. As shown in the bottom right photograph, a small area was already raveling.

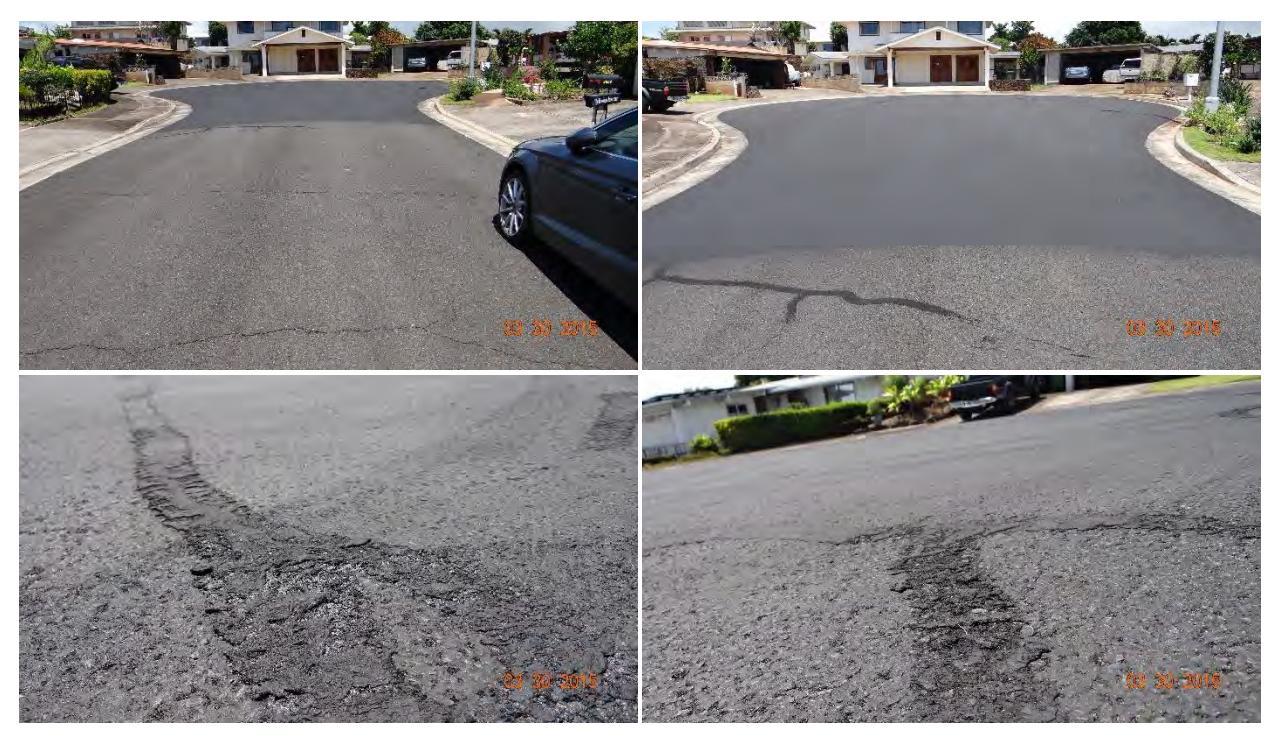
Figure C-126 Condition of the section on Hooheno Street, treated with Resurfacer by Brewer Cote (work performed by Oahu Seal Coating and Paving), on 3/30/2015.

Figure C-126 shows the condition on 3/30/2015, two months after treatment (this section was completed on 1/28/2015). As for other treatments dicussed in this report, there was a high contrast (visual and condition) between the treated and untreated surfaces. As it occurred for other sections, tracking of the crack sealing was often an issue, providing an unsightly visual appearance.
