PERFORMANCE MONITORING OF PRESERVATION TREATMENTS IN HONOLULU

FINAL PROJECT REPORT

Adrián Ricardo Archilla University of Hawaii at Manoa

May 2019

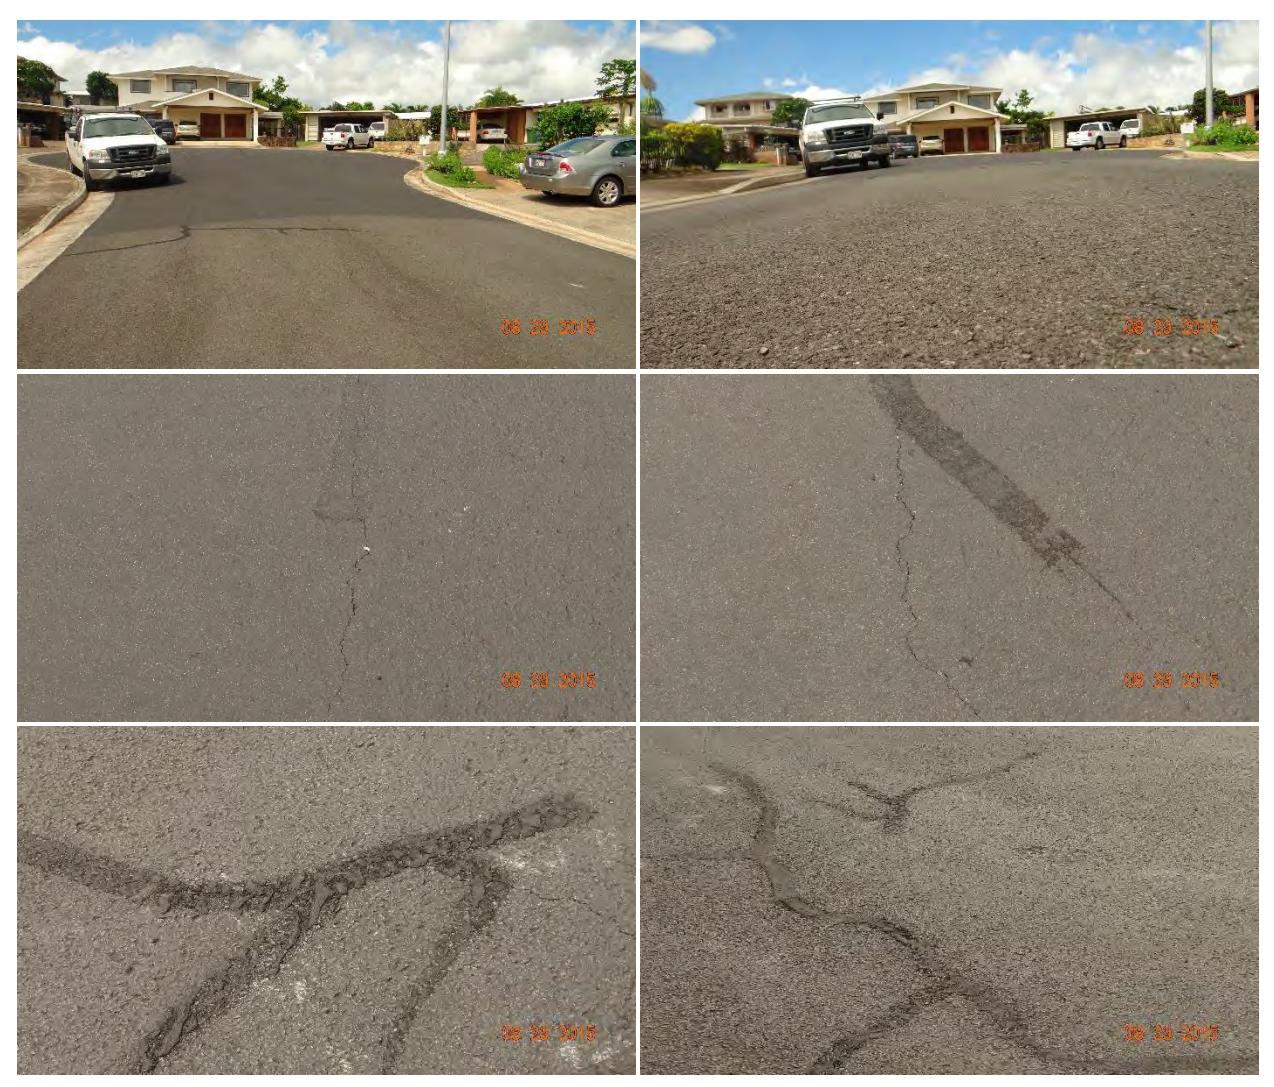
Figure C-127 Condition of the section on Hooheno Street, treated with Resurfacer by Brewer Cote (work performed by Oahu Seal Coating and Paving), on 8/29/2015.

The top two photos in Figure C-127 illustrate the contrast between the untreated and treated surfaces, as of 8/29/15 with just seven months in service, was not only visual but also in terms of the condition. The photograph in the top left shows that raveling was occuring on the untreated surface. The other photos in the figure show the development of new heailine cracks as continuation of sealed cracks and the condition of some of the crack sealing.

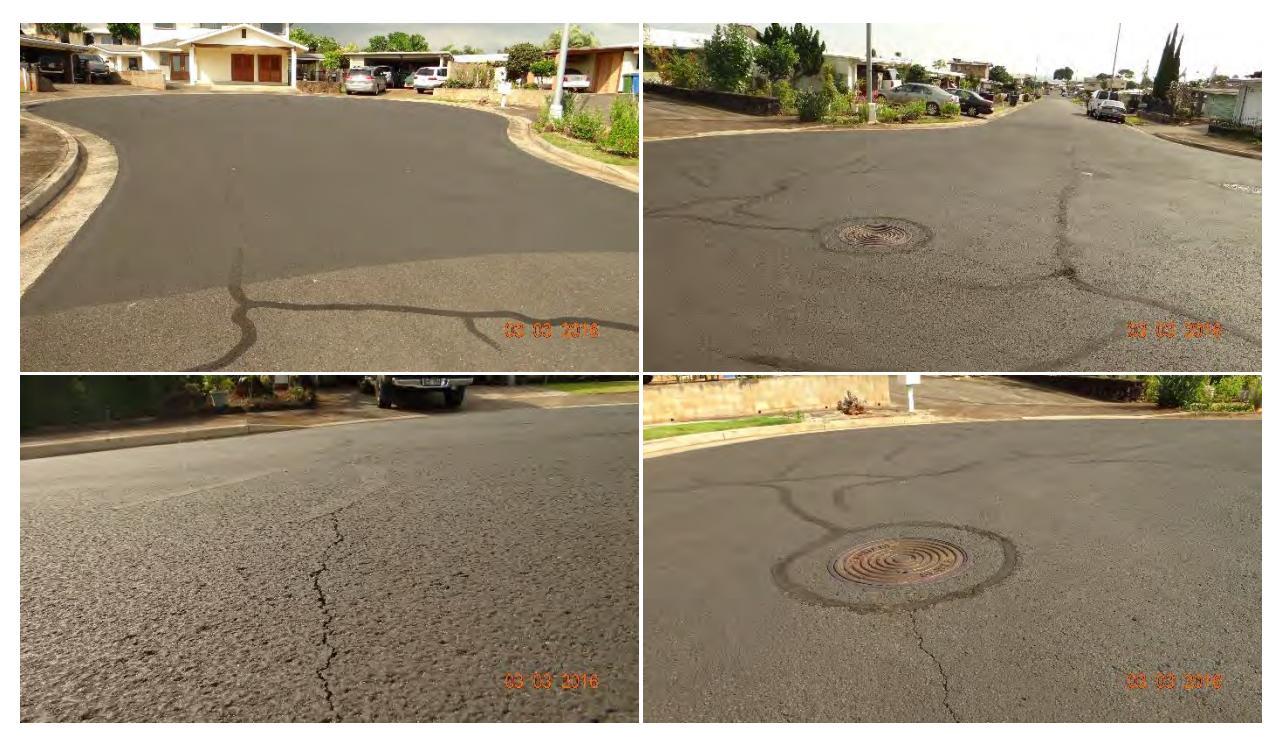
Figure C-128 Condition of the section on Hooheno Street, treated with Resurfacer by Brewer Cote (work performed by Oahu Seal Coating and Paving), on 3/3/2016.

As illustrated in Figure C-128, not much change could be appreciated visually on 3/3/2016, a year and a month after the treatment application, except that some of the cracks were getting wider. Of course, as indicated by the trend in Figure 4-26, the length of cracking was also increasing.

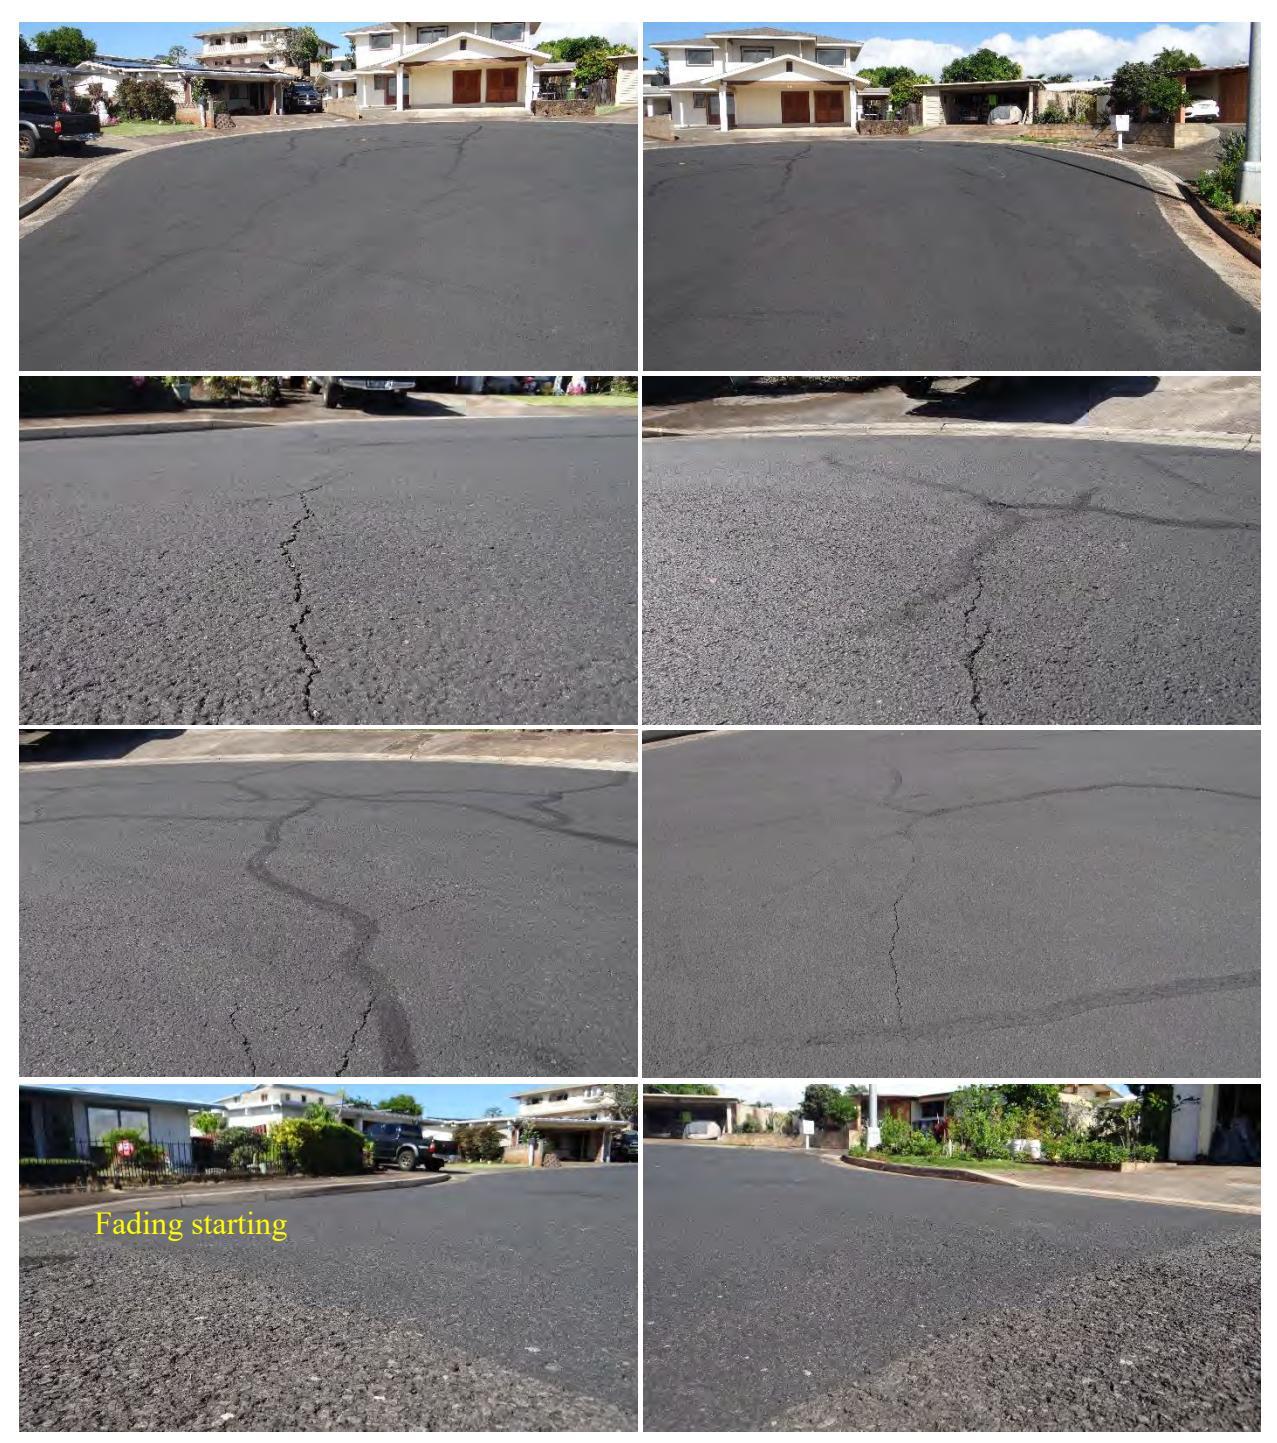
Figure C-129 Condition of the section on Hooheno Street, treated with Resurfacer by Brewer Cote (work performed by Oahu Seal Coating and Paving), on 12/14/2016.

Figure C-129 shows the conditions on 12/14/2016, after about 22 months in service. As seen in the top two photos, the general condition still looked good though there were some signs of wearing off on one of the sides. The four middle photos show that many cracks were becoming moderate. In addition to illustrating the significant different texture between the treated and untreated surfaces, the last two photographs also show some incipient wearing off the treatment near the end of the section.

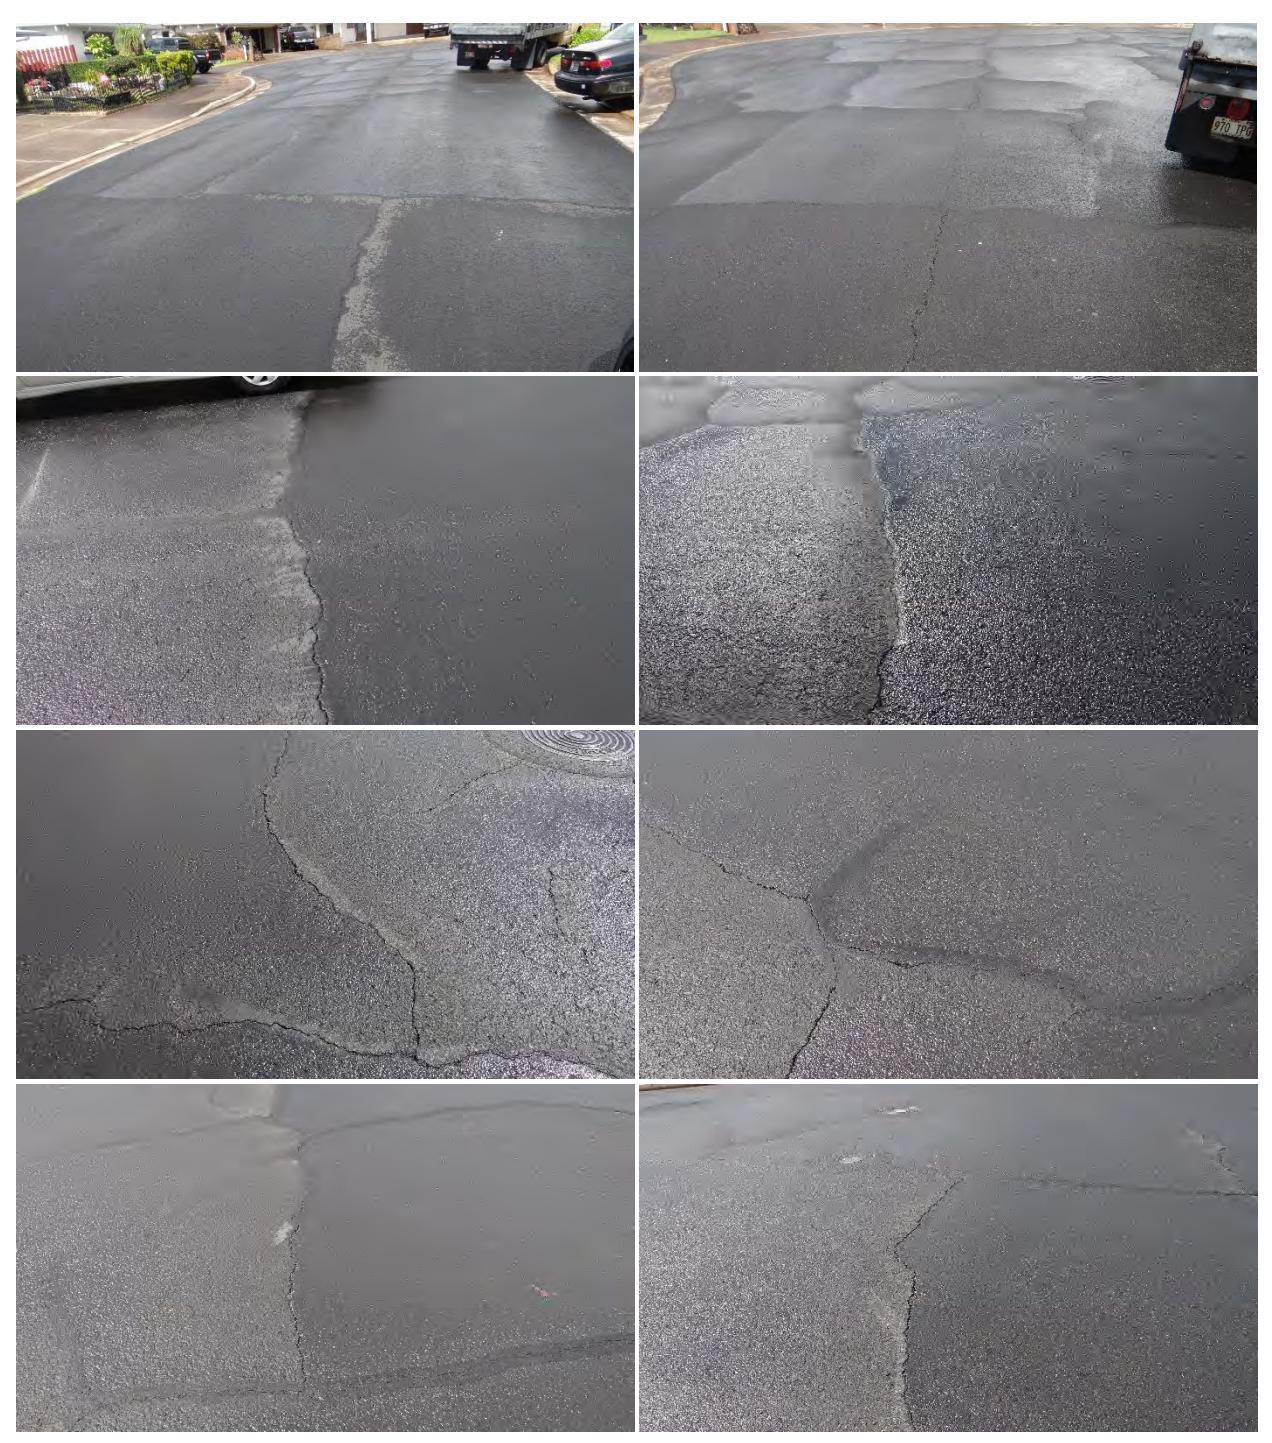
Figure C-130 Condition of the section on Hooheno Street, treated with Resurfacer by Brewer Cote (work performed by Oahu Seal Coating and Paving), on 2/7/2018.

Figure C-130 show the conditions on 2/7/2018, just about three years of the treatment application. The photos in this figure show that the original cracking pattern had completely reappeared and expanded by additional cracks. Although not shown in these photos, some additional wearing off of the seal coat was noted.

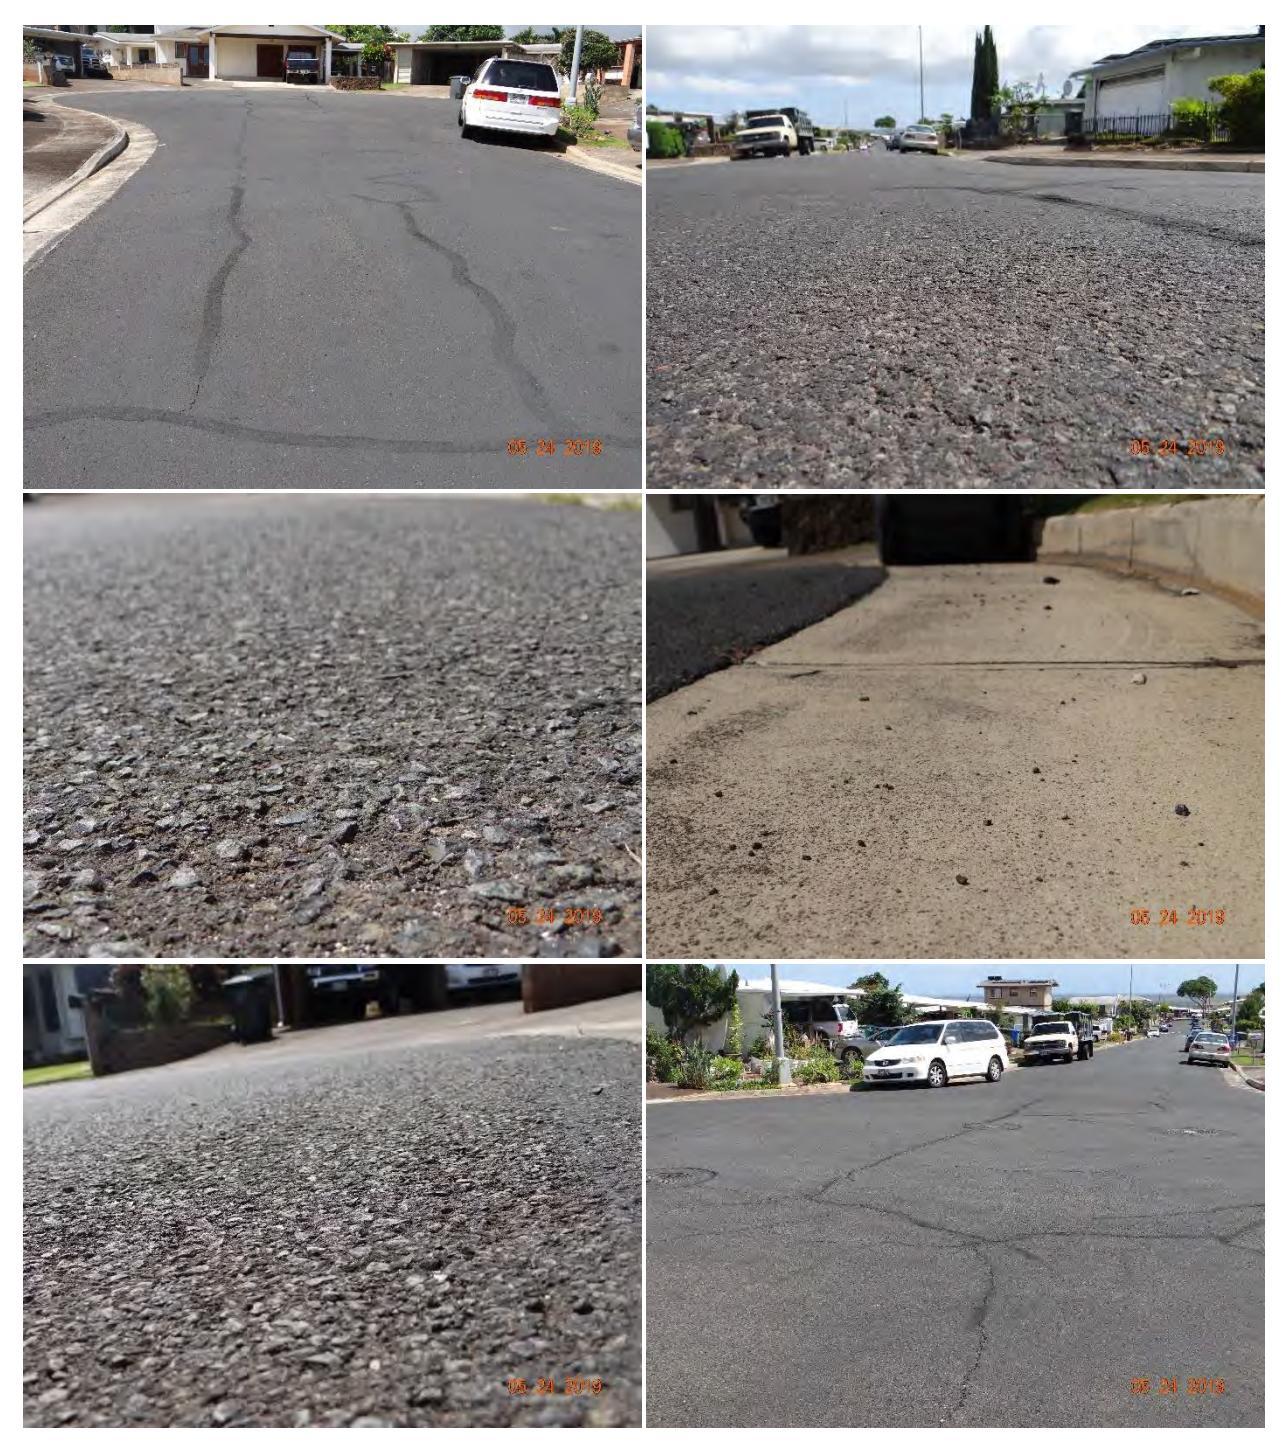
Figure C-131 Condition of the section on Hooheno Street, treated with Resurfacer by Brewer Cote (work performed by Oahu Seal Coating and Paving), on 5/24/2019.

Finally, Figure C-131 shows that the treatment was clearly wearing off. This can be seen when looking outward from the cul-de-sac since the adjacent section had now been treated. Raveling was now clearly seen in parts of the section.

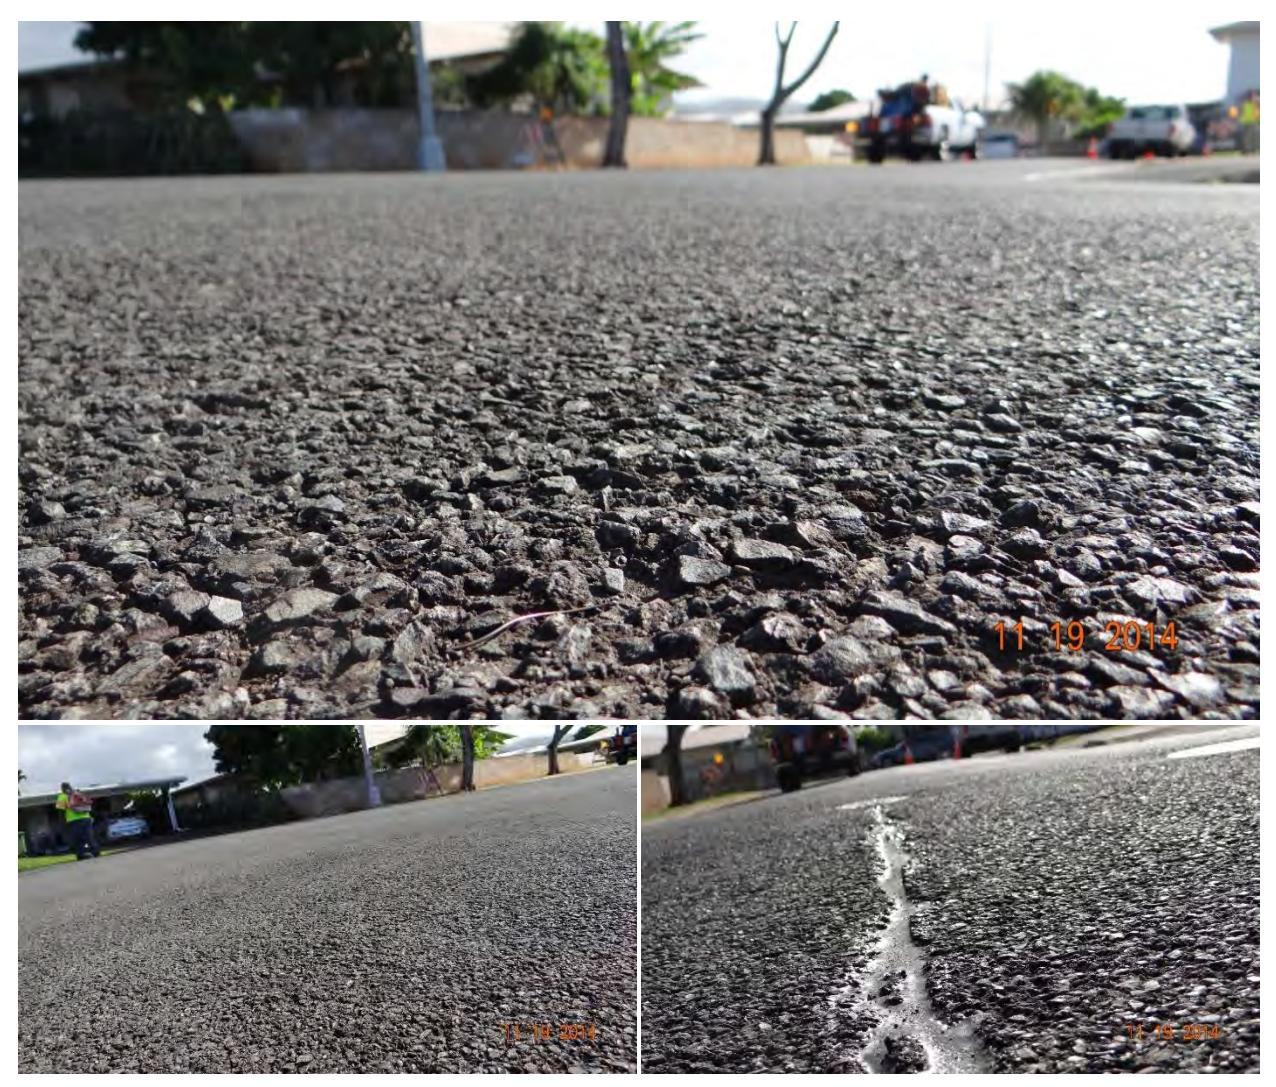
Figure C-132 Surface condition on Hooheno Place, before treatment with CarbonSeal-HF by Carbonyte Systems Inc., on 11/19/2014.

Figure C-132 shows the condition of the surface before treatment on the date the cracks were sealed on 11/19/2014. The surface had some sign of raveling as seen by some loose aggregates. In addition, the clear stripping of binder between aggregates makes them more easily to dislodge.

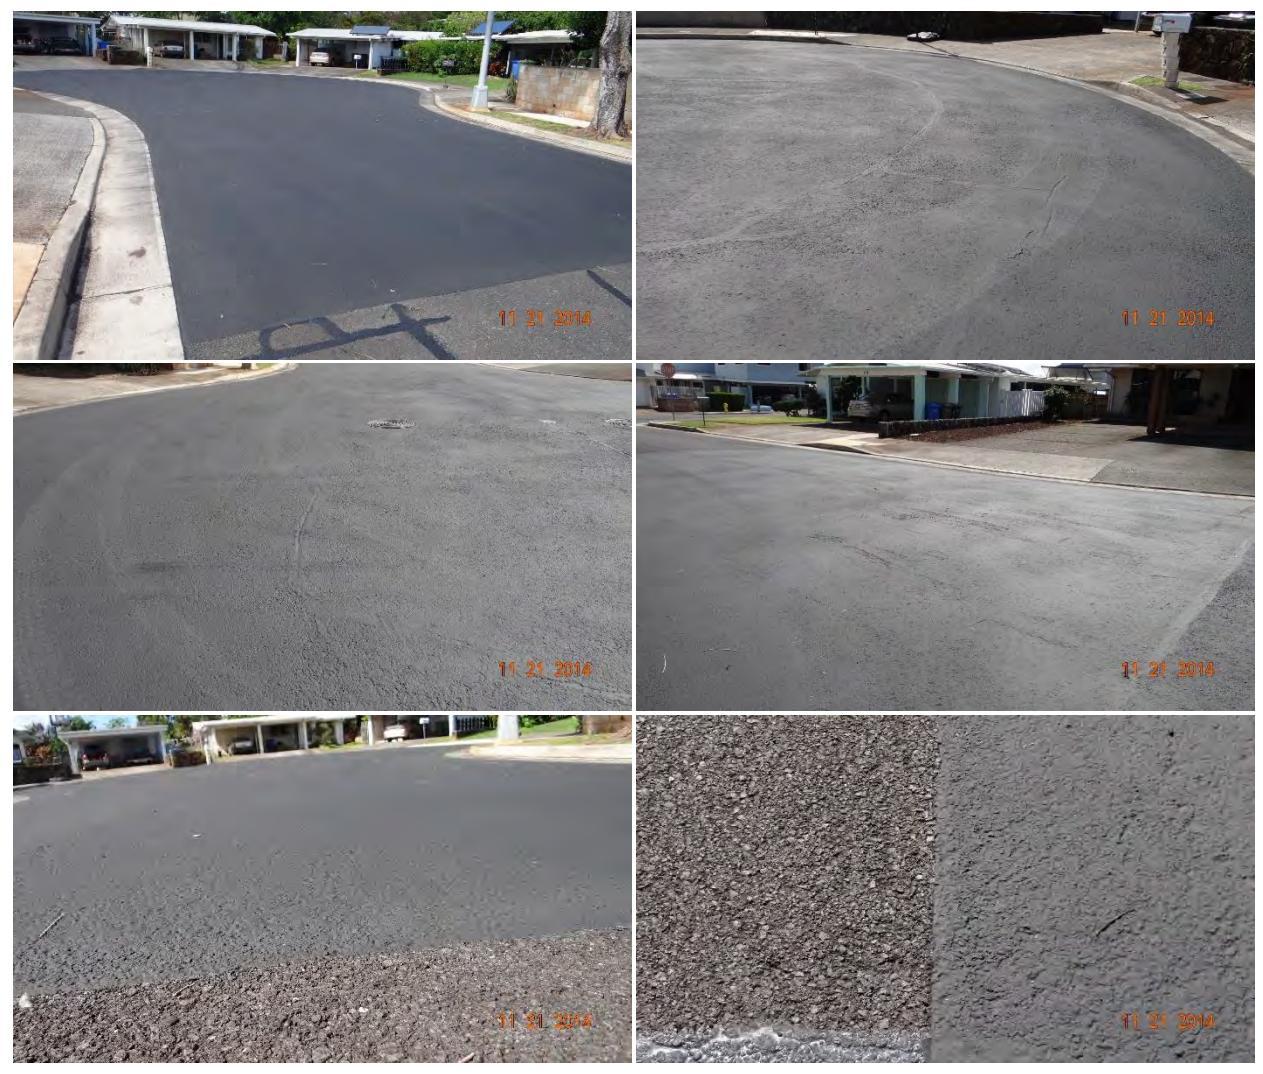
Figure C-133 Condition of the section on Hooheno Place, before treatment with CarbonSeal-HF by Carbonyte Systems Inc., on 11/21/2014.

Figure C-133 shows the condition immediately after the second coat application on 11/21/2014. As usual, despite some of the crack sealing being visible, the visual appearance of the treated section is much more appealing.

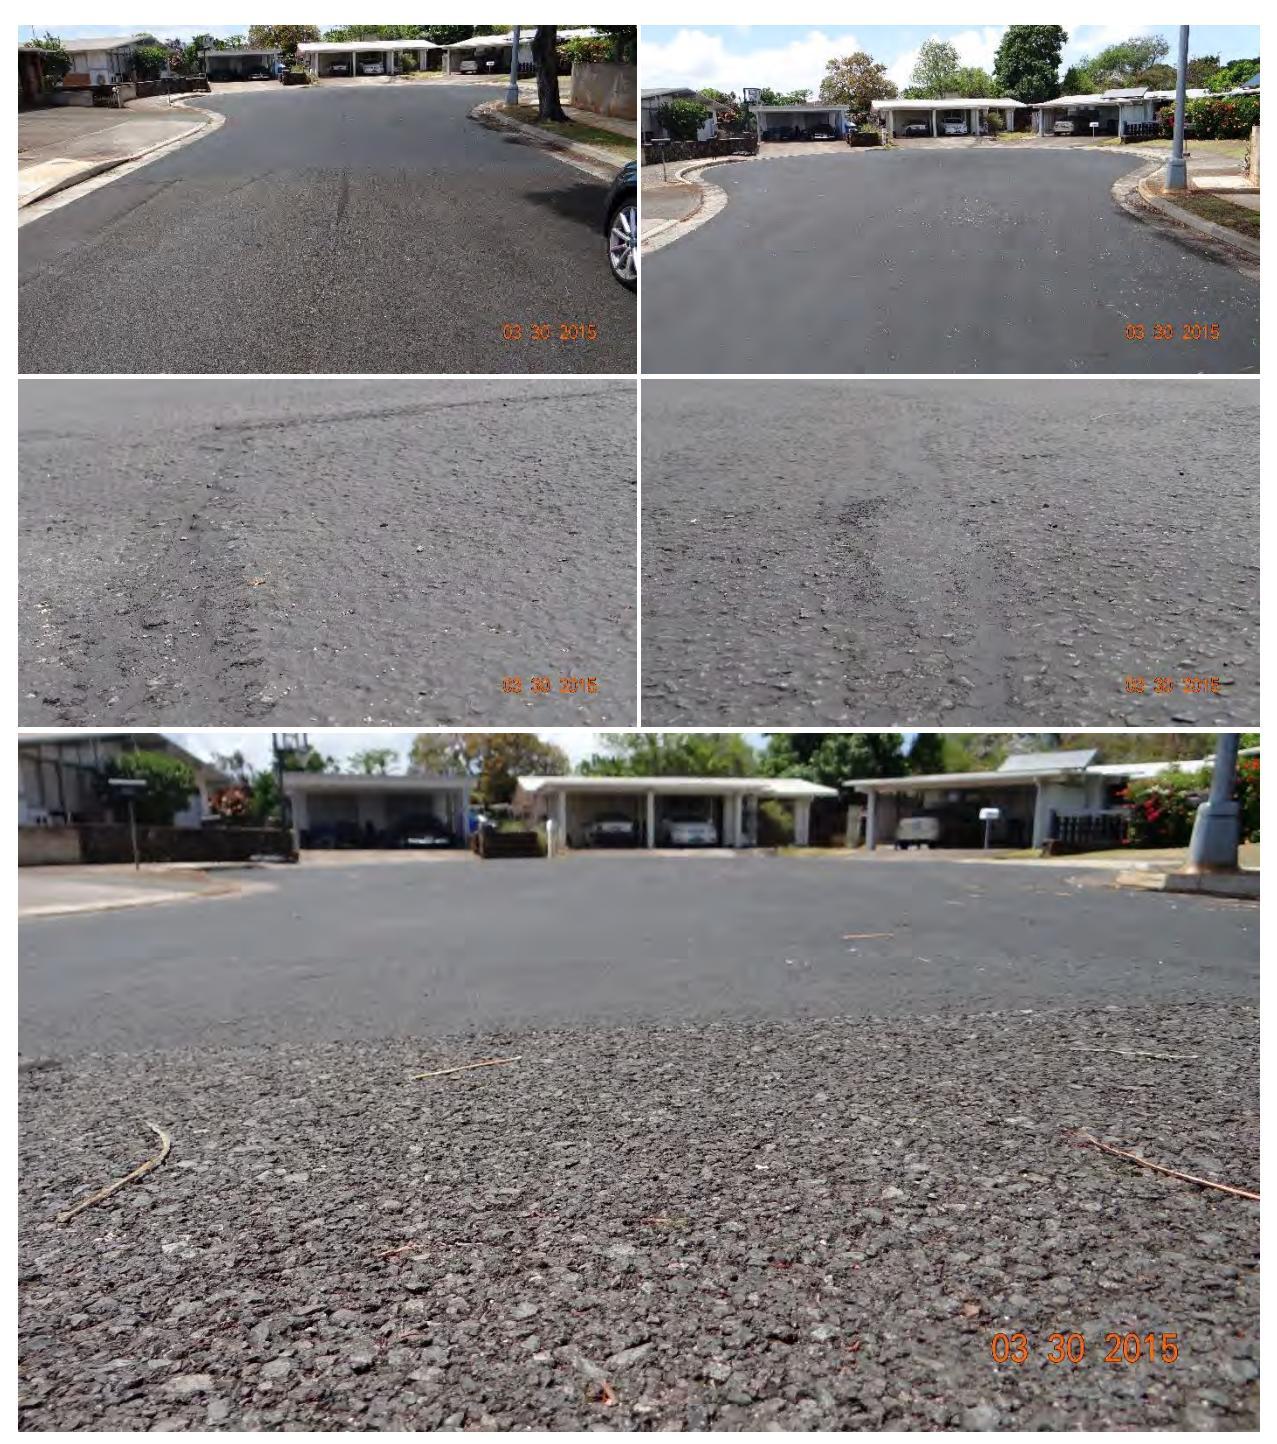
Figure C-134 Condition of the section on Hooheno Place, before treatment with CarbonSeal-HF by Carbonyte Systems Inc., on 3/30/2015.

Figure C-134 shows the condition on 3/30/2015, with four months in service. The bottom photograph in this figure provides a good example of the different textures of the treated and untreated surfaces. Again, several dislodged aggregates can be observed on the untreated surface.

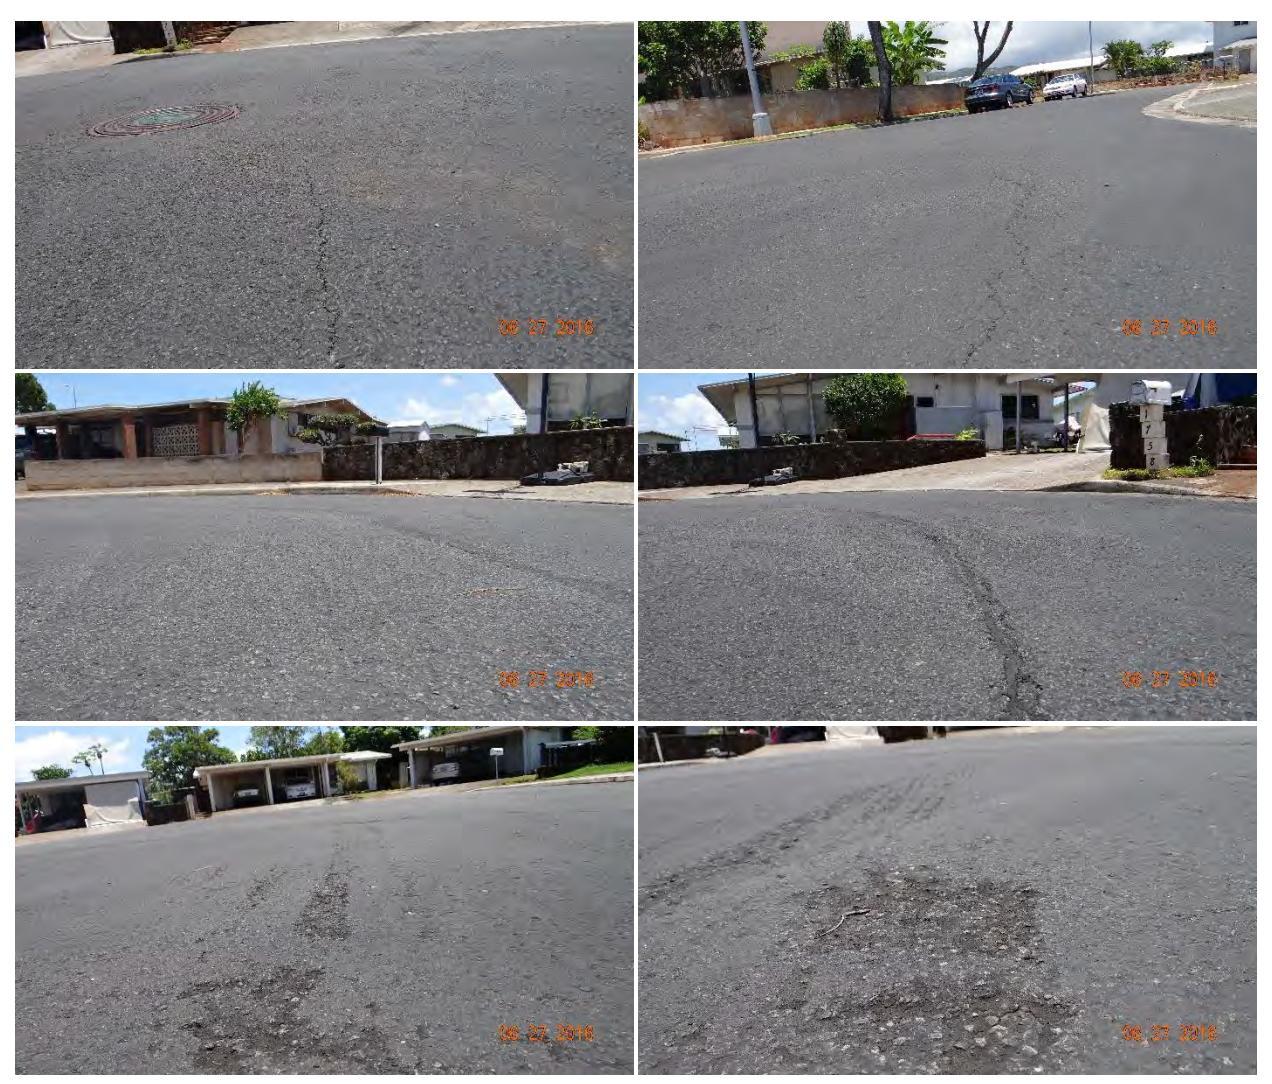
Figure C-135 Condition of the section on Hooheno Place, before treatment with CarbonSeal-HF by Carbonyte Systems Inc., on 6/27/2016.

As illustrated in Figure C-135, consistent with the relatively low rate in Figure 4-27, there were a few additional low severity cracks on 6/27/2016, about 19 months after the treatment application. The last two photos illustrate one more time that in general, these seal coats cannot hide or correct severe surface defects.

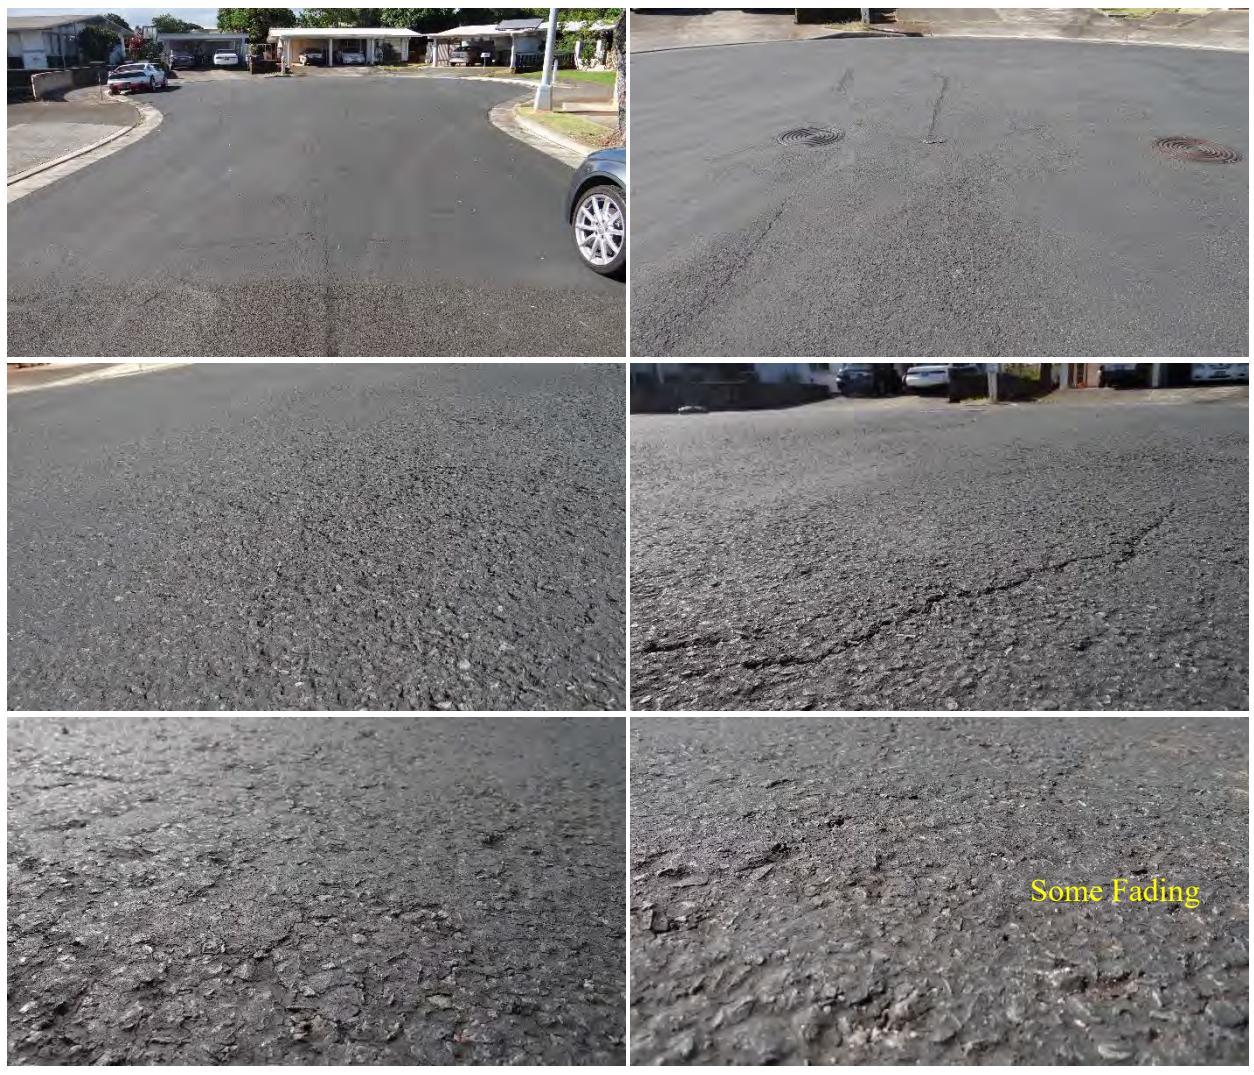
Figure C-136 Condition of the section on Hooheno Place, before treatment with CarbonSeal-HF by Carbonyte Systems Inc., on 12/14/2016.

Figure C-136 shows the condition on 12/14/2016, almost 25 months after the treatment application. The conditions were similar to the ones described earlier. However, some wearing off or fading of the treatment was noticed in turning areas. These fading continued progressing until the end of the study, although it was not as dramatic as the fading that occurred in the straight section treated with the same product. The difference may be related to the fact that the straight section was on a steep grade with water runoff running at high speed.

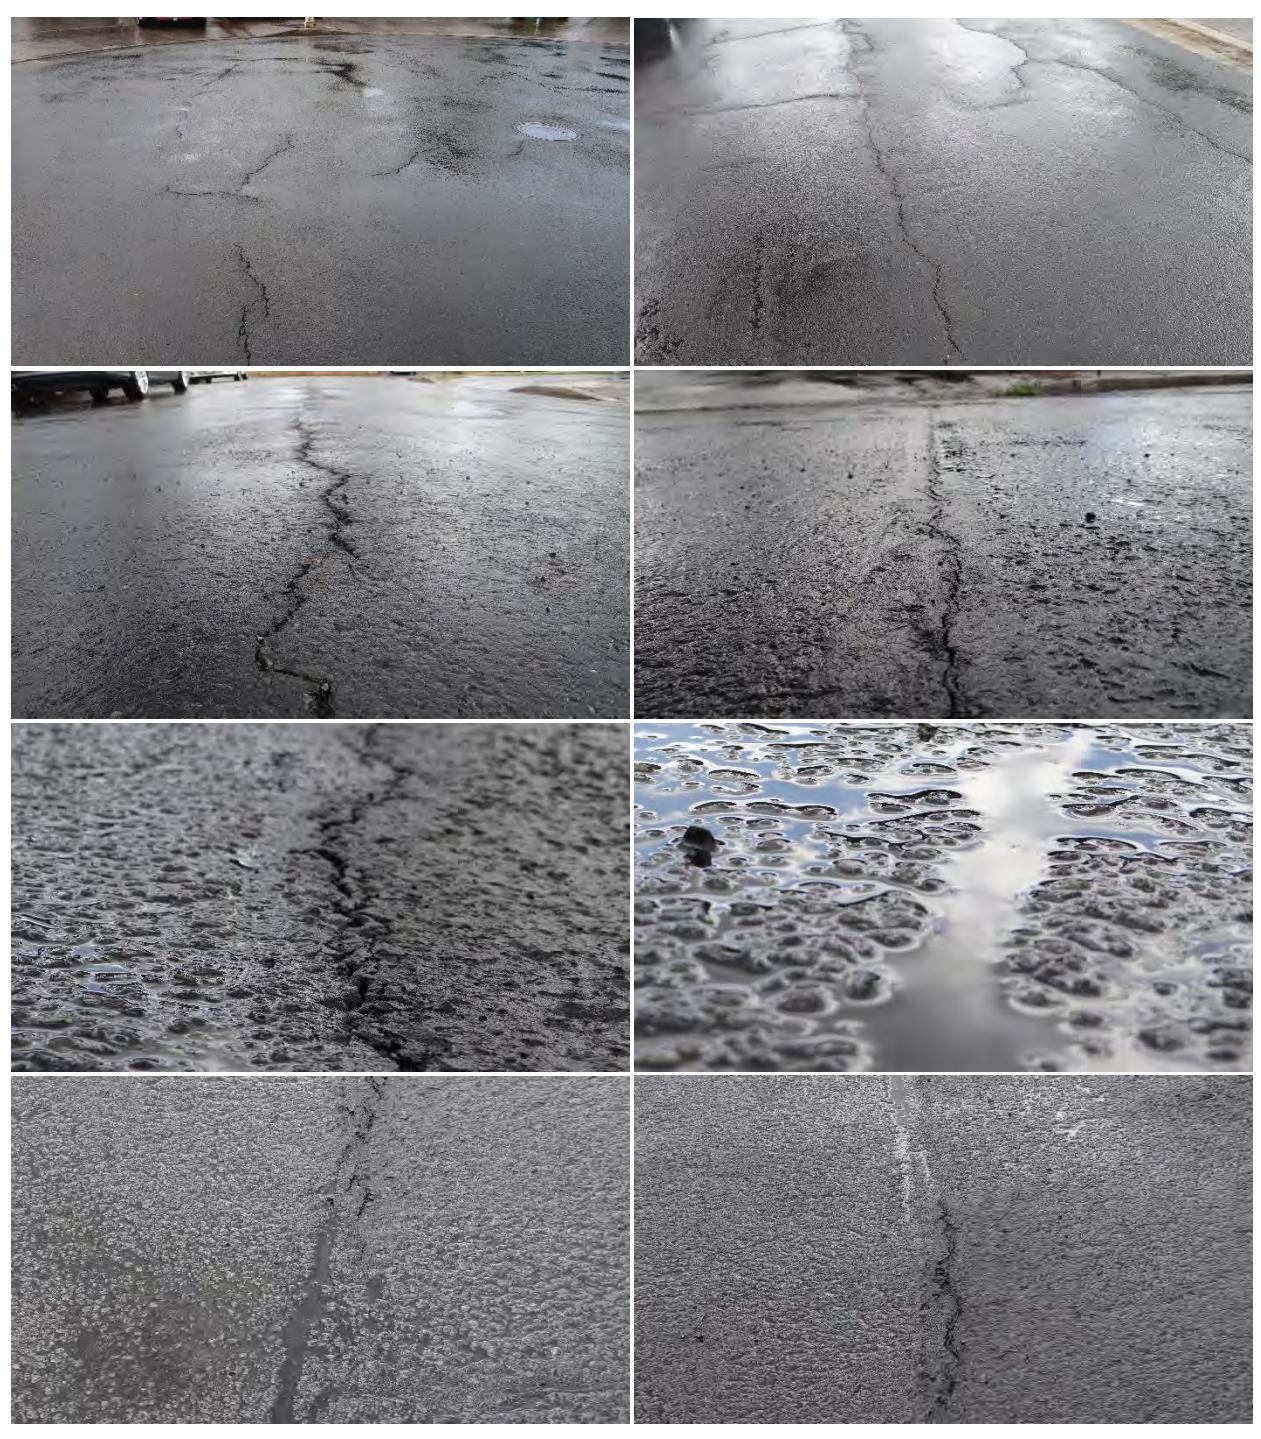
Figure C-137 Condition of the section on Hooheno Place, before treatment with CarbonSeal-HF by Carbonyte Systems Inc., on 2/7/2018.

Figure C-137 illustrates the performance of the section immediately after a rain event on 2/7/2018. The top four photos show that unsealed cracks, or cracks where the sealant was not performing well, allow the ingress of water. The photos in the third row provide a more direct comparison between two sealed cracks, the one on the left where the sealer had lost contact with the crack wall (an unrouted thin crack) that allows the infiltration of water versus the one on the right, which is a routed sealed crack with the sealer performing well. Each of the last two photos provide similar examples, but in these cases, the sealer was performing well in the part of the crack with water on the surface and not well in other parts of the crack.

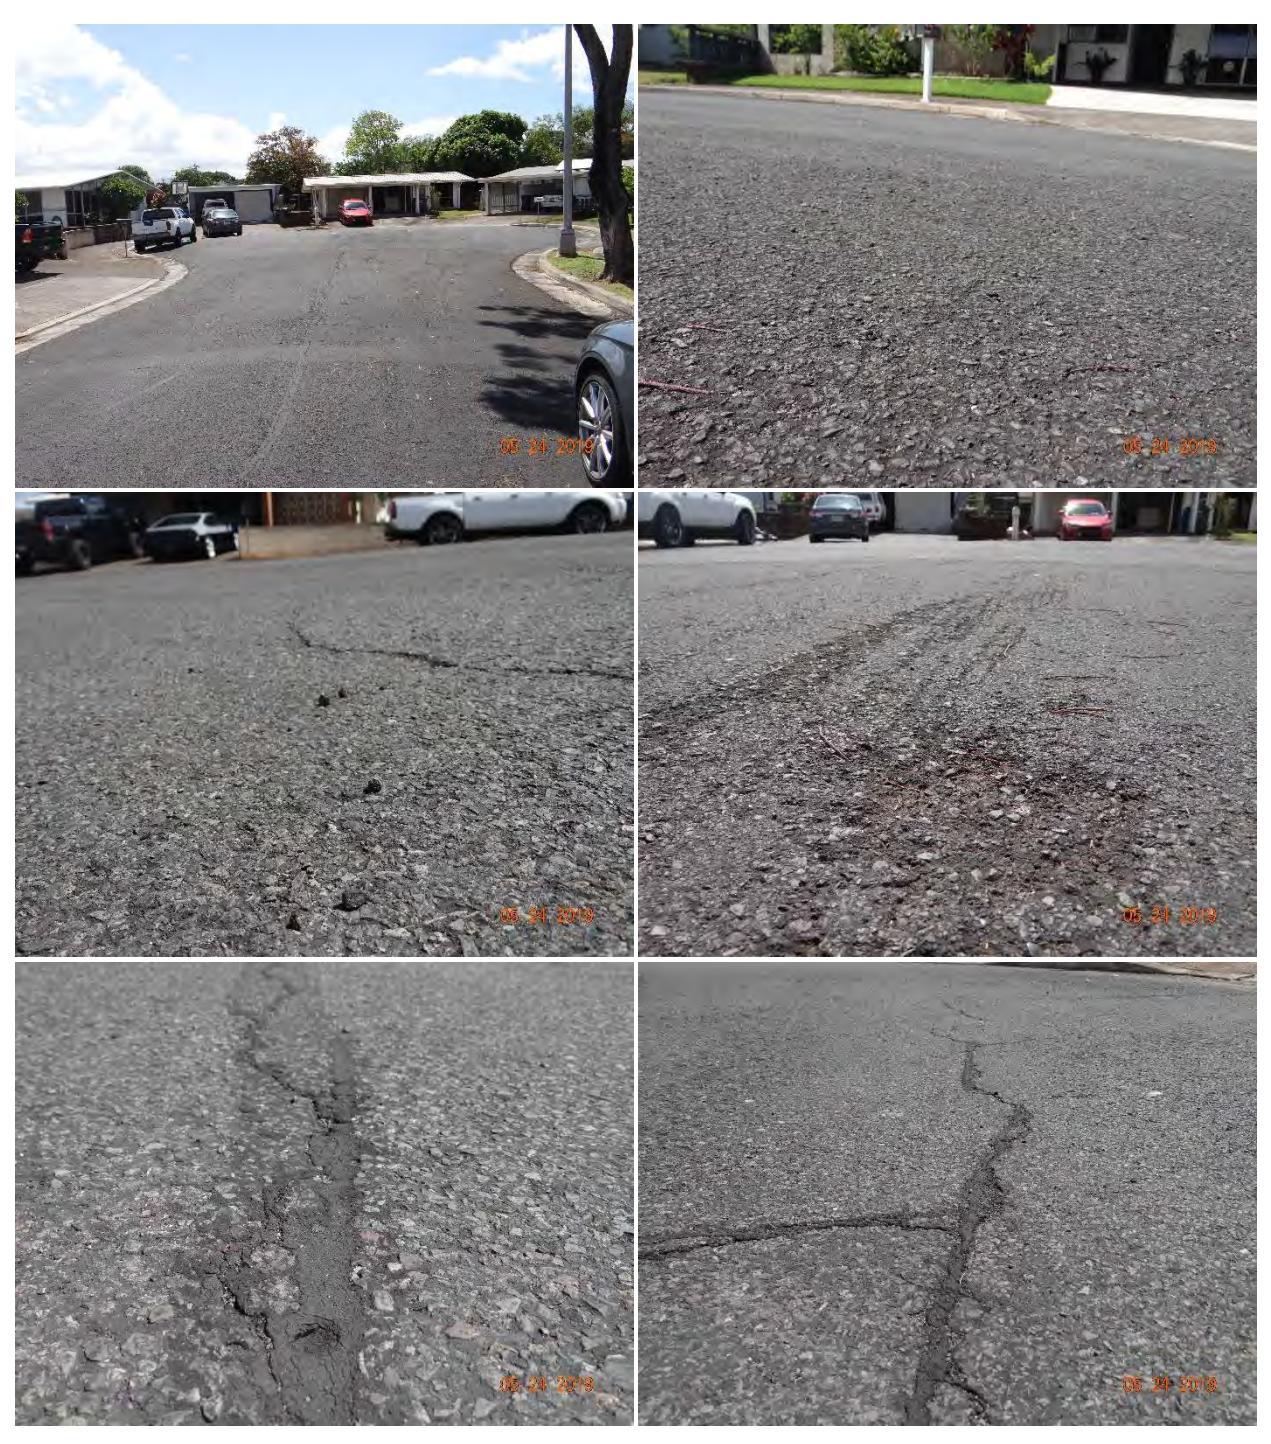
Figure C-138 Condition of the section on Hooheno Place, before treatment with CarbonSeal-HF by Carbonyte Systems Inc., on 5/24/2019.
C.5 SLURRY SEAL IN STRAIGHT SECTIONS

Figure C-138 shows that on 5/24/2019, the seal coat had worn off substantially, to the point that it was not easily distinguishable anymore. This was also revealed by the noticeable amount of raveling seen on the surface. On the other hand, the crack sealer in this section was performing well. As seen in one of the photos, it was still soft enough that it could be indented.

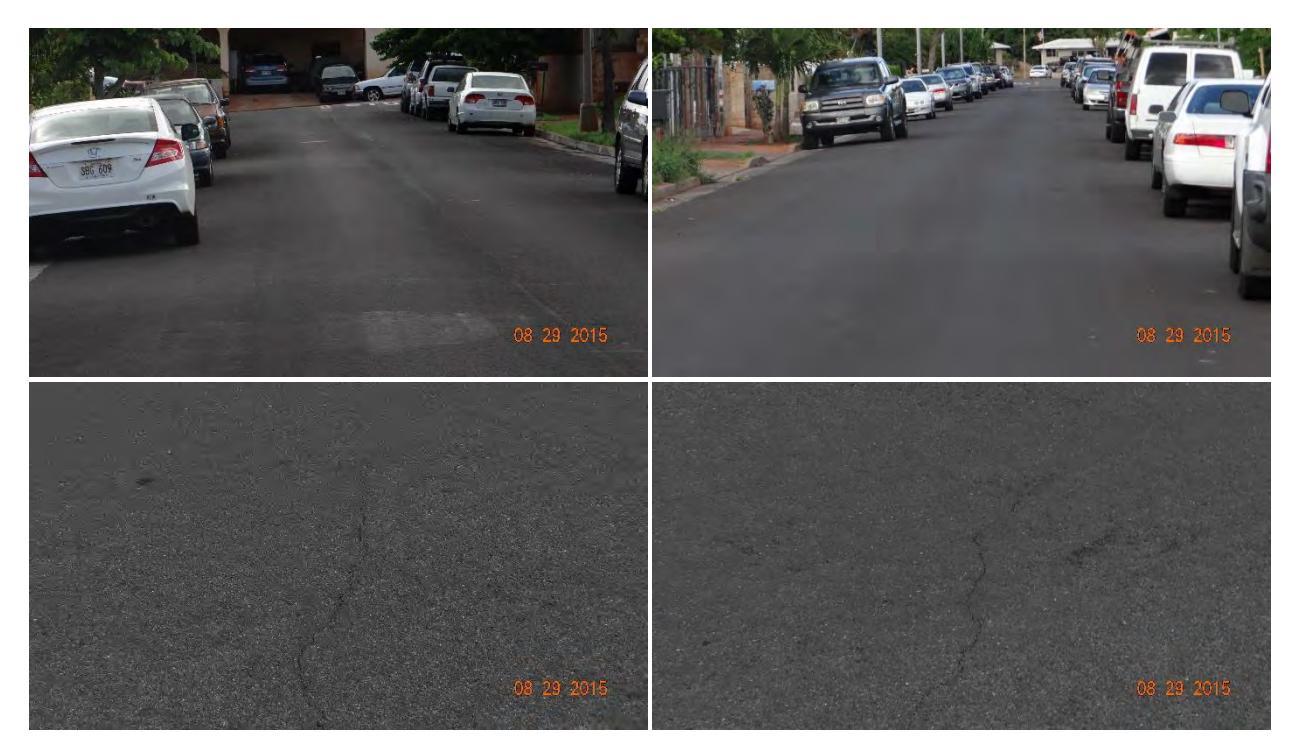
Figure C-139 Condition of the section on Hulahe Street, treated with Slurry Seal by Alakona Corp., on 8/29/2015.

Figure C-139 shows the condition of the section's surface on 8/29/2015, eight and a half months after the slurry seal application. The overall appearance of the section was good, though there were a few defects that are highlighted in the photos corresponding to later surveys. In general, because of its thicker application and some of the hand work required on the joints with the gutter, slurry seals tend to show some uneven appearance. The two photos on the bottom of Figure C-139 show some of the few cracks observed up to this point. Although it can not be appreciated in these photos, a common issue with this treatment is the initial high loss of aggregate depending on the slurry consistency. As shown later, the amount of loose aggregate can be substantial in some cases.
