PERFORMANCE MONITORING OF PRESERVATION TREATMENTS IN HONOLULU

FINAL PROJECT REPORT

Adrián Ricardo Archilla University of Hawaii at Manoa

May 2019

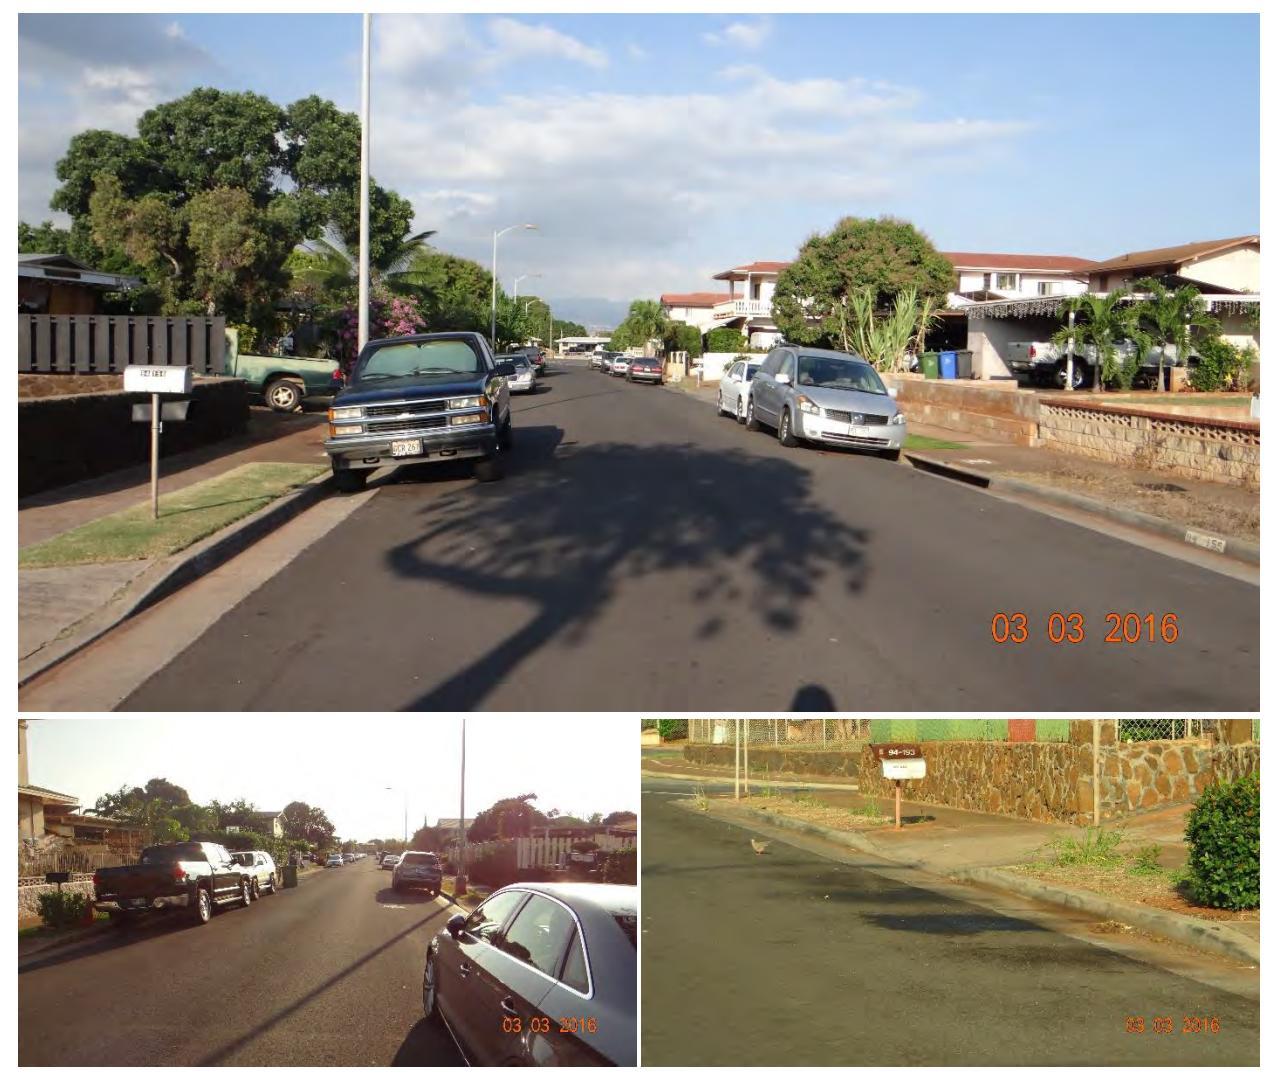
Figure C-140 Condition of the section on Hulahe Street, treated with Slurry Seal by Alakona Corp., on 3/3/2016.

Figure C-140 shows that as of 3/3/2016, about 15 months after the slurry seal application, although the cracking length was growing (not shown in these photos) the overall appearance of the section was still good. The bottom right photo in Figure C-140 illustrates the common problem of oil spills from parked cars. This is not only unsightly but also ends up eventually affecting the condition of those spots.

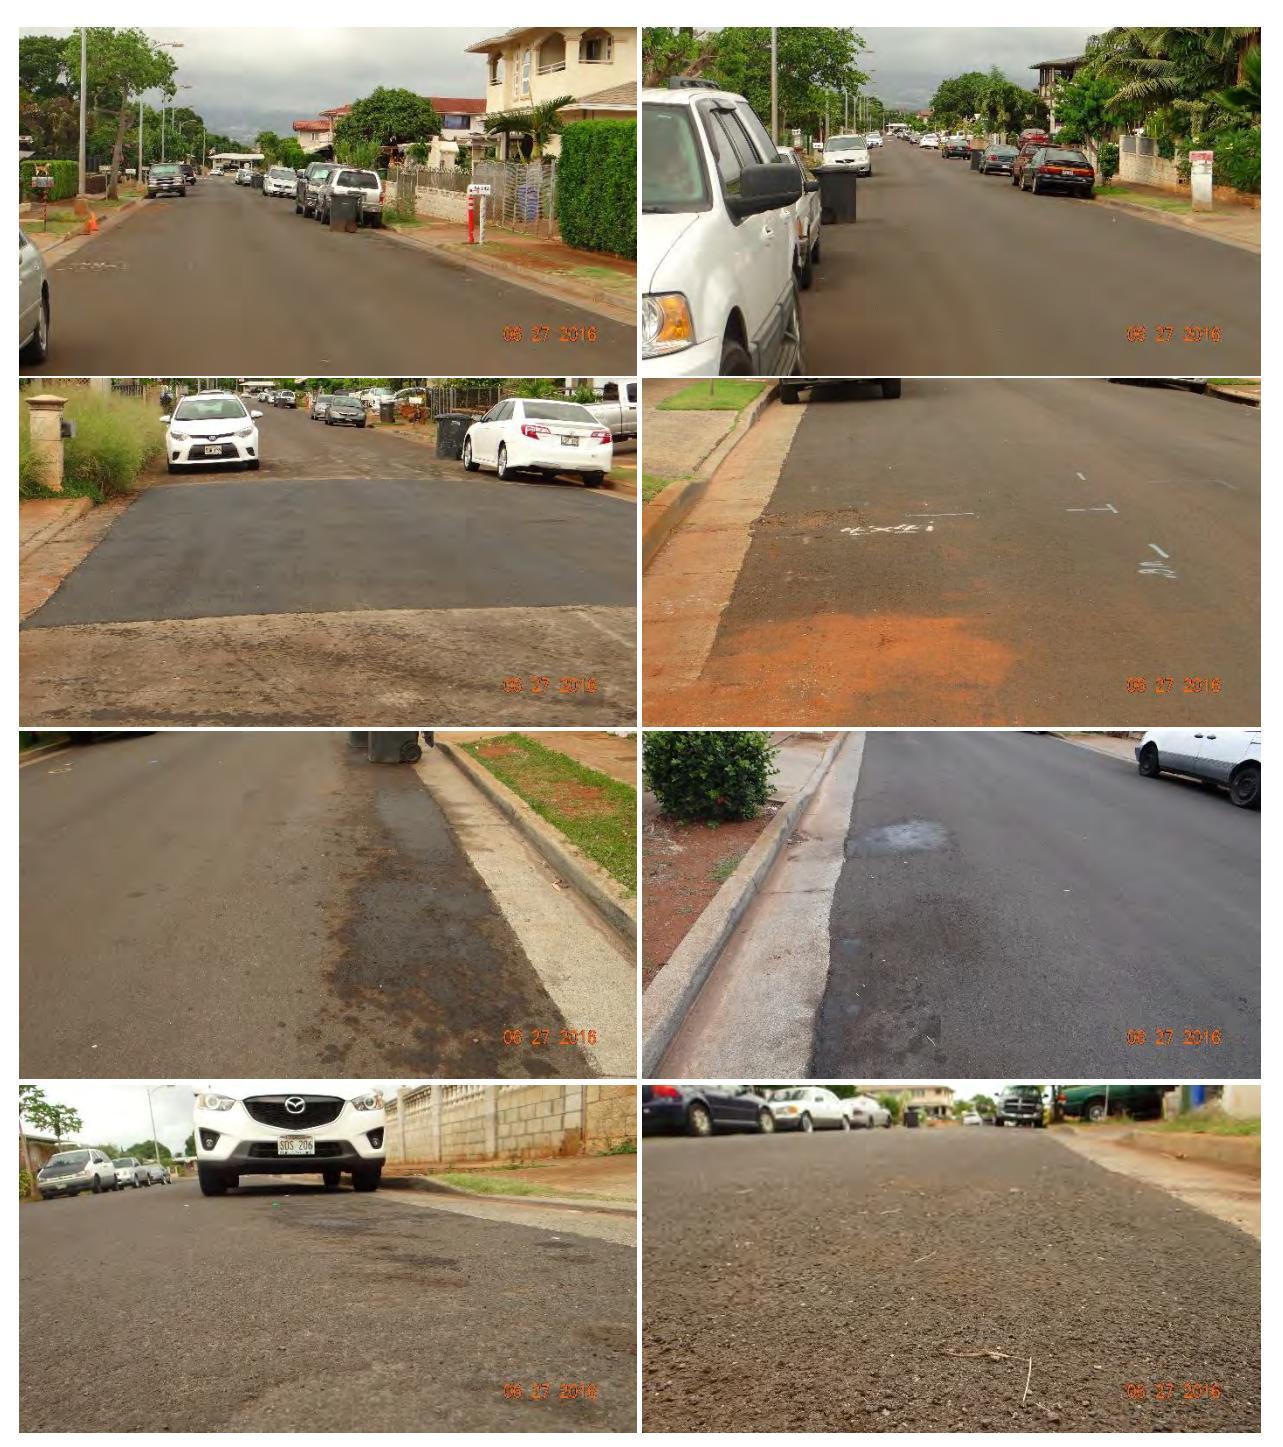
Figure C-141 Condition of the section on Hulahe Street, treated with Slurry Seal by Alakona Corp., on 6/27/2016.

Figure C-141 shows the condition of the section on 6/27/2016, after slightly more than 19 months of service. Although the overall appearance of the section was still acceptable (top photos), several problems (some unrelated to the treatment) were more noticeable. First, as shown in the photos in the second row, a patch had already been performed within the section and another area had been marked for repair. Both were apparently related to a water main breaks. The photos on the third row highlight the fact that oil spills on this street were quite common. The last two photos show the coarse texture that this treatment often exhibits (when compared with the other seal coats in this study) and the problem of aggregate loss, particularly on parking areas. As shown in the bottom right photo, the amount of loose aggregate can be quite substantial.

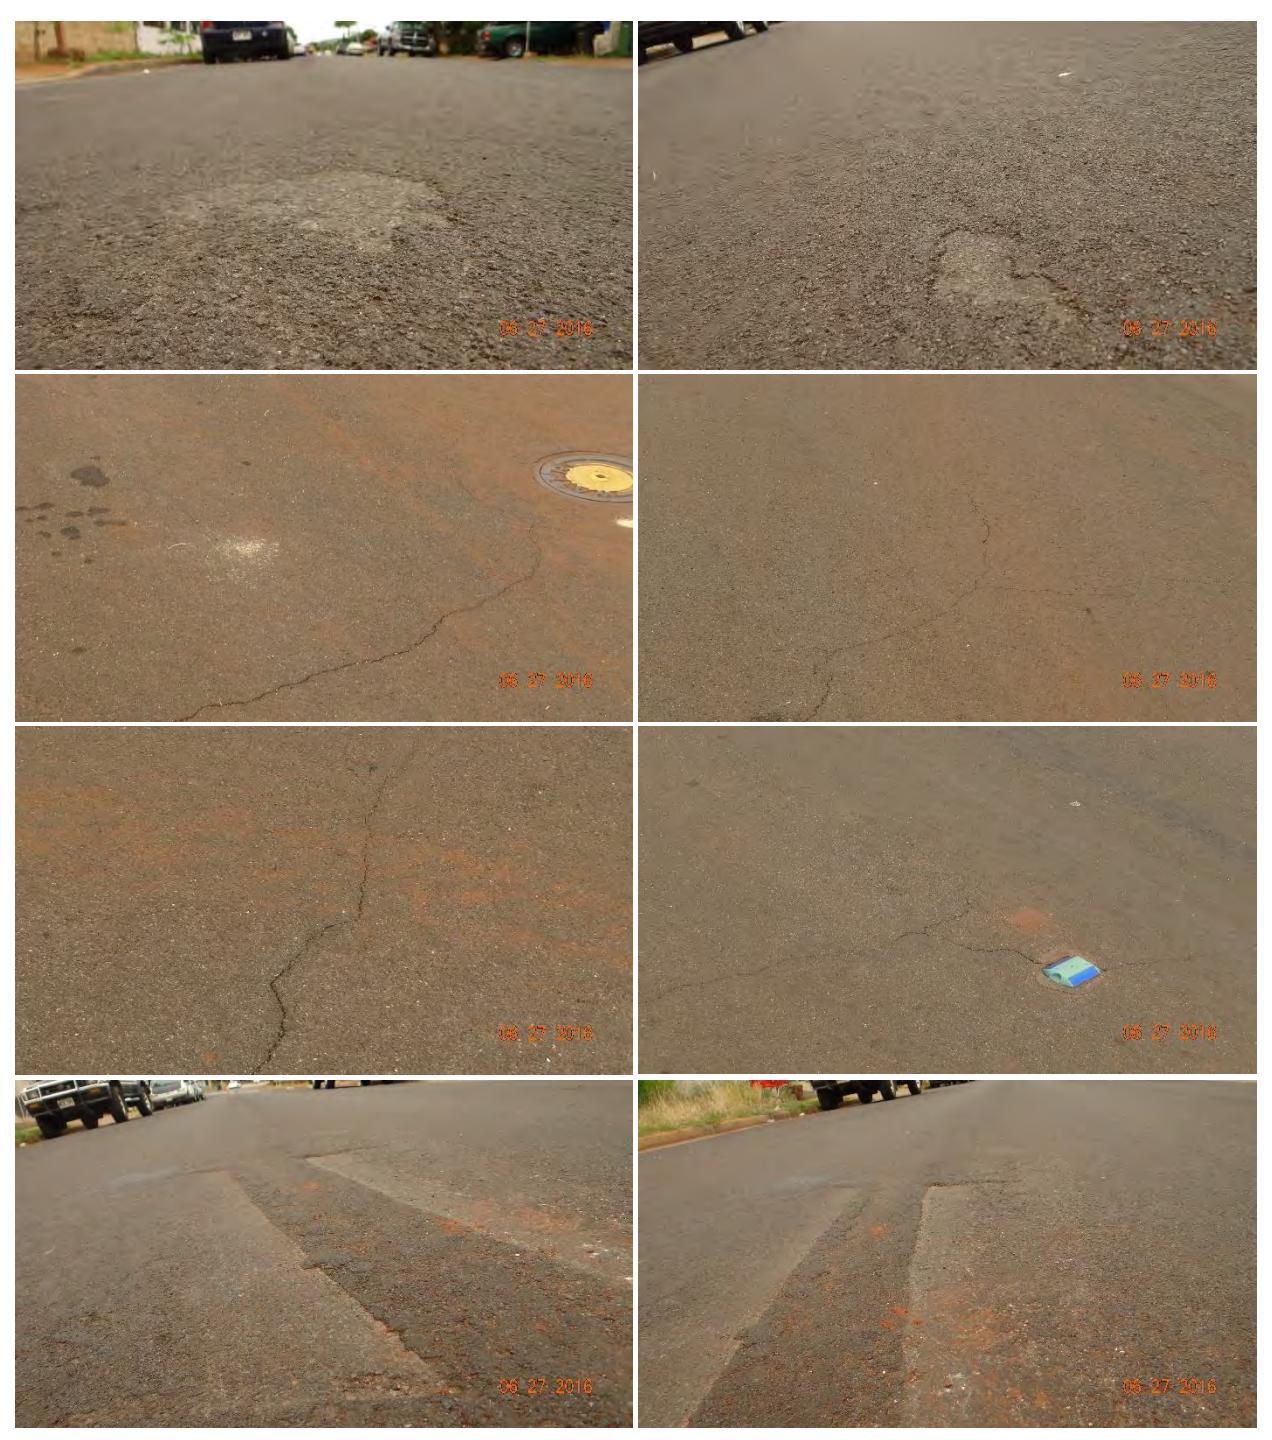
Figure C-142 Condition of the section on Hulahe Street, treated with Slurry Seal by Alakona Corp., on 6/27/2016.

The top photos in Figure C-142 illustrate that further loss of material may result in spots with delamination. The four middle photos show some of the cracking observed on 6/27/2016 and the last two photos show a construction defect that persisted over the whole study period.

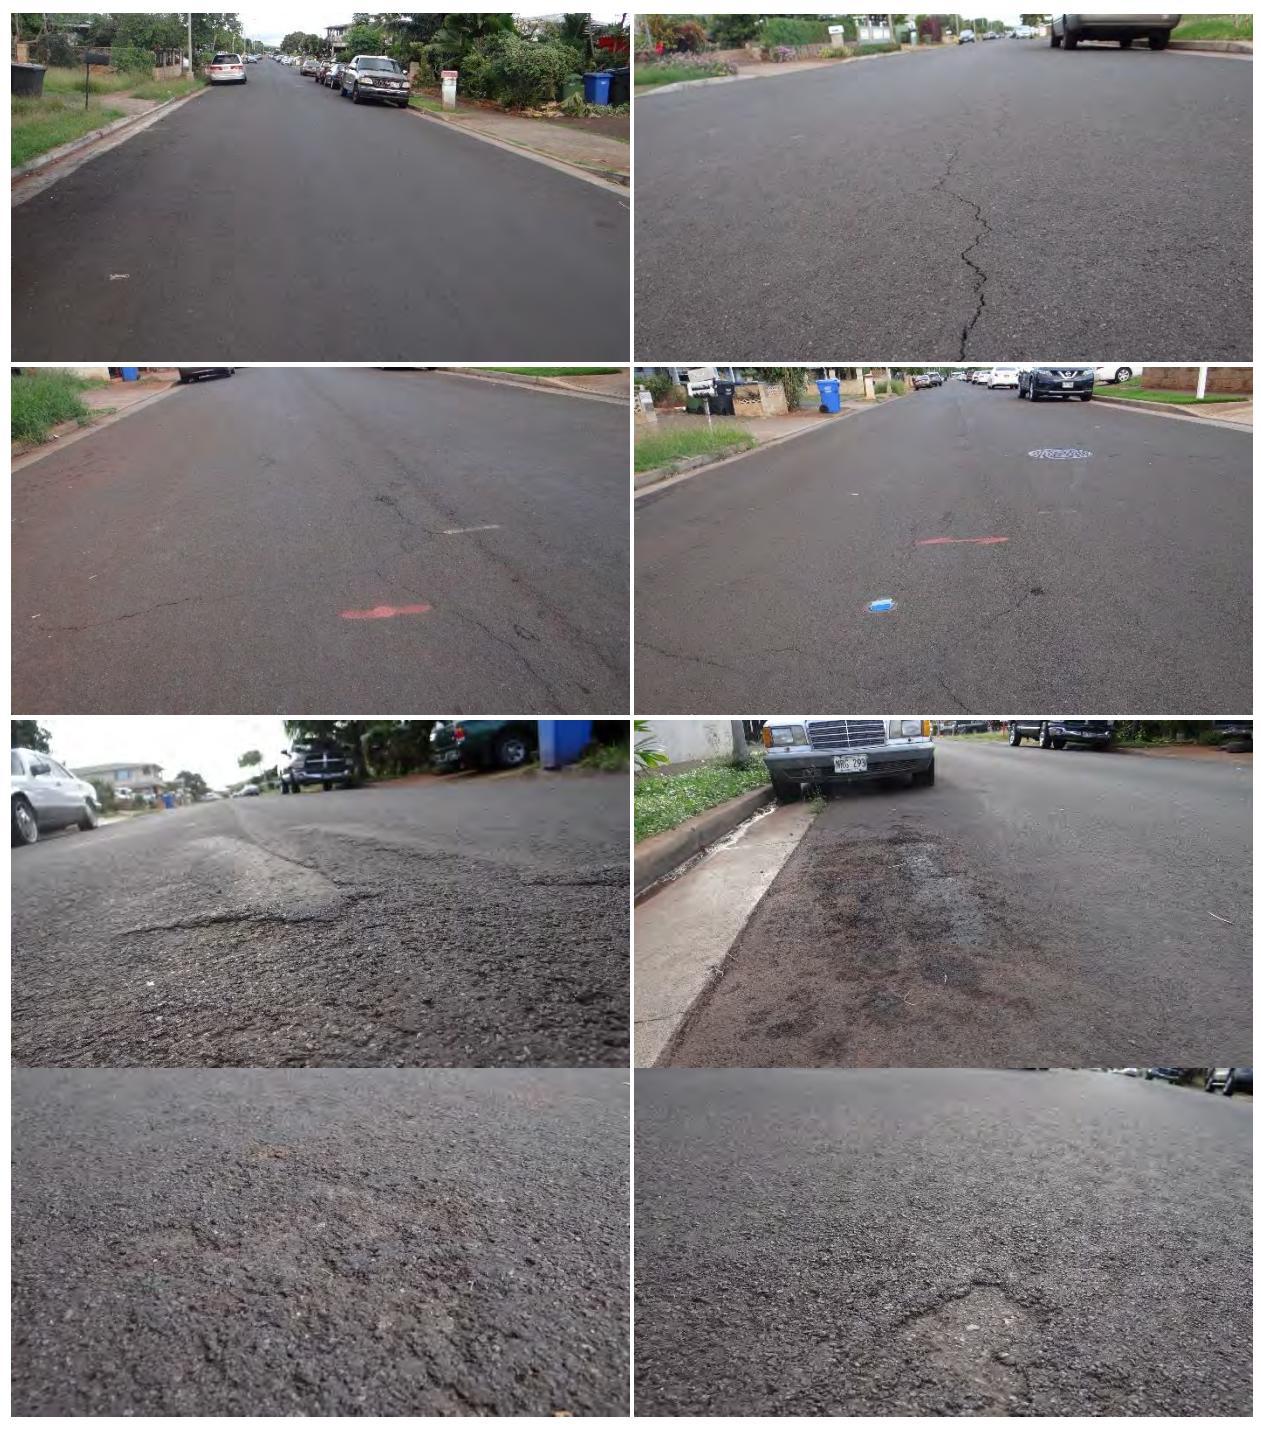
Figure C-143 Condition of the section on Hulahe Street, treated with Slurry Seal by Alakona Corp., on 12/14/2016.

Figure C-143 shows the conditions on 12/14/2016, with 25 months in service. Once again, as shown on the top left photo, the overall appearance of the section was good even though as shown in the other photos some of the same issues observed in other surveys were still present.

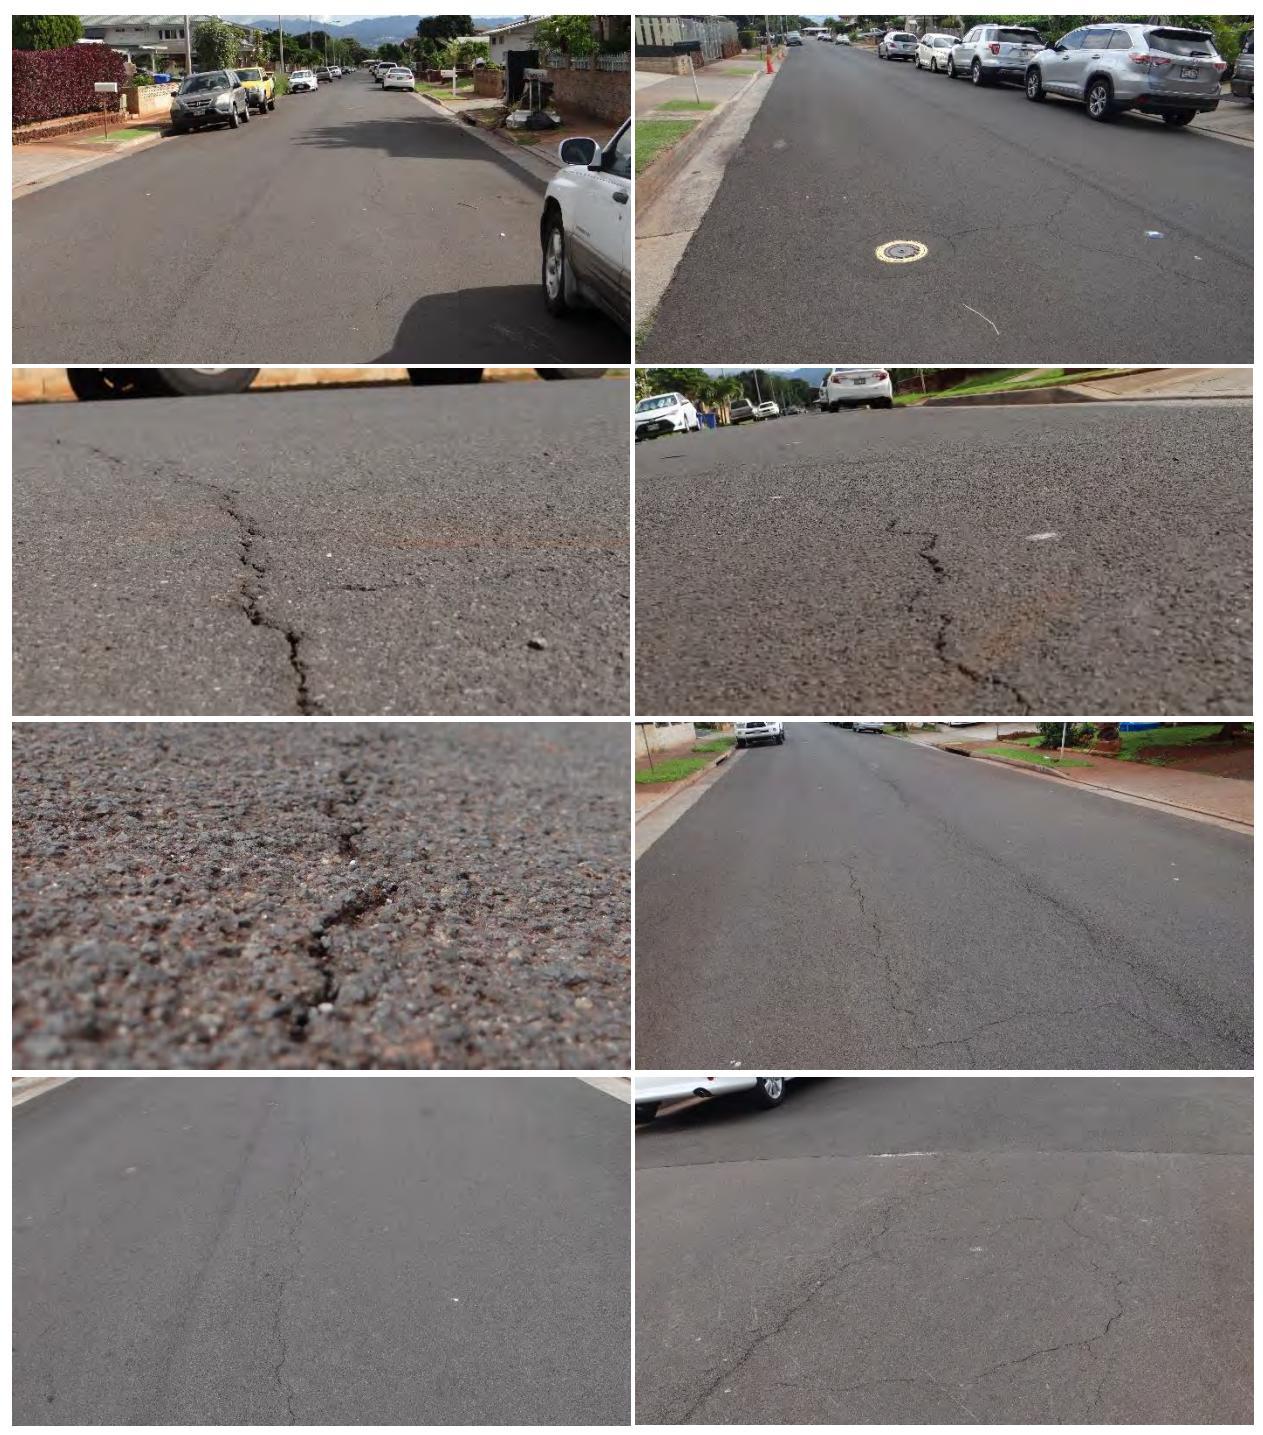
Figure C-144 Condition of the section on Hulahe Street, treated with Slurry Seal by Alakona Corp., on 2/7/2018.

Figure C-144 and Figure C-145 show the condition of the section on 2/7/2018, after 38 months of service. The top photos in Figure C-144 show that the section still had a generally good appearance though the cracking was now more noticeable. The other photos in the figure show different examples of the type of cracks observed.

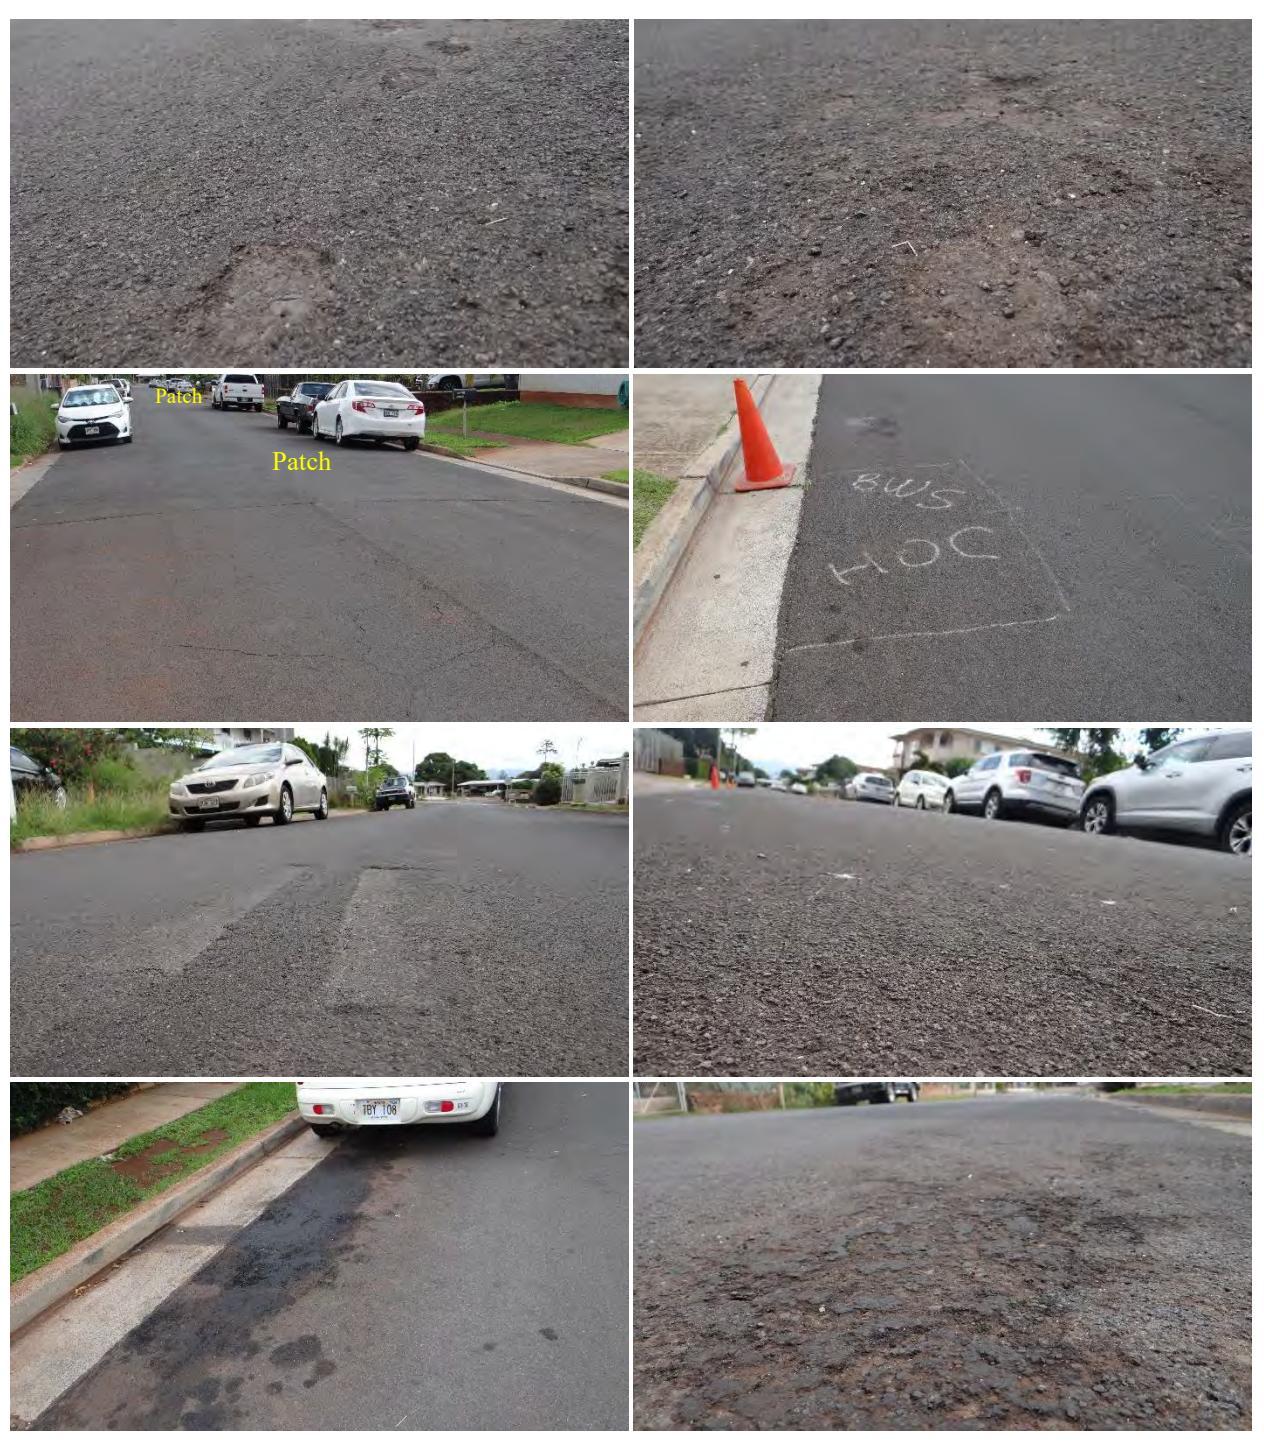
Figure C-145 Condition of the section on Hulahe Street, treated with Slurry Seal by Alakona Corp., on 2/7/2018.

Figure C-145 highlights other issues discussed before. Namely, the top two photos show the condition of delaminated areas, the photos in the second row show patched areas and another area marked for a new repair by the Board of Water Supply, the photos in the third row show that

the construction defect noted earlier persisted almost intact while in some areas the pavement surface was showing significant aggregate loss, and the last two photos show the effects of oil spots.

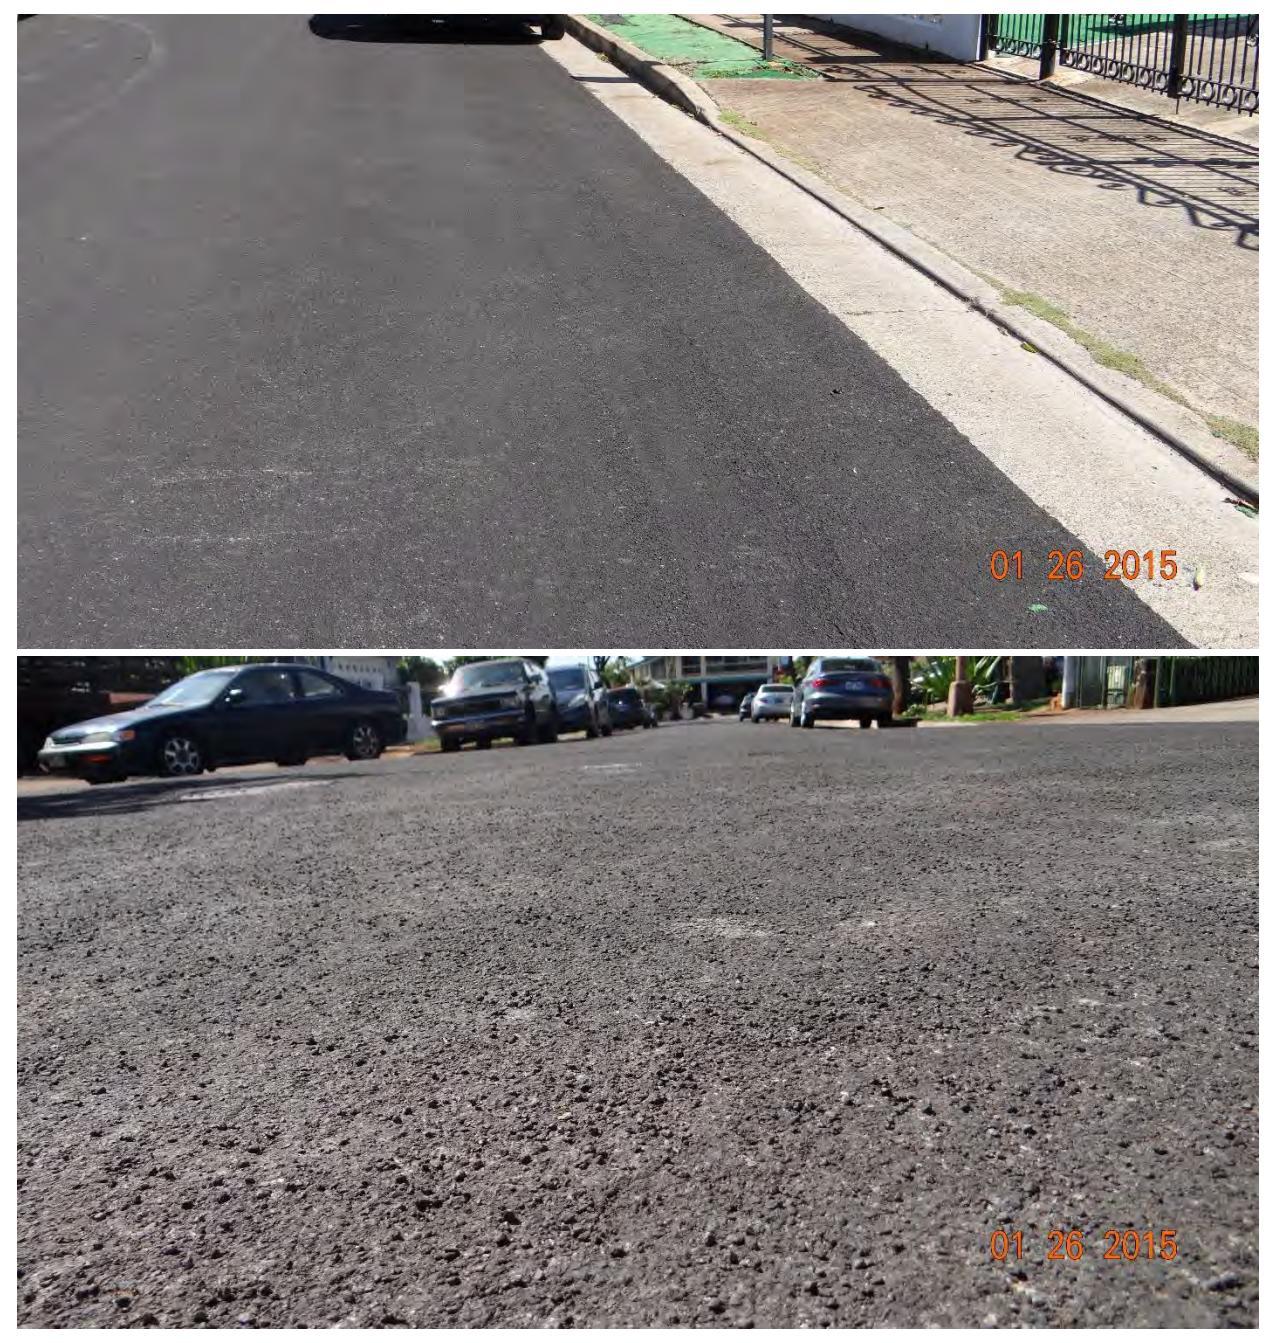
Figure C-146 Condition of the section on Hiana Place, treated with Slurry Seal by Alakona Corp., on 1/26/2015.

Figure C-146 shows the condition of the section's surface on 1/26/2015, soon after it was opened to traffic on 1/26/2015. The top photo shows the typical appearance of the slurry seal mix. The photo on the bottom illustrates the significant amount of loose aggregate this treatment may leave behind. This would typically need to be brushed.

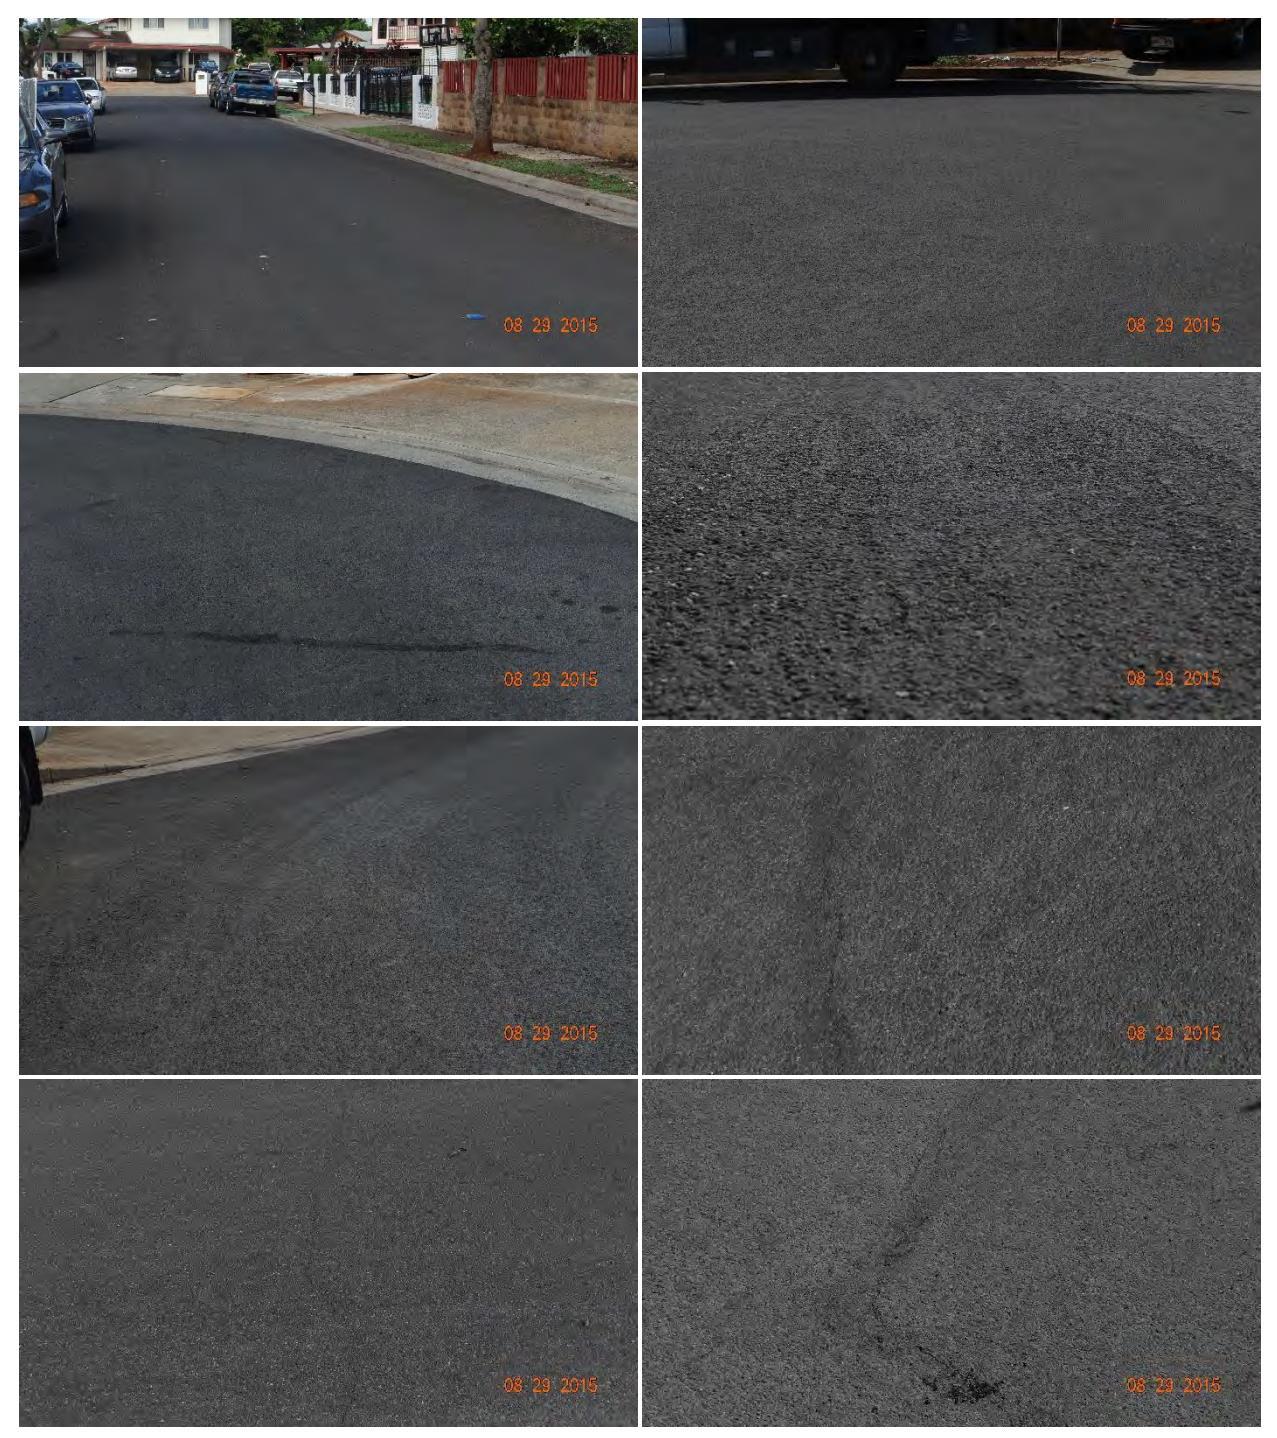
Figure C-147 Condition of the section on Hiana Place, treated with Slurry Seal by Alakona Corp., on 8/29/2015.

Figure C-147 shows the conditions on 8/29/2015, seven months after the application of the slurry seal. The section had an overall nice appearance but some closeups show some typical marks and changes in texture with this treatment due to the handwork required by the marks left at the edges of the spreader box of the slurry sealer truck. Some of these photos show some barely noticeable incipient cracking either new or reflecting from sealed cracks.

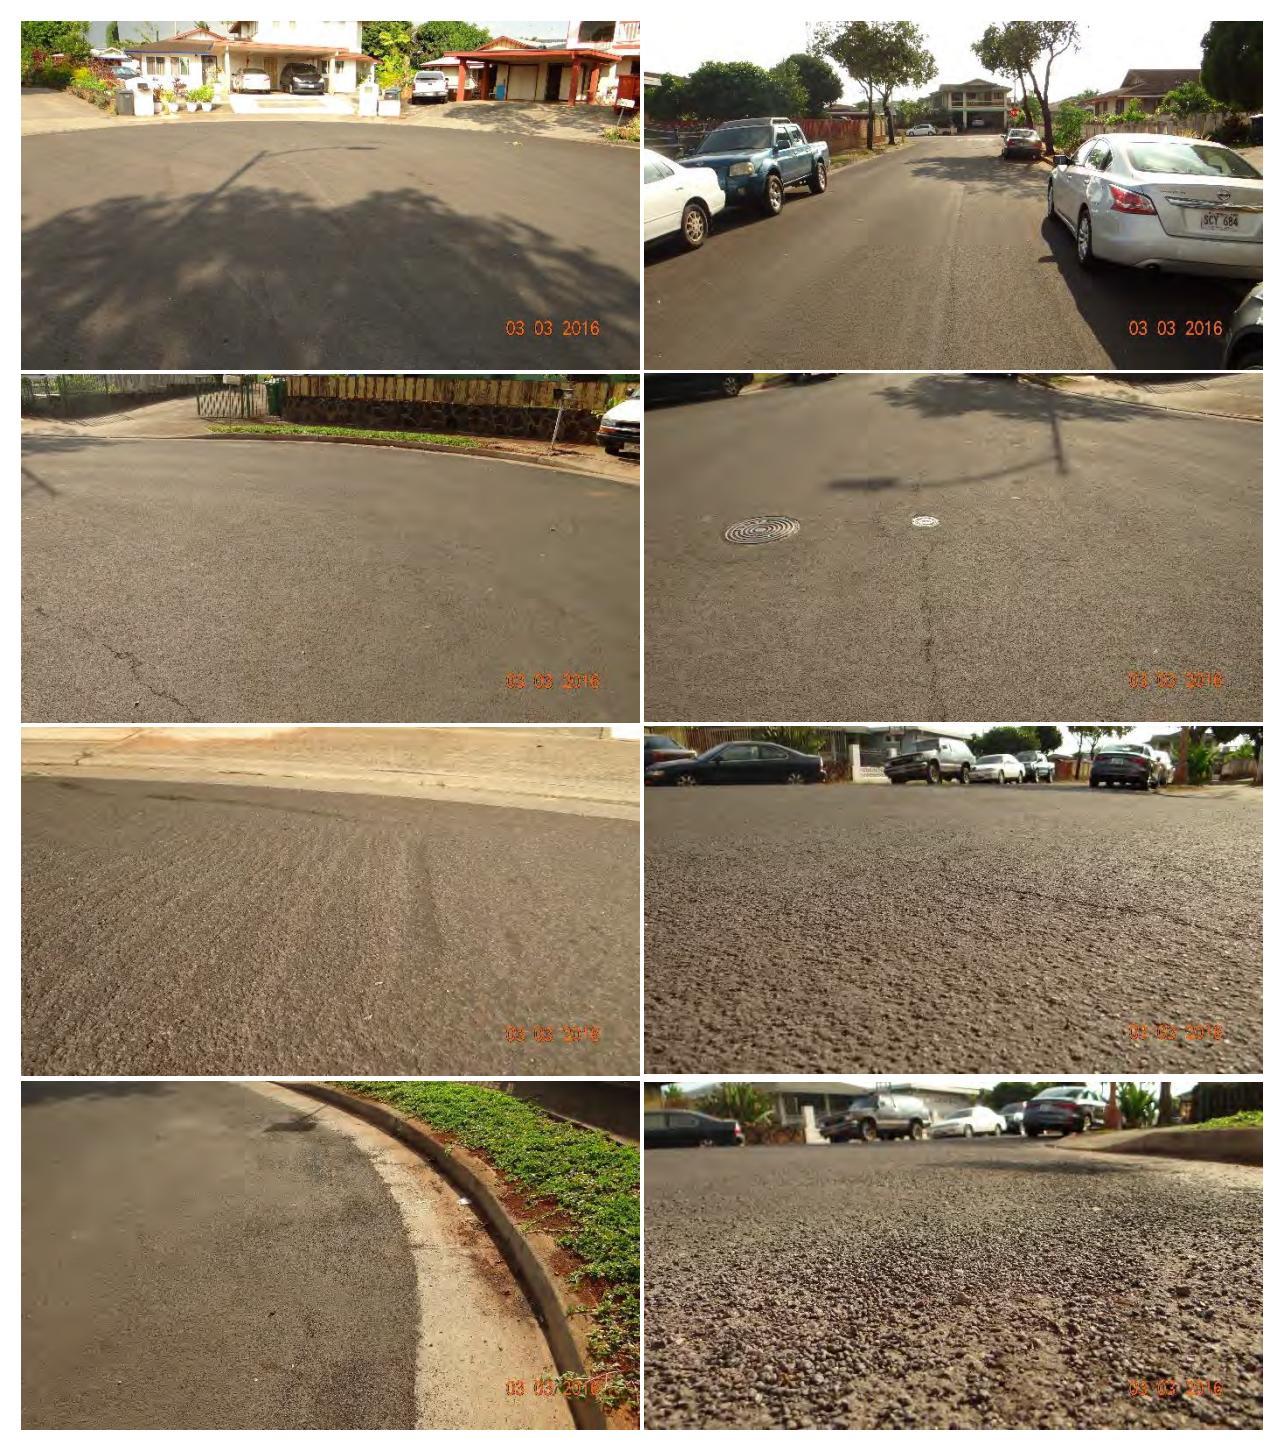
Figure C-148 Condition of the section on Hiana Place, treated with Slurry Seal by Alakona Corp., on 3/3/2016.

Figure C-148 shows the conditions on 3/3/2016, about 13 months after the treatment application. The photos in the first row show the overall nice appearance of section. The second-row photos show that cracks were more noticeable whereas the third-row photos provide closeups to illustrate some of the textures that can be observed with this treatment. The last two photos illustrate again the high amount of loose aggregate, which typically accumulates near the gutter.

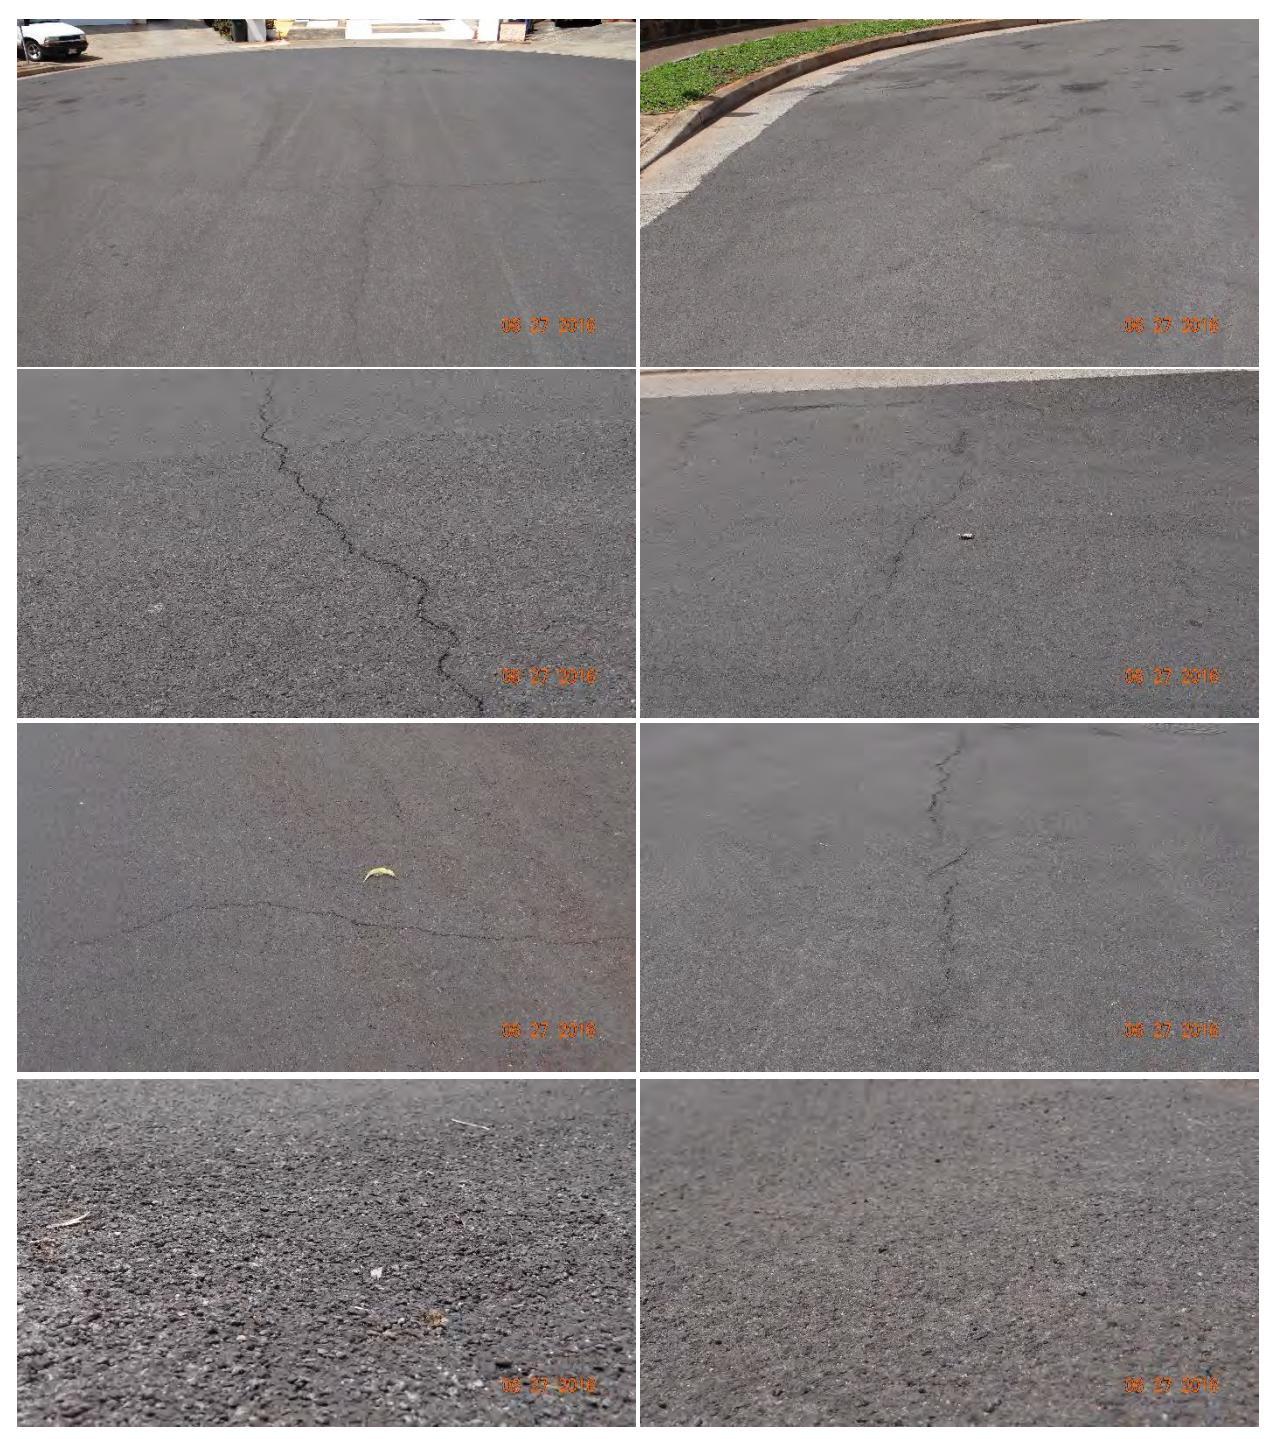
Figure C-149 Condition of the section on Hiana Place, treated with Slurry Seal by Alakona Corp., on 6/27/2016.

Figure C-149 shows the conditions on 6/27/2016, about 17 months after the treatment application. The figure provides several examples of the cracking observed in the section and once again the existence of loose aggregates on the surface.

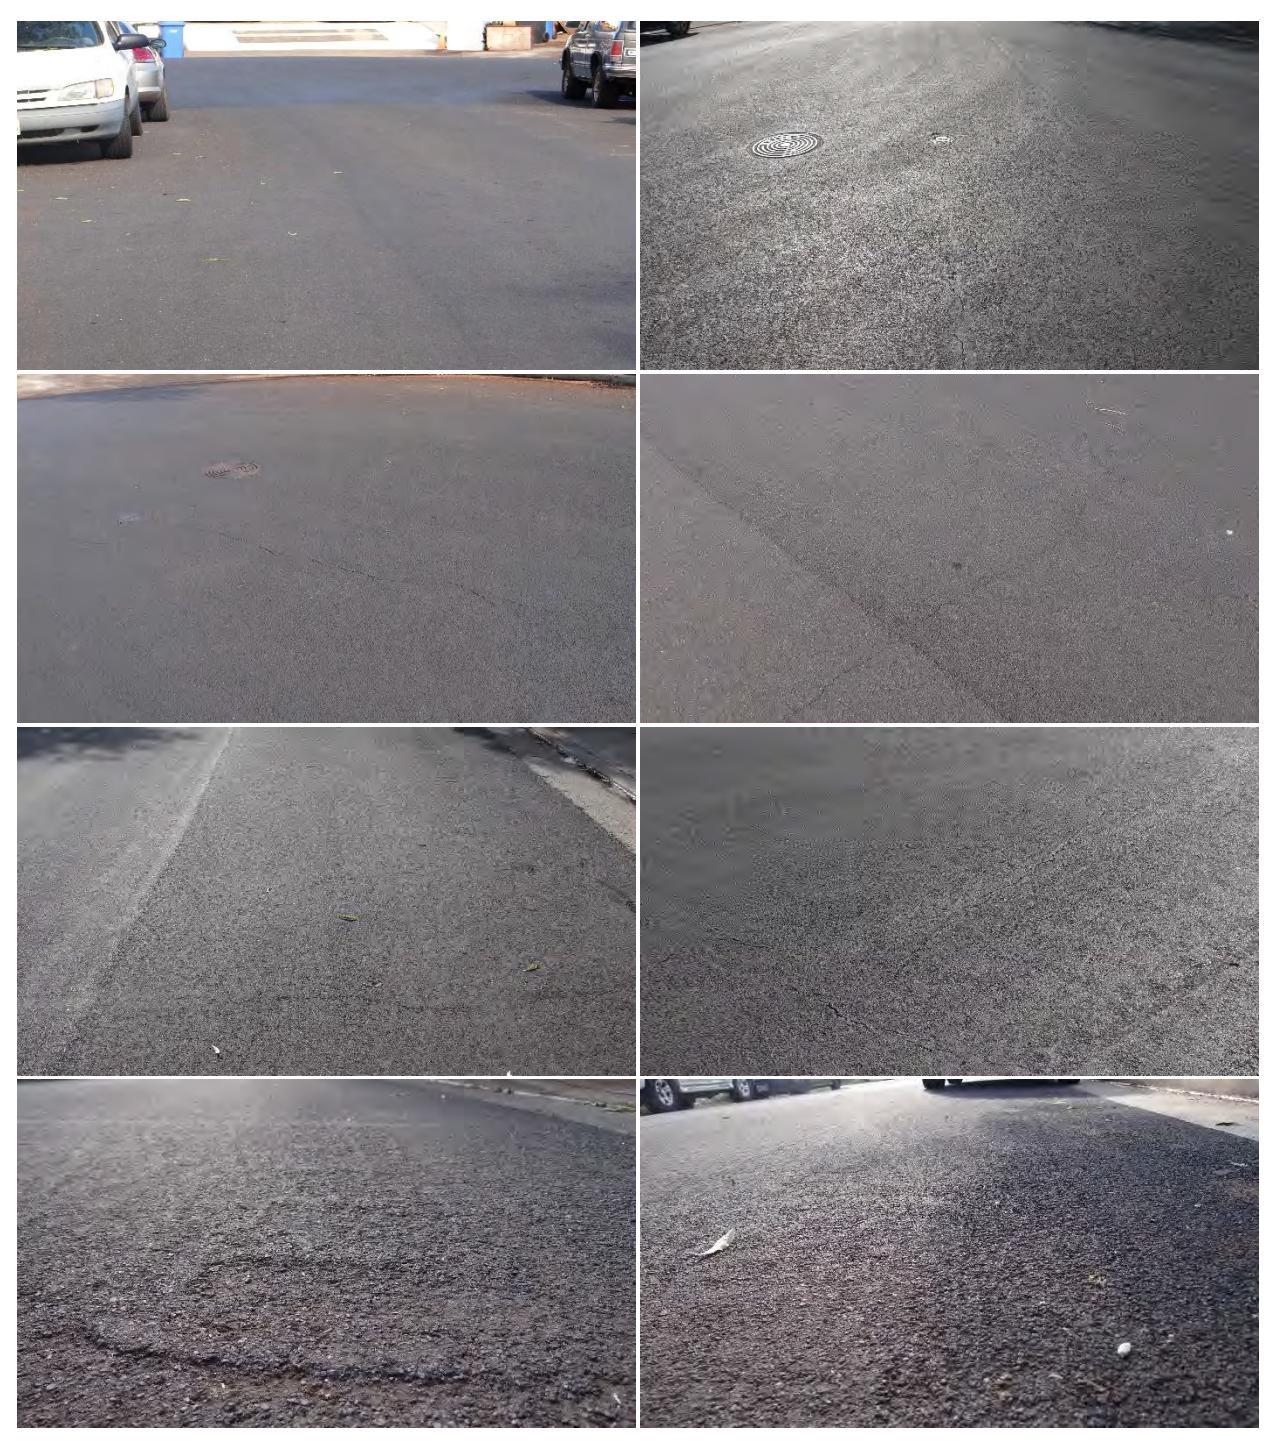
Figure C-150 Condition of the section on Hiana Place, treated with Slurry Seal by Alakona Corp., on 12/14/2016.

As seen in the top left photograph in Figure C-150, on 12/14/2016, with 23 months in service, the cul-de-sac had a distinctive appearance from the adjacent straight portion. It was not clear at the time what was had been done but on the last survey a neighbor indicated that it had been treated. It appears that a seal coat may have been applied to stop the aggregate loss. The other photos just provide additional examples of the condition observed on that date.

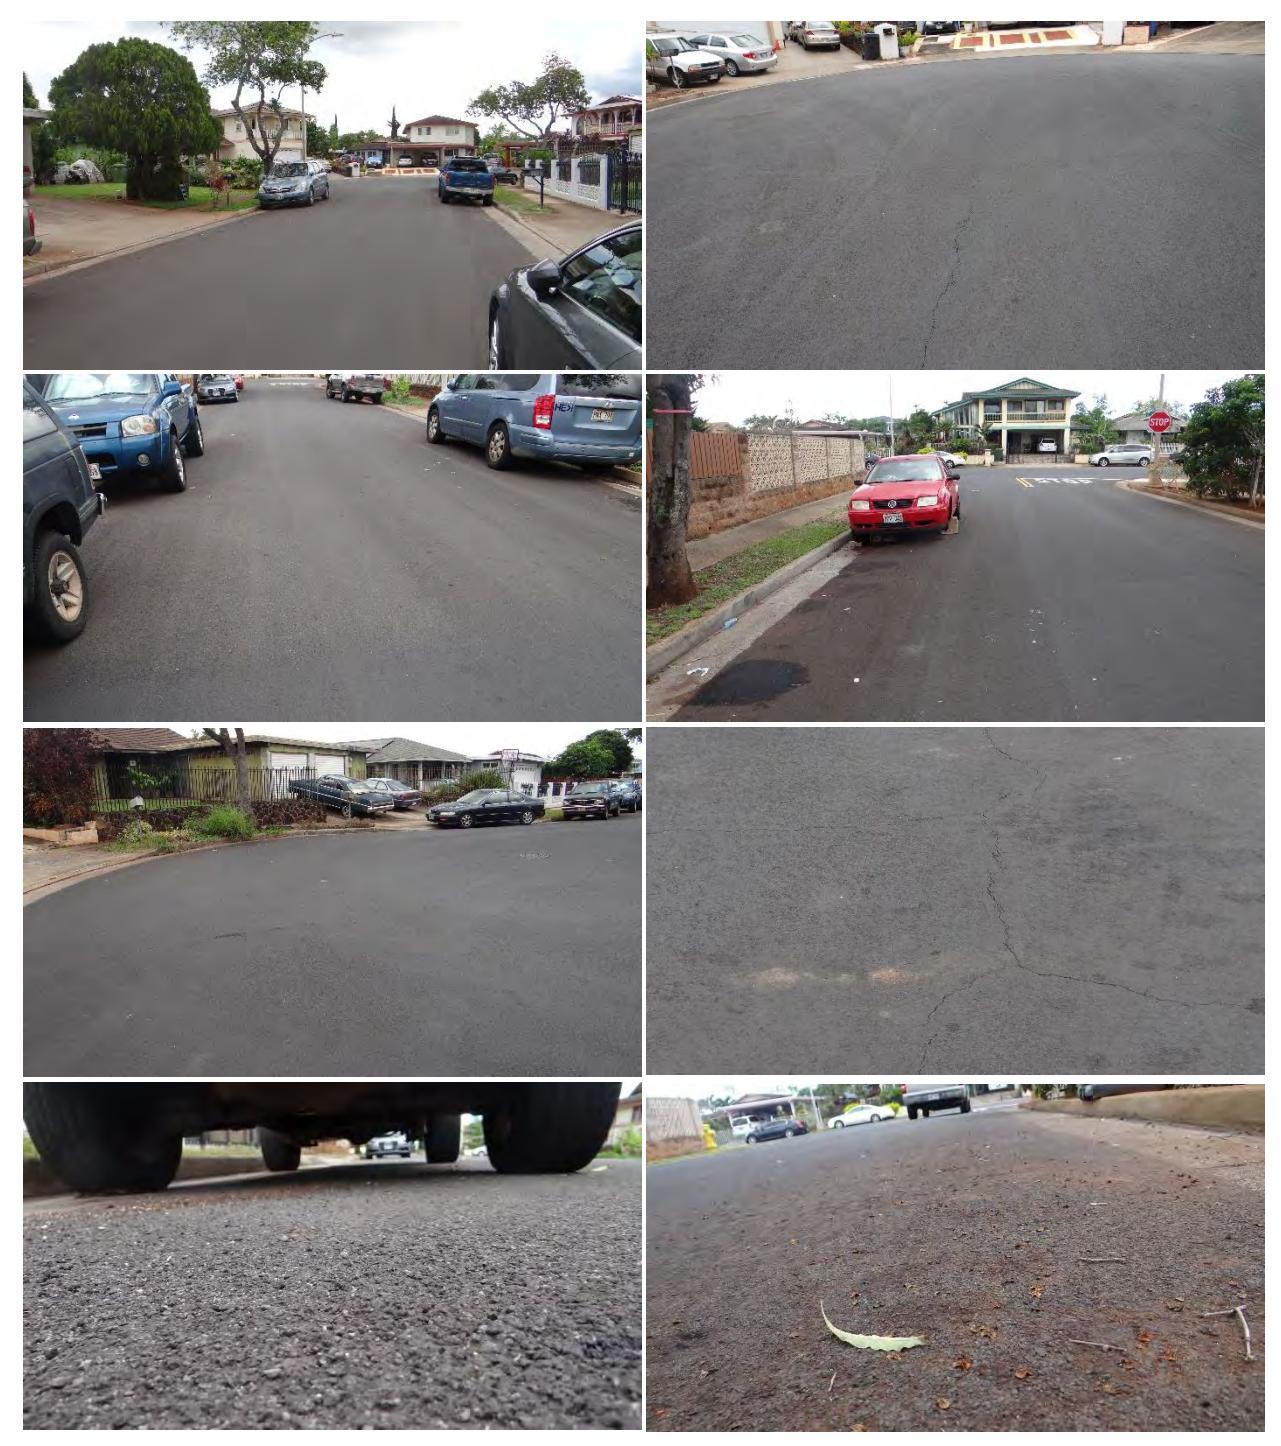
Figure C-151 Condition of the section on Hiana Place, treated with Slurry Seal by Alakona Corp., on 2/7/2018.

Finally, Figure C-151 shows that on 2/7/2018, about three years after the slurry seal application, the section still exhibited a nice appearance with cracking mostly of low severity. As shown in the last two photos, there were still areas with loose aggregates on the surface on the straight portion of the segment.
