PERFORMANCE MONITORING OF PRESERVATION TREATMENTS IN HONOLULU

FINAL PROJECT REPORT

Adrián Ricardo Archilla University of Hawaii at Manoa

May 2019

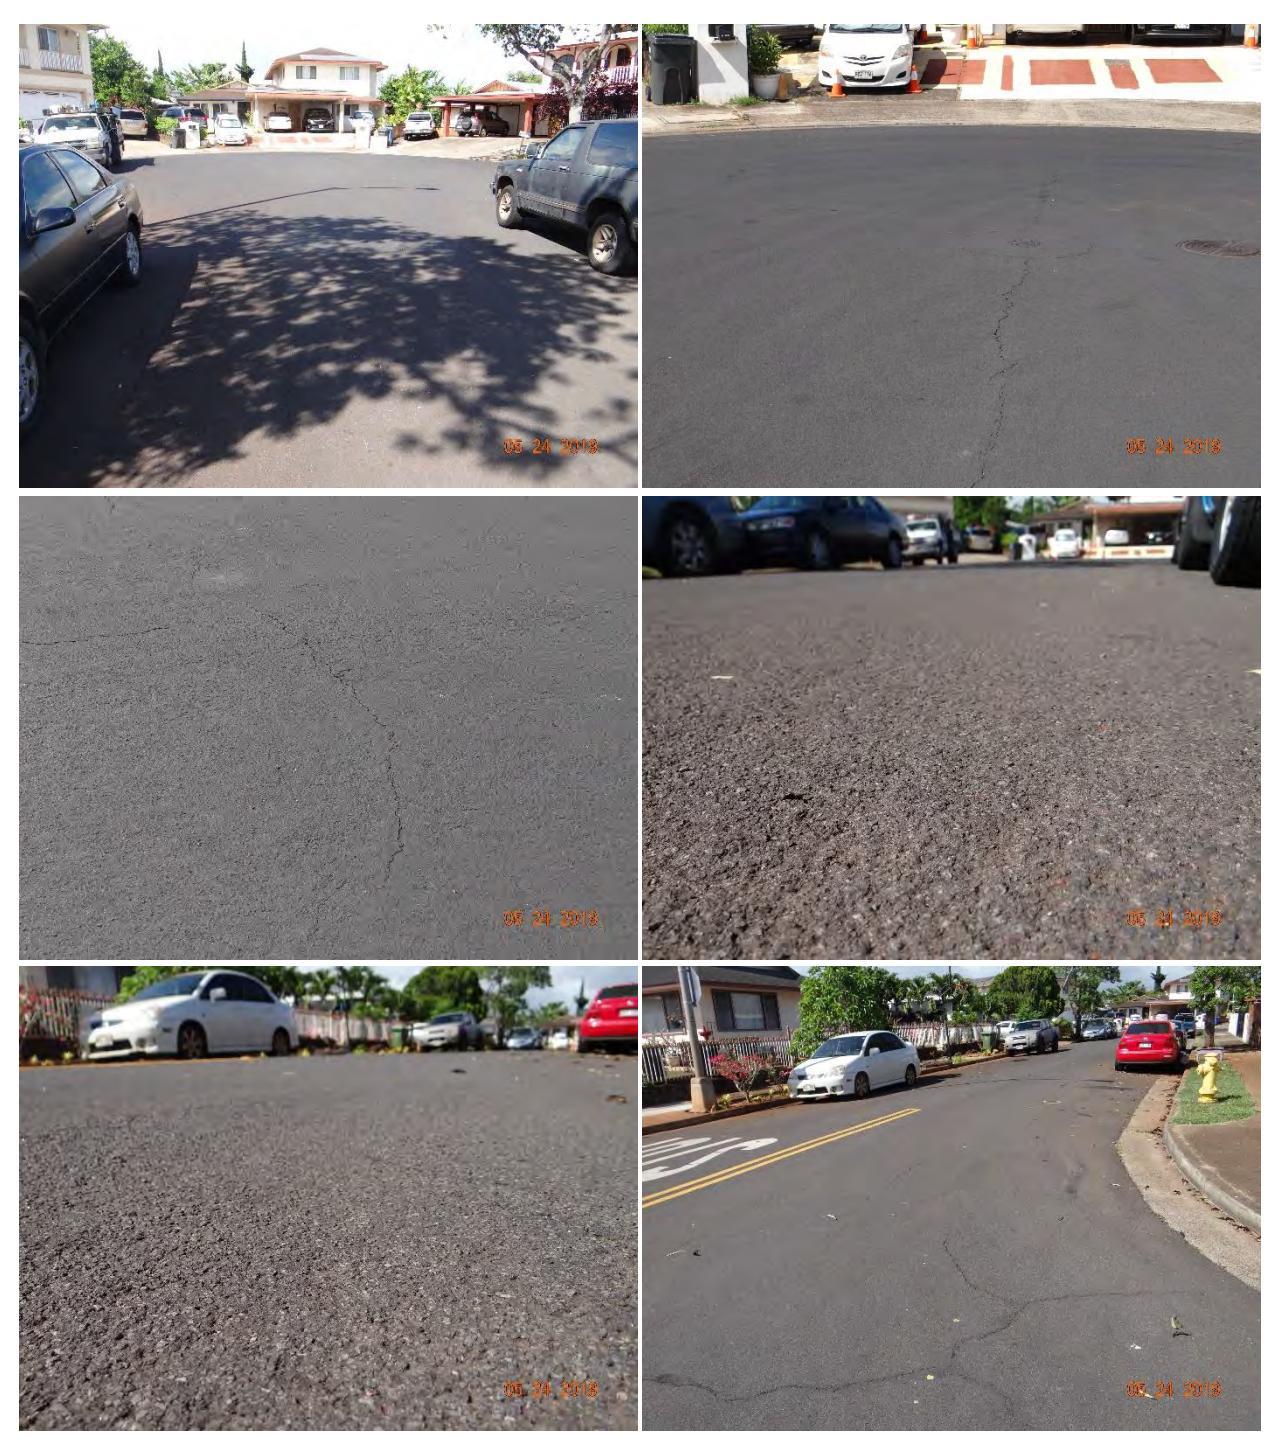
Figure C-152 Condition of the section on Hiana Place, treated with Slurry Seal by Alakona Corp., on 5/24/2019.

Figure C-152 shows the conditions on 5/24/2019. As expected, the aggregate loss from the slurry was a lot less in the cul-de-sac portion, which as described before was apparently sealed, than on the straight portion where it is still noteworthy.

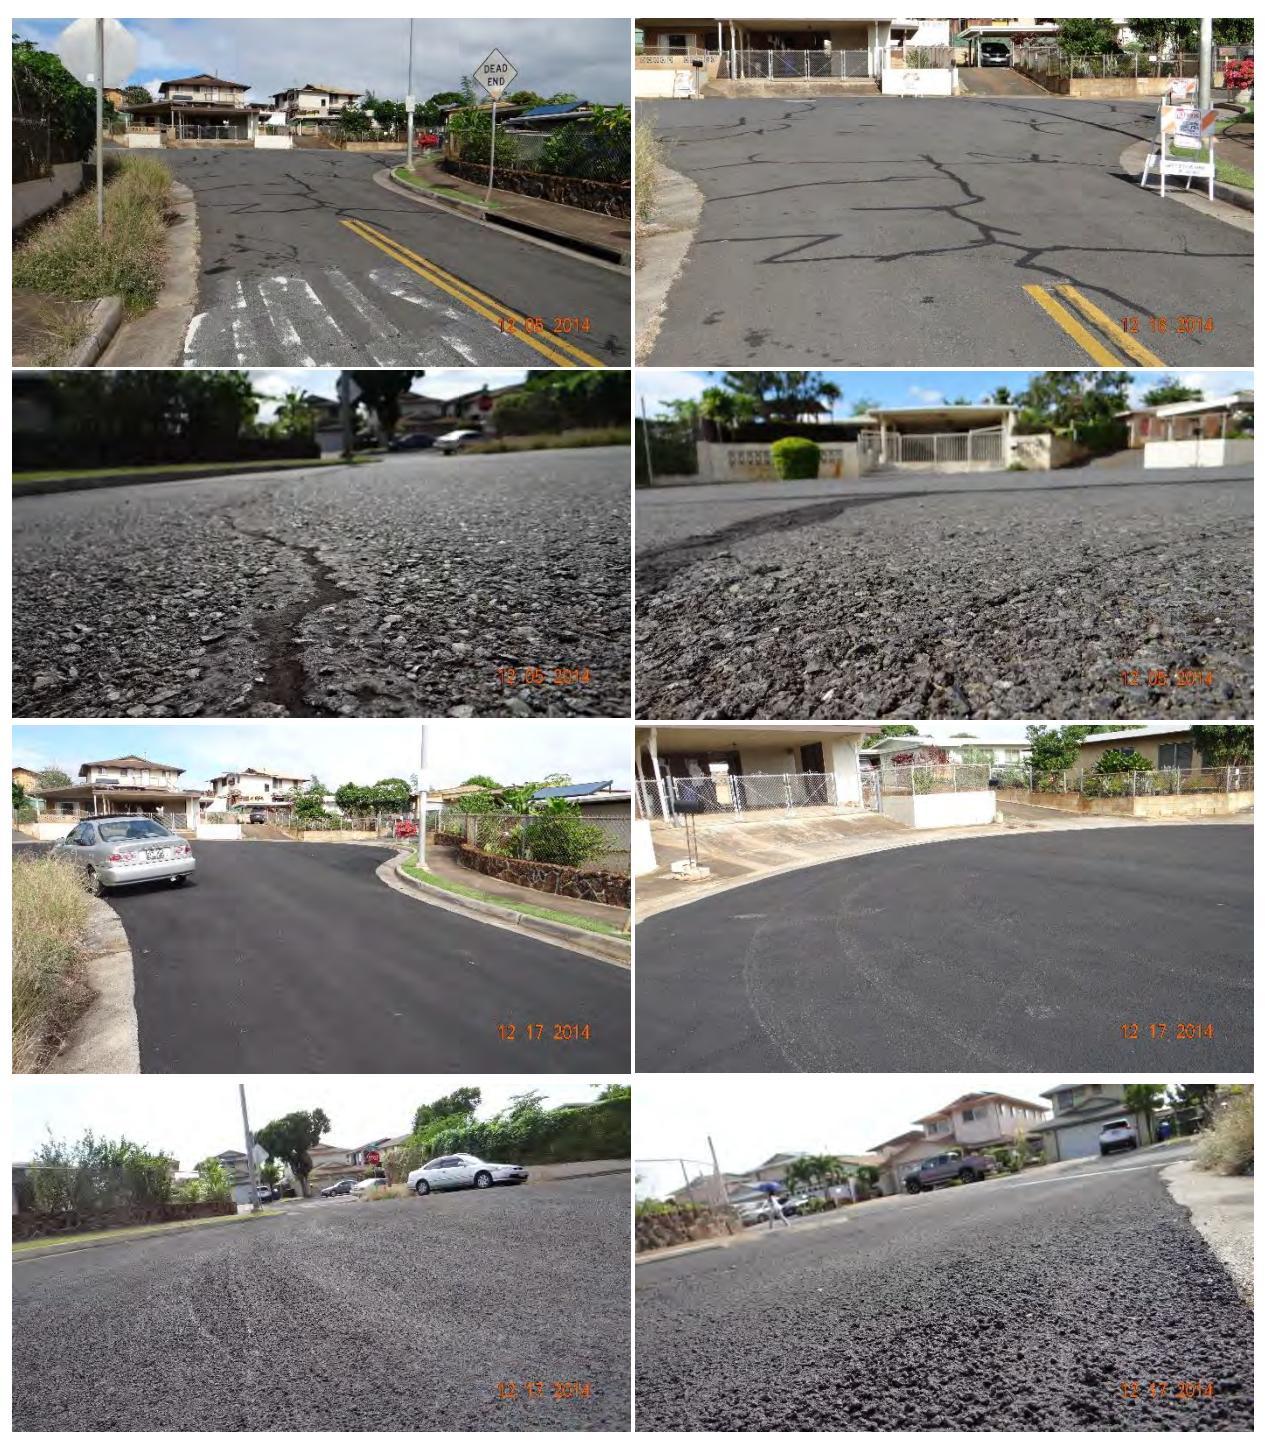
Figure C-153 Condition of the section on Hapapa Place, treated with Slurry Seal by Alakona Corp., on 12/5/2014 to 12/17/2014.

The top four photos in Figure C-153 show the condition of the section's surface (cracking and texture) before the slurry seal appication on 12/17/2014 and the last four photos show the section appearance immediate after its application. The original section had an advanced block cracking pattern though apparently not yet fully developed. The last two photos illustrate the typical appearance of the slurry mix shortly after its application. The grade of the cul-de-sac is about 4.4%, which is steep and clearly visible in the photos.

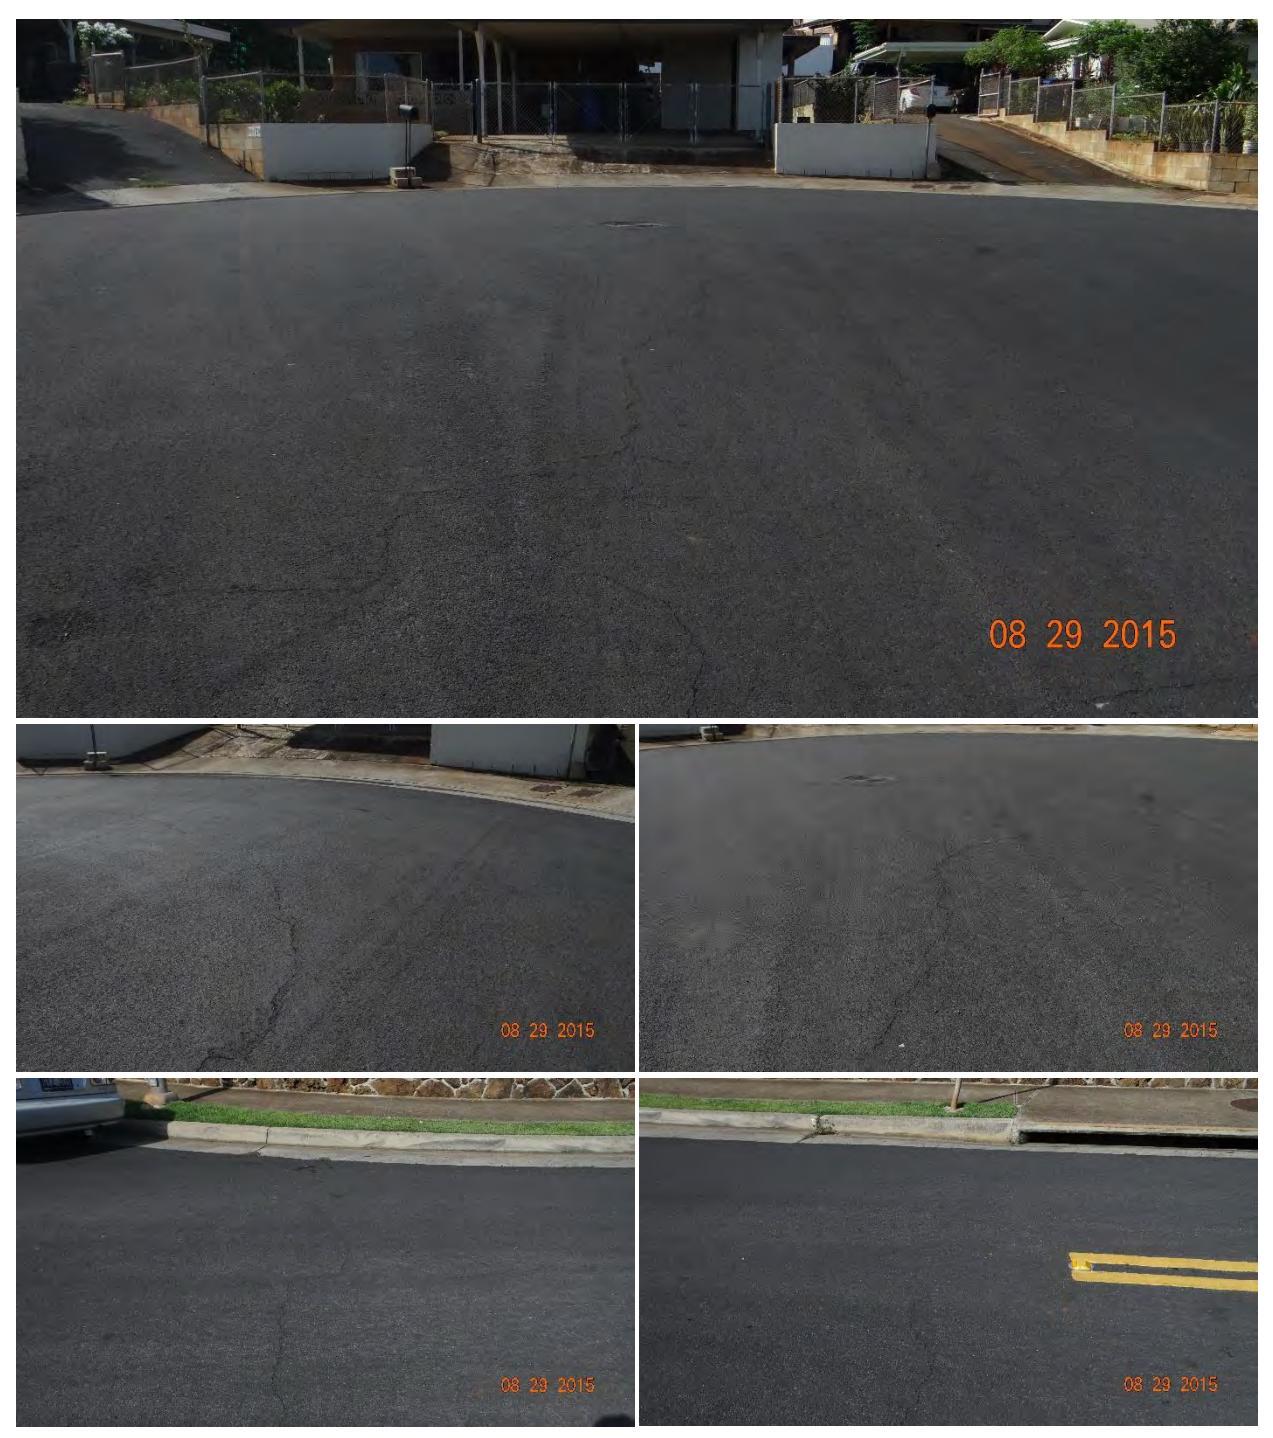
Figure C-154 Condition of the section on Hapapa Place, treated with Slurry Seal by Alakona Corp., on 8/29/2015.

As shown in Figure C-154, by 8/29/2015, nine months after the application of the slurry seal, several cracks had formed or reflected on the slurry seal. Other than that, the treatment still exhibited a good appearance.

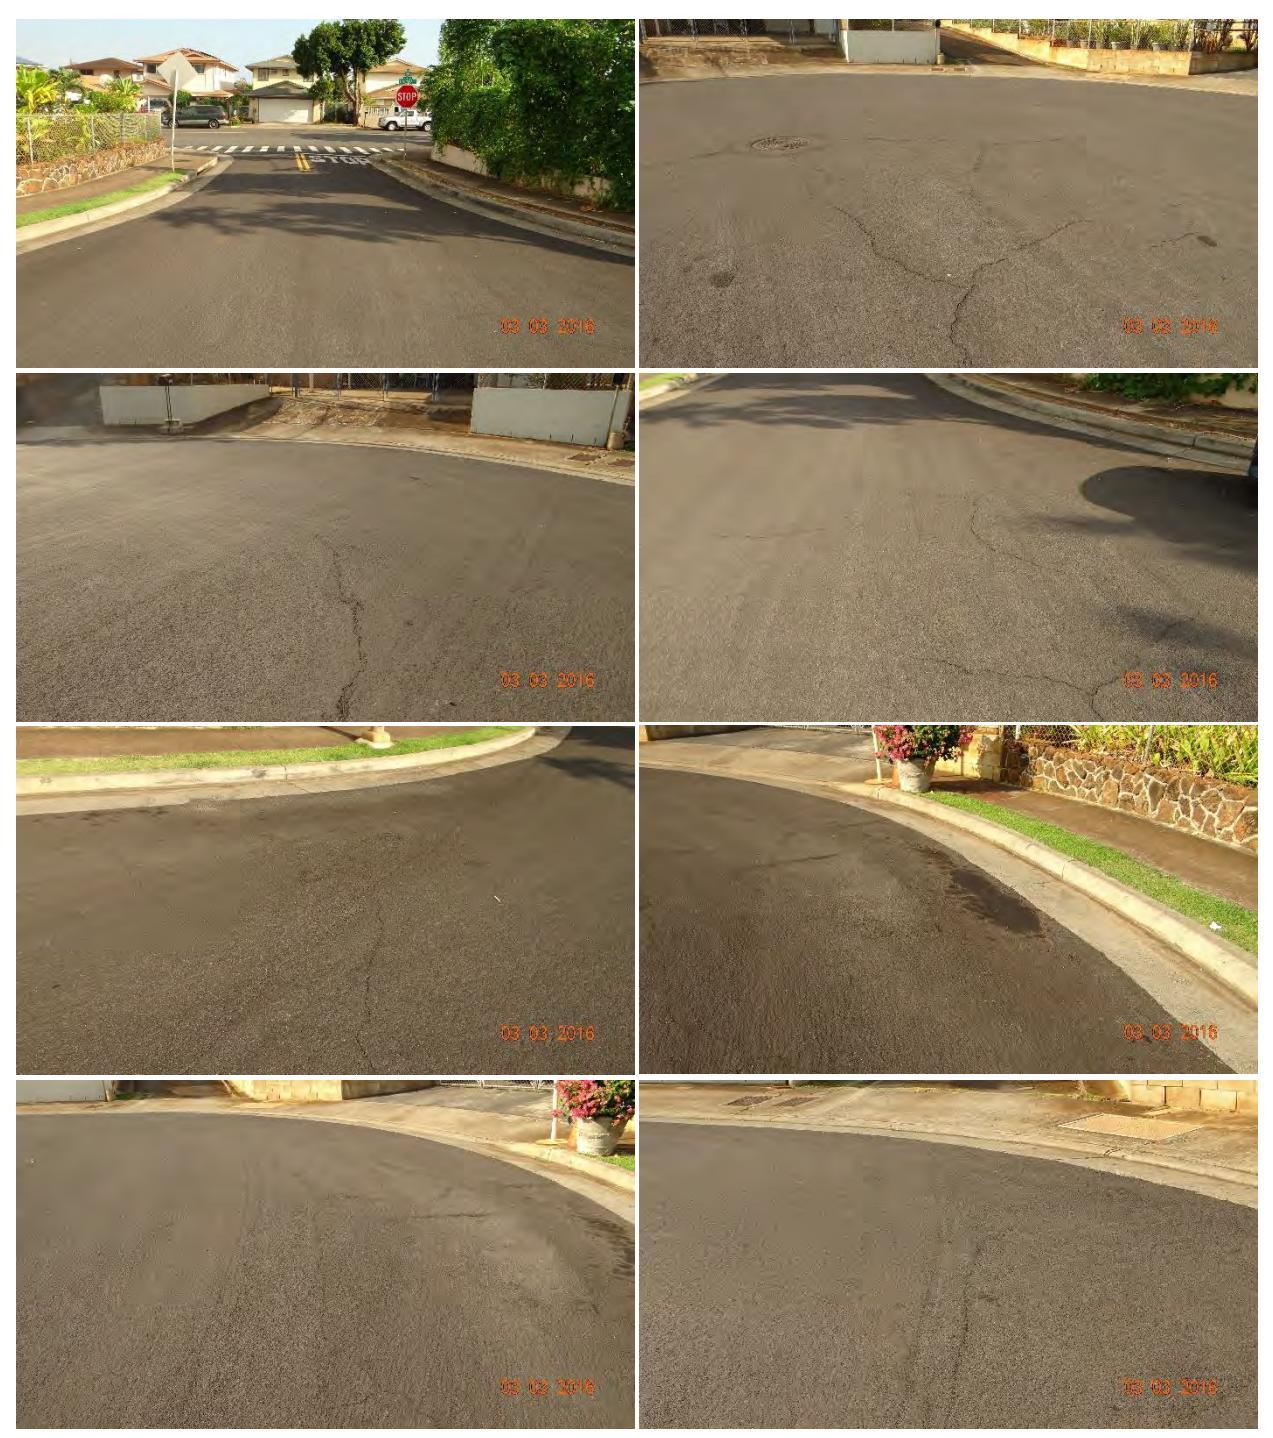
Figure C-155 Condition of the section on Hapapa Place, treated with Slurry Seal by Alakona Corp., on 3/3/2016.

The same can be said about the conditions on 3/3/2016 shown in Figure C-155, with slightly more than 15 months in service, except that cracking was getting much more noticeable. These photos also illustrate the common occurrence of oil spots and the marks left during the slurry seal application.

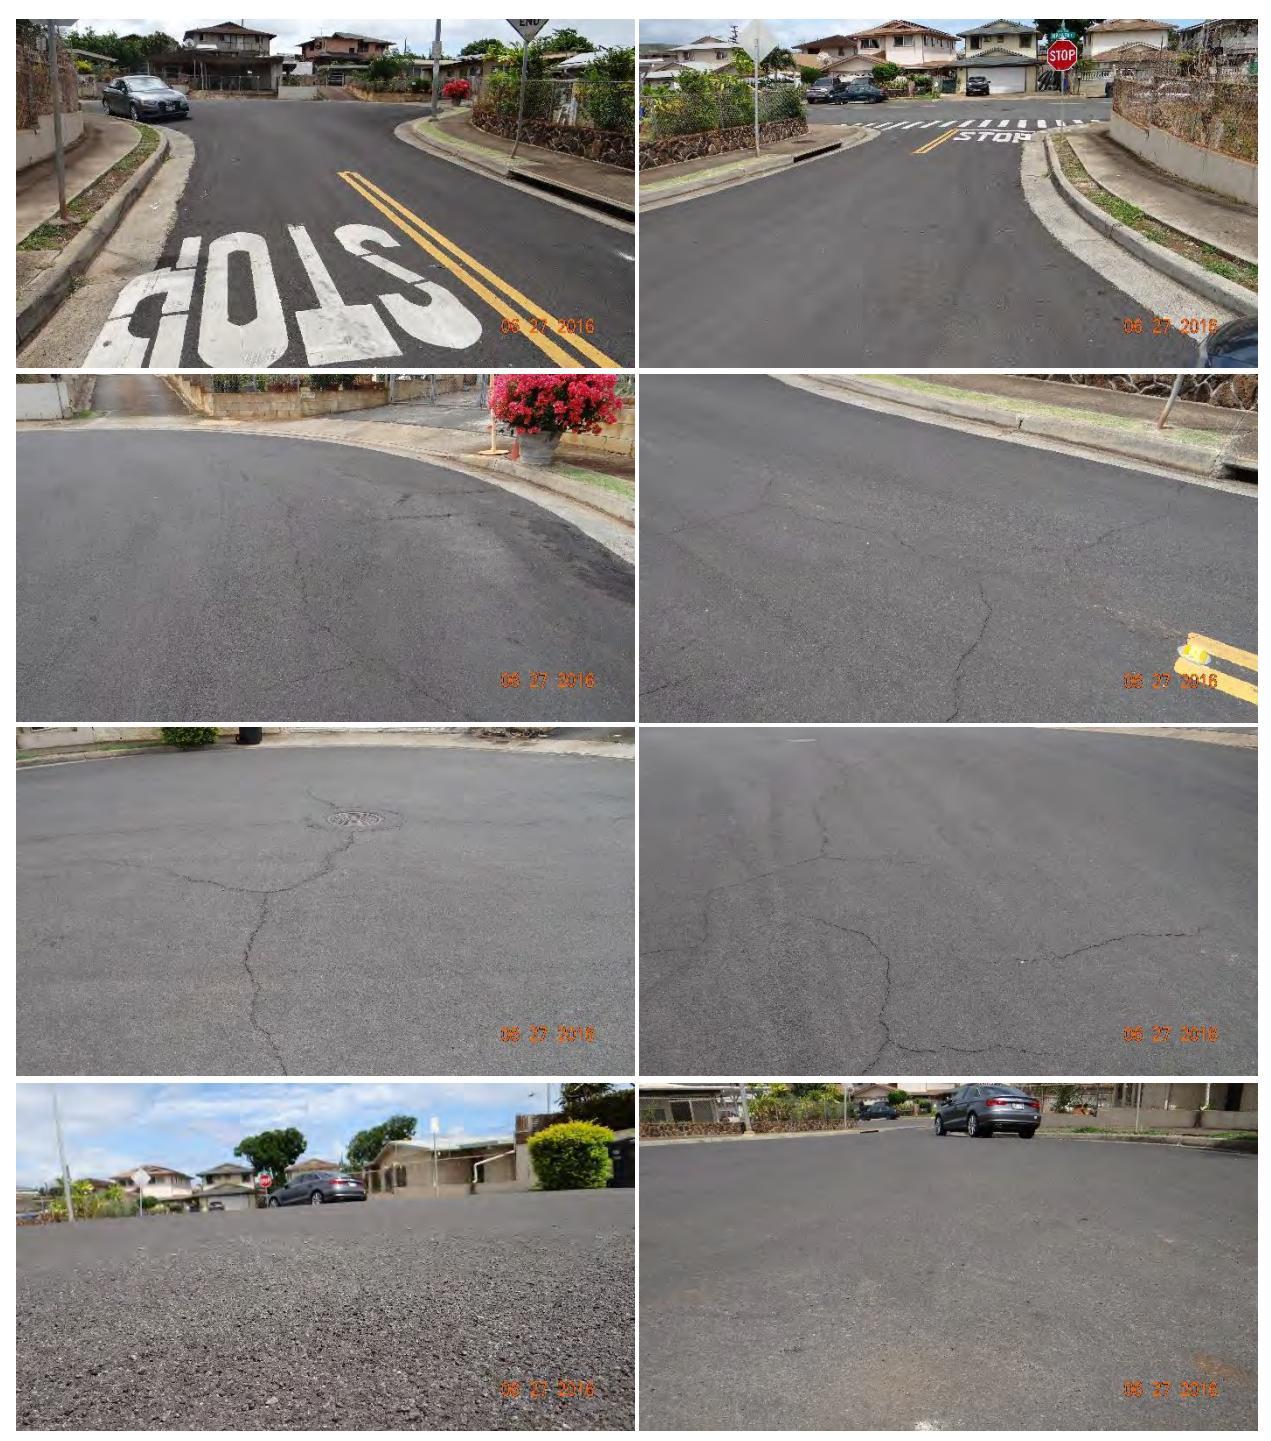
Figure C-156 Condition of the section on Hapapa Place, treated with Slurry Seal by Alakona Corp., on 6/27/2016.

Figure C-156 shows the conditions almost four month later, on 6/27/2016. Note the last two photos in this figure showing the common issue of loose aggregates in the surface.

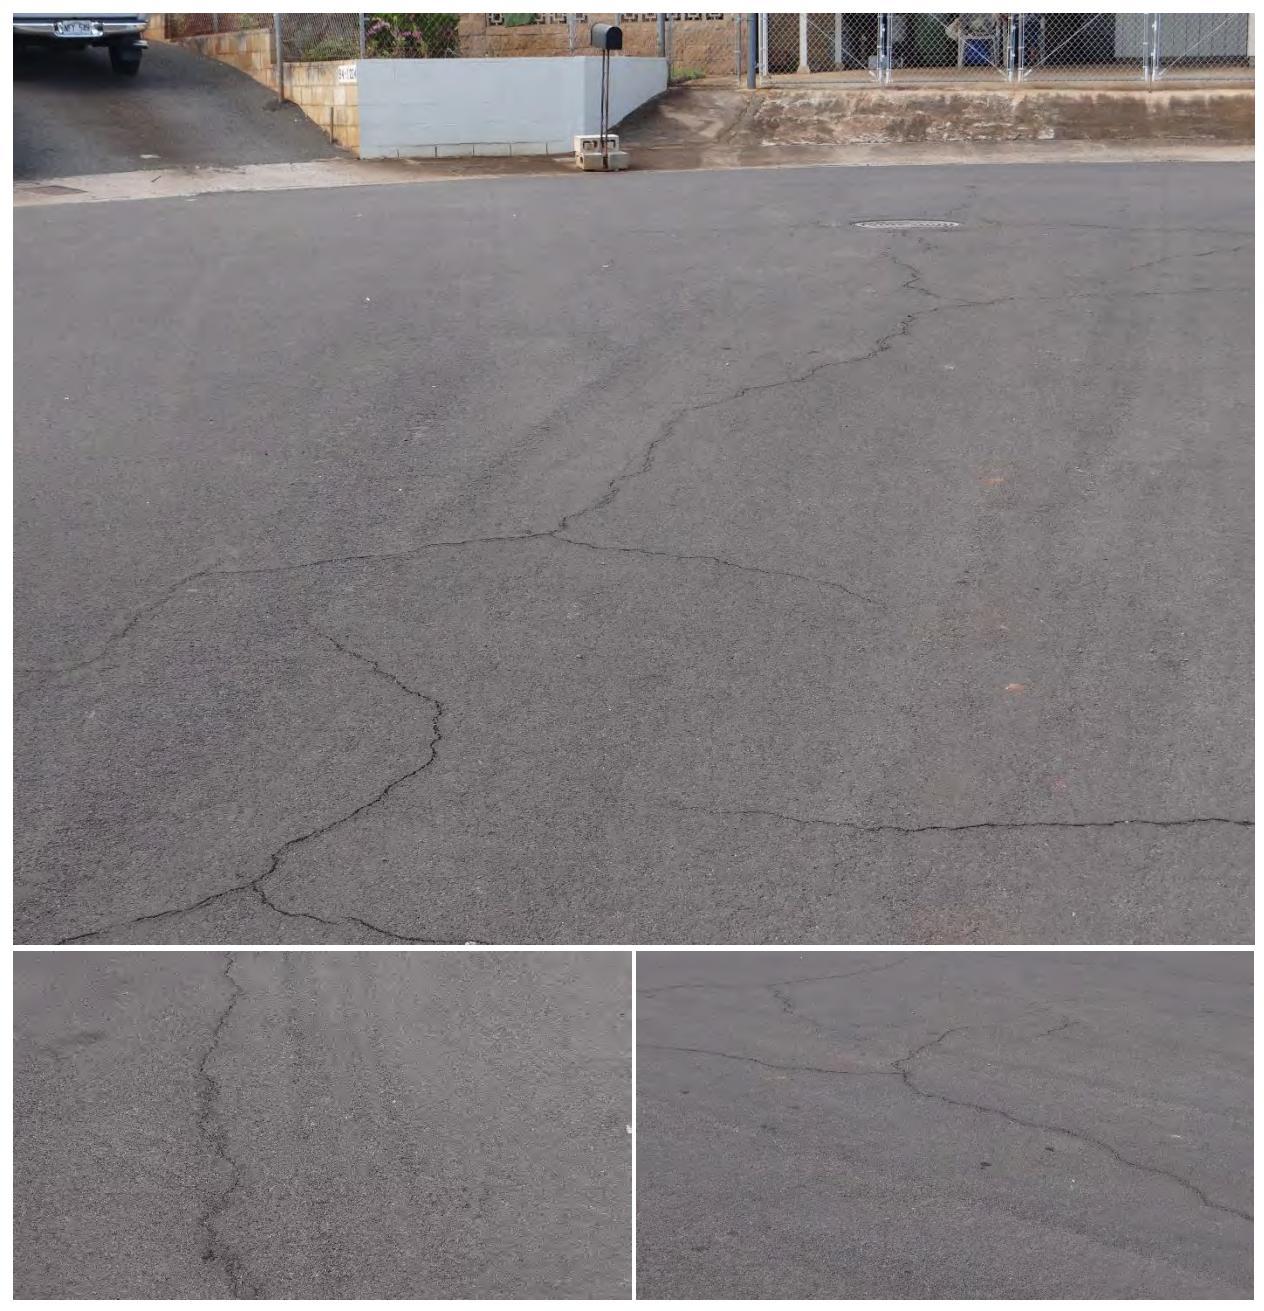
Figure C-157 Condition of the section on Hapapa Place, treated with Slurry Seal by Alakona Corp., on 12/14/2016.

Figure C-157 and Figure C-158 show the conditions on 12/14/2016 and 2/7/2018. These figures illustrate that cracking continued growing in length steadily and eventually surpassed the length of cracking existing before the application of the slurry seal. Many of these cracks were also getting wider.

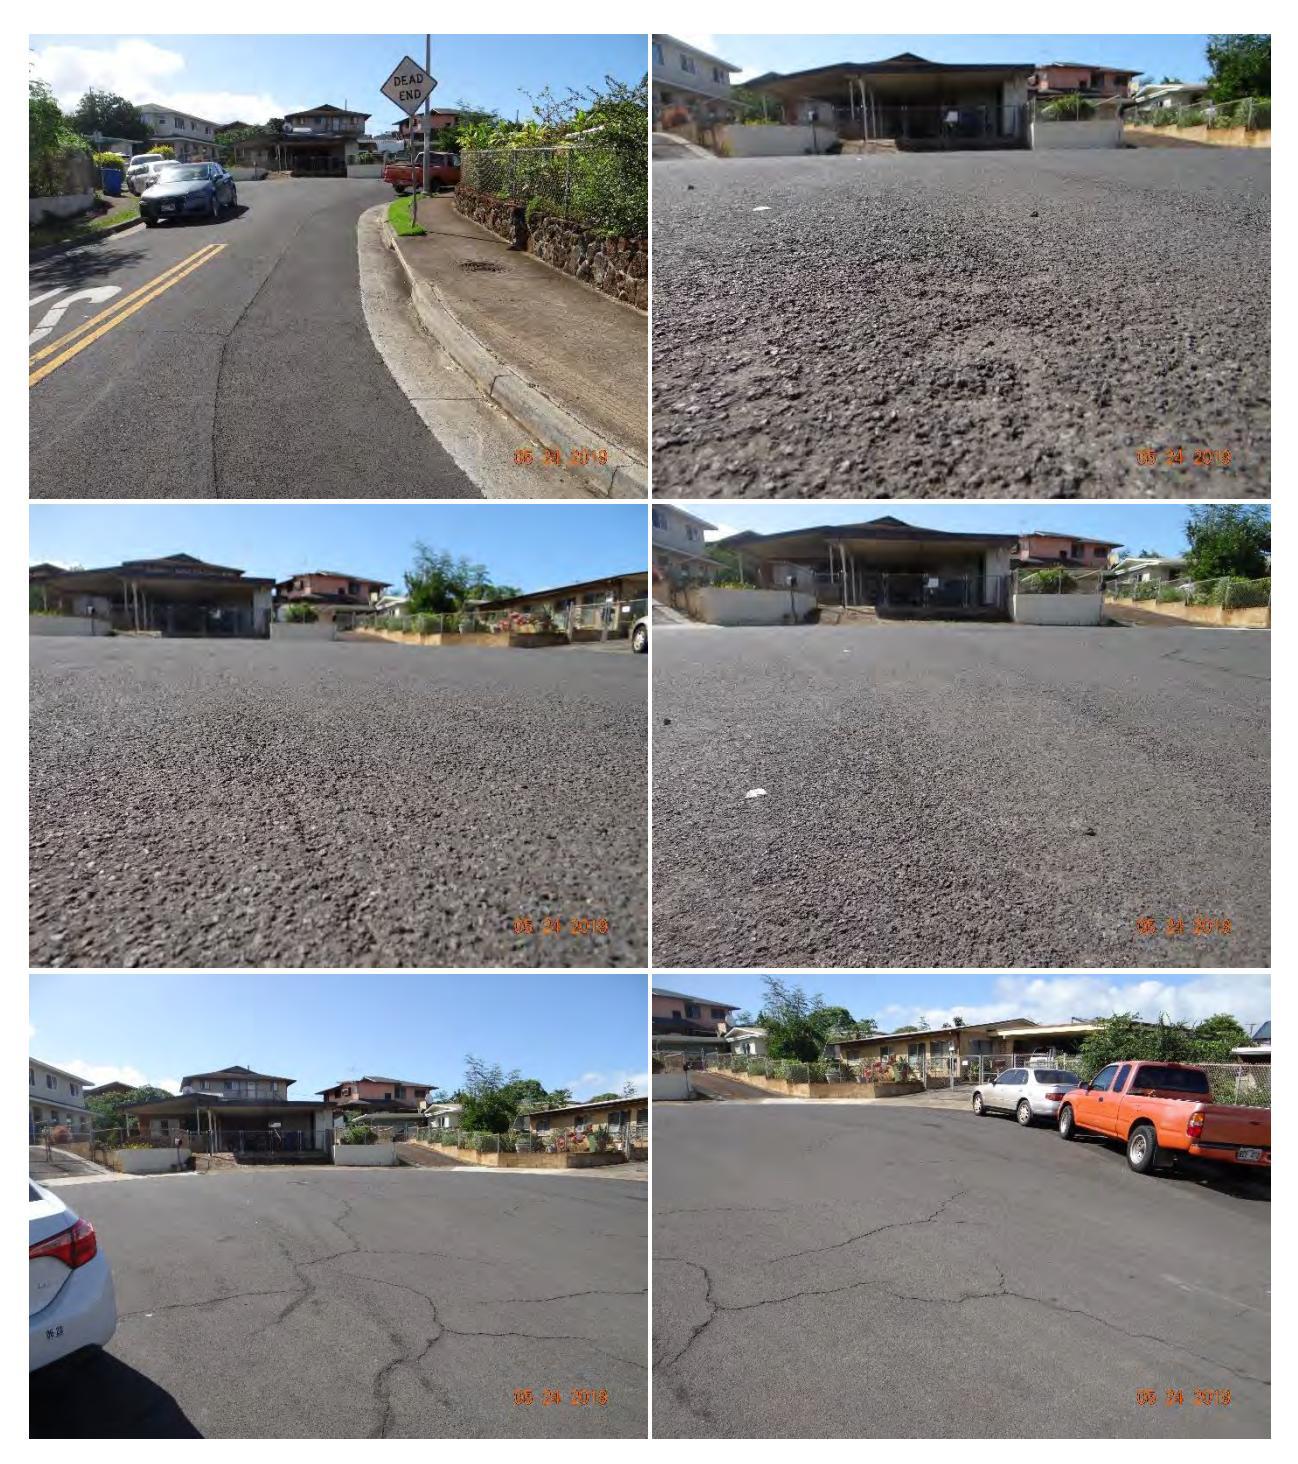
Figure C-159 Condition of the section on Hapapa Place, treated with Slurry Seal by Alakona Corp., on 5/24/2019.

As shown in Figure C-159, part of the section had been patched before 5/24/2019. The figure also illustrates that in some areas there was significant loss of aggregate on the surface, creating a rough texture.
